**RE: Construction Storm Water, SIC 1542, NPDES Compliance Evaluation Inspection, Taos Municipal School District / Enos Garcia Elementary School 3<sup>rd</sup> - 5<sup>th</sup> Grade Addition, NMU001749, August 5, 2011**

**NPDES Compliance Inspection Report**

## NPDES Industrial Storm Water Worksheet (Construction)

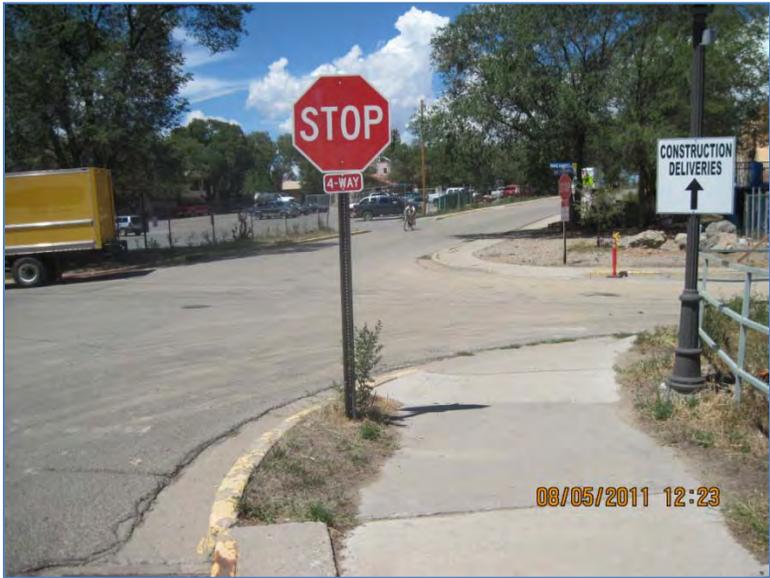
<b>NMED/SWQB          Official Photograph Log          Photo # 1</b>		
Photographer: Erin S. Trujillo	Date: 08/05/2011	Time: 1223 hours
City/County: Taos / Taos		State: New Mexico
Location: Enos Garcia Elementary School 3rd - 5th Grade Addition, Taos Municipal School District		
Subject: Accumulated sediment on Manzanares Street had been tracked onto Don Fernando Street. Drop inlets to storm sewer exist at this intersection.

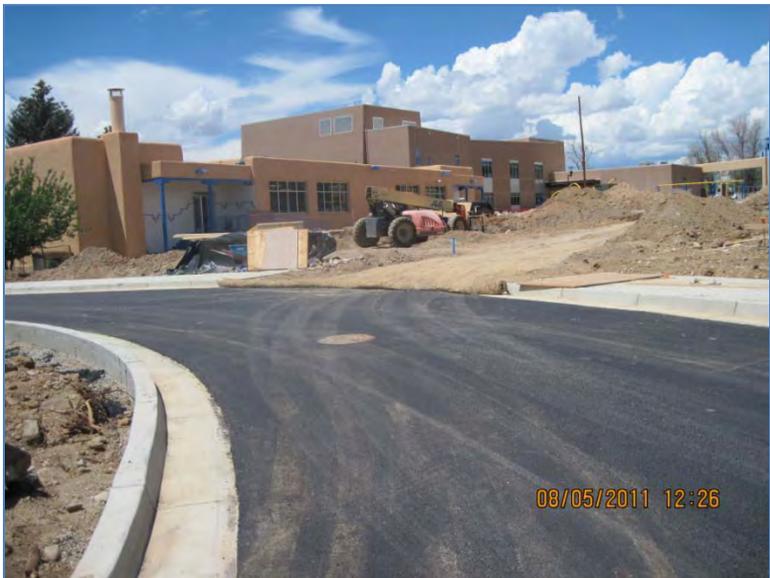
<b>NMED/SWQB          Official Photograph Log          Photo # 2</b>		
Photographer: Erin S. Trujillo	Date: 08/05/2011	Time: 1226 hours
City/County: Taos / Taos		State: New Mexico
Location: Enos Garcia Elementary School 3rd - 5th Grade Addition, Taos Municipal School District		
Subject: No track out control as described in SWPPP. Straw-filled sock at edge of unpaved driveway did not appear sufficient to control tracking. Drainage from driveway would flow to Manzanares St. & Don Fernando St. with drop inlets to storm sewer.

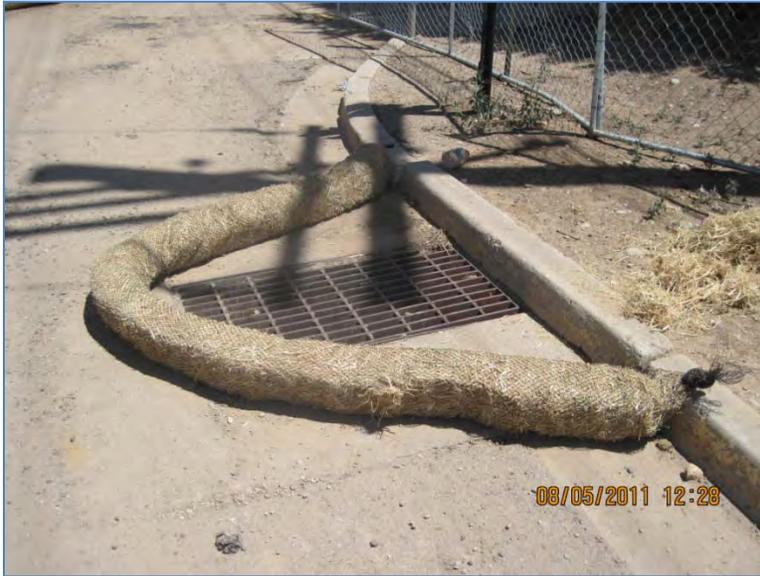
<b>NMED/SWQB          Official Photograph Log          Photo # 3</b>		
Photographer: Erin S. Trujillo	Date: 08/05/2011	Time: 1229 hours
City/County: Taos / Taos	State: New Mexico	
Location: Enos Garcia Elementary School 3rd - 5th Grade Addition, Taos Municipal School District		
Subject: Straw-filled sock around drop inlet on Manzanares Street. Drop inlet protection not installed as described in SWPPP.
