NEW MEXICO
ENVIRONMENT DEPARTMENT
Surface Water Quality Bureau

RE: Construction Storm Water, SIC 1542, NPDES Compliance Evaluation Inspection, Taos Municipal School District / Bus Barn and Fill Area, NMU001755, August 9, 2011

NPDES Compliance Inspection Report

Taos Municipal School District
NPDES Tracking No. NMU001755
Taos Municipal School District Bus Barn and Fill Area
August 9, 2011

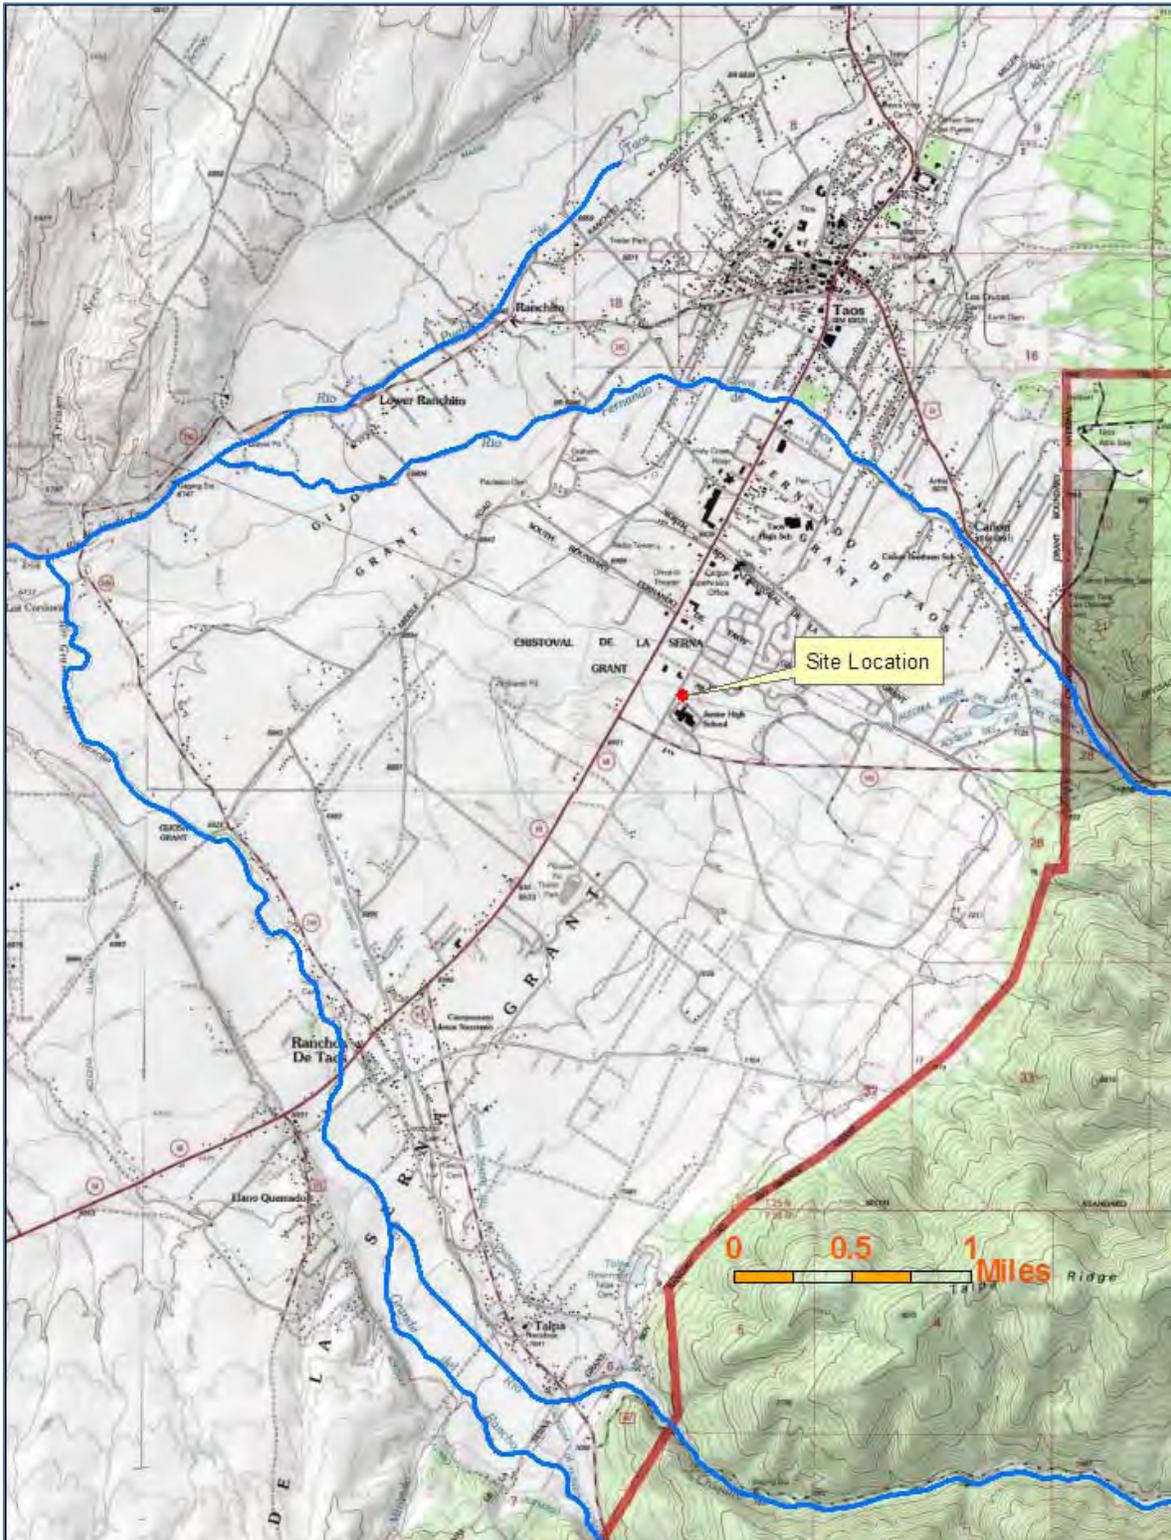
NMED/SWQB Approximate Area of Disturbance		
Created by: Erin S. Trujillo		
City/County: Taos / Taos		State: New Mexico
Location: Bus Barn and Fill Area, Taos Municipal School District		
Notes: The approximate location of disturbance on the day of this inspection is shown for informational purposes. The area was not surveyed by the inspector.

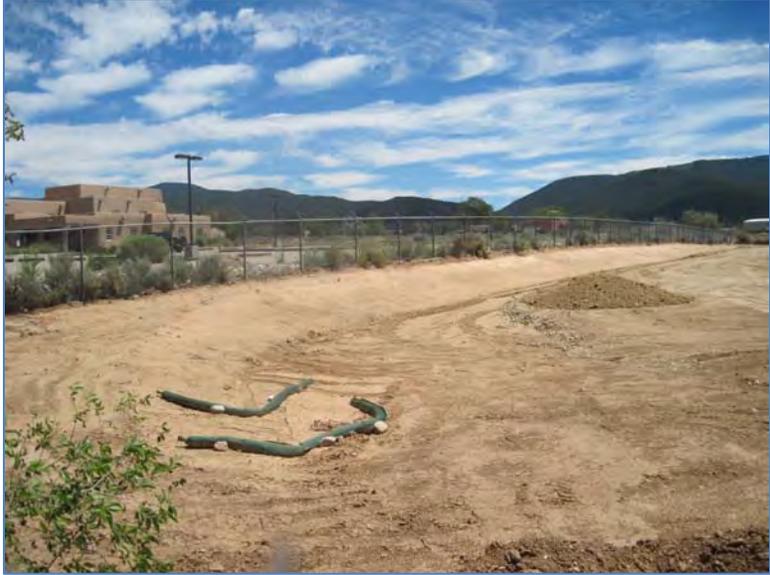
NMED/SWQB Official Photograph Log Photo # 1		
Photographer: Erin S. Trujillo	Date: 08/09/2011	Time: 1232 hours
City/County: Taos / Taos	State: New Mexico	
Location: Bus Barn and Fill Area, Taos Municipal School District		
Subject: Constructed side slope not stabilized per definition in 2008 CGP. Socks do not appear to be of sufficient quantity, length across width of channel or position to provide sediment filtration during rain event.

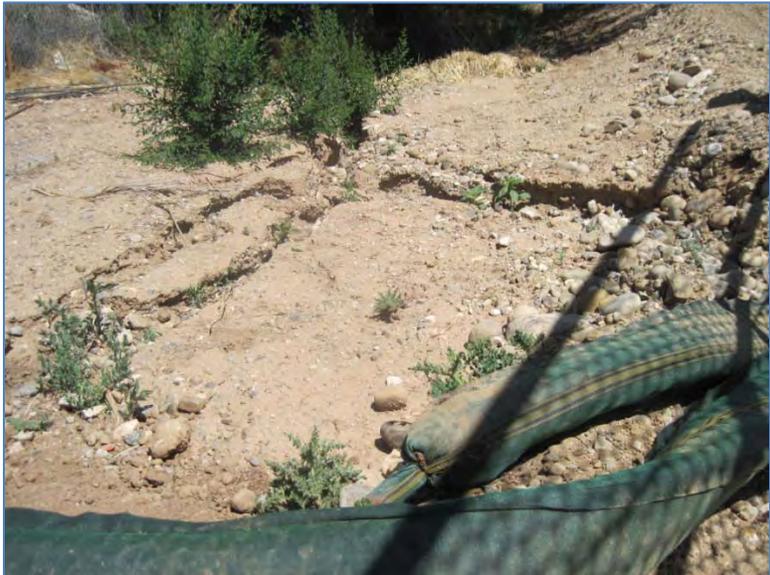
NMED/SWQB Official Photograph Log Photo # 2		
Photographer: Erin S. Trujillo	Date: 08/09/2011	Time: 1238 hours
City/County: Taos / Taos	State: New Mexico	
Location: Bus Barn and Fill Area, Taos Municipal School District		
Subject: Erosion rills in western portion of the site. Sock had been moved (not installed) near entrance.

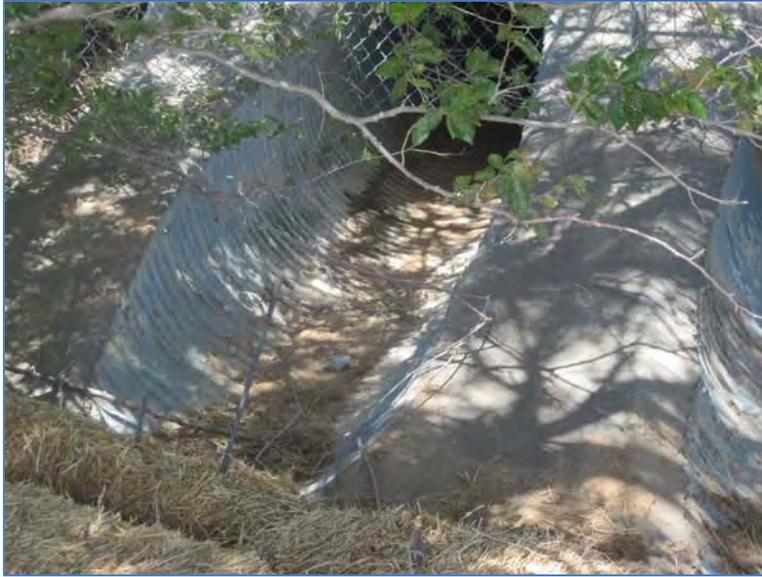
NMED/SWQB Official Photograph Log Photo # 3		
Photographer: Erin S. Trujillo	Date: 08/09/2011	Time: 1241 hours
City/County: Taos / Taos	State: New Mexico	
Location: Bus Barn and Fill Area, Taos Municipal School District		
Subject: Accumulated sediment and loose hay at culverts leading off site.

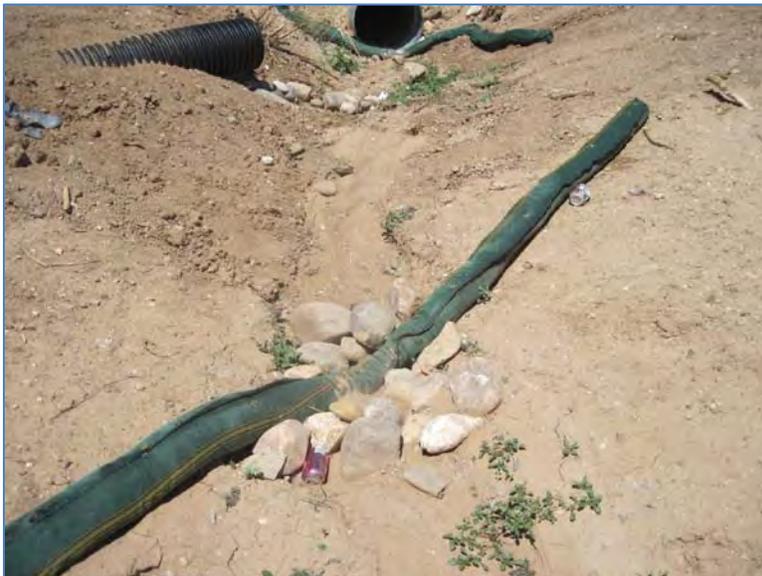
NMED/SWQB Official Photograph Log Photo # 4		
Photographer: Erin S. Trujillo	Date: 08/09/2011	Time: 1307 hours
City/County: Taos / Taos	State: New Mexico	
Location: Bus Barn and Fill Area, Taos Municipal School District		
Subject: Erosion, rock and compost sock in constructed channel. Sediment has accumulated at rock, on sock and in culvert. Measures near culvert inlet do not appear to be of a height or position to provide sediment filtration during rain event.

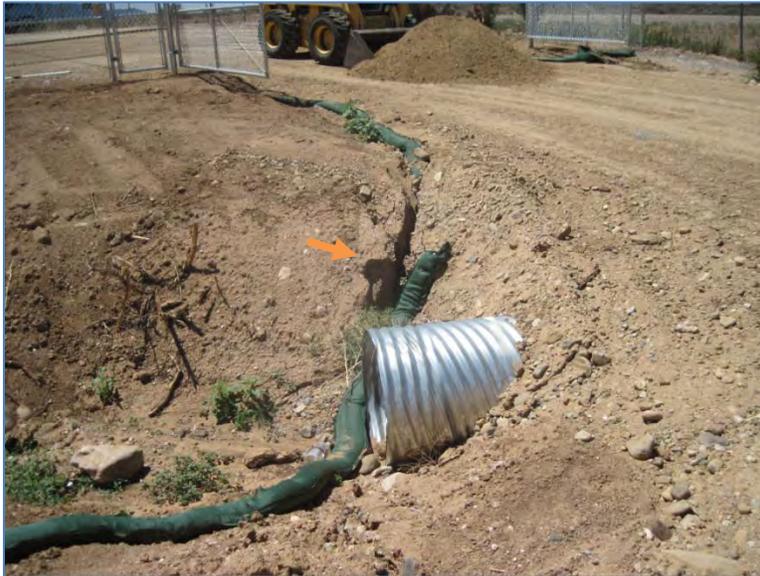
NMED/SWQB Official Photograph Log Photo # 5		
Photographer: Erin S. Trujillo	Date: 08/09/2011	Time: 1307 hours
City/County: Taos / Taos		State: New Mexico
Location: Bus Barn and Fill Area, Taos Municipal School District		
Subject: Sock placed along road fill and in front of culvert inlet. Arrow points to erosion rill along the sock leading to culvert inlet. Accumulated sediment on sock indicates that the measure was overtopped during rain event.

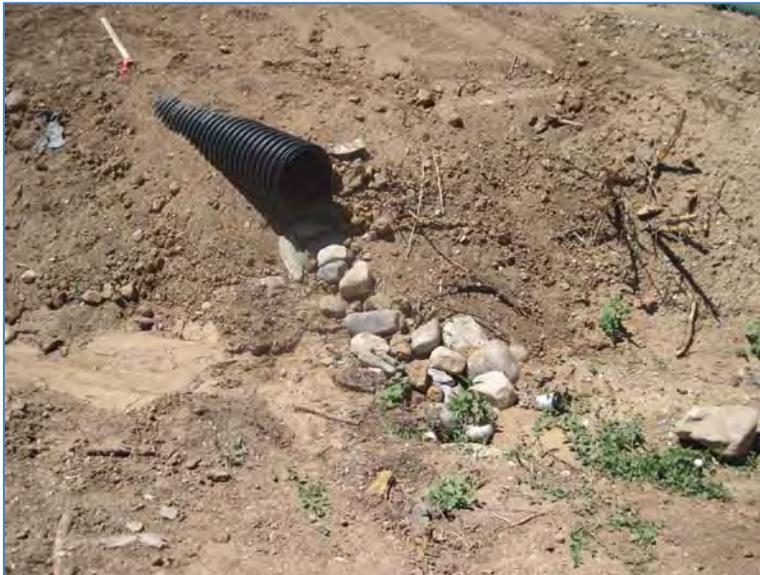
NMED/SWQB Official Photograph Log Photo # 6		
Photographer: Erin S. Trujillo	Date: 08/09/2011	Time: 1307 hours
City/County: Taos / Taos		State: New Mexico
Location: Bus Barn and Fill Area, Taos Municipal School District		
Subject: Rock had been placed beneath a storm water pipe outlet. Permanent outfall erosion control measures appear needed at drainage outlets.

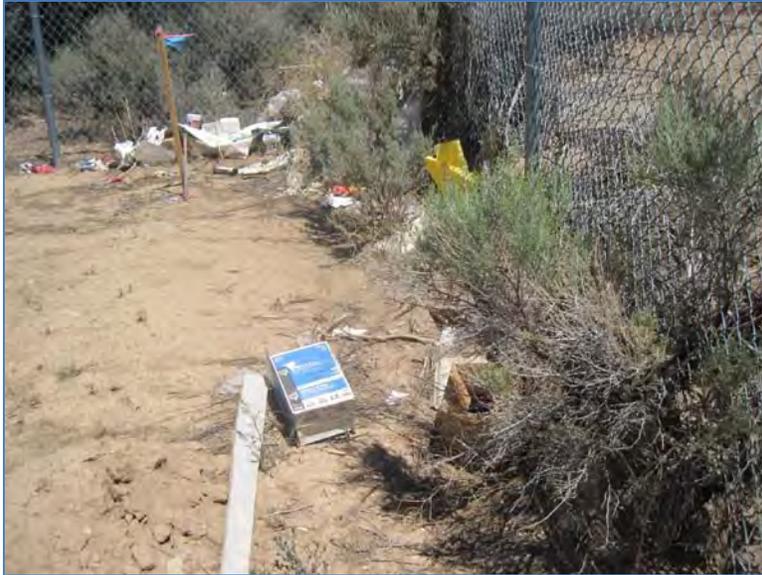
NMED/SWQB Official Photograph Log Photo # 7		
Photographer: Erin S. Trujillo	Date: 08/09/2011	Time: 1313 hours
City/County: Taos / Taos	State: New Mexico	
Location: Bus Barn and Fill Area, Taos Municipal School District		
Subject: Windblown trash and some construction debris had accumulated at this location.

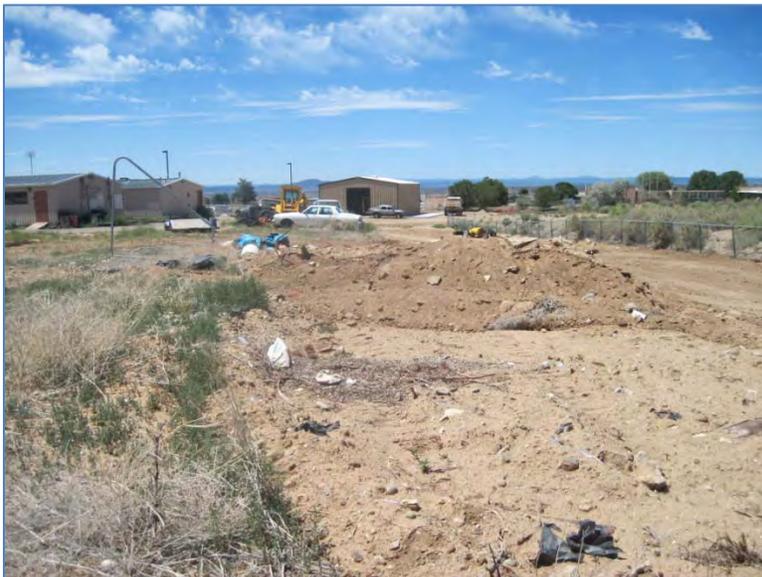
NMED/SWQB Official Photograph Log Photo # 8		
Photographer: Erin S. Trujillo	Date: 08/09/2011	Time: 1323 hours
City/County: Taos / Taos	State: New Mexico	
Location: Bus Barn and Fill Area, Taos Municipal School District		
Subject: Overview of additional fill area. Broken concrete and some trash was observed in fill.
