**RE: Construction Storm Water, SIC 1542, NPDES Compliance Evaluation Inspection, Silva's
Excavation, Inc. / Bus Barn and Fill Area, NMU001757, August 9, 2011**

Silva's Excavation, Inc.
Taos Municipal School District Bus Barn and Fill Area
NPDES Tracking No. NMU001757
August 9, 2011

NPDES Industrial Storm Water Worksheet (Construction)

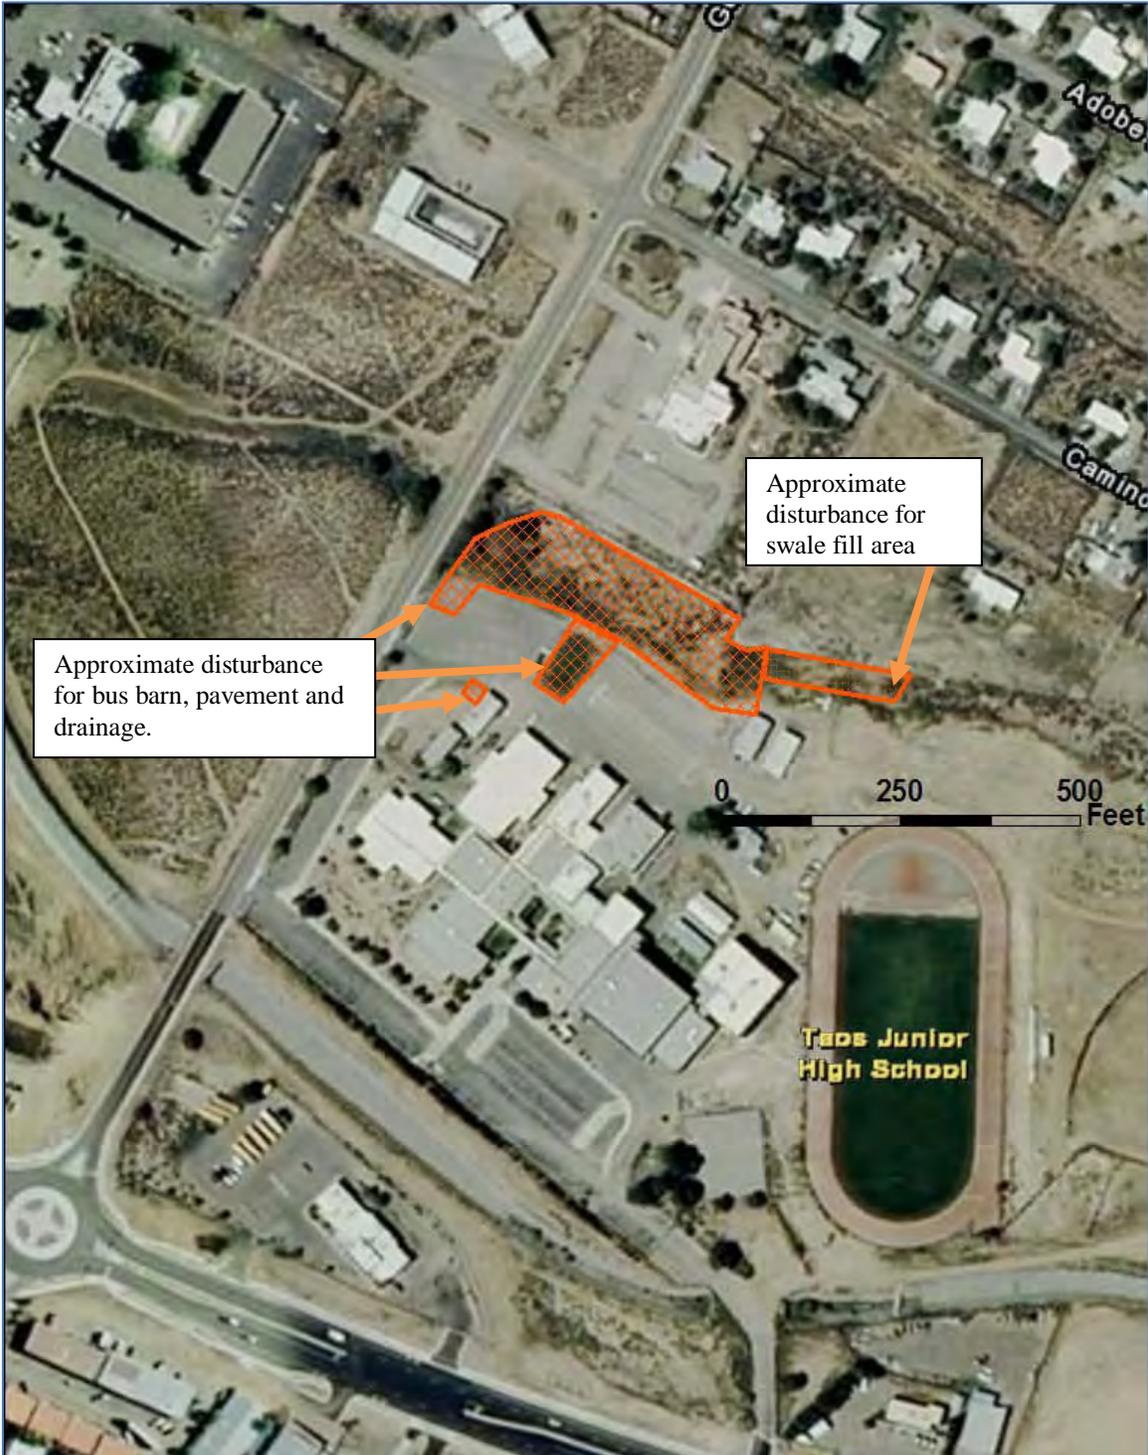
NMED/SWQB Approximate Area of Disturbance		
Created by: Erin S. Trujillo		
City/County: Taos / Taos		State: New Mexico
Location: Bus Barn and Fill Area, Taos Municipal School District		
Notes: The approximate location of disturbance on the day of this inspection is shown for informational purposes. The area was not surveyed by the inspector.
