RE: Industrial Storm Water; SIC 1422; NPDES Compliance Evaluation Inspection; Oldcastle SW Group, Inc.;
NPDES Permit No. NMU001763; August 16, 2011

NPDES Compliance Inspection Report

**Compliance Evaluation Inspection
Four Corners Materials
August 16, 2011
NMU001763**

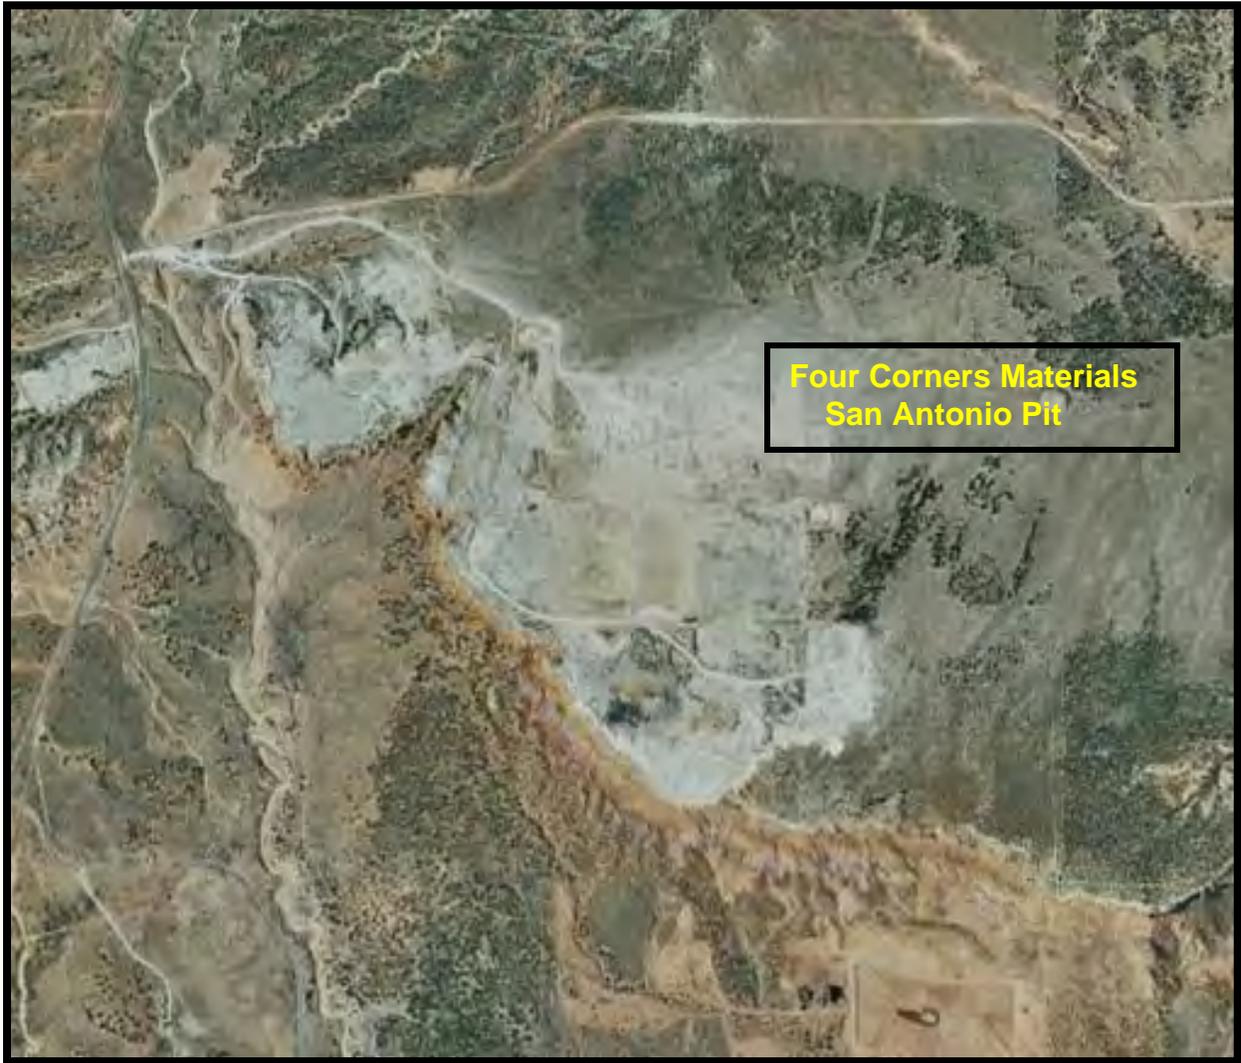
**NMED/SWQB
Site Overview**

City/County: East of Gallup, New Mexico /Cibola County	
Location: Approximately 5 miles northeast of Thoreau, New Mexico city limits	
Subject: Overview of mined area and surrounding area.
