RE: Industrial Storm Water; SIC 2499; NPDES Compliance Evaluation Inspection; Mt. Taylor Manufacturing, LLC; NPDES Permit NMU001767; September 29, 2011

NPDES Compliance Inspection Report

Mt. Taylor Manufacturing, LLC
Compliance Evaluation Inspection – Industrial Stormwater
NPDES Permit NMU001767
September 29, 2011

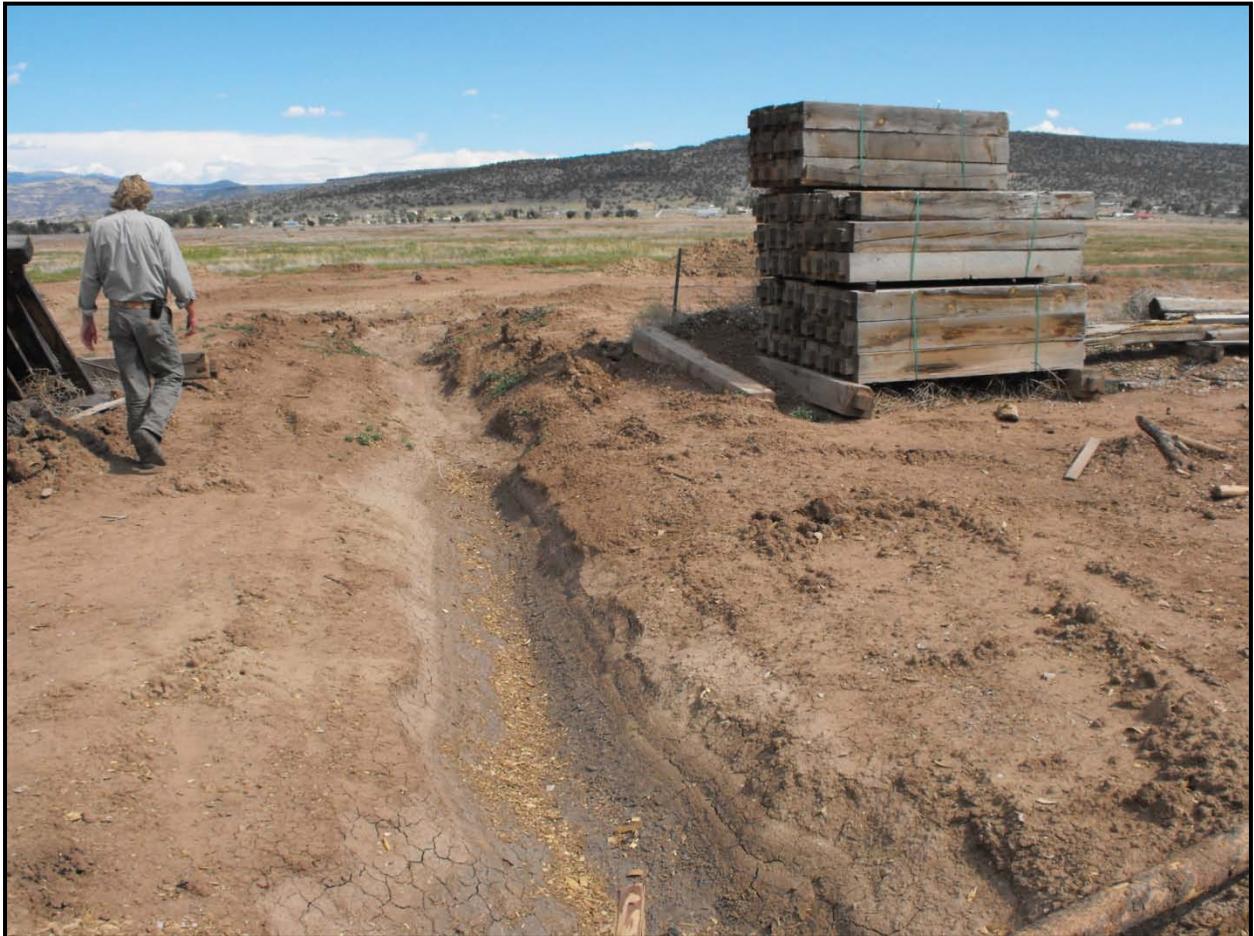
Photo # 1

Photographer: Daniel Valenta	Date: 9/29/2011	Time: 1429 hours
City/County: 1.8 miles north of Milan, NM/Cibola County		
Location: Mt. Taylor Manufacturing, LLC, West Old Rout 66 facing toward east side of property.		
Subject: Shallow ditches are present at the site to catch and direct stormwater.

The site the facility operates on is fairly flat; rainwater falling on the site tends to pond. A series of shallow channels has been dug to drain the area and collect rainwater in a settling pond found on the east side of the facility, (see photo 1). This depression may minimize pollutants from leaving the area and allow rainwater to be absorbed into the ground. An unmaintained berm is present along the southeast border of the property to reduce run-on or runoff of rainwater. An elevated roadbed for a railroad is present along the west side of the property.

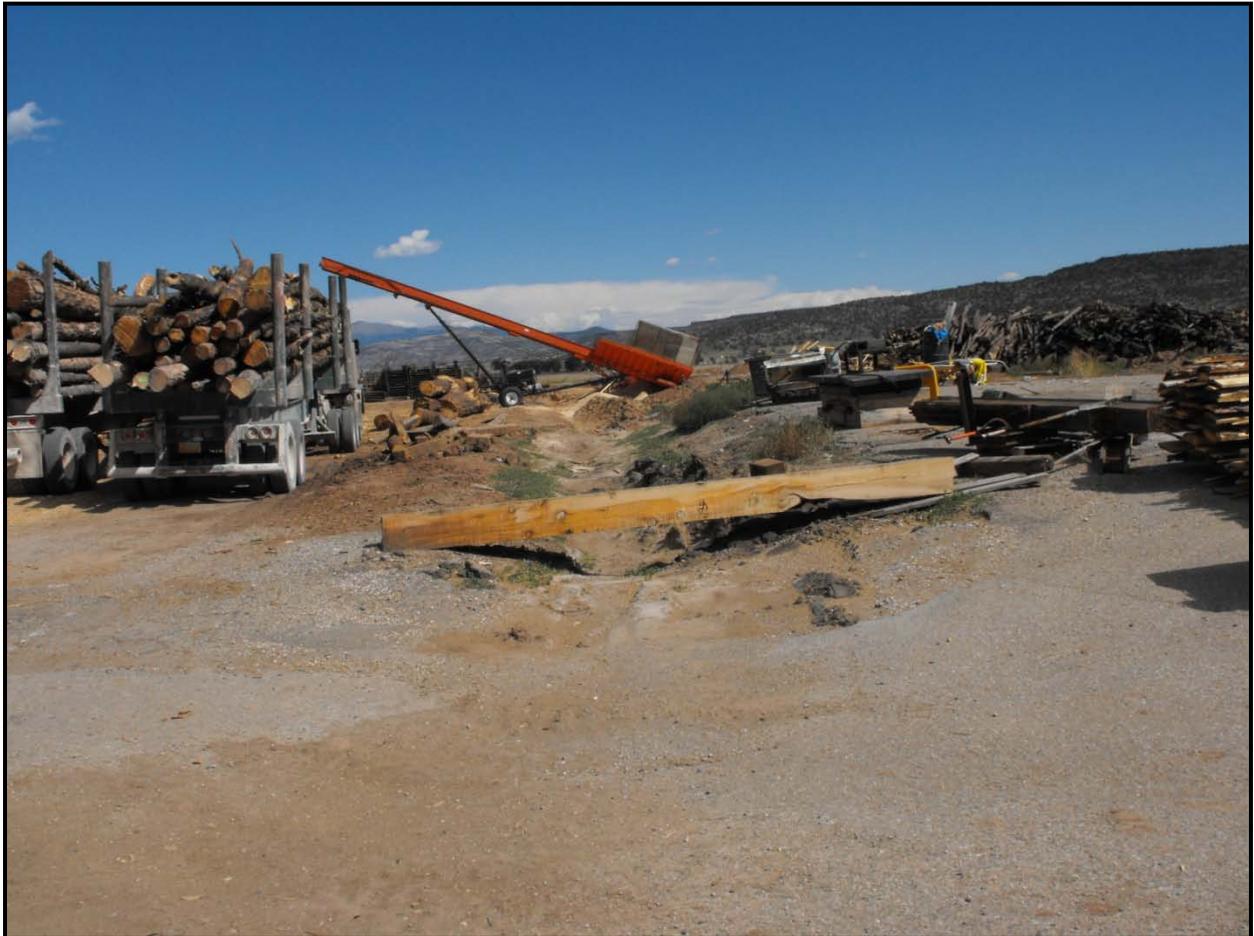
Photo # 2

Photographer: Daniel Valenta	Date: 9/29/2011	Time: 1427 hours
City/County: 1.8 miles north of Milan, NM/Cibola County		
Location: Mt. Taylor Manufacturing, LLC, West Old Rout 66 facing toward east side of property.		
Subject: Shallow ditches are present to catch and direct stormwater, unloading logs for processing.

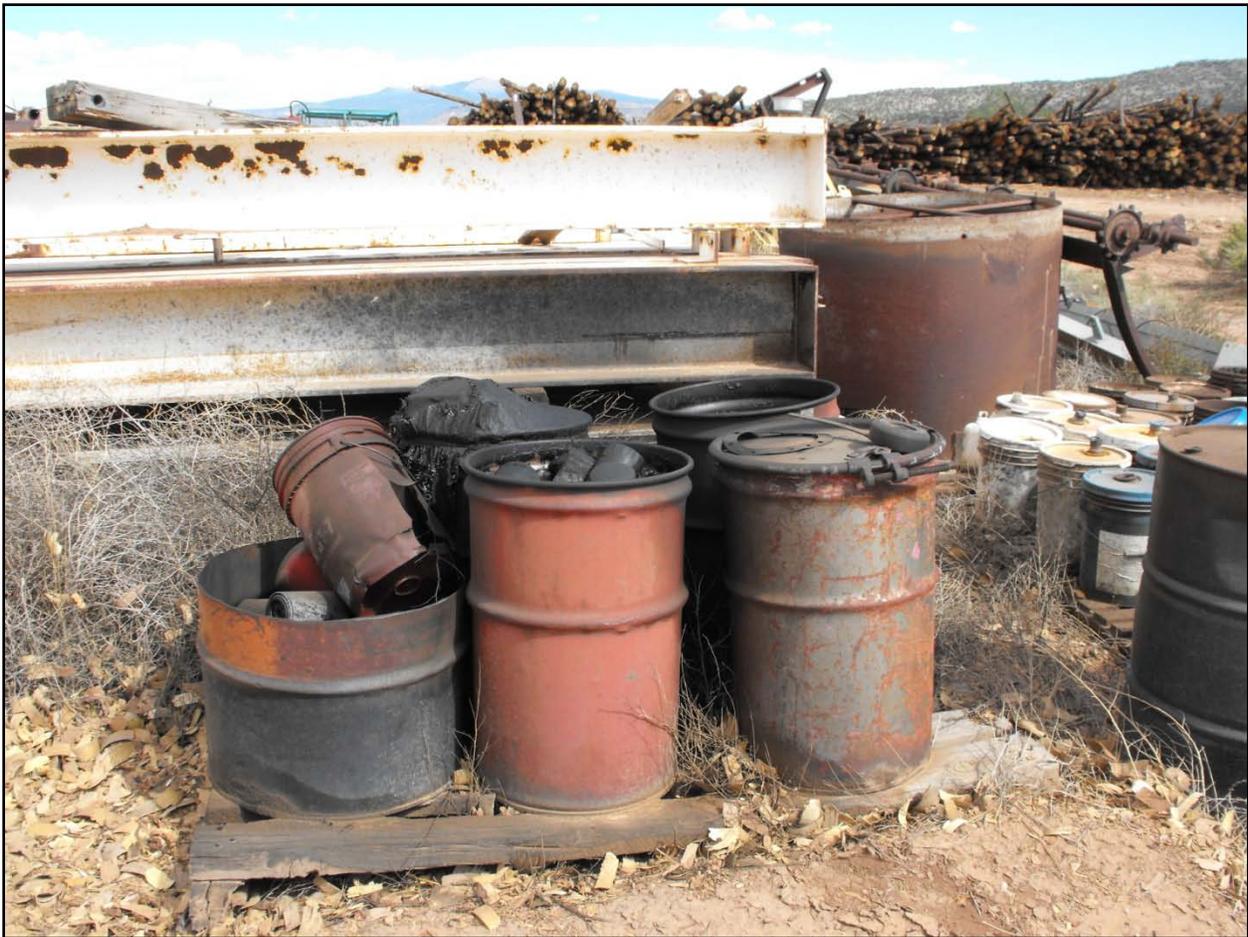
Photo # 3

Photographer: Daniel Valenta	Date: 9/29/2011	Time: 1434 hours
City/County: 1.8 miles north of Milan, NM/Cibola County		
Location: Mt. Taylor Manufacturing, LLC, West Old Rout 66 facing toward east side of property.		
Subject: Open containers of oil in scrap metal area.
