RE: Industrial Storm Water; SIC 5093; NPDES Compliance Evaluation Inspection; Salvage Plus Metal Recycling; NPDES Permit NMU001771; October 12, 2011

NPDES Compliance Inspection Report

Salvage Plus Metal Recycling
NPDES Tracking No. NMU001771
October 12, 2011

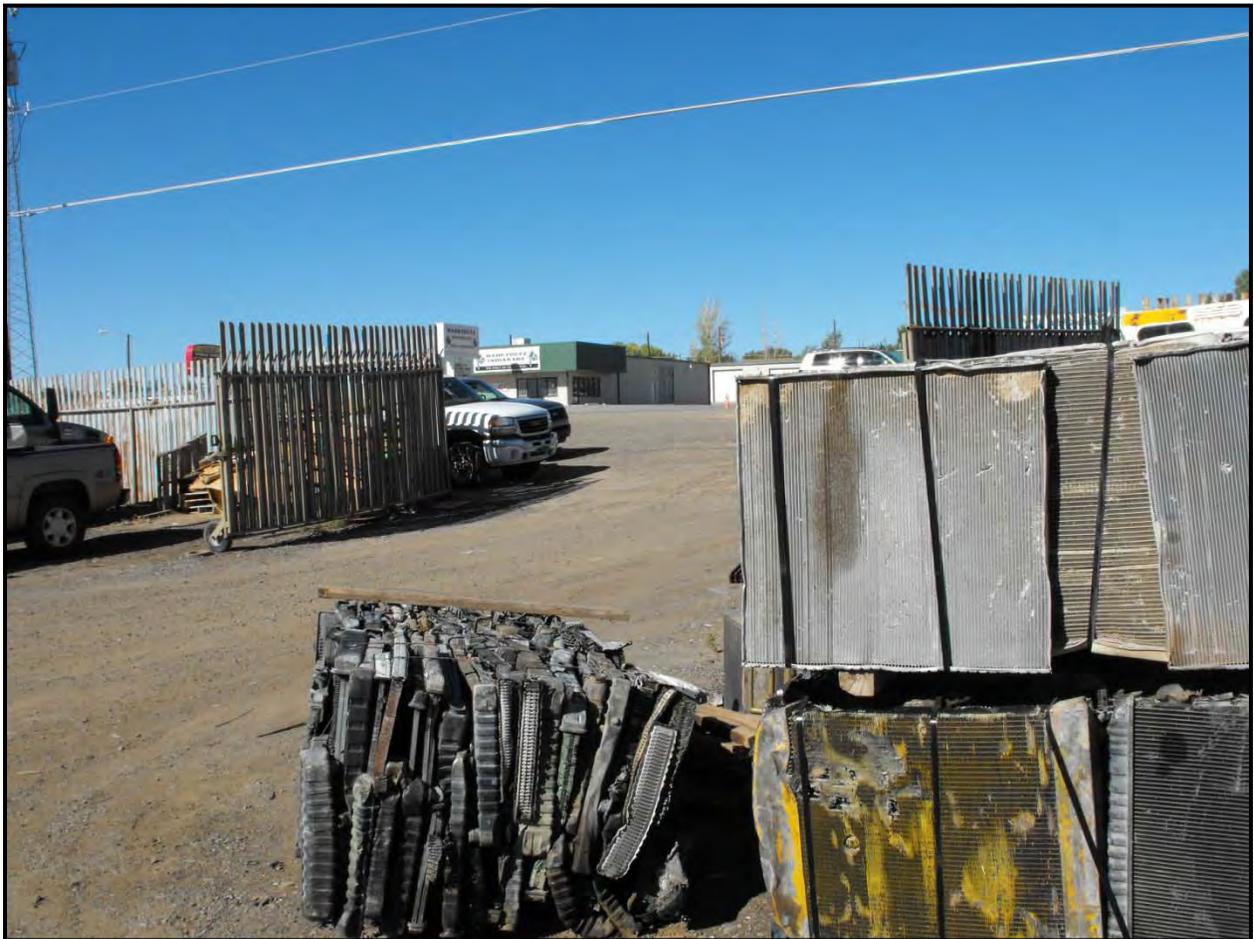
Photo # 1

The site slopes toward the south, towards the river. Hwy 64 in front of the business drains towards the site, (see photo 1). The 4 acre site has a small sand berm at the back of the property (see photo 2). At both back corners of the property there appears to be small unmaintained containment ponds. These have been partially filled in by blowing sand. It is unknown when these Best Management Practices (BMP's) were installed. During the writing of this report the Inspector was contacted by a stormwater consultant who has been contracted to review the site and develop a SWPPP. An NOI was filed on 10/25/2011 with coverage beginning on 11/24/2011, NMR05HK35.

Photographer: Daniel Valenta	Date: 10/12/2011	Time: 1510 hours
City/County: Kirtland/San Juan		
Location: Salvage Plus Metal Recycling, 4279 Hwy 64, Kirtland, New Mexico, facing north.		
Subject: Main entrance road into the salvage yard, note slope is inward.

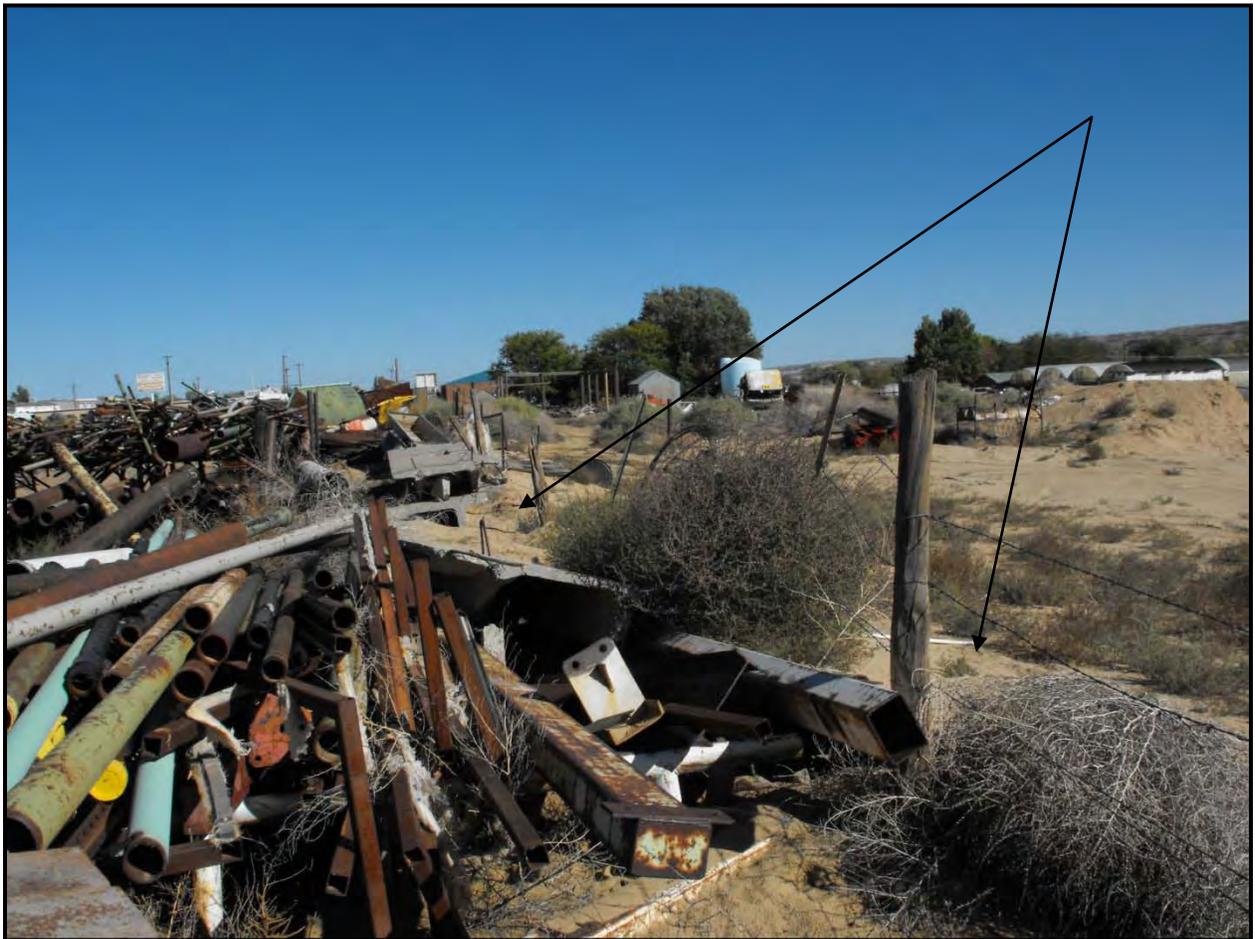
Photo # 2

Photographer: Daniel Valenta	Date: 10/12/2011	Time: 1532 hours
City/County: Kirtland/San Juan		
Location: Salvage Plus Metal Recycling, 4279 Hwy 64, Kirtland, New Mexico, facing east.		
Subject: At the back of property is an unmaintained berm.

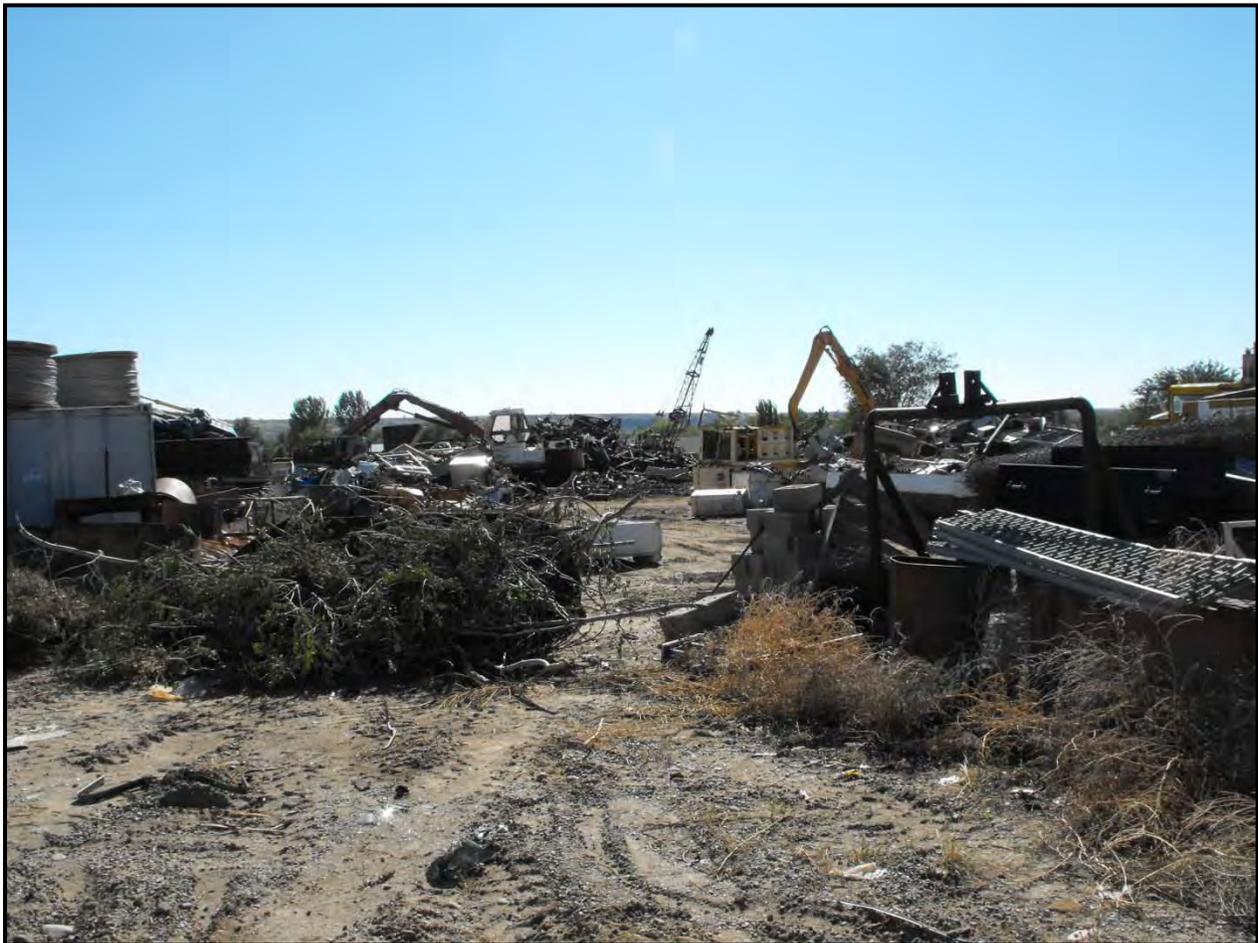
Photo # 3

At the site a wide variety of materials are brought in to be sold and recycled. Some items observed were white goods, automotive rims and tires; radiators, see attached photos of assortment of items. Metal items were sorted into piles depending on the type of material, sorting involved cutting, crushing, and stacking.

Photographer: Daniel Valenta	Date: 10/12/2011	Time: 1514 hours
City/County: Kirtland/San Juan		
Location:	Salvage Plus Metal Recycling, 4279 Hwy 64, Kirtland, New Mexico, facing south.	
Subject:	Looking across the property, north to south, various sorting, crushing, and cutting activities.
