**RE: Industrial Storm Water; SIC 5093; NPDES Compliance Evaluation Inspection; Malouff Salvage;
NPDES Permit NMU001772; October 12, 2011**

NPDES Compliance Inspection Report

Malouff Salvage
NPDES Tracking No. NMU001772
October 24, 2011

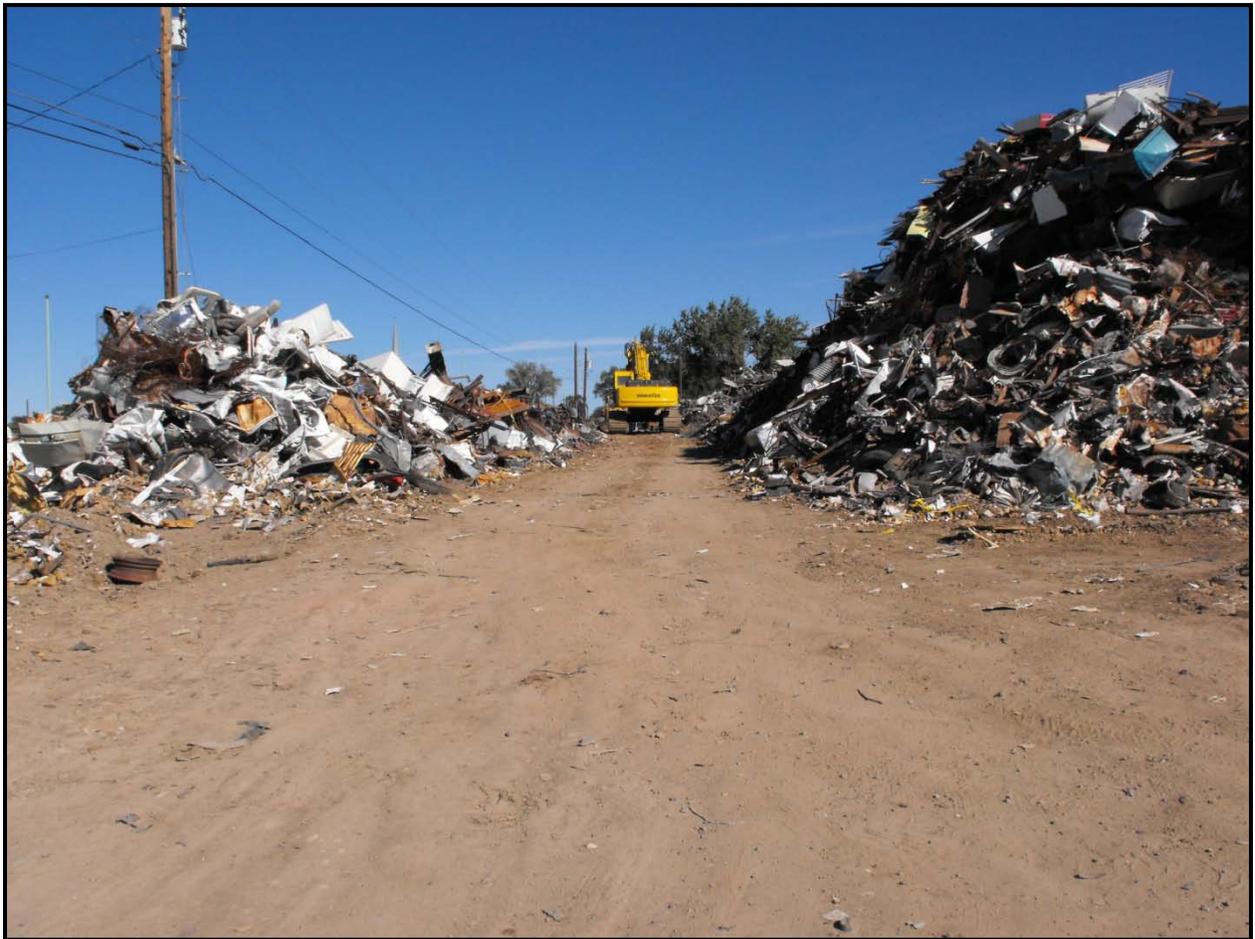
Photo # 1

Photographer: Daniel Valenta	Date: 10/12/2011	Time: 1044 hours
City/County: Kirtland/San Juan		
Location: Malouff Salvage, 4140 Hwy 64, Kirtland, New Mexico, facing north.		
Subject: Main entrance road through the salvage yard.

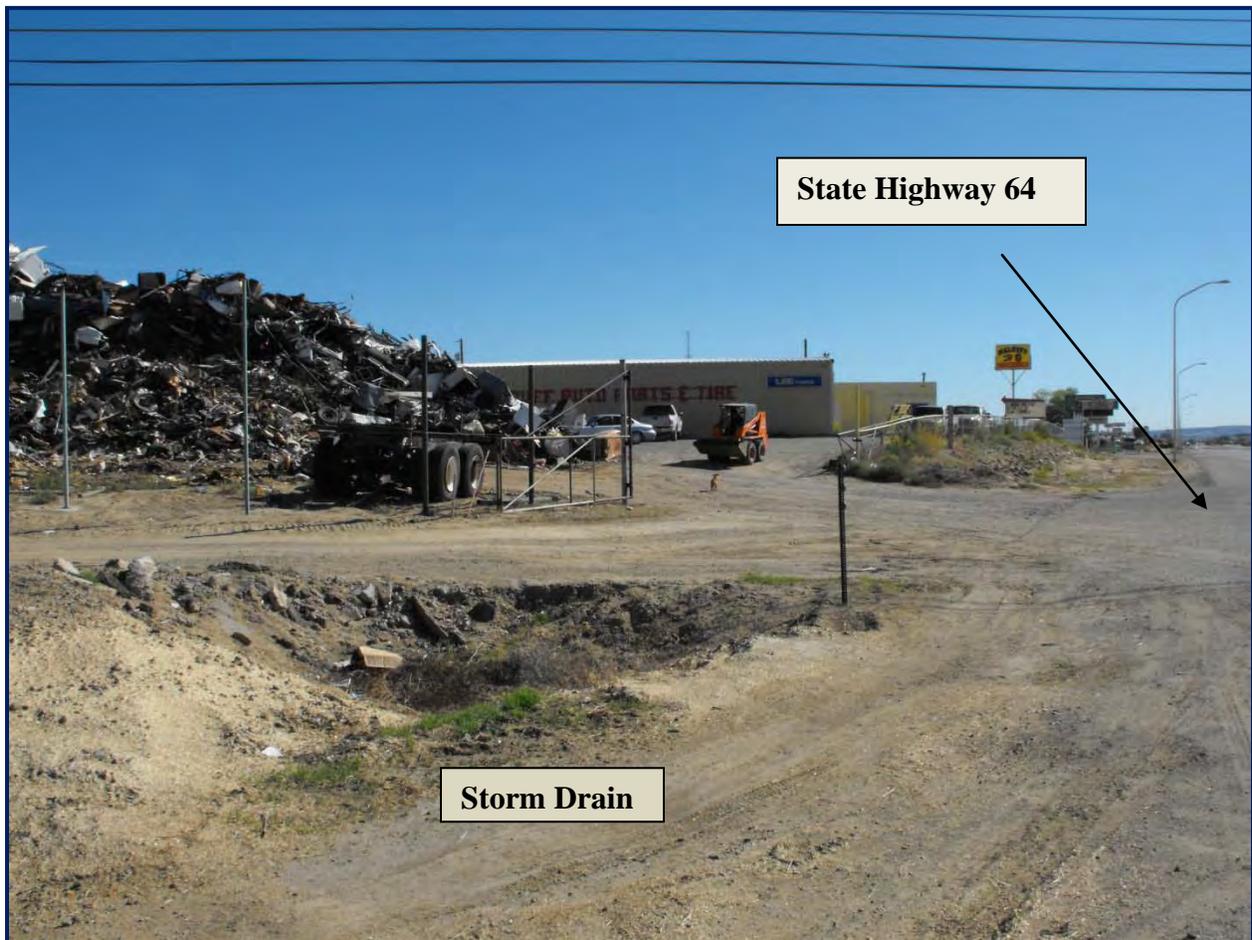
Photo # 2

At the entrance there is a stormwater drain. A drain pipe could be seen, Mr. Malouff said the pipe was blocked and did not drain. It is unknown if the pipe has been permanently sealed. The site appears to slope towards the south or out the entrance road. The Malouff Salvage Scrap yard is higher than the surrounding area thus the site will be a challenge to manage. They are installing a fence around the site, note pipes in pictures. If installed with an eye to stormwater control as well as a visual barrier it may aid the company in managing its stormwater issues. At present there are no Best Management Practices (BMP's) in place to manage or monitor discharges from the facility.

Photographer: Daniel Valenta	Date: 10/12/2011	Time: 1111 hours
City/County: Kirtland/San Juan		
Location: Malouff Salvage, 4140 Hwy 64, Kirtland, New Mexico, facing northeast.		
Subject: Front of property, stormwater may discharge to the storm drain.

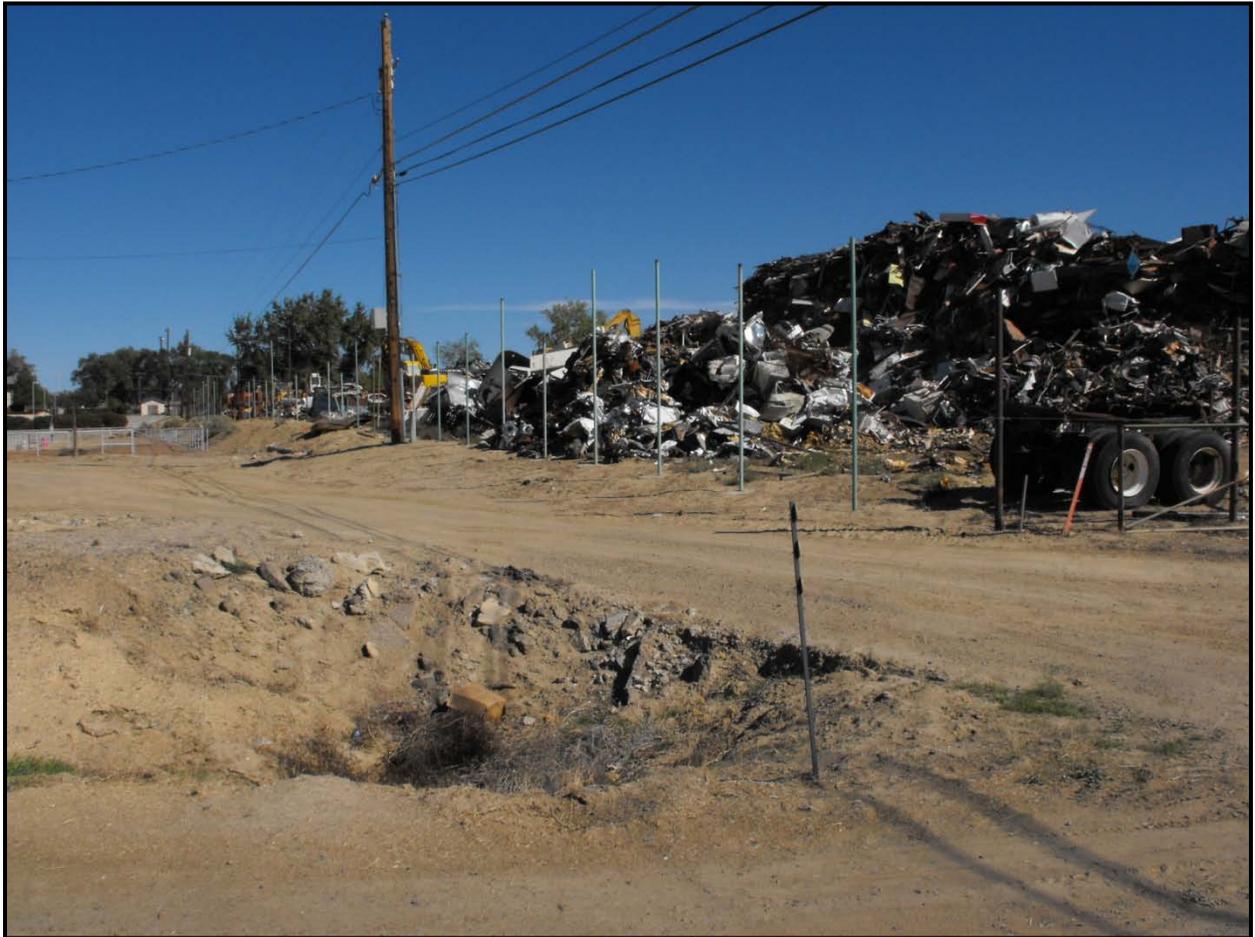
Photo # 3

Photographer: Daniel Valenta	Date: 10/12/2011	Time: 1111 hours
City/County: Kirtland/San Juan		
Location: Malouff Salvage, 4140 Hwy 64, Kirtland, New Mexico, facing northeast.		
Subject: West side of property.

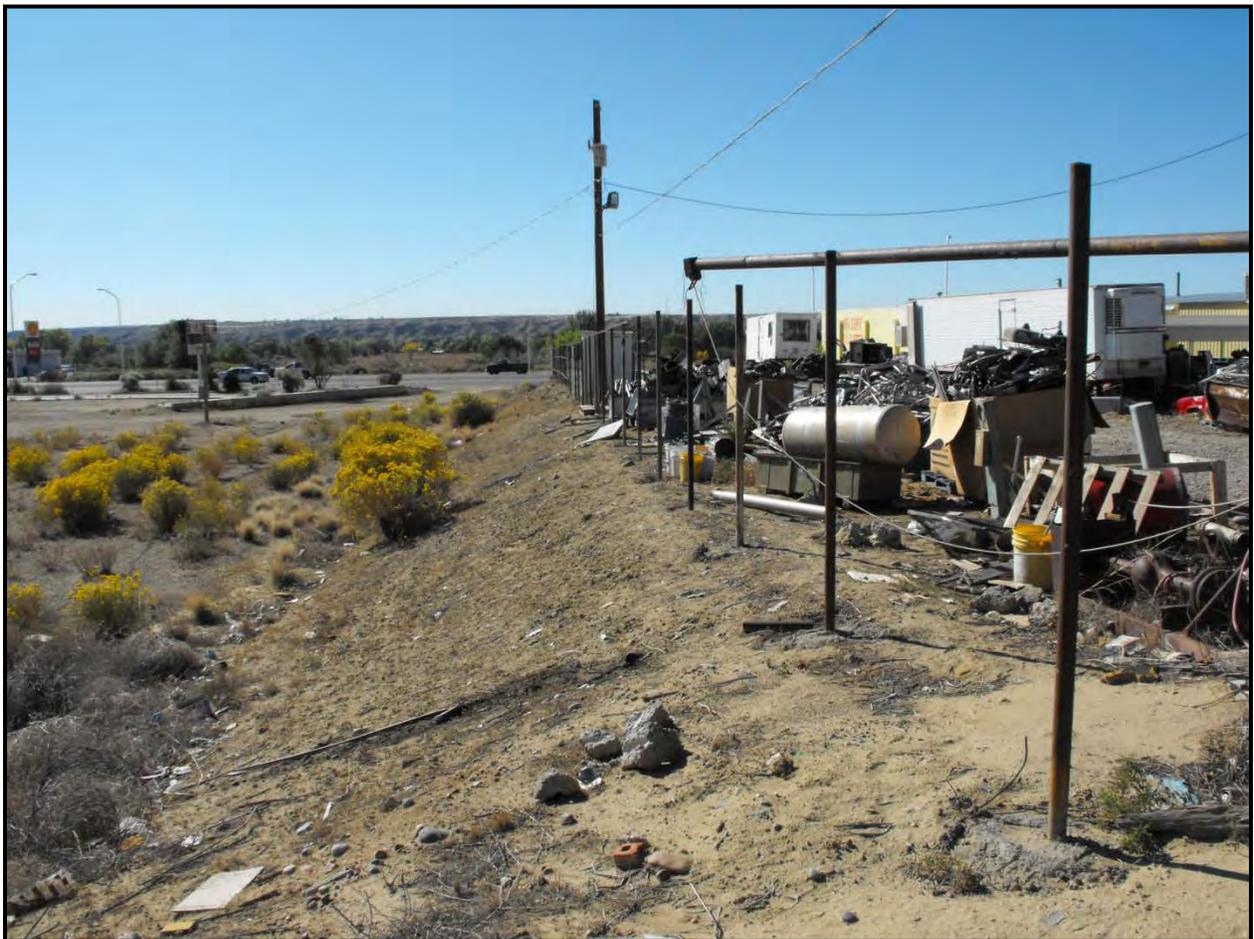
Photo # 4

Photographer: Daniel Valenta	Date: 10/12/2011	Time: 1056 hours
City/County: Kirtland/San Juan		
Location: Malouff Salvage, 4140 Hwy 64, Kirtland, New Mexico, facing south.		
Subject: East side of property facing Hwy 64.

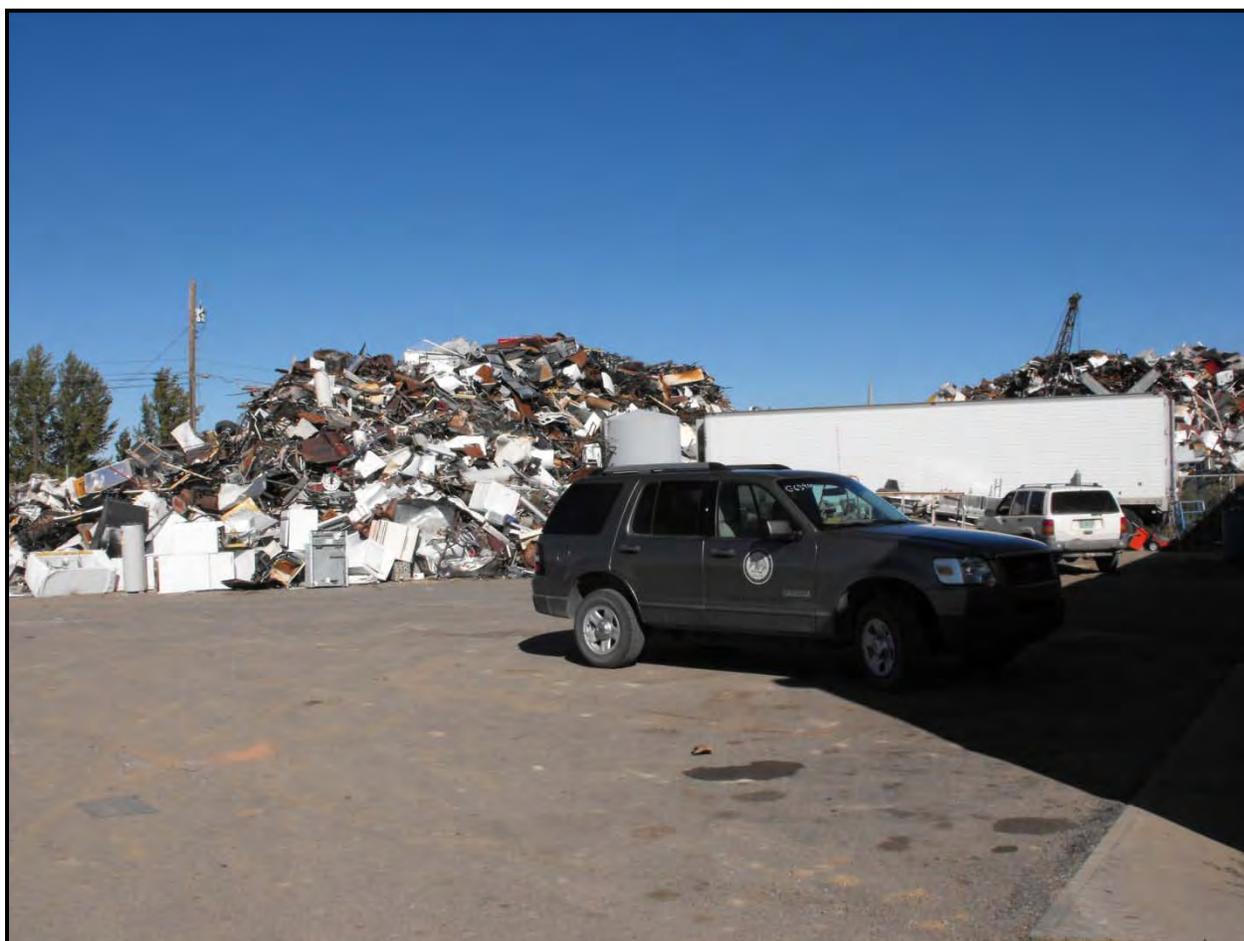
Photo # 5

The operator did not obtain coverage under the USEPA 2008 MSGP when the permit became available. At the site a wide variety of materials are brought in to be sold and recycled. Some items observed were white goods, automotive rims and tires; see attached photos of assortment of items. Metal items were sorted into large piles depending on the type of material, sorting involved cutting, crushing, and stacking.

Photographer: Daniel Valenta	Date: 10/12/2011	Time: 1040 hours
City/County: Kirtland/San Juan		
Location: Malouff Salvage, 4140 Hwy 64, Kirtland, New Mexico, facing northwest.		
Subject: Middle of site where the office is, piles of recyclable materials.

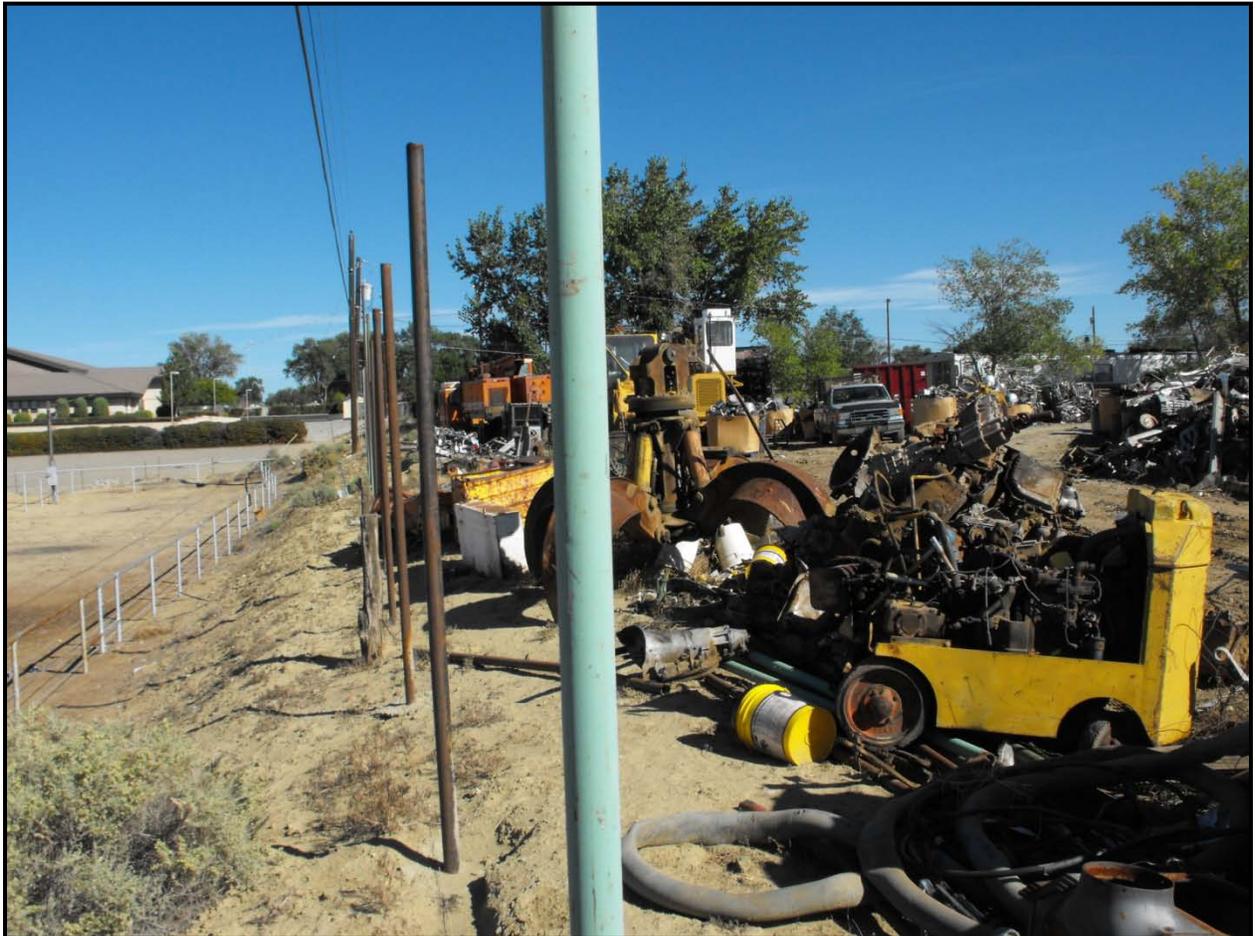
Photo # 6

Photographer: Daniel Valenta	Date: 10/12/2011	Time: 1049 hours
City/County: Kirtland/San Juan		
Location: Malouff Salvage, 4140 Hwy 64, Kirtland, New Mexico, facing north.		
Subject: Back of site, a variety of scrap metal and equipment.

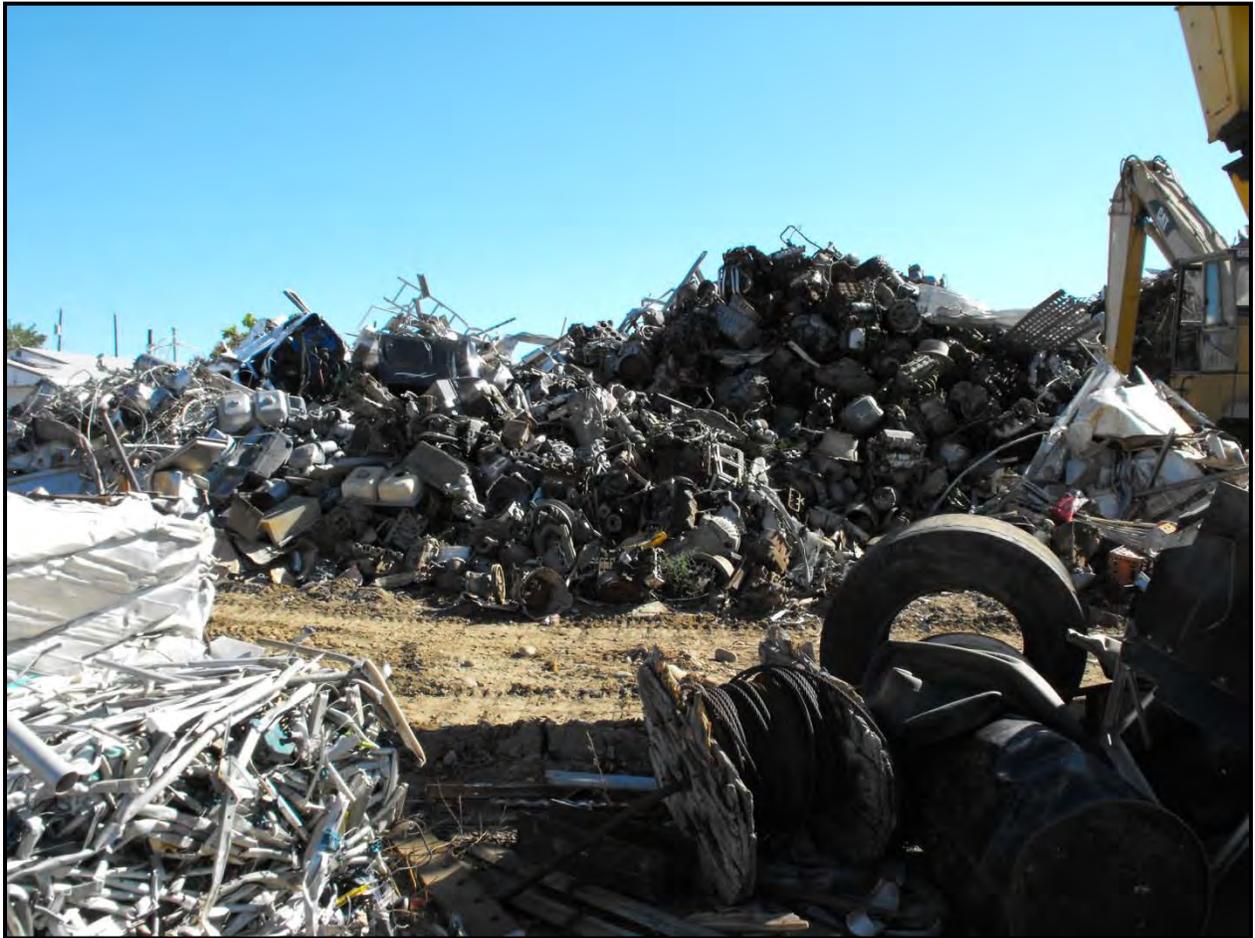
Photo # 7

Photographer: Daniel Valenta	Date: 10/12/2011	Time: 1049 hours
City/County: Kirtland/San Juan		
Location: Malouff Salvage, 4140 Hwy 64, Kirtland, New Mexico, facing east.		
Subject: Back of site, a variety of scrap metal.
