RE: Industrial Storm Water; SIC 5093; NPDES Compliance Evaluation Inspection; New Mexico Recycling, Inc.; NPDES Permit NMU001776; November 3, 2011

NPDES Compliance Inspection Report

New Mexico Recycling, Inc.
NPDES Tracking No. NMU001776
November 3, 2011

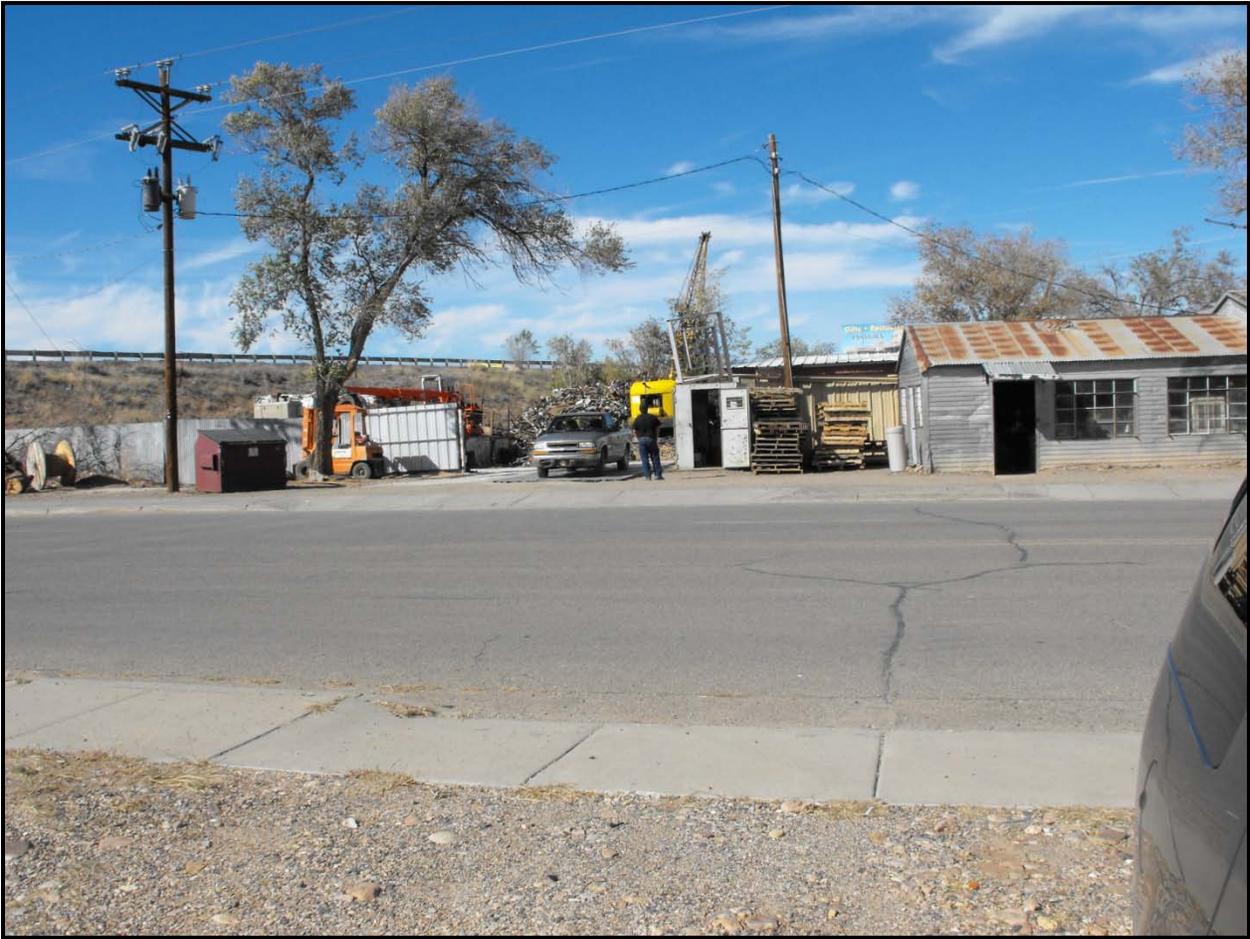
Photo # 1

Photographer: Daniel Valenta	Date: 11/3/2011	Time: 1332 hours
City/County: Milan/Cibola		
Location: 707 Airport Road, Milan, New Mexico, facing northwest.		
Subject: Main entrance into the salvage yard.

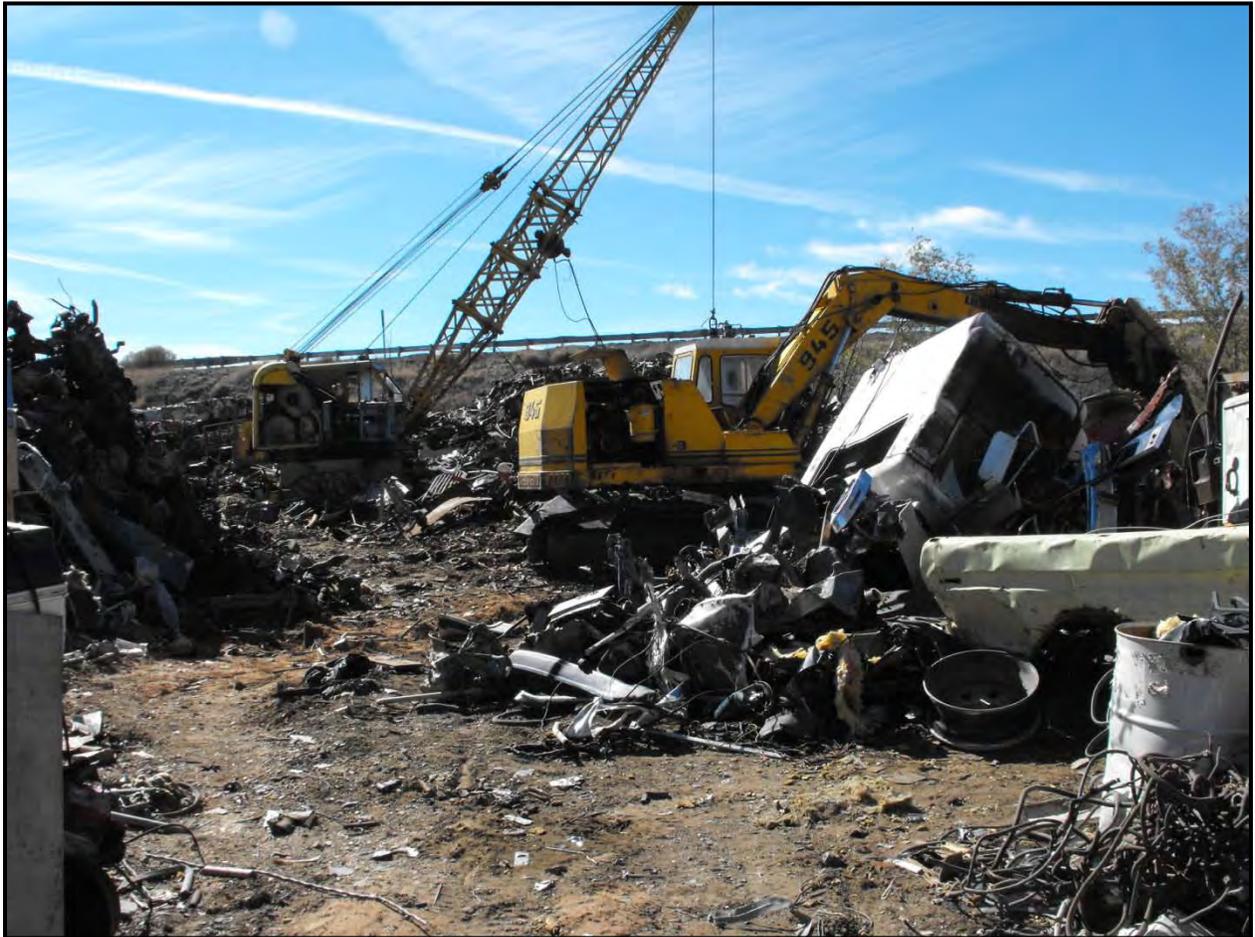
Photo # 2

Photographer: Daniel Valenta	Date: 11/3/2011	Time: 1400 hours
City/County: Milan/Cibola		
Location: 707 Airport Road, Milan, New Mexico, facing southwest.		
Subject: Area where crushing, sorting, and separating materials occurs.

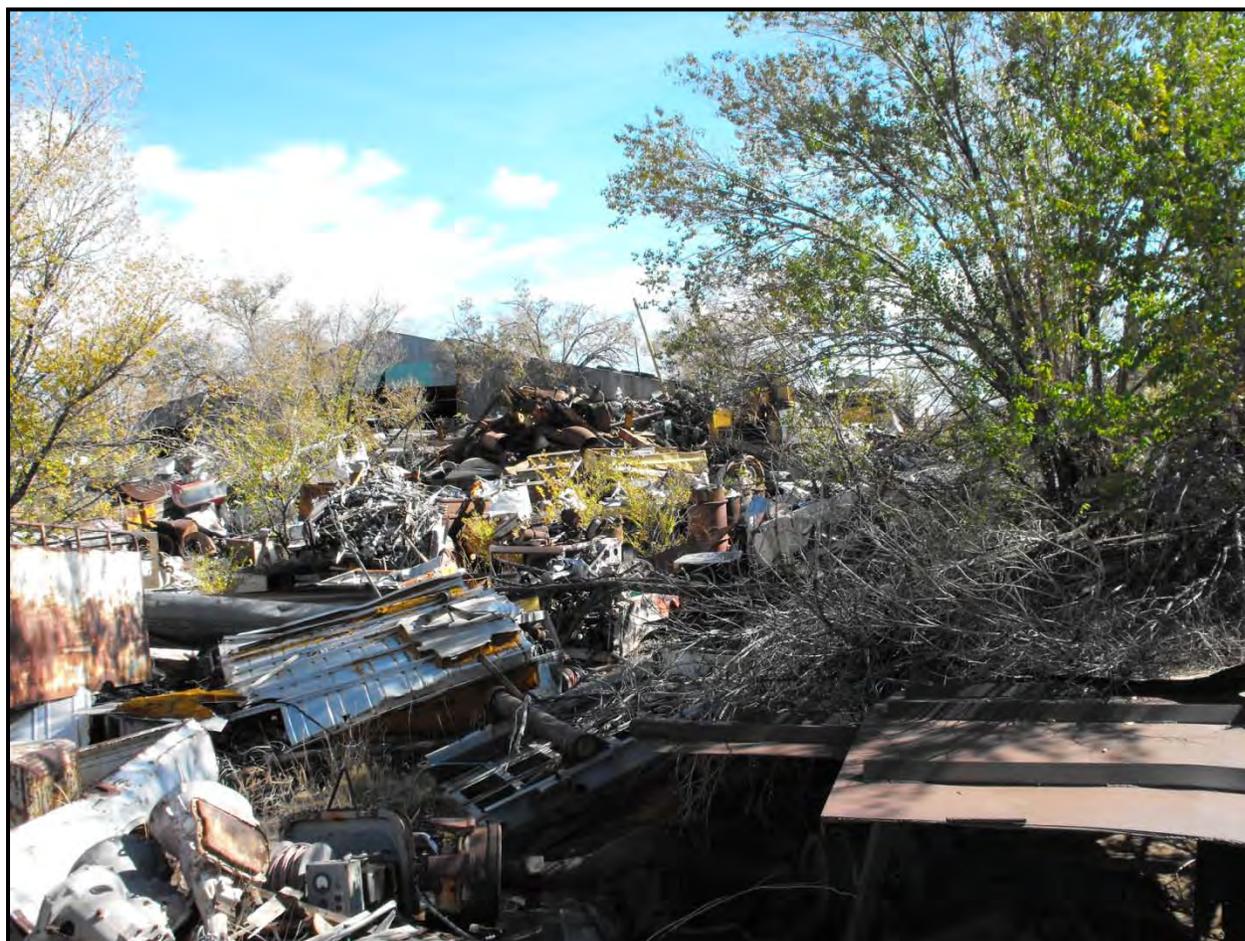
Photo # 3

Photographer: Daniel Valenta	Date: 11/3/2011	Time: 1404 hours
City/County: Milan/Cibola		
Location: 707 Airport Road, Milan, New Mexico, facing southeast.		
Subject: From the back of the yard toward the entrance.
