**RE: Industrial Storm Water; SIC 5093; NPDES Compliance Evaluation Inspection; Grants Recycling; NPDES Permit NMU001777; November 3, 2011**

### NPDES Compliance Inspection Report

**Grants Recycling**  
**NPDES Tracking No. NMU001777**  
**November 3, 2011**

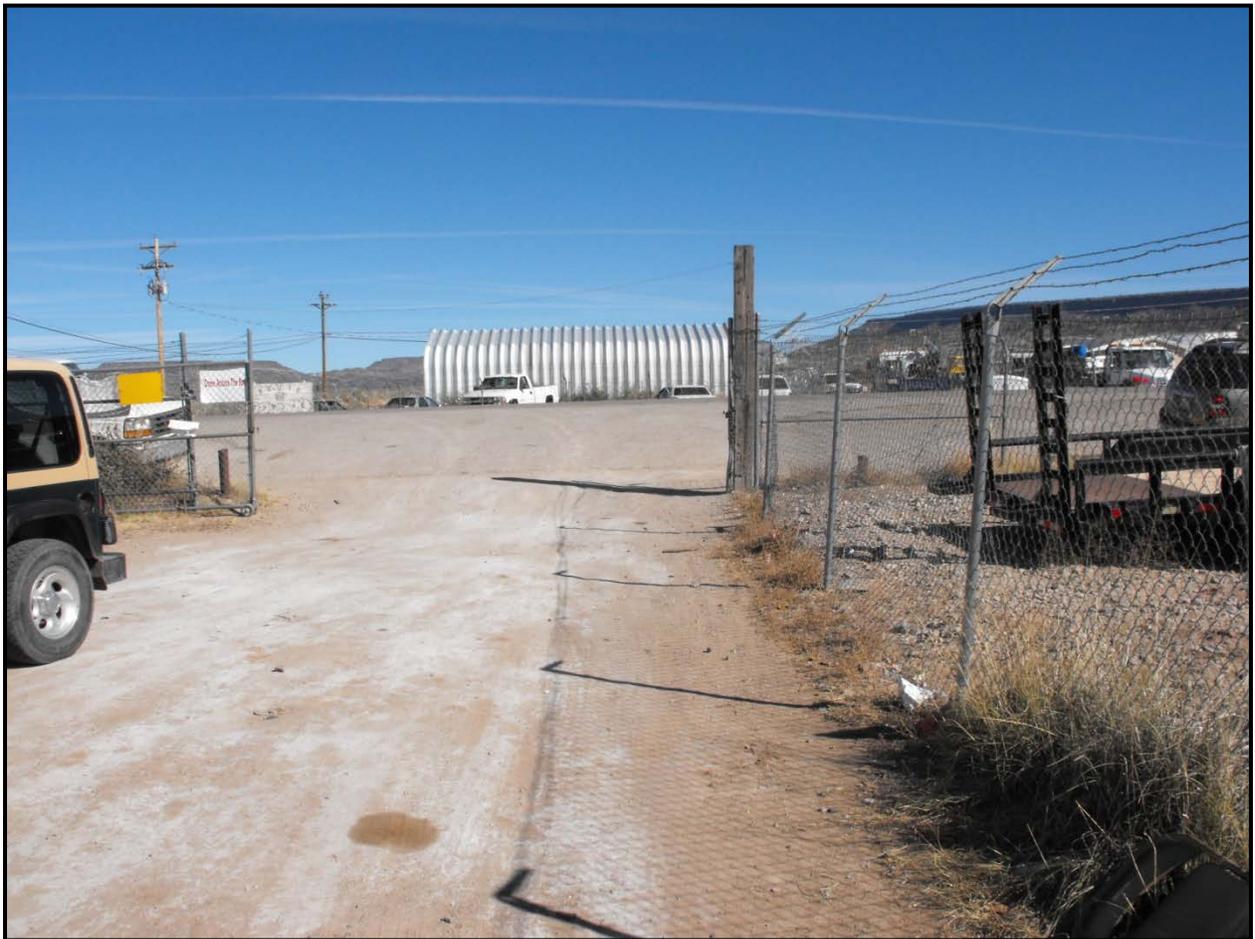
Photo # 1

Photographer: Daniel Valenta	Date: 11/3/2011	Time: 1138 hours
City/County: Grants/Cibola		
Location: Grants Recycling, 1553 East Old Hwy 66, Grants, New Mexico, facing northeast.		
Subject: Main entrance road into the salvage yard, note slope is inward.

Mr. Valdez became the Owner/Operator of the 1.5 acre site in May of 2011. At the time of the inspection he had two employees at the site. The site slopes slightly south from Old Hwy 66 toward the Rio San Jose, (see overview & photo 1). The south side of the property faces the Rio San Jose. This section of the river through town has been channelized with a dirt road running alongside the river. As stormwater falls and flows from the road onto the property it ponds onsite or may discharge to the neighbor's property on either side. The site may also discharge along the road beside the river, (see photo 4). Motors and other parts are placed on truck beds to help contain leaking fluids. A covered shed on site is used to store batteries and aluminum cans.

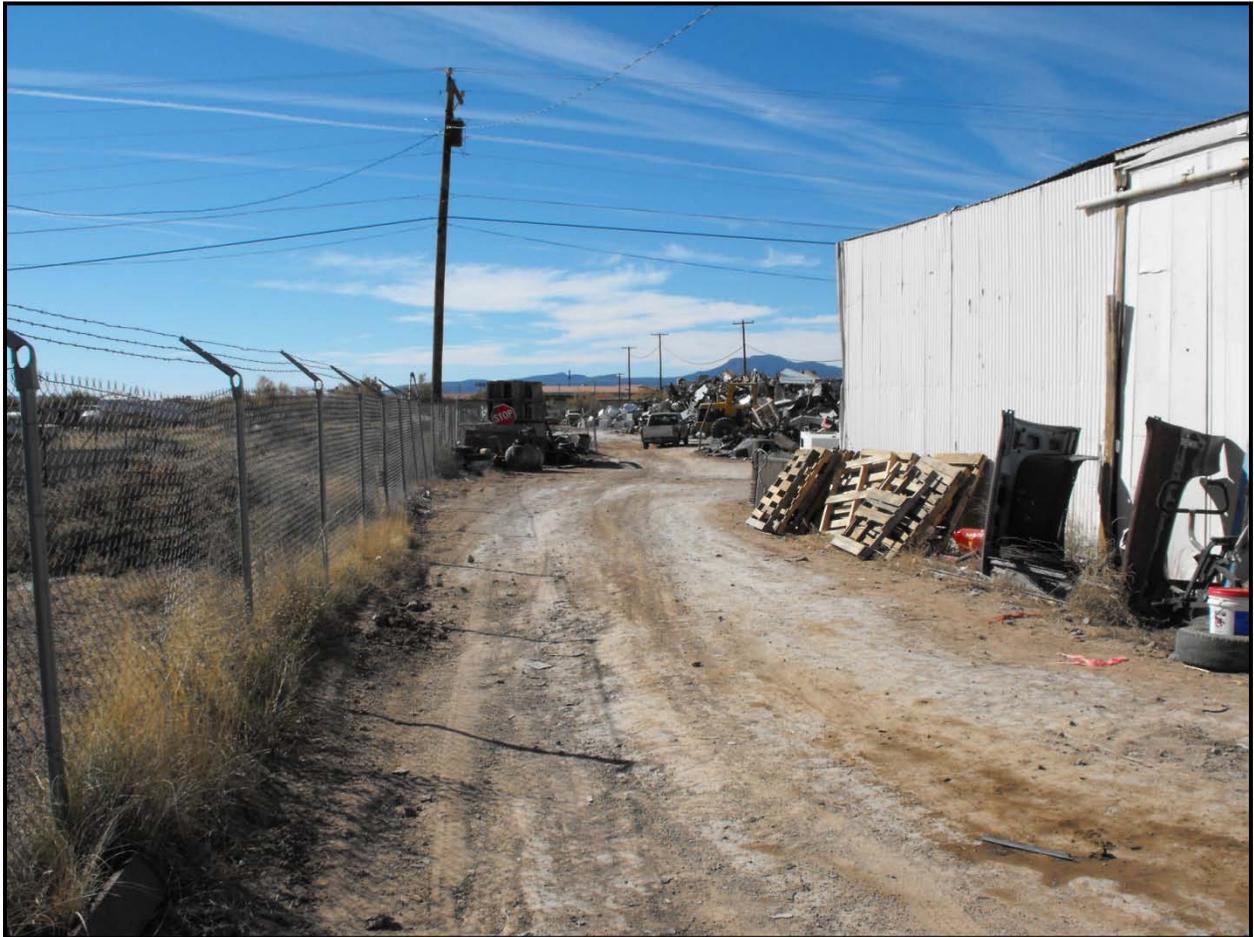
Photo # 2

Photographer: Daniel Valenta	Date: 11/3/2011	Time: 1138 hours
City/County: Grants/Cibola		
Location: Grants Recycling, 1553 East Old Hwy 66, Grants, New Mexico, facing southwest.		
Subject: Entrance road along the east side of property.

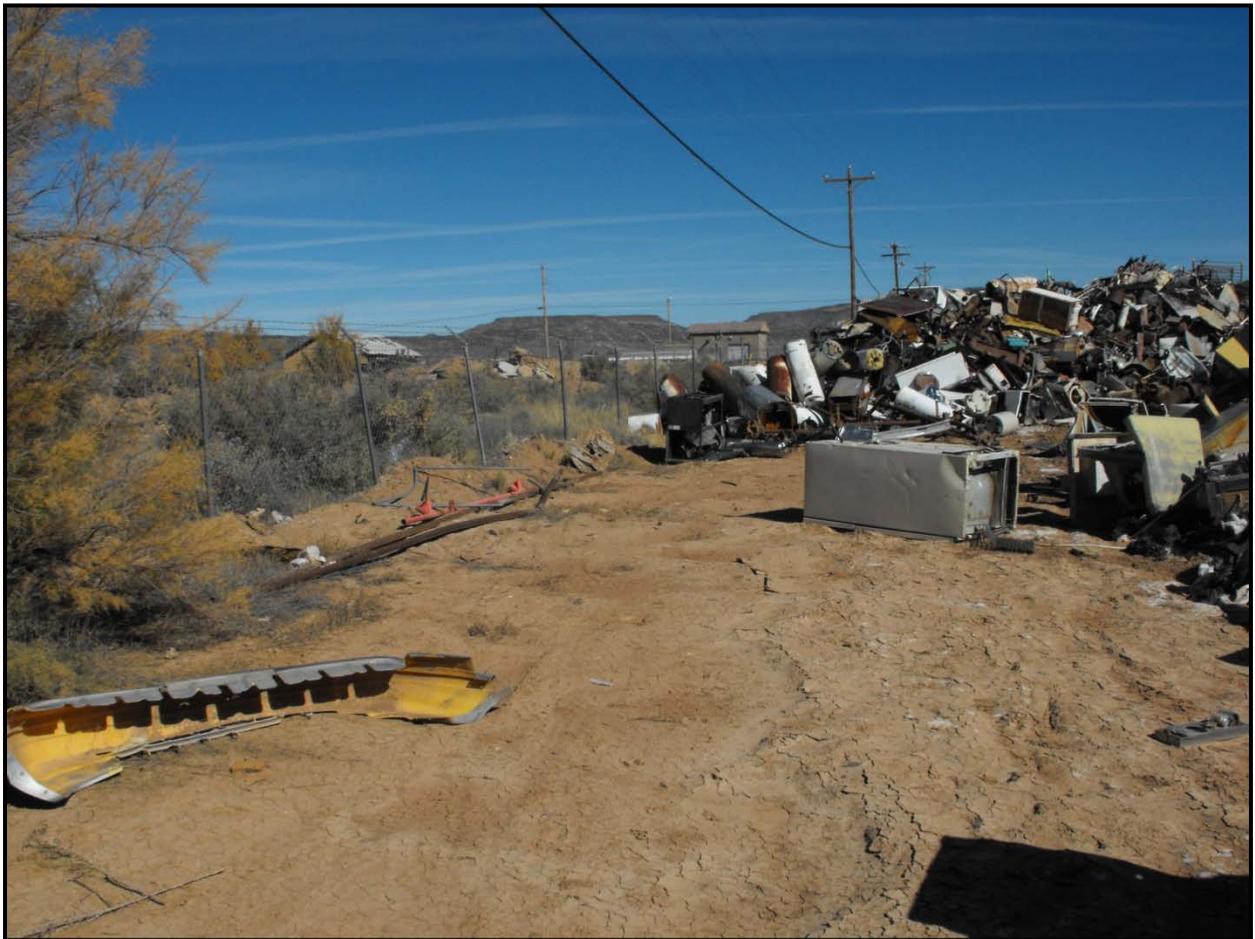
Photo # 3

Photographer: Daniel Valenta	Date: 11/3/2011	Time: 1146 hours
City/County: Grants/Cibola		
Location: Grants Recycling, 1553 East Old Hwy 66, Grants, New Mexico, facing southwest.		
Subject: Scrap metal piled along the west side of property.

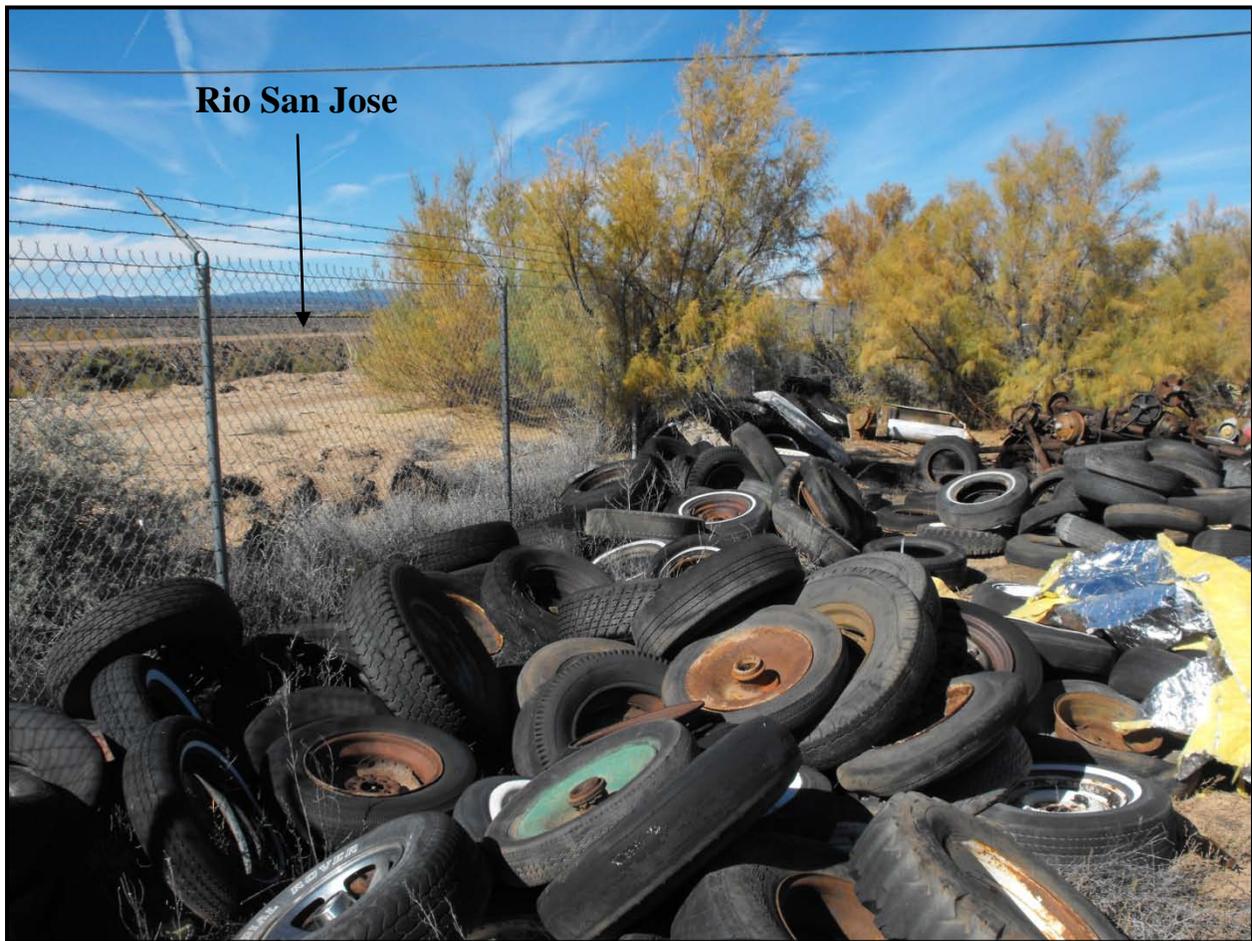
Photo # 4

Photographer: Daniel Valenta	Date: 11/3/2011	Time: 1143 hours
City/County: Grants/Cibola		
Location: Grants Recycling, 1553 East Old Hwy 66, Grants, New Mexico, facing southwest.		
Subject: Back of property facing the river, this area contained mostly tires and rims.
