**NEW MEXICO
ENVIRONMENT DEPARTMENT**

Surface Water Quality Bureau

Re: Concentrated Animal Feeding Operation, SIC 7948, SIC 0272, NPDES Compliance Evaluation Inspection, Expo New Mexico and The Downs Racetrack, NMU001778 and NMU001779, November 15, 2011

NPDES Compliance Inspection
Expo New Mexico/The Downs at Albuquerque
Further Explanations

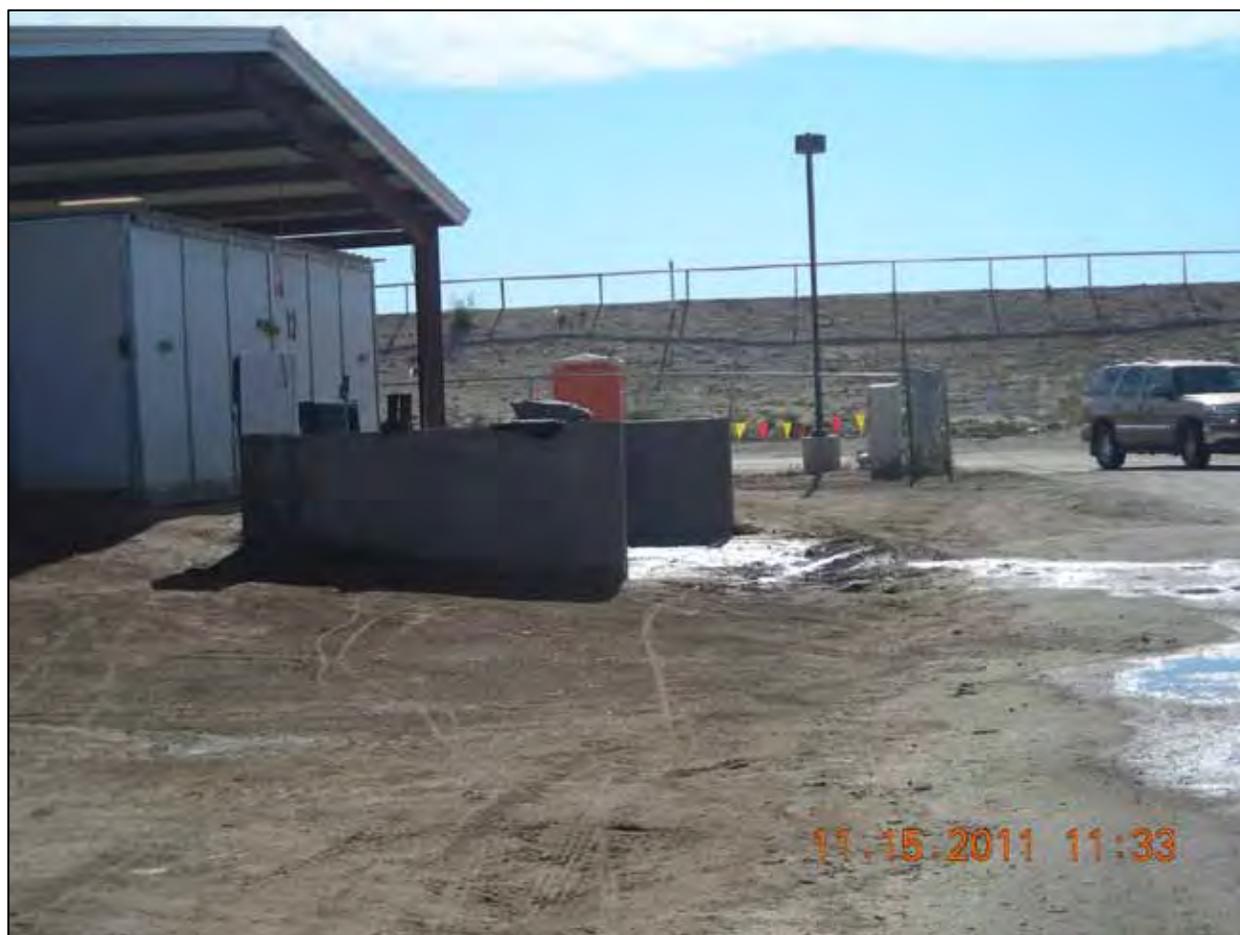
NMED/SWQB
Official Photograph Log
Photo # 1

northern most cell receives both the above offsite drainage from the east as well as stormwater from the racetrack, stable area and manure storage areas. There are also numerous wash racks located around the stabling facilities (please see picture #1). Discharges of contaminated stormwater from both the racetrack, stable area and manure storage areas, and the water from these wash racks is allowed to flow, mostly via the stable area road drainage system, uncontained to several drop inlets located throughout the stable area. Runoff to these drop inlets is conveyed to the above Albuquerque MS4 pipe and thence to this north cell. The north cell overflows into a second, south cell. There is also some additional sheet flow from the stable and manure storage areas to this north cell.

Photographer: Sarah Holcomb	Date: 11-15-2011	Time: 1133 hours
City/County: Albuquerque/Bernalillo County		
Location: Expo NM, near Lomas and San Pedro Blvd.		
Subject: Wash racks located in the stabling areas of the CAFO.

This facility appears to meet the definition at 40 CFR 122.23(b) of a large CAFO and a CAFO that “discharges or proposes to discharge” must seek authorization to discharge under an NPDES permit even if such discharges are intermittent, sporadic, even occasional. These intermittent or sporadic discharges are nonetheless “discharges” under the federal Clean Water Act (CWA) and are prohibited unless authorized under the terms of an NPDES permit. This facility did not have NPDES CAFO general permit coverage on the date of this inspection. A CAFO that operates without a permit must be designed, constructed, operated, and maintained such that no discharge will occur, because any discharge (other than agricultural storm water) is prohibited from an unpermitted CAFO pursuant to CWA section 301(a). This facility discharges via an internal small MS4 system, directly into the Albuquerque MS4. This appears to represent an unpermitted discharge to a “water of the United States.” This also appears to indicate a failure by the City of Albuquerque to adequately implement the “Illicit Discharges and Improper Disposal” component (Part II.A.6) required by their Phase I MS4 permit (NMS000101). The operators of this facility have not documented that the production area is designed, constructed, operated, and maintained so as not to discharge. In addition, the operators have not developed and implemented a Nutrient Management Plan (NMP) to ensure no discharge that, at a minimum, addresses the elements set forth in 40 CFR 122.42(e)(1) and 40 CFR 412.37(c).

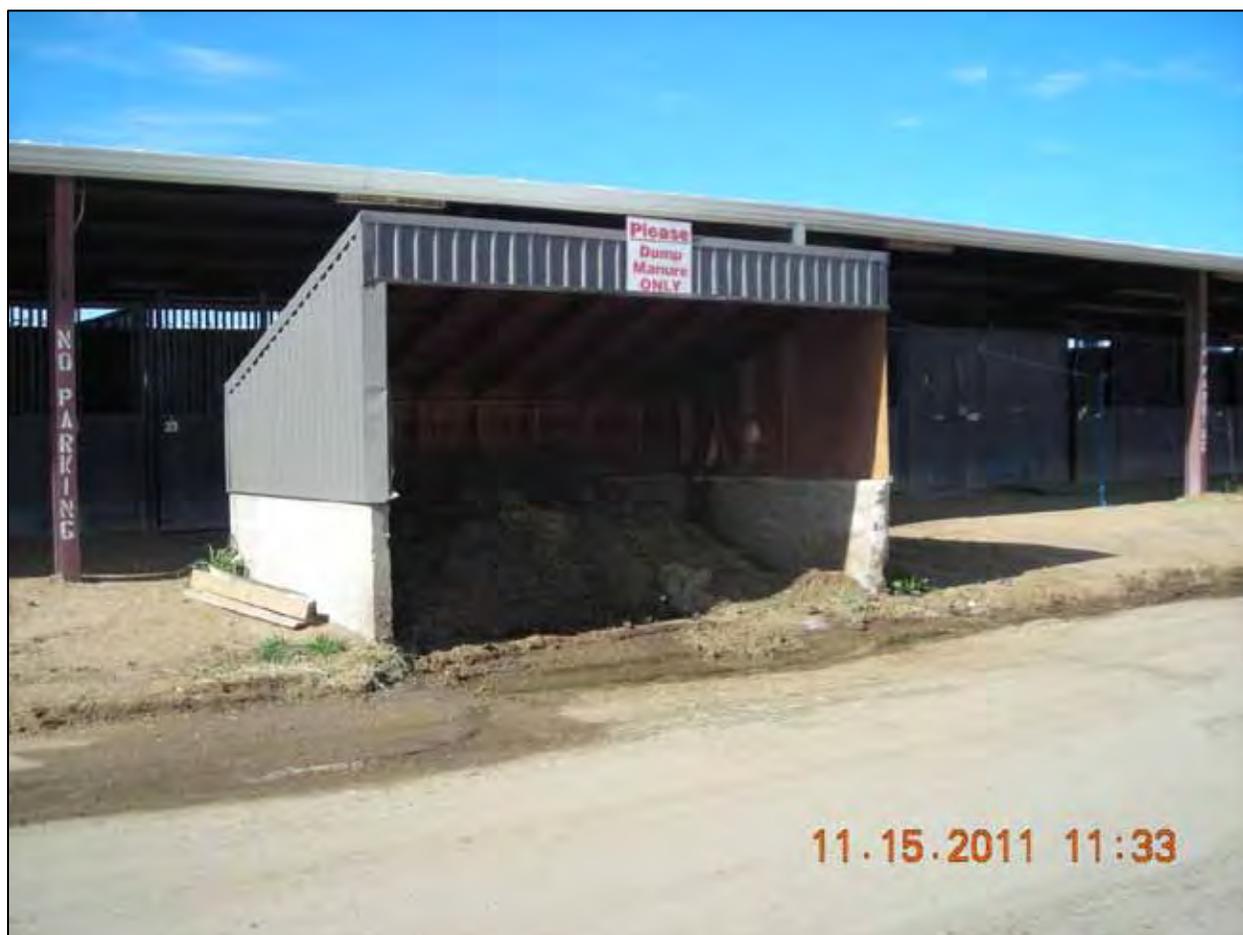
NMED/SWQB
Official Photograph Log
Photo # 2

There is no long term manure storage on site. The animal waste is collected daily, placed into a plastic bin, and transported to one of several (generally covered) muck bins (See picture #2). A loader is then used to empty the bins and load the waste into a dump truck. The truck hauls the waste to a Waste Management container, which is then shipped offsite to a composting facility.

Photographer: Sarah Holcomb	Date: 11-15-2011	Time: 1133 hours
City/County: Albuquerque/Bernalillo County		
Location: Expo NM, near Lomas and San Pedro Blvd.		
Subject: Muck bins as part of the manure management process.

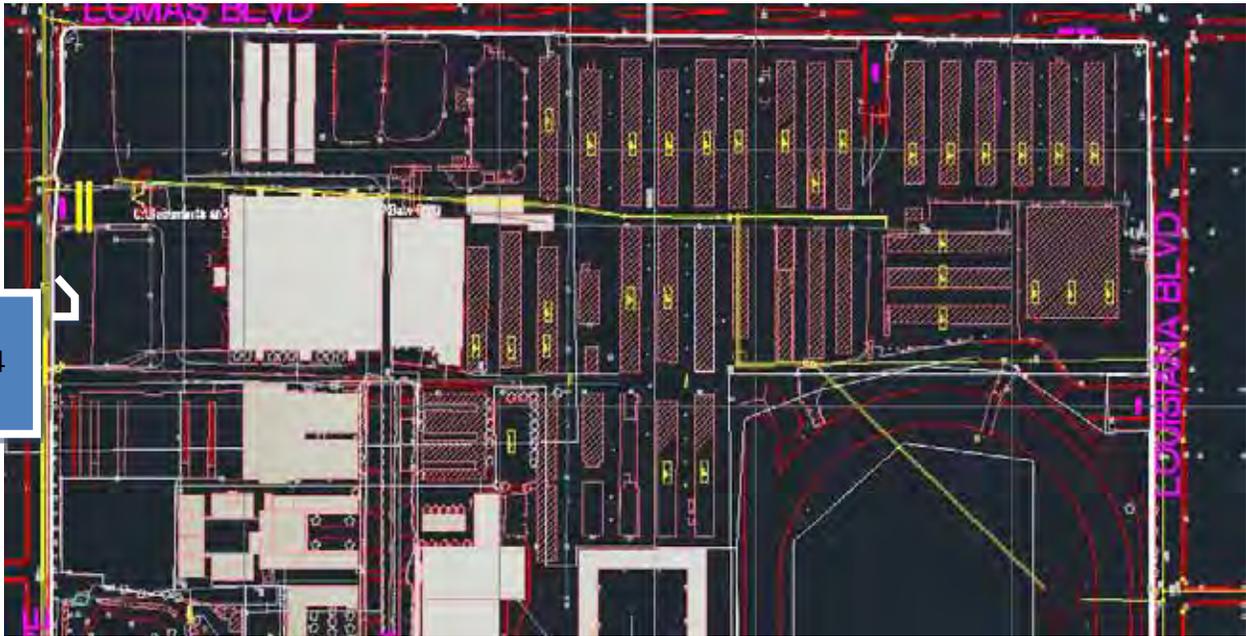
Exhibit #1:

There is a complex infrastructure situation that complicates matters at this facility. Please see attached map for a demonstration of this. Expo New Mexico is located in the middle of the city of Albuquerque on land owned by the state of New Mexico. Apparently in 1982, an easement was granted to allow the city to install flood control/stormwater infrastructure at this site on state land. This infrastructure drains approximately 2.6 square miles of the neighborhoods that directly border Expo NM to the East. The drainage from this area is sent to a large sectionalized storm surge pond located at the east end of Expo NM. An outlet from this pond was constructed to connect it to the existing storm drain system constructed in the 50s. This subsurface outlet pipe crosses the north end of Expo, through the area where the animals are stabled. According to the facility representatives, pond overflows occasionally also discharge on the surface and flow through the stable areas.

After this stormwater drainage pipe passes the stabling area, the pipe terminates in a two-cell stormwater surge detention pond located near the northwest corner of Expo NM. (Please see the attached map.) The

This southern cell collects stormwater runoff from both the northern cell as well as from San Pedro Boulevard. There is a culvert between the two ponds that equalize the two in the event of a large storm. The discharge structure from these two ponds is located in the southern cell. This pond system is designed primarily to provide temporary, short duration detention of storm surges prior to discharge back into the Albuquerque MS4 conveyance infrastructure. As such, the outlet is basically located at the bottom of the structure to allow relatively rapid de-watering.

Storm drainage layout of the facility. Stormwater enters Expo NM on the Louisiana Blvd. side and follows the pipes (indicated by the yellow lines) through the CAFO facility. Drainage from the CAFO facility is directed to the stormwater pipe through various drop inlets. The pipe continues to the stormwater retention pond located at the top left corner of the diagram below. The two large yellow lines in this area indicate the culvert used to equalize the two ponds in this area. The discharge to the Albuquerque MS4 is from the southern pond in this area (indicated by the inspector's added number 1.)

Outfall to
ABQ MS4
"1"

This facility also appears to meet the definition at 40 CFR 122.26(b)(16) of a Small Municipal Separate Storm Sewer System (sMS4). The facility was queried in a Section 308 letter in 2009 as to why they had not submitted a Notice of Intent for permit coverage under the sMS4 permit, and the facility’s response at that time was that they were unable to, due to the infrastructure situation as described above.
