**RE: Industrial Storm Water; SIC 5093; NPDES Compliance Evaluation Inspection; Omar's Recycling; NMU001781; December 28, 2011**

**NPDES Compliance Inspection Report**

**Omar's Recycling**  
**NMU001781**  
**December 28, 2011**

**Further Explanation**

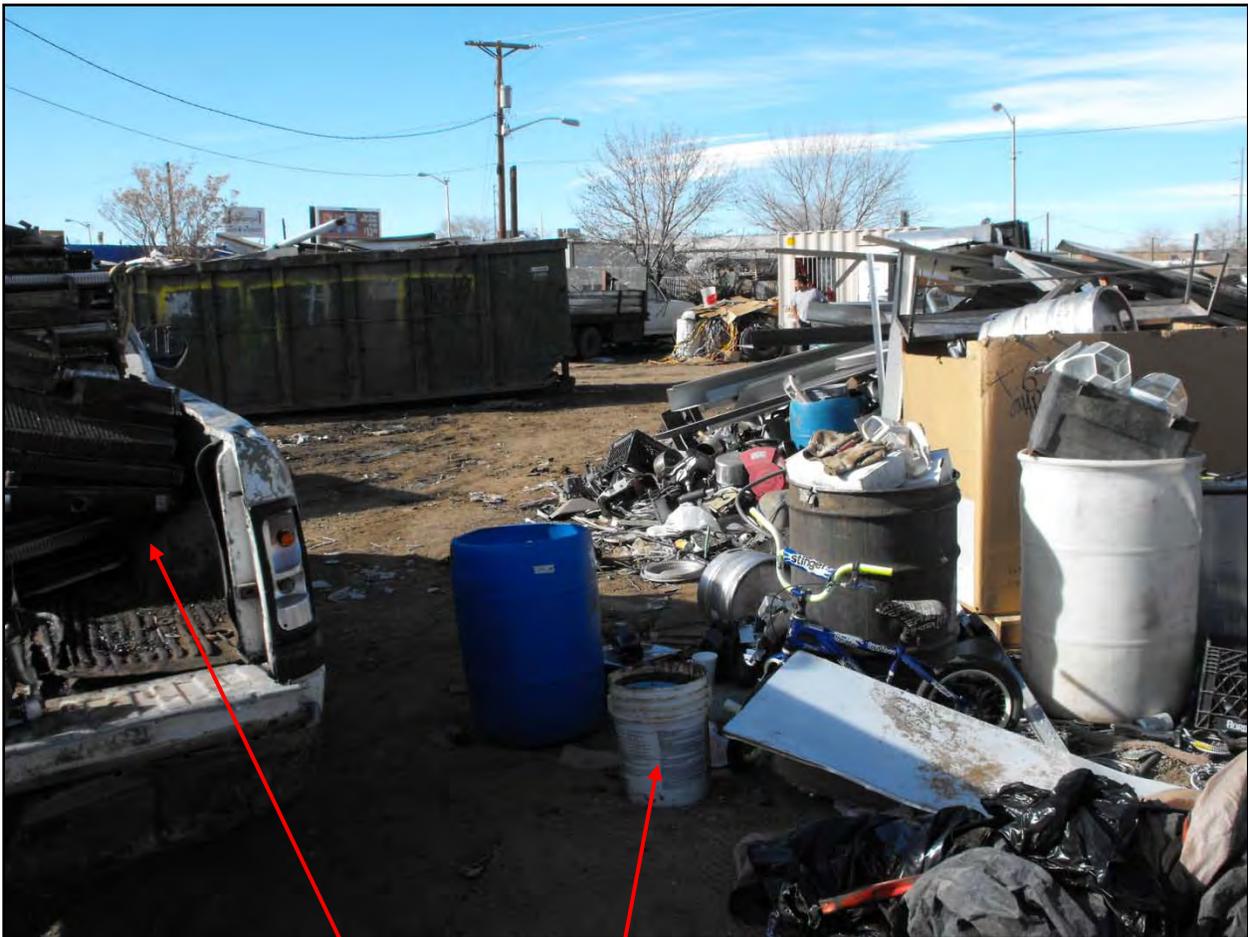
Photo # 1

Photographer: Daniel Valenta	Date: 12/28/2011	Time: 1105 hours
City/County: Albuquerque/Bernalillo		
Location: Omars Recycling, 2930 2 <sup>nd</sup> St NW, Albuquerque, New Mexico, facing southwest.		
Subject: Scrap storage yard, oil and grease spills, debris, and waste material of various sorts.

Radiators

Used Oil

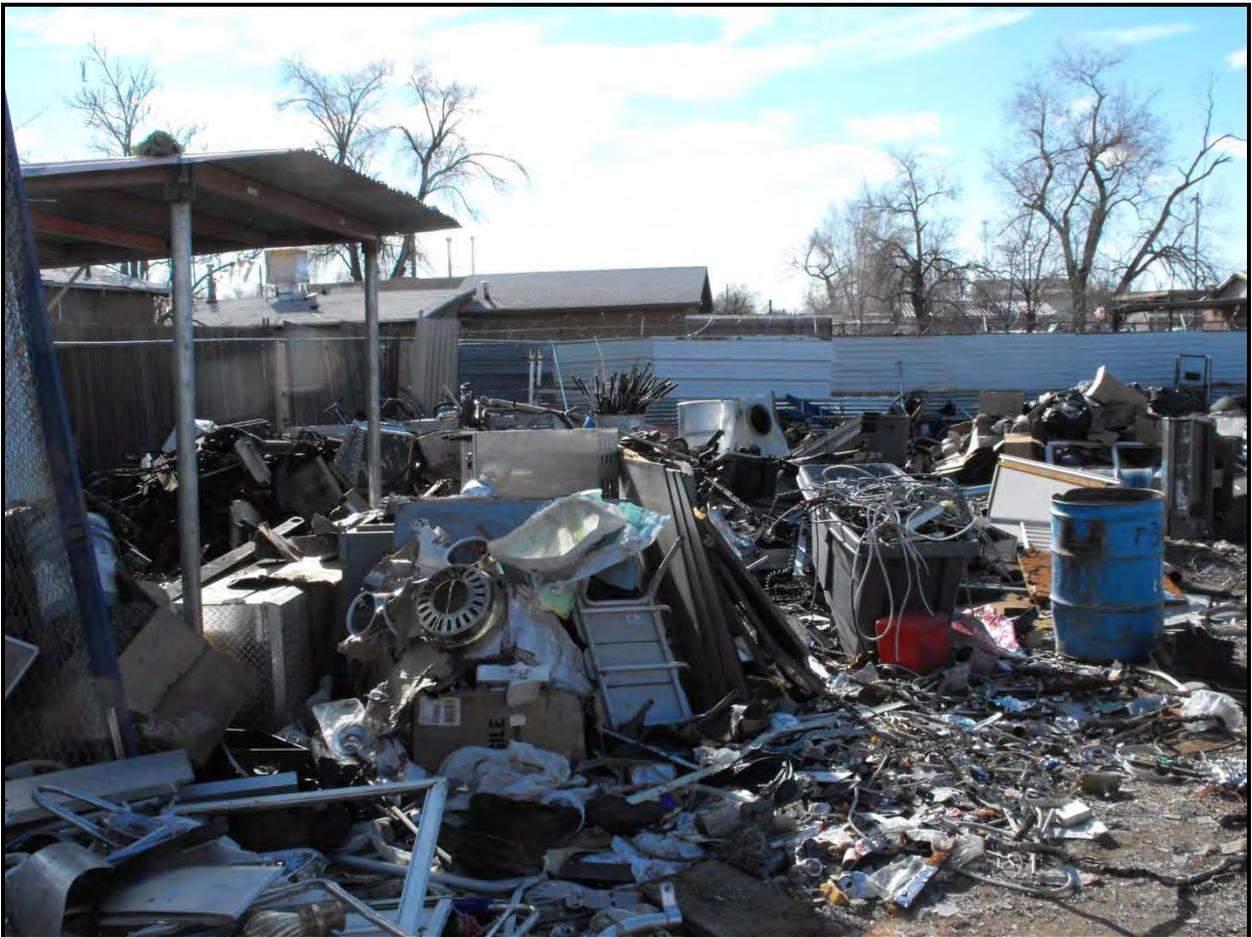
Photo # 2

Photographer: Daniel Valenta	Date: 12/28/2011	Time: 1106 hours
City/County: Albuquerque/Bernalillo		
Location: Omars Recycling, 2930 2 <sup>nd</sup> St NW, Albuquerque, New Mexico, facing east.		
Subject: Scrap storage yard, oil and grease spills, debris, and scrap material of various sorts.

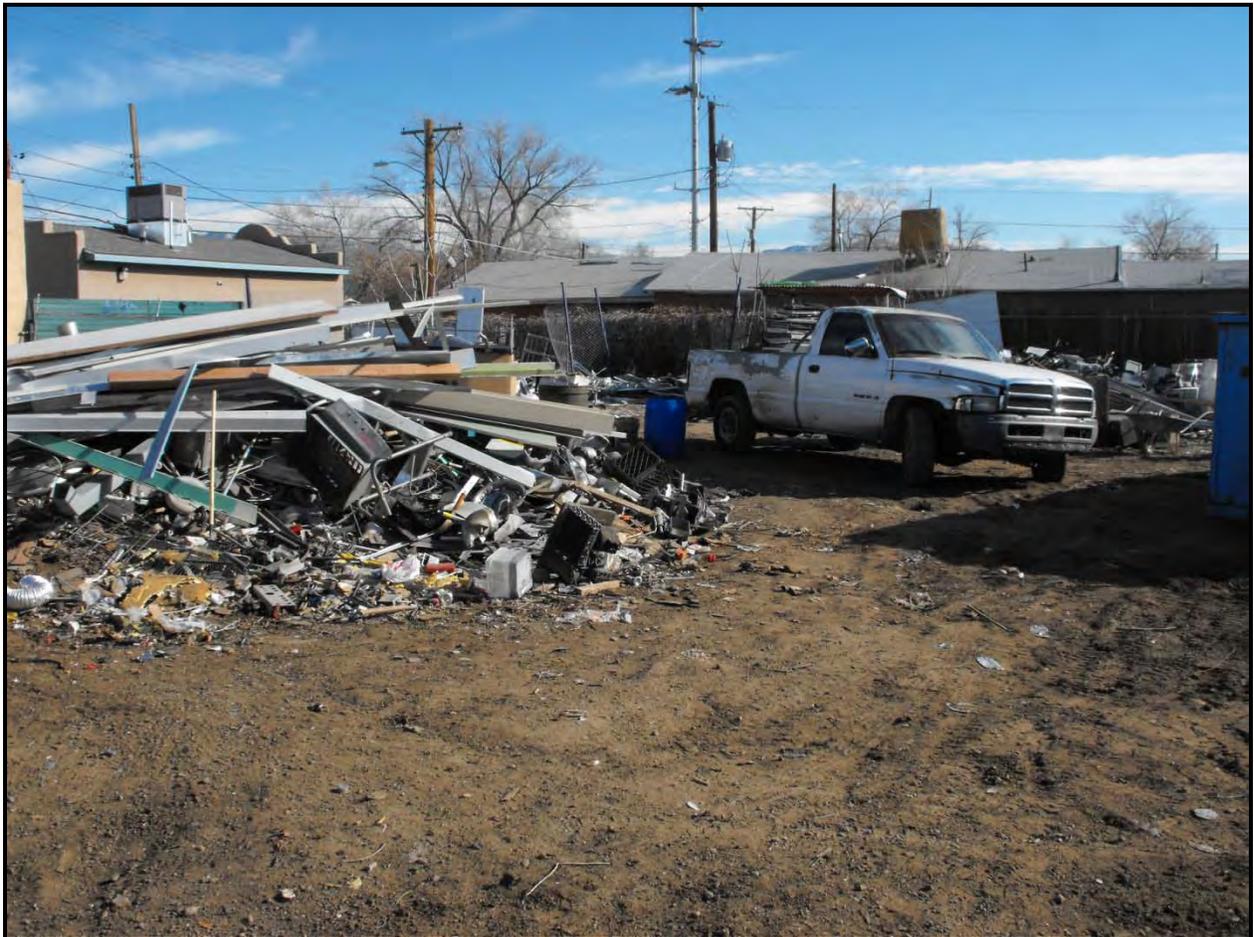
Photo # 3

Photographer: Daniel Valenta	Date: 12/28/2011	Time: 1105 hours
City/County: Albuquerque/Bernalillo		
Location: Omars Recycling, 2930 2 <sup>nd</sup> St NW, Albuquerque, New Mexico, facing east.		
Subject: Scrap storage yard, oil and grease spills, debris, and scrap material of various sorts.

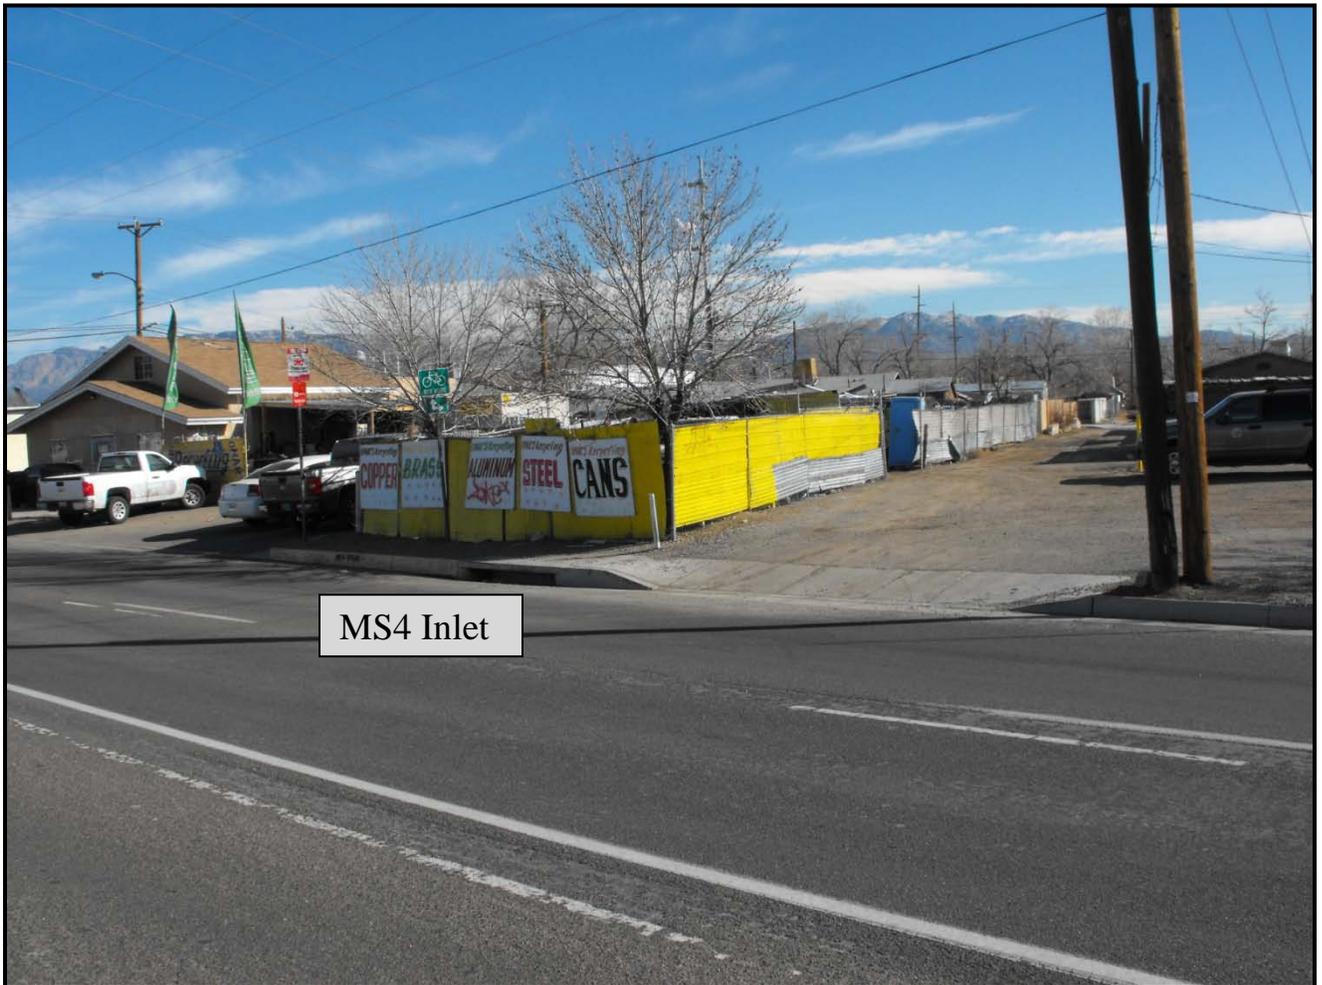
Photo # 4

This small, less than a half acre site is set up for customers to drive in, unload and drive out. Material is then separated and piled up. As the yard fills a wholesale recycler is called who takes the material offsite. Although not a large site, all collected material is exposed to stormwater and the MS4 inlets are next to the site, see attached photos. The site had no BMP's in place to prevent stormwater/snowmelt from transporting pollutants offsite and into the MS4 inlets. Mr. Diaz said he had not heard of the Multi-Sector General Permit (MSGP) for stormwater discharges associated with industrial activity.

The site may be a challenge for the owner to manage, small lot size, close proximity of the MS4 inlets.

Photographer: Daniel Valenta	Date: 12/28/2011	Time: 1110 hours
City/County: Albuquerque/Bernalillo		
Location: Omar's Recycling, 3508 2 <sup>nd</sup> St NW, Albuquerque, New Mexico, facing northeast.		
Subject: Location of Omar's Recycling site to stormwater drain inlet.
