NEW MEXICO
ENVIRONMENT DEPARTMENT

RE: Industrial Storm Water; SIC 5093; NPDES Compliance Evaluation Inspection; South Valley Metals; NMU001784; January 4, 2012

NPDES Compliance Inspection Report

Further Explanation

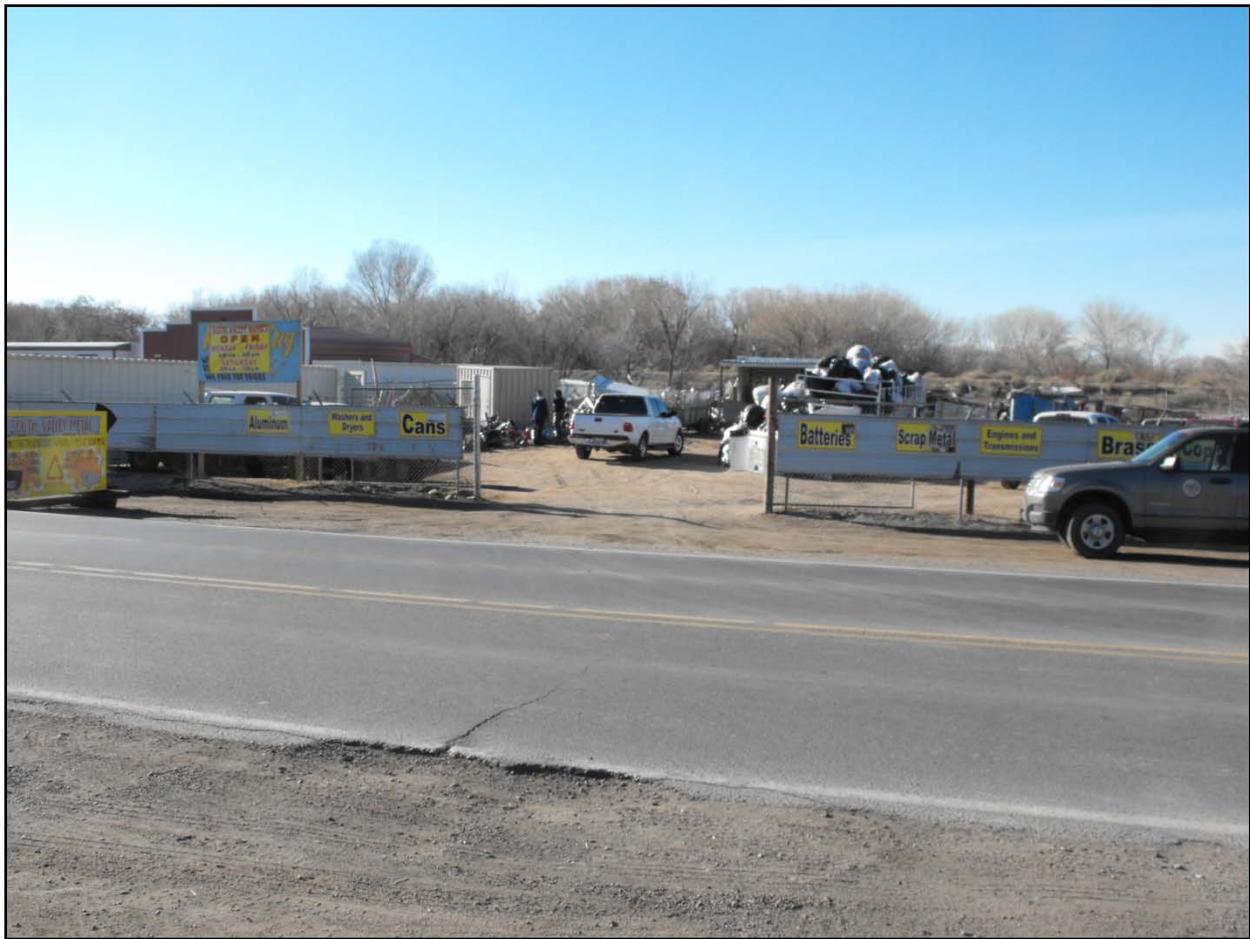
Photo # 1

| Subject: Entrance to storage yard, loading/unloading zone. | | |

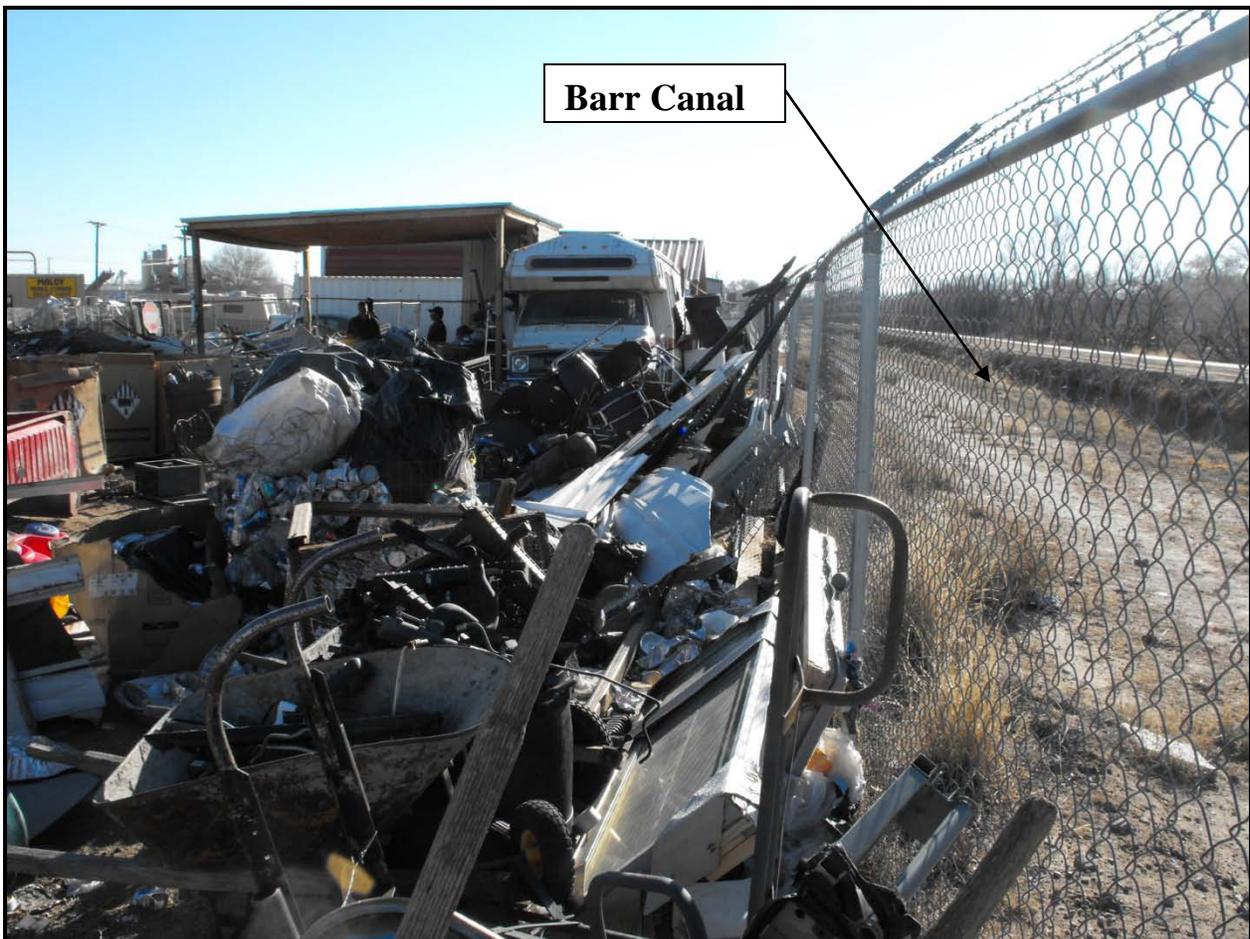
Photo # 2

| Subject: Scrap storage yard, oil and grease spills, debris, and waste material of various sorts. | | |

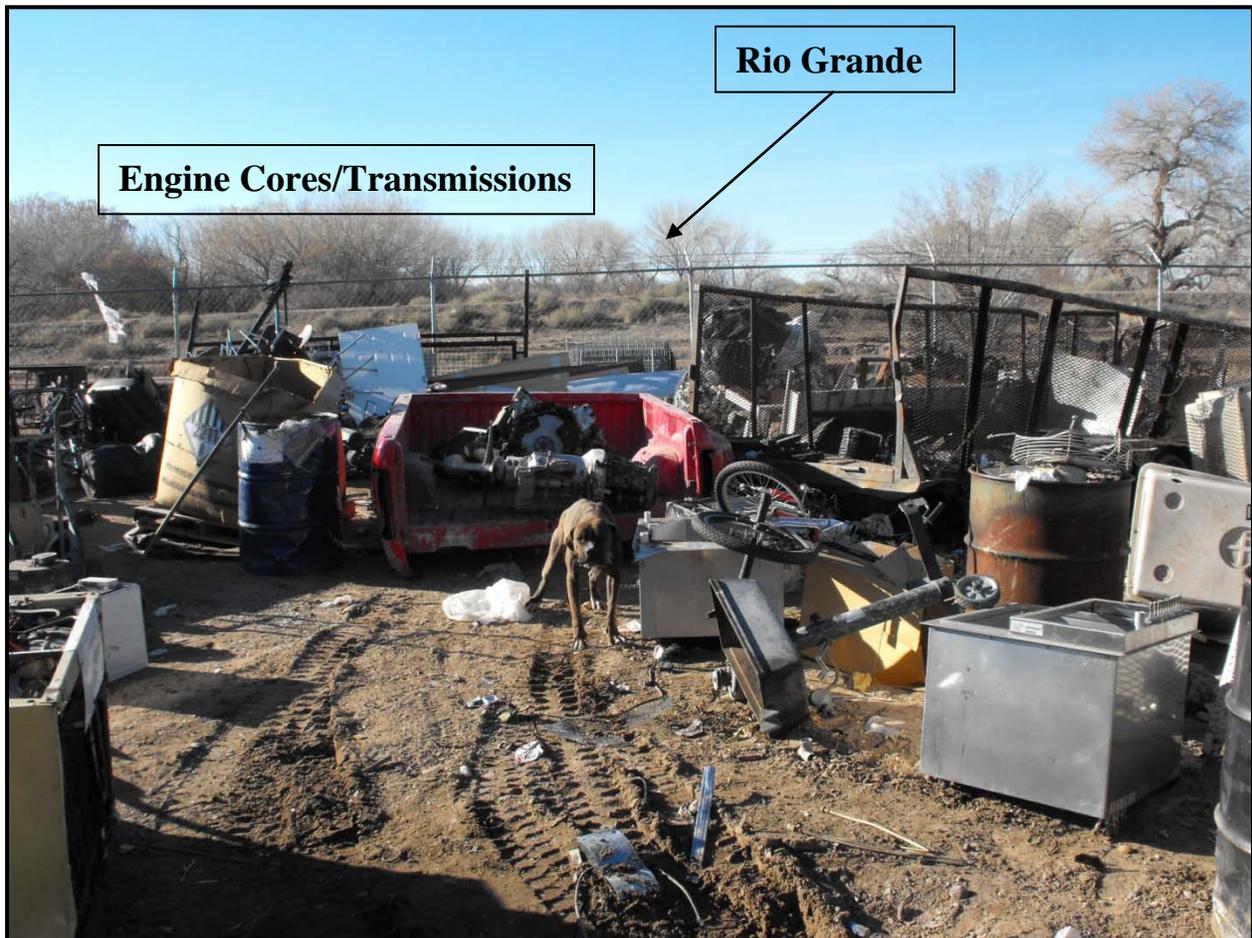
Photo # 3

| Subject: Scrap storage yard, oil and grease spills, debris, and waste material of various sorts, and an insane dog. | | |

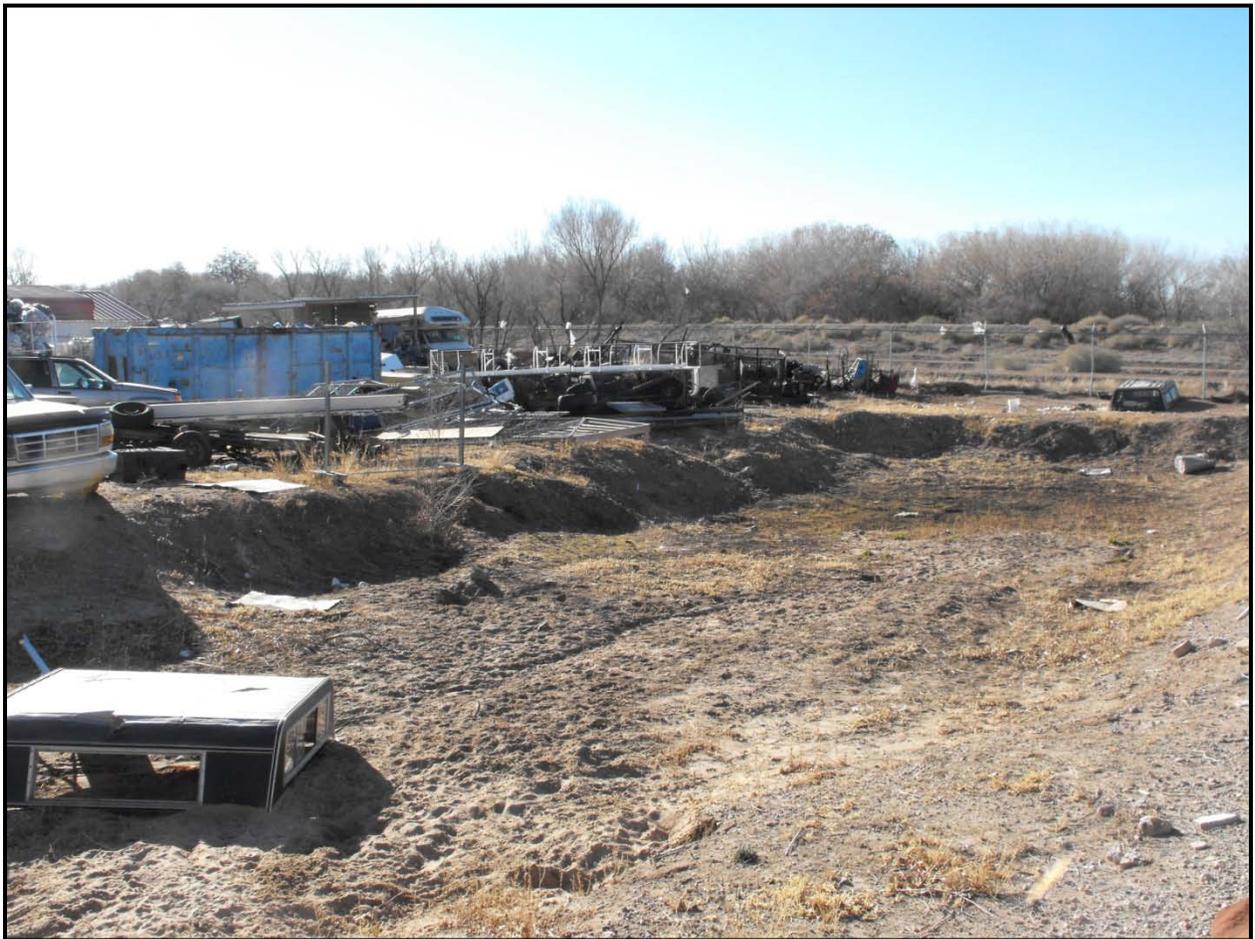
Photo # 4

BMP's have been constructed and are still present at the site although the present owner appeared unaware of their purpose. On the north side of the yard is a sediment pond that may contain most of the stormwater falling on the site and most of the run on, (see photo 4). Mr. Barraza said that during a rain event the depression will fill up. The back of the property leading to the river has a small berm present that has not been maintained and may be breached. The manager did not know it was there or its purpose. Batteries, copper wire, and brass are stored in a shipping container that can be locked and out of the weather.

| Subject: Unmaintained containment pond. | | |

There are some structural BMP's in place which will aid the manager in meeting the requirements of the MSGP; however, knowledge of the permit requirements and maintenance and evaluation of BMP's will be required. Due to the close proximity of the river and irrigation canal there is a high potential for the release of contaminated stormwater if these measures fail.
