RE: Construction Storm Water, SIC 1623, NPDES Compliance Evaluation Inspection, ENMR Telephone Cooperative, Inc. / Telecommunications Round II Broadband Project Support Activity, NMU001794, August 7, 2012

NPDES Compliance Inspection Report

NPDES Construction Storm Water Compliance Evaluation Inspection
ENMR Telephone Cooperative, Inc.
Telecommunications Round II Broadband Project
Construction Support Activity at 4519 Agua Fria Street, Santa Fe, New Mexico
NMU001794
August 7, 2012

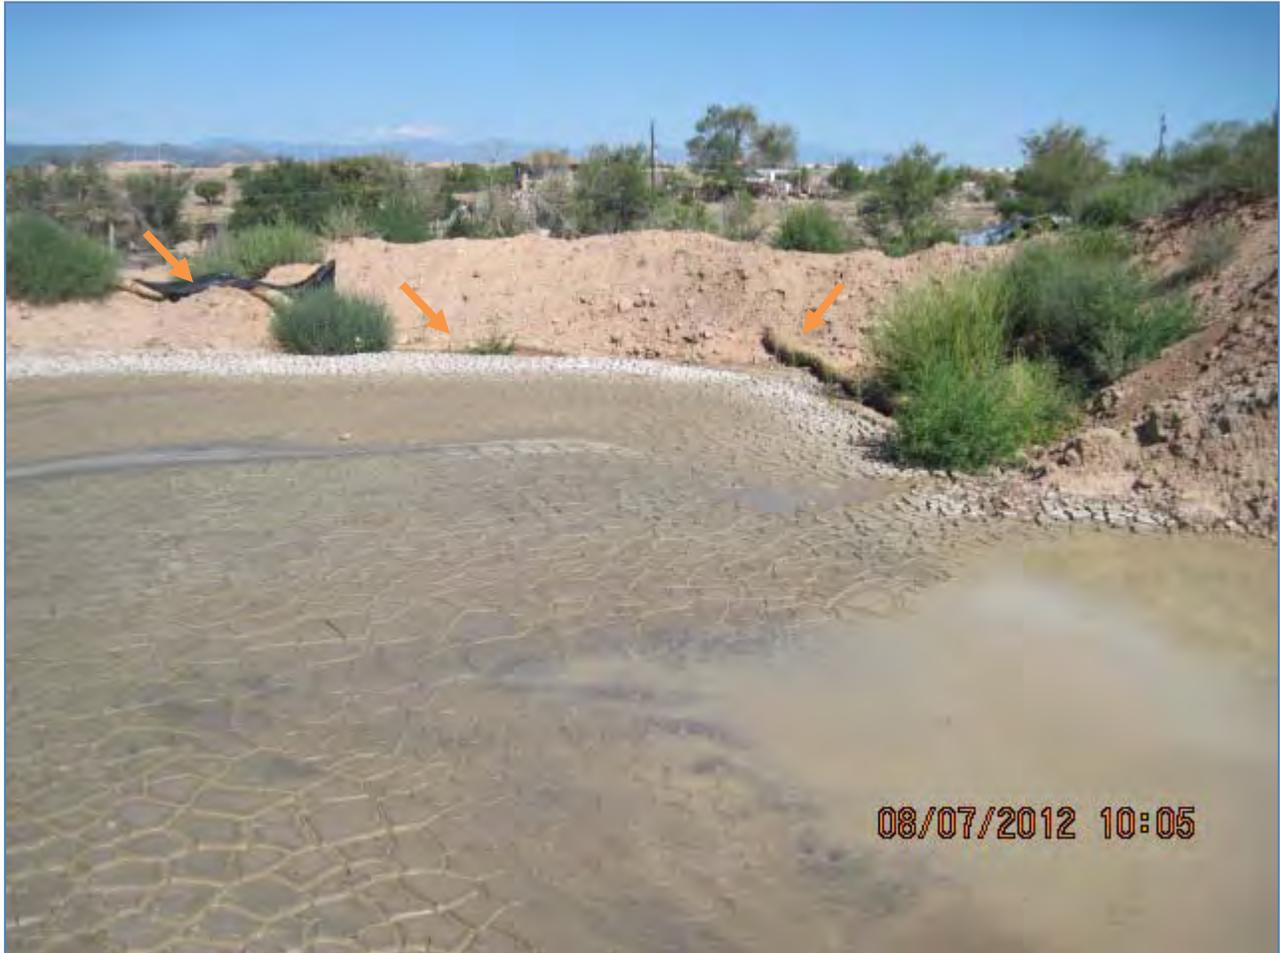
NMED/SWQB
Official Photograph Log
Photo # 1

Subject: Looking north at drilling mud pit and earth berm. Arrows point to silt fence and straw wattle on the inside of the pit that would not provide sediment and erosion control on the outside slope of the berm.

Structural control measures (berm, silt fence and straw wattle) were observed at the site, but were damaged and not maintained. The placement of some of the silt fence and wattle did not appear to provide sediment or erosion control of the disturbed areas of the berm. An erosion rill and gully continued from the berm, down the side slope of the embankment, and to the first terrace above the Santa Fe River. There was no barrier to stop stormwater discharge over the edge of the terrace at this location.

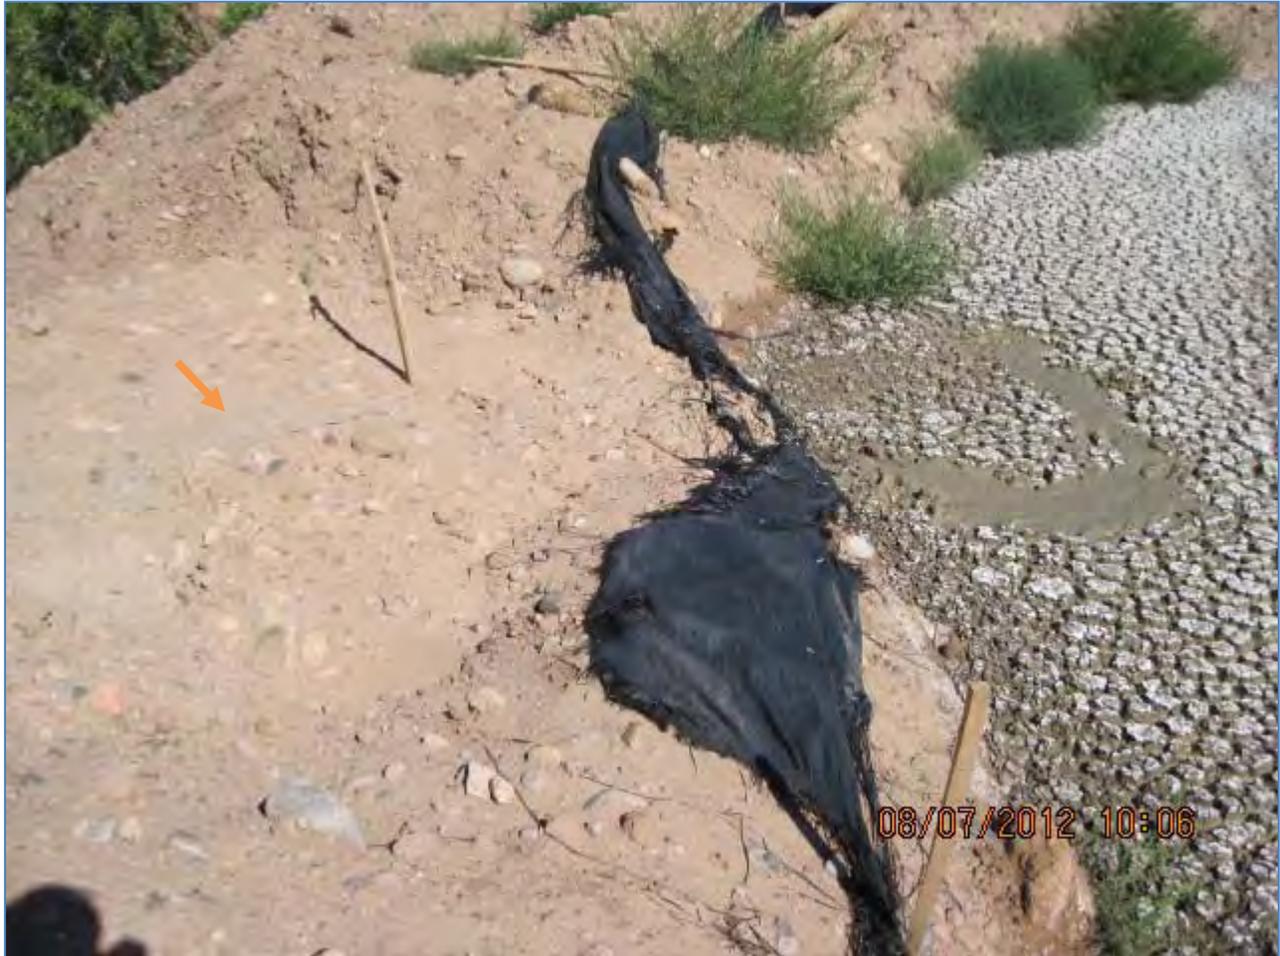
NMED/SWQB
Official Photograph Log
Photo # 2

Subject: A portion of the earth berm on west side of the drilling mud pit shown in previous photo was lower (missing). Level of drilling muds is near the top of the berm in this location. Arrow points to gray solids, which appeared to be drilling mud fluids, outside the pit. Photo also shows damaged silt fence.

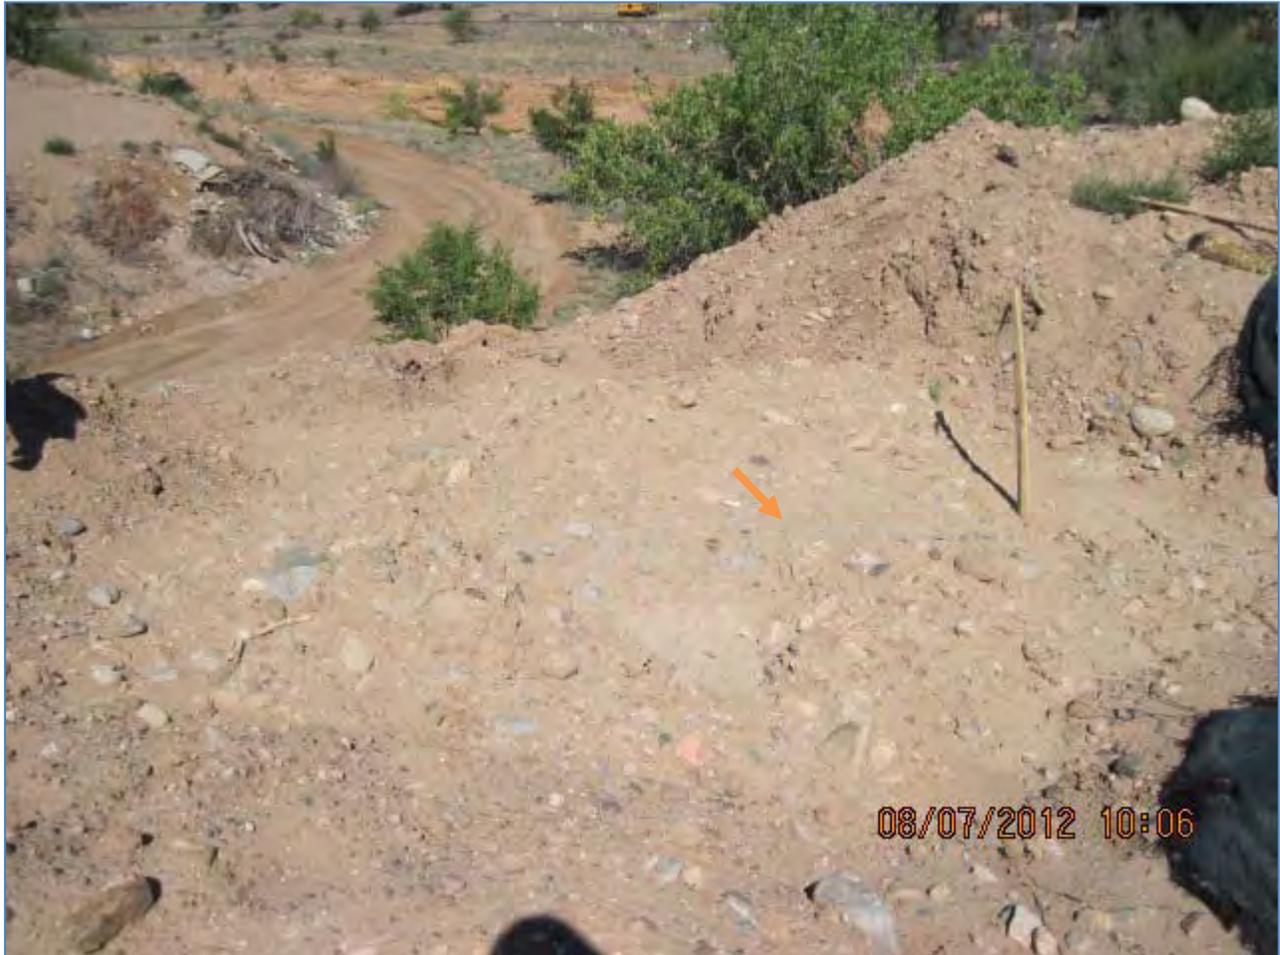
NMED/SWQB
Official Photograph Log
Photo # 3

Subject: Lower (missing) berm shown in previous photo. Arrow in this photo again points to gray solids, which appeared to be drilling mud fluids, outside the pit.

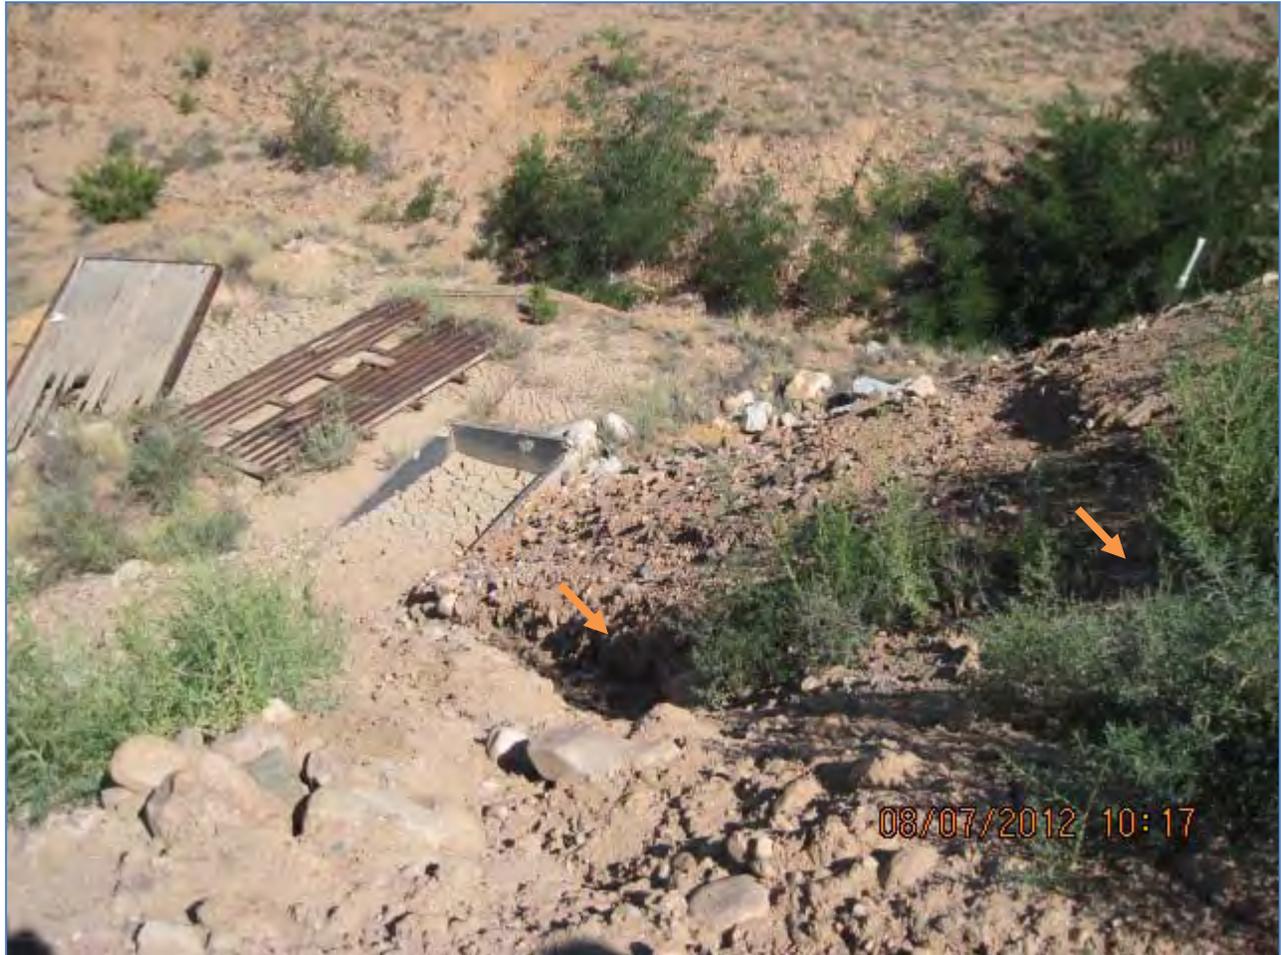
NMED/SWQB
Official Photograph Log
Photo # 4

Subject: Arrows point to an erosion gully that continued from the top of berm, down the side slope of the embankment to the first terrace above the Santa Fe River. It is unknown if this gully existed prior to the excavation of the berm, but the gully would convey storm water from the berm.

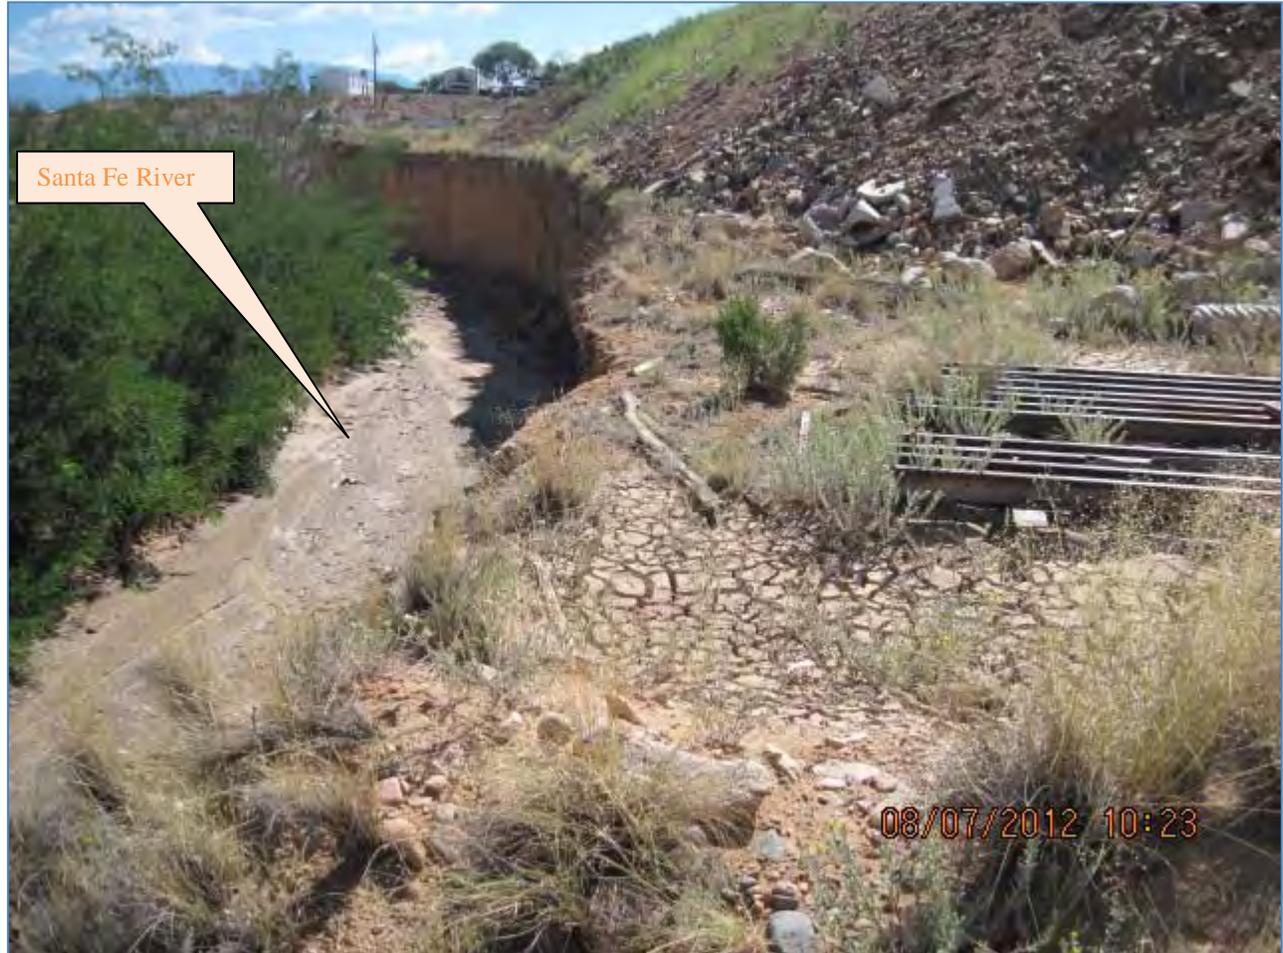
NMED/SWQB
Official Photograph Log
Photo # 5

Subject: Photo taken from the first terrace above the Santa Fe River. Stormwater from the berm appeared to collect in this area. There was no barrier to stop stormwater discharge over the edge of the terrace at this location.

If not properly managed or treated in accordance with an NPDES permit, the construction support activities at this site represent a potential threat to water quality through storm water discharges. According to Mr. Williams, ENMR Telephone Cooperative, Inc. decided to request a plan from the design engineer/consultant and/or general contractor to “close” (stop using and remove the bentonite slurry from the broadband construction project) from this Agua Fria site due to its proximity to the Santa Fe River.
