**RE: Construction Storm Water; SIC 1611; NPDES Compliance Evaluation Inspection; Team Fishel; NMU001795; May 14, 2012**

### NPDES Compliance Inspection Report

**NPDES Construction Storm Water  
Compliance Evaluation Inspection  
Team Fishel  
May 14, 2012**

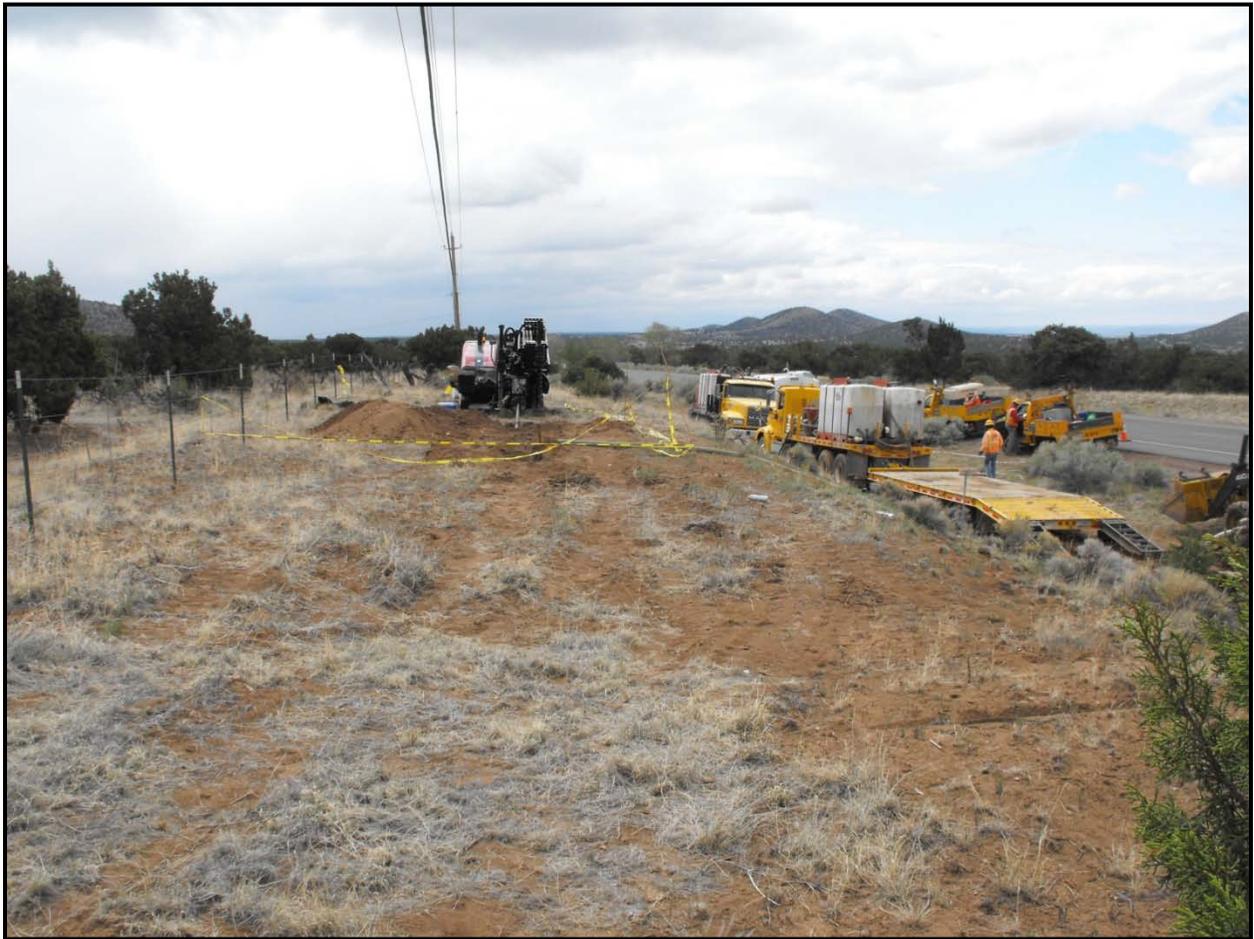
Photo # 1

| Location: Near the intersection of Hwy 285/Bobcat Road/Old Vegas Hwy, facing east. | | |
| Subject: Directional bore used at this site, surface trenching used when the ground is rocky. | | |

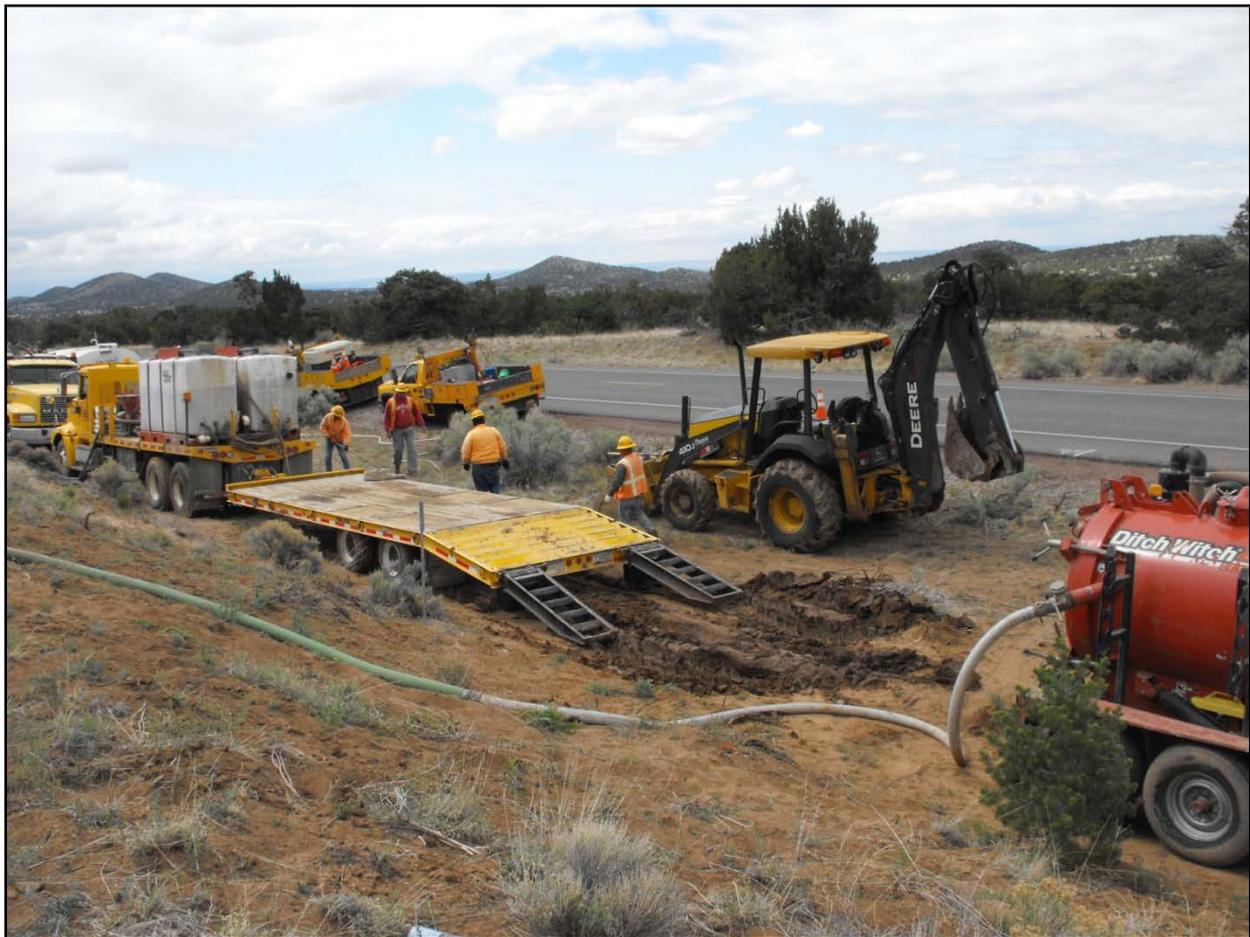
Photo # 2

| Location: Near the intersection of Hwy 285/Bobcat Road/Old Vegas Hwy, facing southeast. | | |
| Subject: Disturbance footprint at this site. | | |

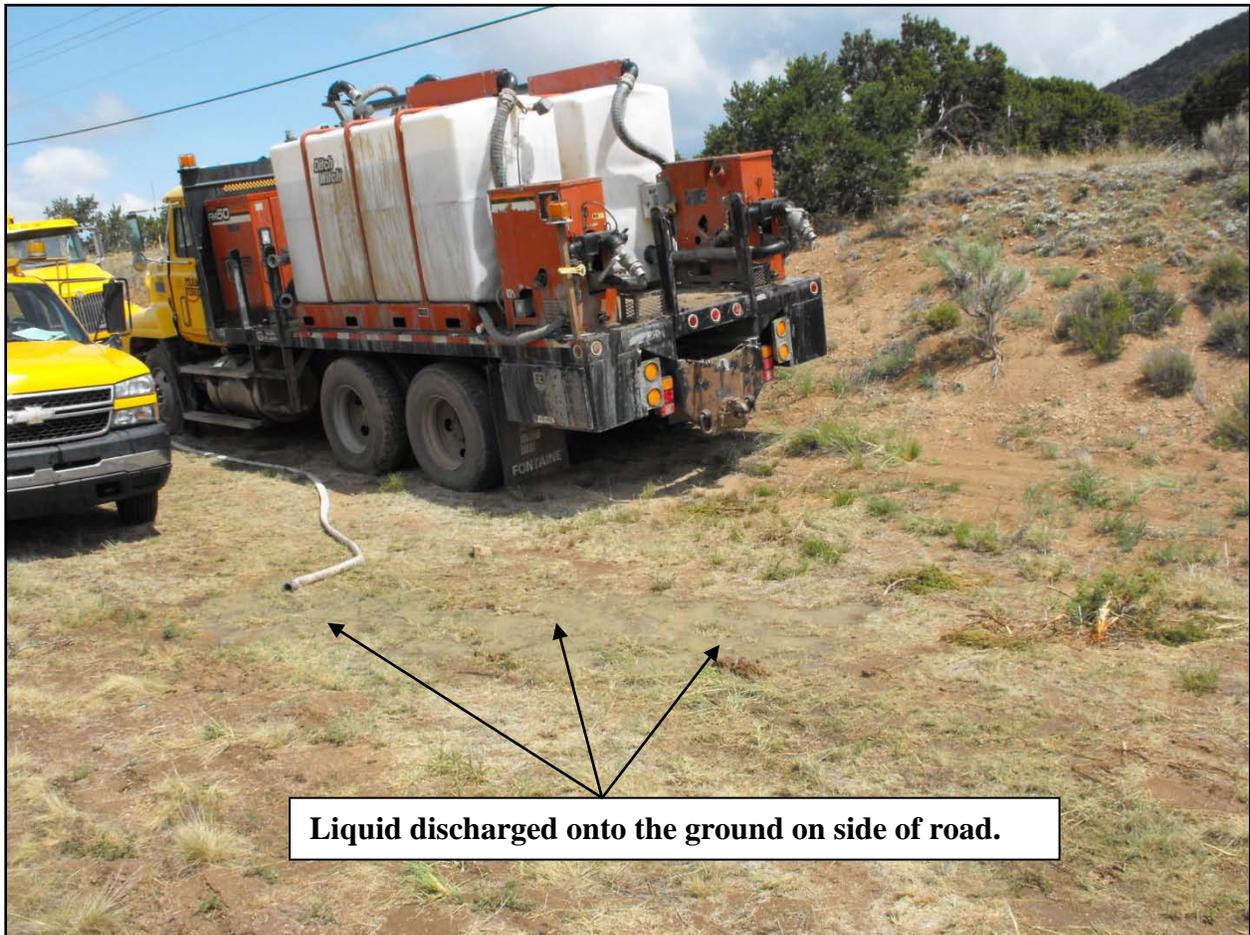
Photo # 3

| Location: Near the intersection of Hwy 285/Bobcat Road/Old Vegas Hwy, facing northwest. | | |
| Subject: Unknown liquid discharge. | | |
