RE: Construction Storm Water, SIC 1623, NPDES Compliance Evaluation Inspection, The Fishel Company / Telecommunications Round II Broadband Project Support Activity, NMU001795, August 7, 2012

NPDES Construction Storm Water Compliance Evaluation Inspection
The Fishel Company
Telecommunications Round II Broadband Project
Construction Support Activity at 4519 Agua Fria Street, Santa Fe, New Mexico
NMU001795
August 7, 2012

Further Explanations

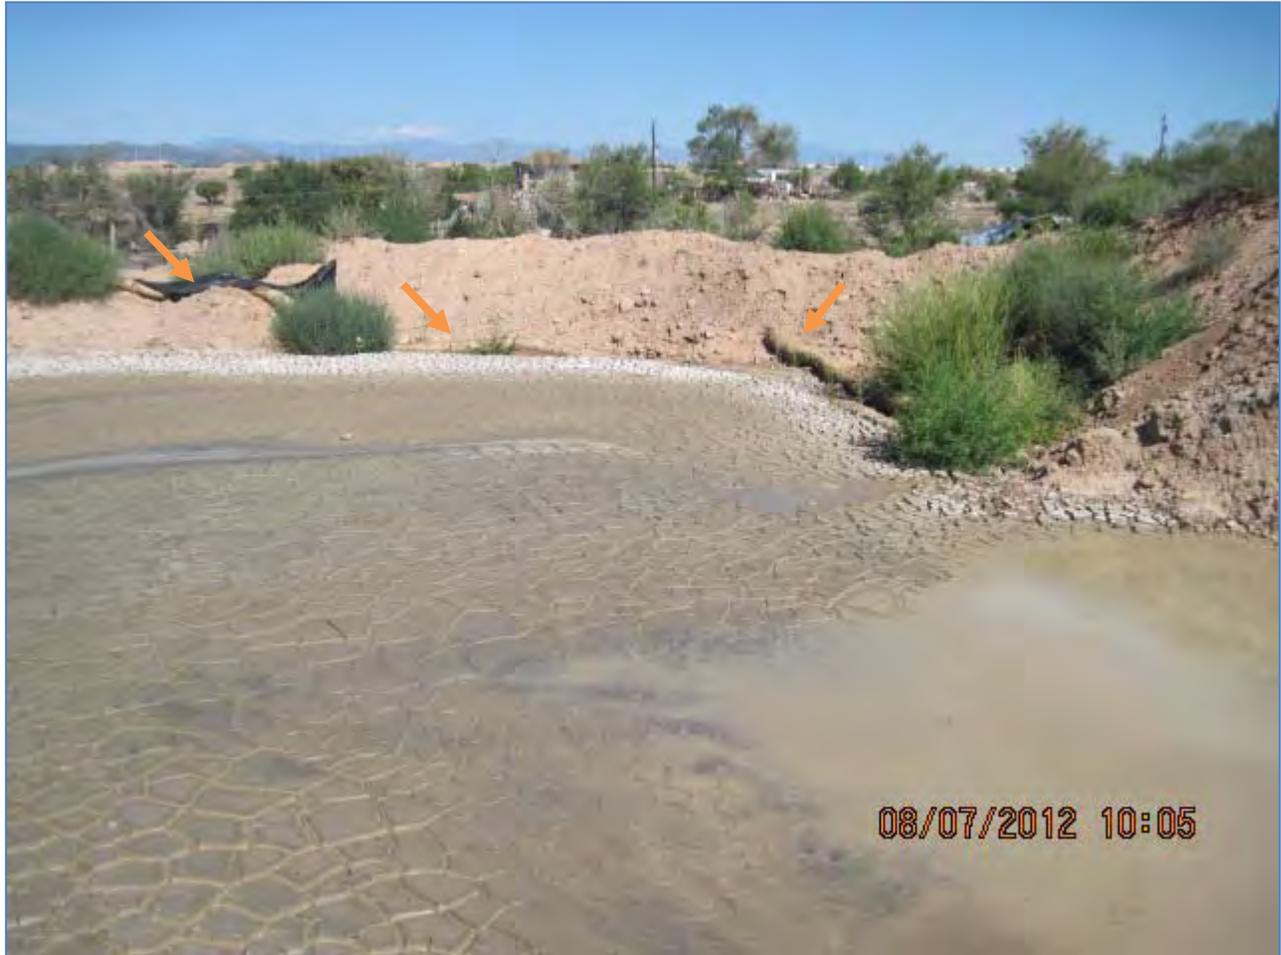
NMED/SWQB
Official Photograph Log
Photo # 1

Subject: Looking north at drilling mud pit and earth berm. Arrows point to silt fence and straw wattle on the inside of the pit that would not provide sediment and erosion control on the outside slope of the berm.

Structural control measures (berm, silt fence and straw wattle) were observed at the site, but were damaged and not maintained. The placement of some of the silt fence and wattle did not appear to provide sediment or erosion control of the disturbed areas of the berm. An erosion rill and gully continued from the berm, down the side slope of the embankment, and to the first terrace above the Santa Fe River. There was no barrier to stop stormwater discharge over the edge of the terrace at this location.

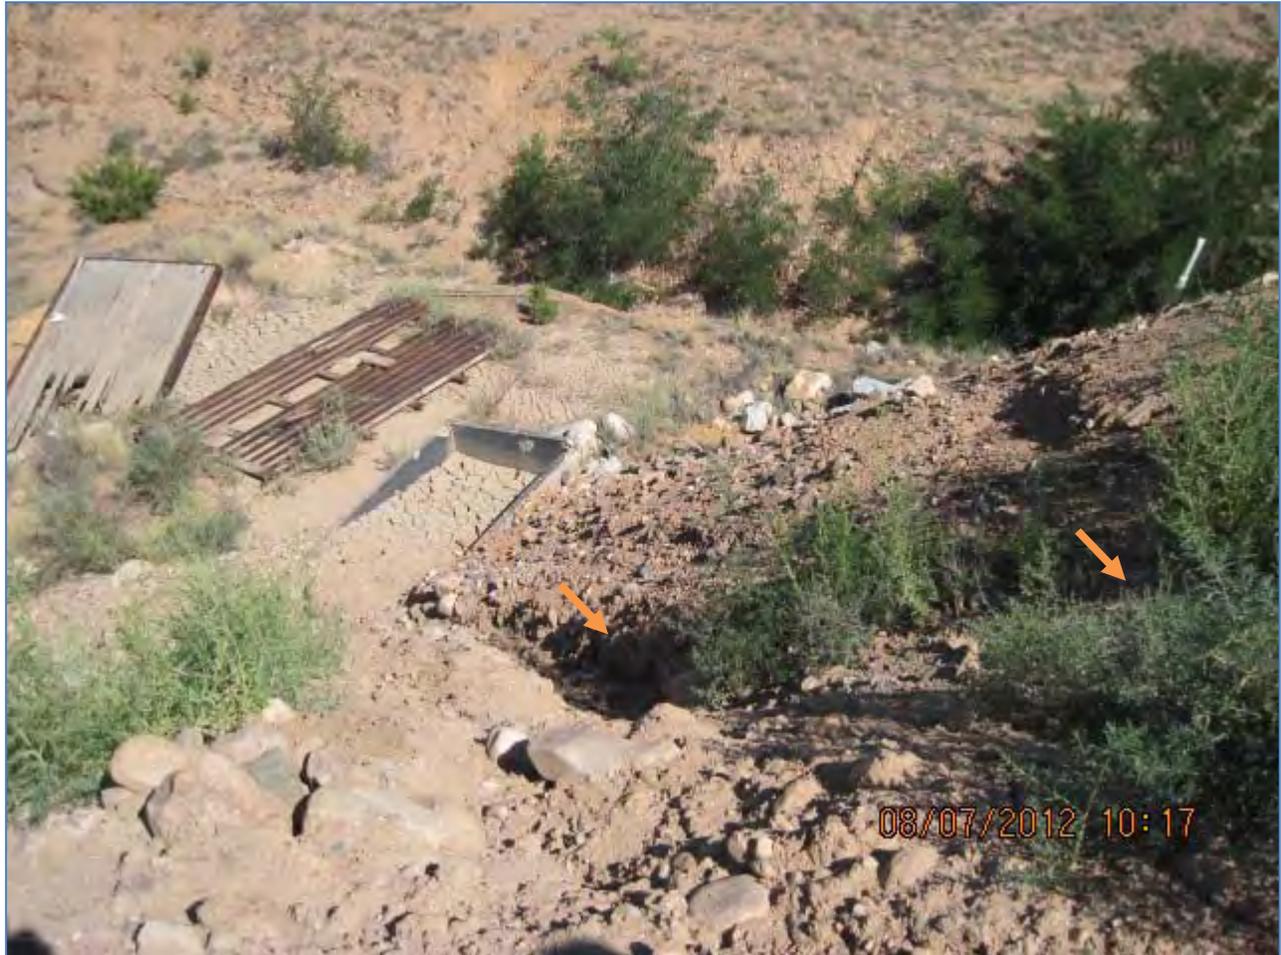
NMED/SWQB
Official Photograph Log
Photo # 4

Subject: Arrows point to an erosion gully that continued from the top of berm, down the side slope of the embankment to the first terrace above the Santa Fe River. It is unknown if this gully existed prior to the excavation of the berm, but the gully would convey storm water from the berm.
