**RE: Industrial Storm Water; SIC 5093; NPDES Compliance Evaluation Inspection; R&M Metals LLC;
NPDES Permit NMU001807; October 3, 2012**

NPDES Compliance Inspection Report

**R&M Metals LLC
NMU001807
October 3, 2012**

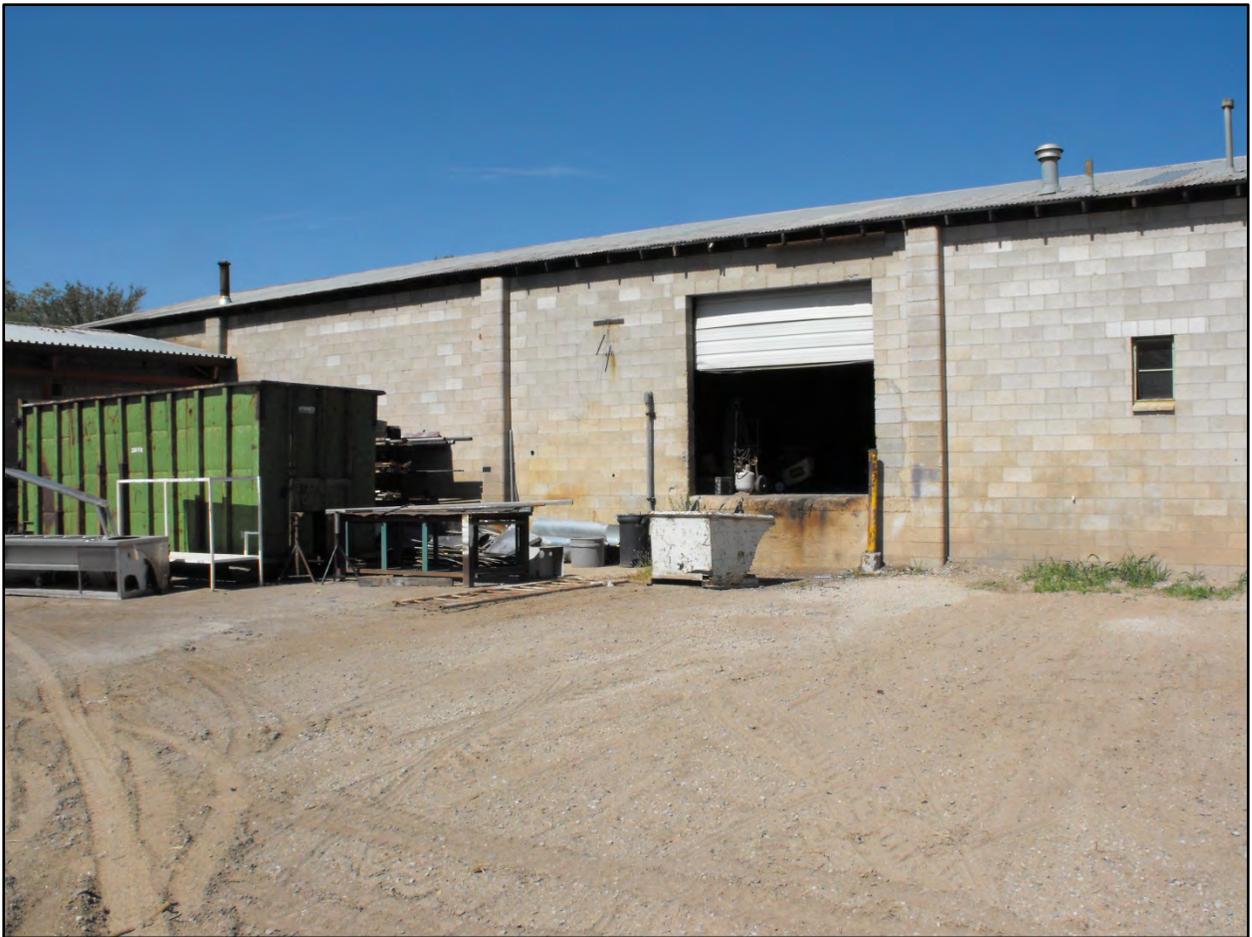
Photo # 1

Photographer: Daniel Valenta	Date: 10/3/2012	Time: 1322 hours
City/County: Albuquerque/Bernalillo		
Location: 2227 Mayflower Rd SW, Albuquerque, New Mexico, facing north.		
Subject: Back of R&M Metals LLC

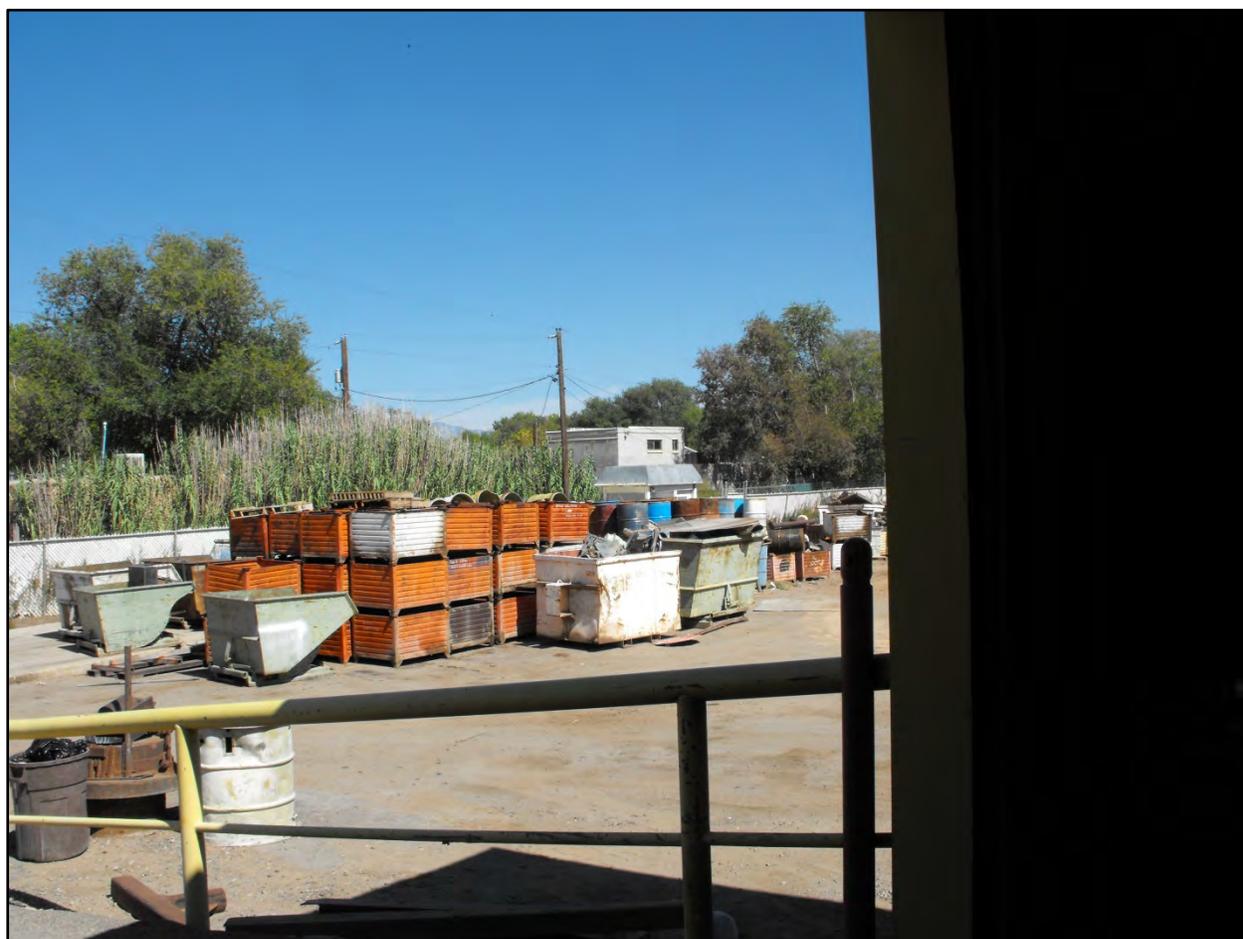
Photo # 2

Photographer: Daniel Valenta	Date: 10/3/2012	Time: 1330 hours
City/County: Albuquerque/Bernalillo		
Location: 2227 Mayflower Rd SW, Albuquerque, New Mexico, facing northeast.		
Subject: Front of R&M Metals LLC

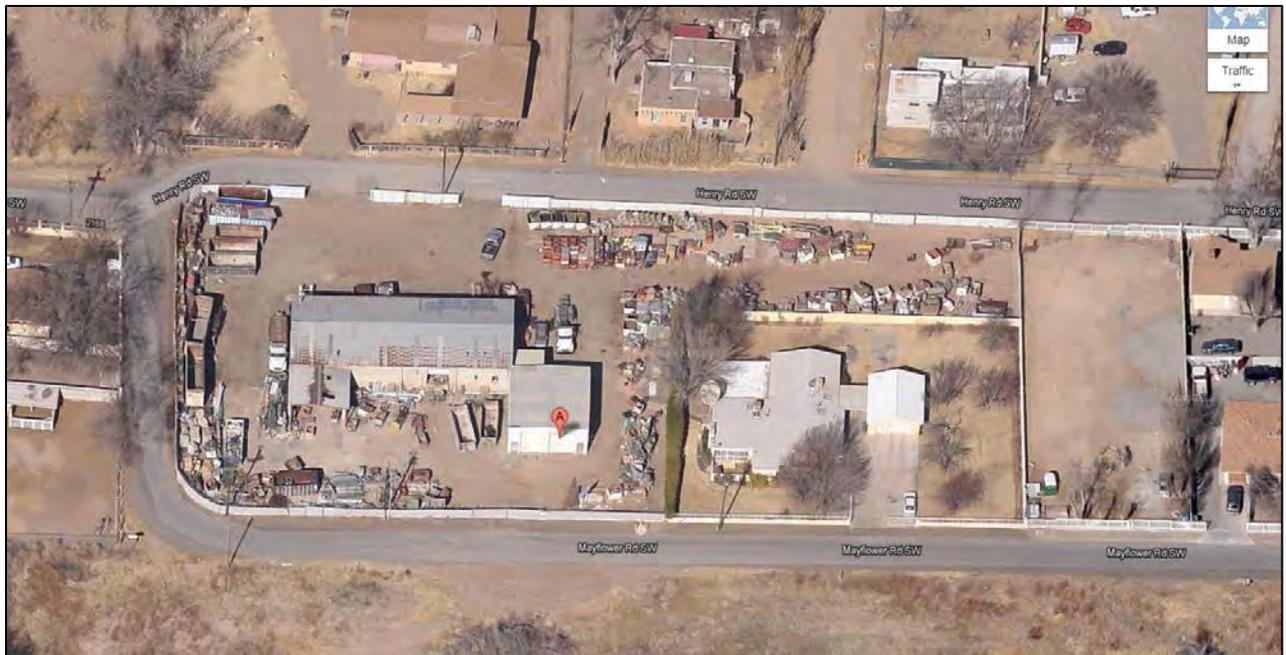
City/County:	Albuquerque/Bernalillo	
Location:	2227 Mayflower Rd SW, Albuquerque, New Mexico 87105.	
Subject:	Overview of R&M Metals LLC

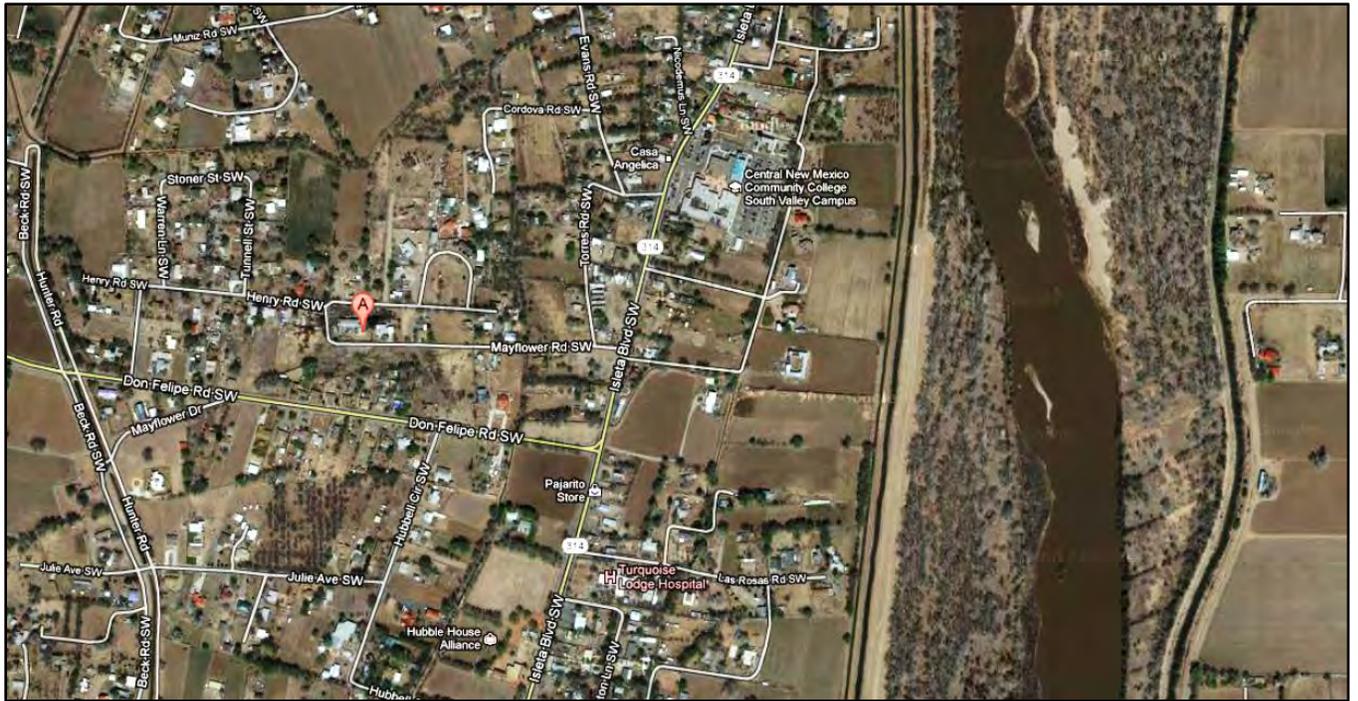
City/County:	Albuquerque/Bernalillo	
Location:	2227 Mayflower Rd SW, Albuquerque, New Mexico 87105.	
Subject:	Overview of R&M Metals LLC
