RE: Industrial Stormwater Inspection; SIC 3721; NPDES Compliance Evaluation Inspection; Utility Block Company, Inc; NPDES Permit NMU001808 ; October 17, 2012

NPDES Compliance Inspection Report

Utility Block Company, Inc.
NPDES Compliance Evaluation Inspection
NPDES Permit NMU001808
Inspection Date: October 17, 2012

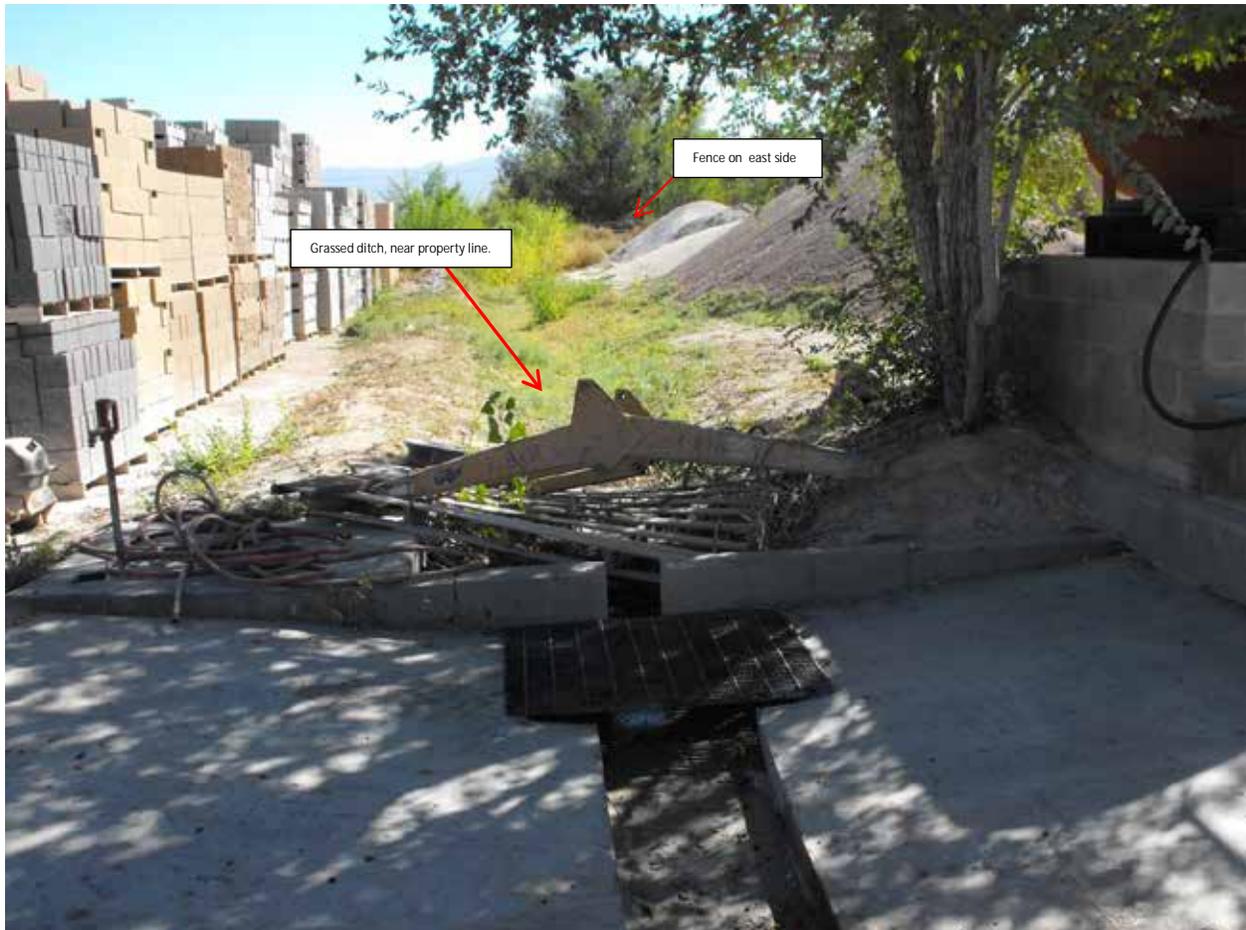
NMED/SWQB
Official Photograph Log
Photo #1

Photographer: Daniel Valenta	Date: October 17, 2012	Time: 1115 Hours
City/County: Albuquerque / Bernalillo		
Location: Utility Block Company, Inc., 7200 Second Street, Albuquerque, NM		
Subject: East side of property – Grassed ditch leading to back of property.

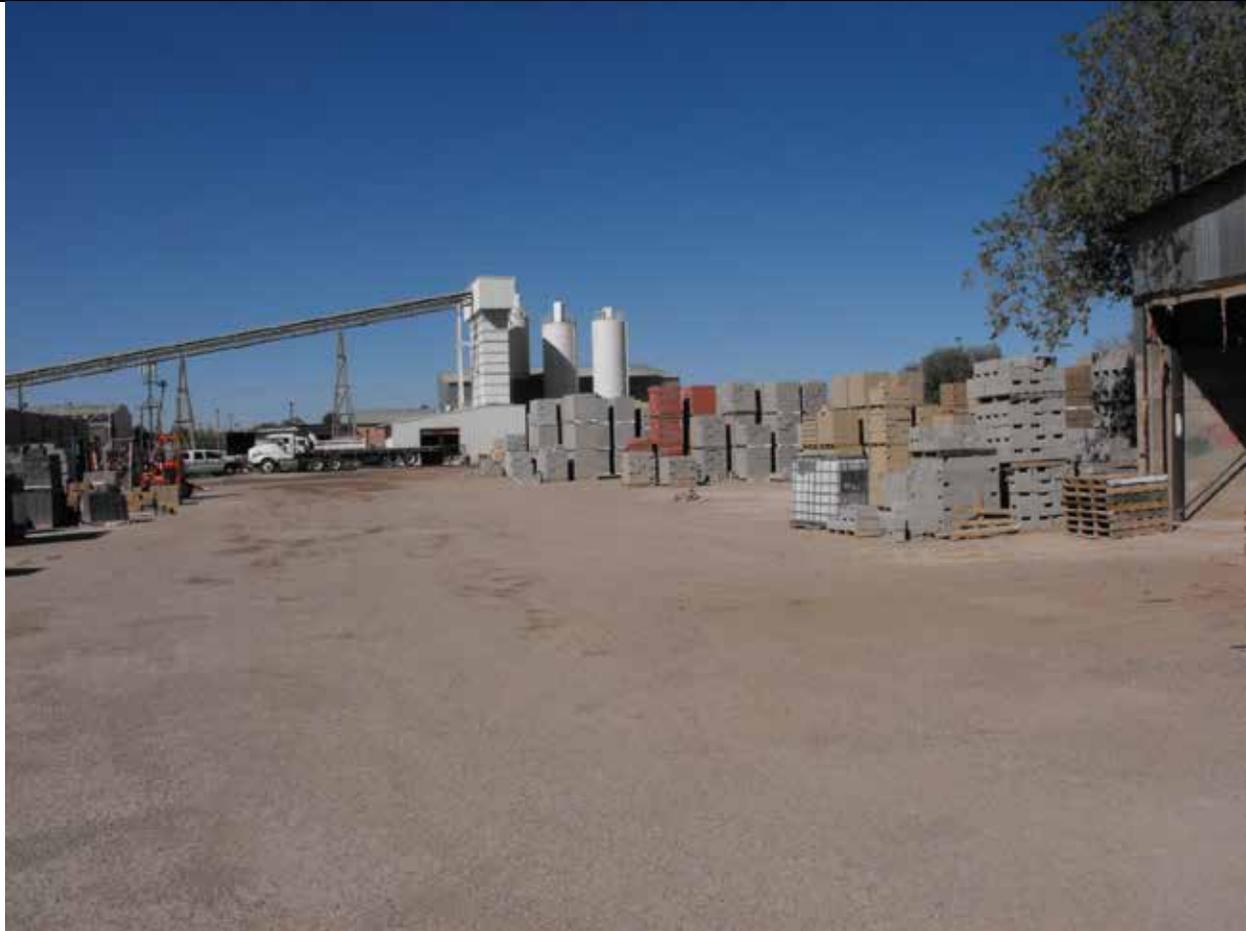
NMED/SWQB
Official Photograph Log
Photo #2

Photographer: Daniel Valenta	Date: October 17, 2012	Time: 1118 Hours
City/County: Albuquerque / Bernalillo		
Location: Utility Block Company, Inc., 7200 Second Street, Albuquerque, NM		
Subject: Looking West – Overview of property.

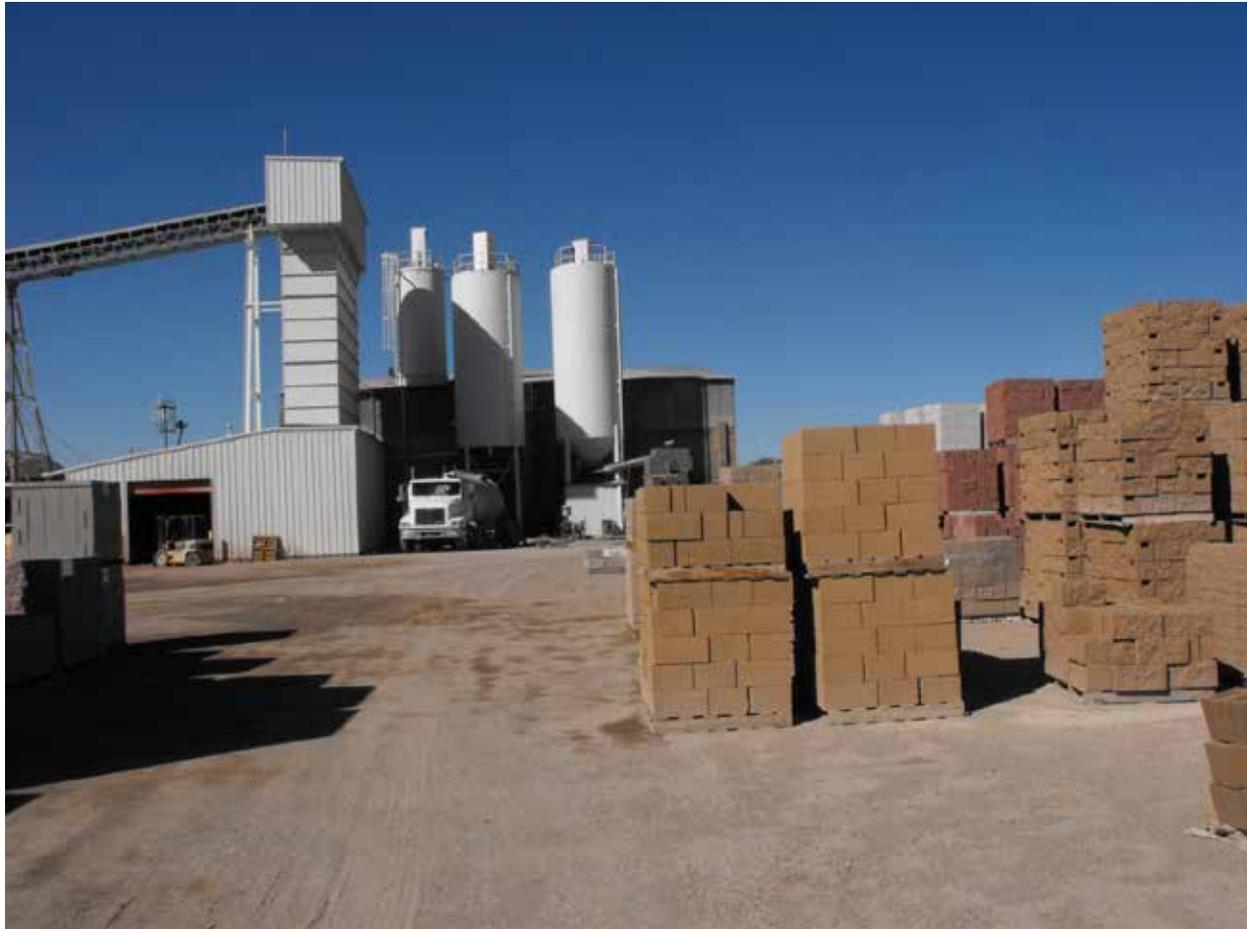
NMED/SWQB
Official Photograph Log
Photo #3

Photographer: Daniel Valenta	Date: October 17, 2012	Time: 1122 Hours
City/County: Albuquerque / Bernalillo		
Location: Utility Block Company, Inc., 7200 Second Street, Albuquerque, NM		
Subject: Looking West – View of silos, loading area.

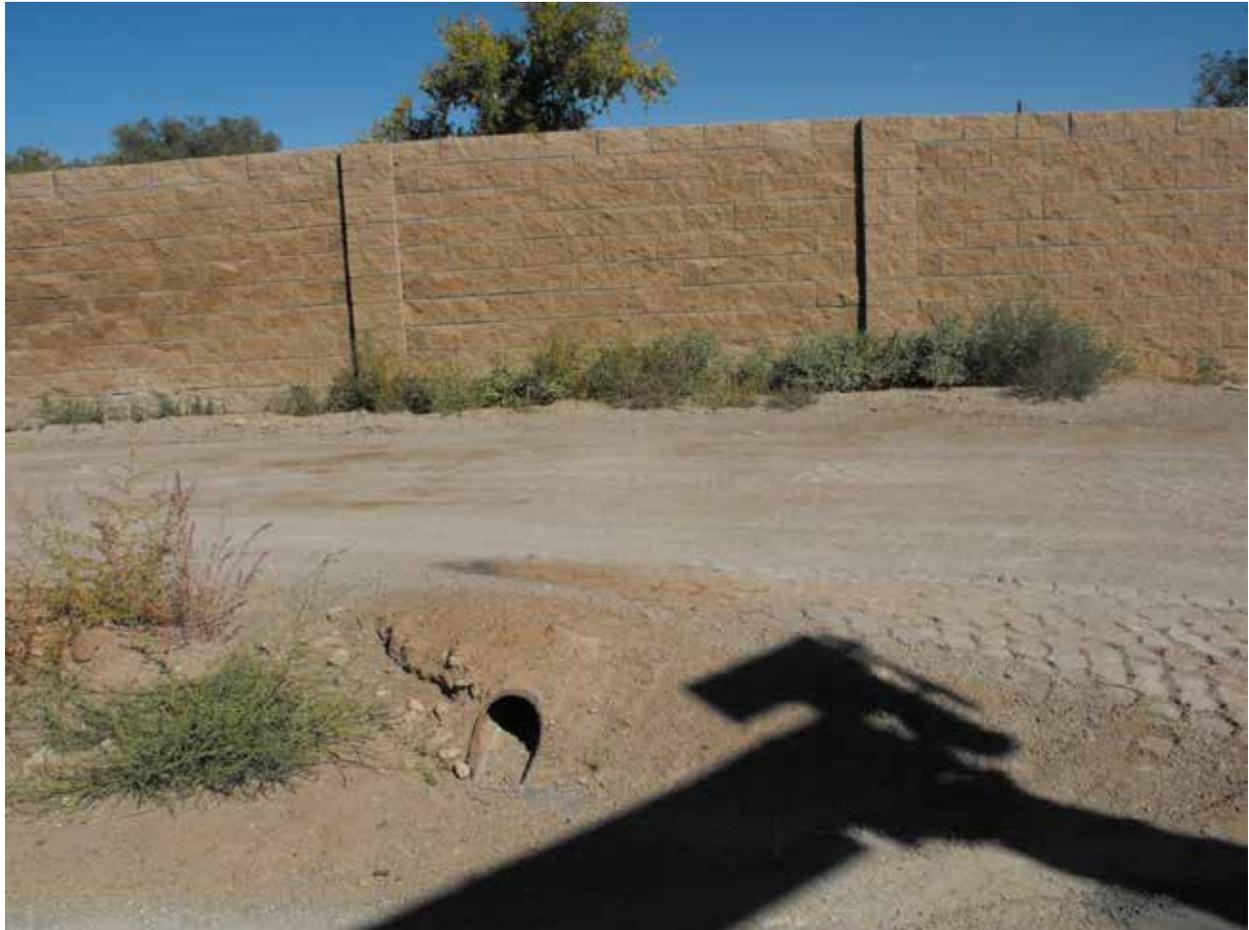
NMED/SWQB
Official Photograph Log
Photo #4

During the tour of the facility, there were several possible discharge points observed. There was a cemented area on the east side of the property that led to a grassed ditch which exited the property on the eastern border. To the north, there was a retention wall, however, there were several areas where concrete blocks provided discharge points. Also, near a loading/unloading silo the inspectors noted a pipe which was placed in the ground that appeared to discharge to an area outside of the property retention wall on the north side. On the northside, outside of the property, there were several storm sewer drains, one of which appeared to have some debris similar to that seen on the pipe.

Photographer: Daniel Valenta	Date: October 17, 2012	Time: 1125 Hours
City/County: Albuquerque / Bernalillo		
Location: Utility Block Company, Inc., 7200 Second Street, Albuquerque, NM		
Subject: Facing north –Discharge via pipe which flows underground past the retention wall to the other side, where it exits at the wall next to a public road. This pipe is near the silos in the previous picture.

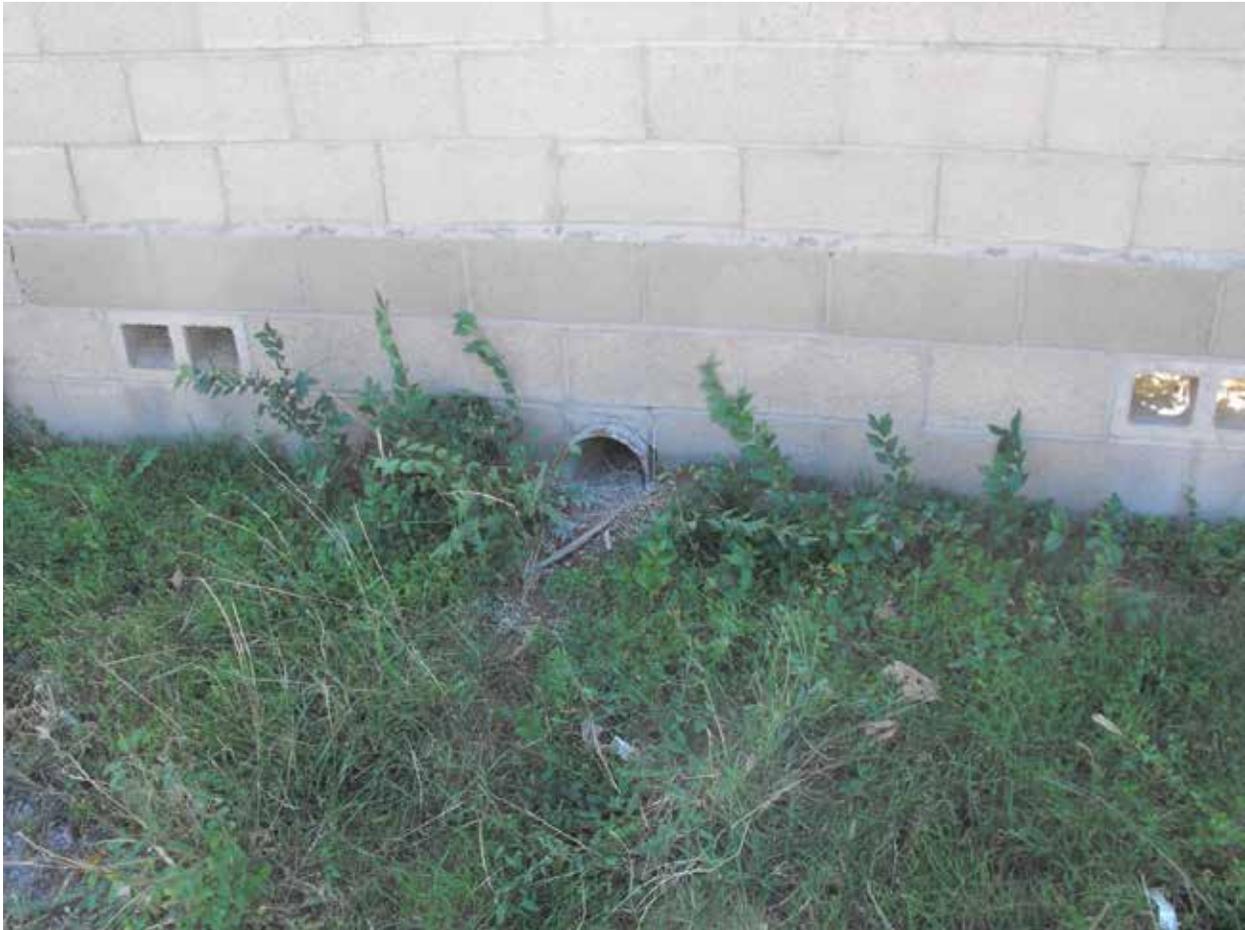
NMED/SWQB
Official Photograph Log
Photo #5

Photographer: Daniel Valenta	Date: October 17, 2012	Time: 1138 Hours
City/County: Albuquerque / Bernalillo		
Location: Utility Block Company, Inc., 7200 Second Street, Albuquerque, NM		
Subject: West side of wall where pipe exits the facility (pipe from previous picture)

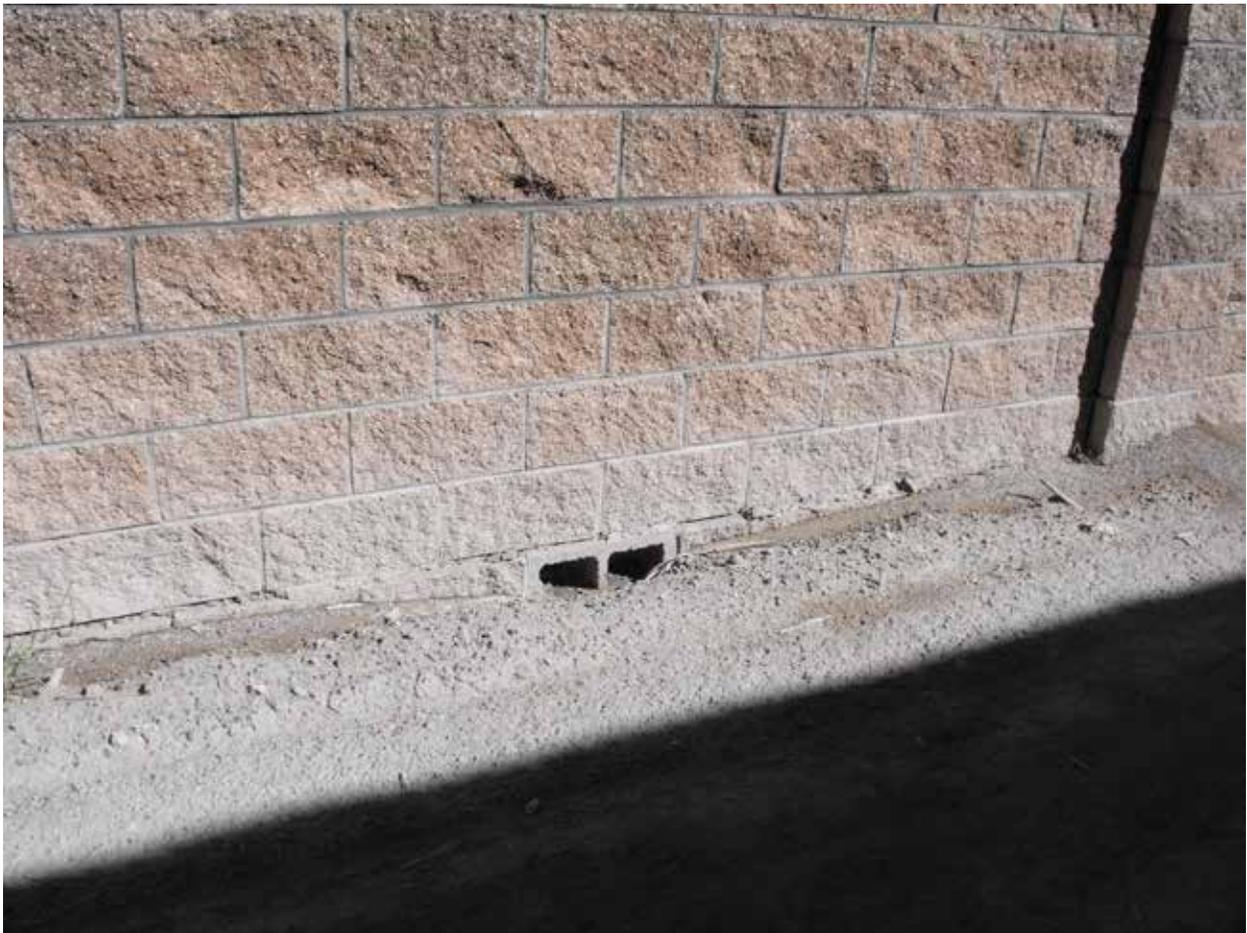
NMED/SWQB
Official Photograph Log
Photo #6

Photographer: Daniel Valenta	Date: October 17, 2012	Time: 1127 Hours
City/County: Albuquerque / Bernalillo		
Location: Utility Block Company, Inc., 7200 Second Street, Albuquerque, NM		
Subject: West side of property – Possible discharge point.

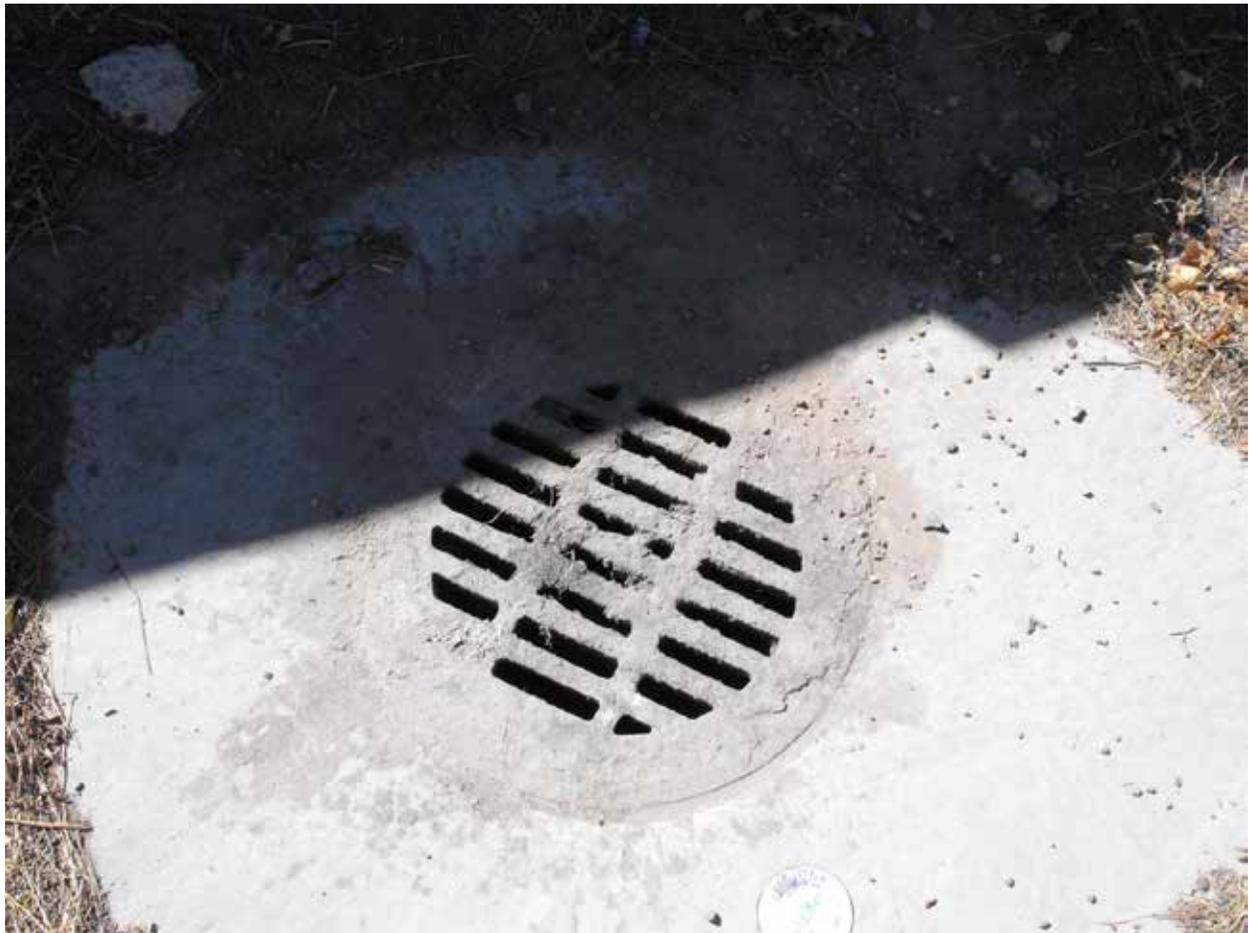
NMED/SWQB
Official Photograph Log
Photo #7

Photographer: Daniel Valenta	Date: October 17, 2012	Time: 1137 Hours
City/County: Albuquerque / Bernalillo		
Location: Utility Block Company, Inc., 7200 Second Street, Albuquerque, NM		
Subject: Storm drain adjacent to Utility Block on west side.
