**RE: Industrial Stormwater Inspection; SIC 3721; NPDES Compliance Evaluation  
Inspection; Superlite – an Oldcastle® Company; NPDES Permit NMU001810 ;  
October 17, 2012**

### NPDES Compliance Inspection Report

**Superlite Block – an Oldcastle® Company**  
**NPDES Compliance Evaluation Inspection**  
**NPDES Permit NMU001810**  
**Inspection Date: October 17, 2012**

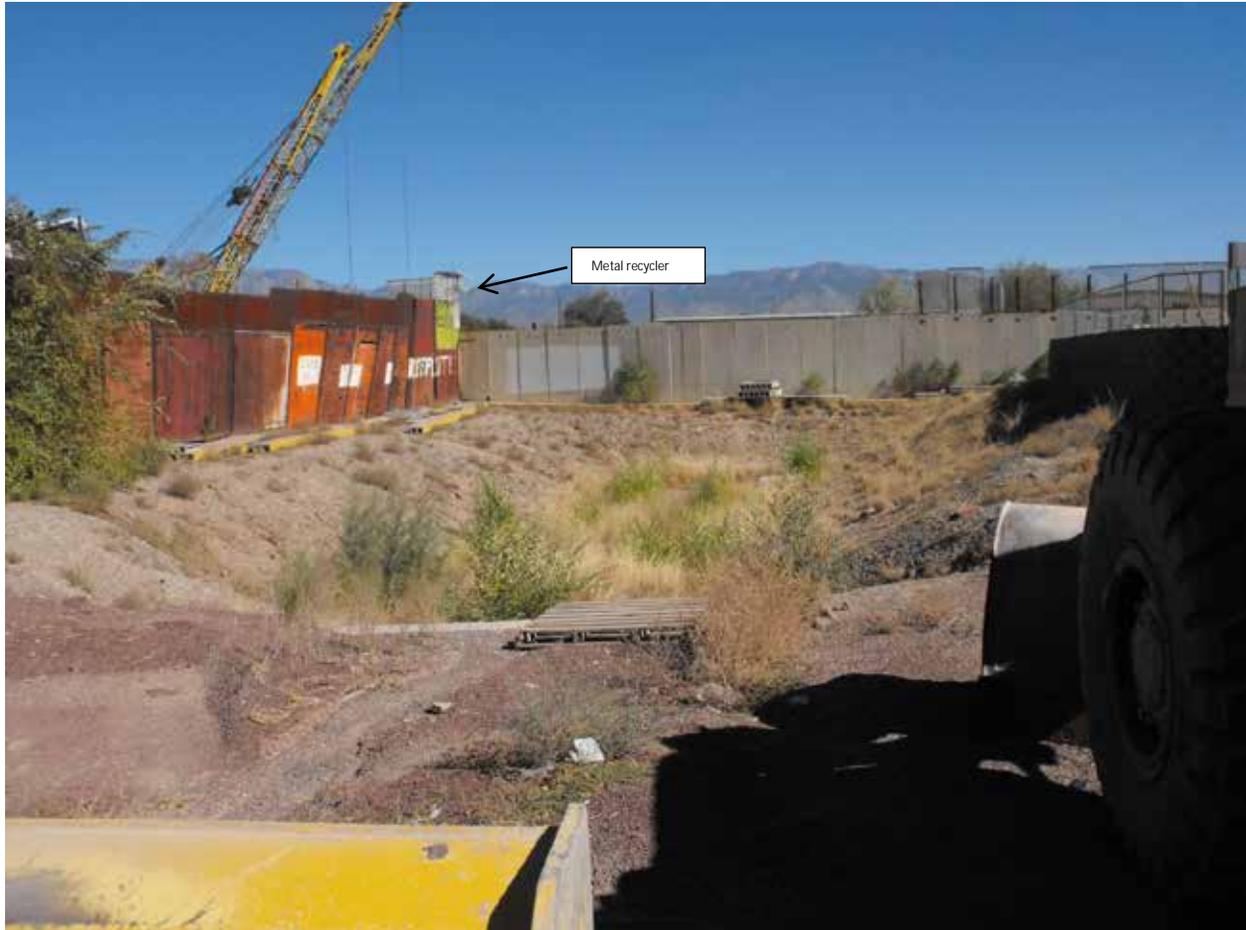
NMED/SWQB  
Official Photograph Log  
Photo #1

Photographer: Daniel Valenta	Date: October 17, 2012	Time: 1416 Hours
City/County: Albuquerque / Bernalillo		
Location: Superlite Block, 6140 2 <sup>nd</sup> Street, NW; Albuquerque, NM		
Subject: Retention Basin on northeast side of property.

Although you do not have coverage, it is noted that the facility has begun to put together a SWPPP which was presented to the inspectors during the inspection. The facility also has constructed a retention pond on the northeast corner of the property. The retention pond will retain stormwater within the pond with no discharge except for when extreme rainfall events occur. The water collected in the retention pond either evaporates or infiltrates.
