RE: Construction Storm Water, SIC 1521, NPDES Compliance Evaluation Inspection, Sandrin, Inc. / Lot 10
Ridge Canyon Subdivision, NMU001819, November 5, 2012

**NPDES Compliance Evaluation Inspection
Industrial Stormwater Construction
Sandrin, Inc. / Lot 10 Ridge Canyon Subdivision
NMU001819
November 5, 2012**

Further Explanations

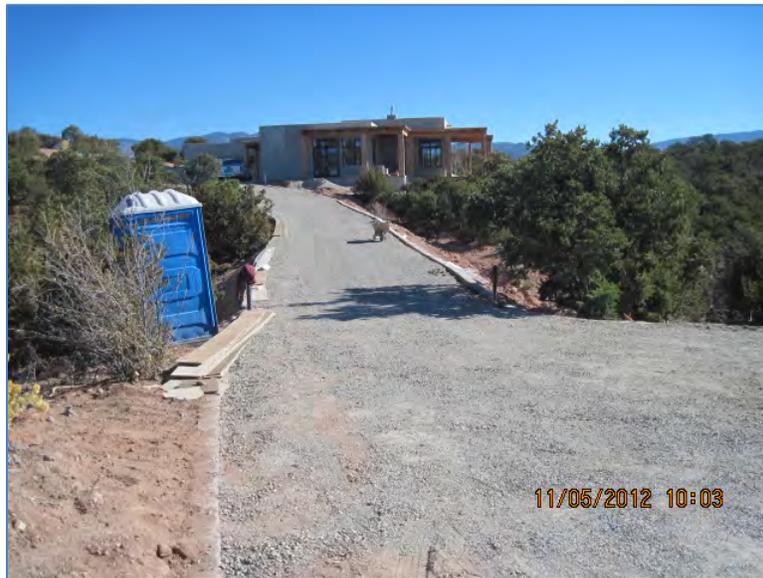
| NMED/SWQB Official Photograph Log Photo # 1 | | |

- Sanitary waste controls (portable toilet) were observed on site. However, the portable toilet was located directly above the on-site stream channel. The toilet was not located on a flat surface, and did not appear to be staked to minimize the potential for overtopping and spills.

| NMED/SWQB Official Photograph Log Photo # 1 | | |
|--|---|---|
| Subject: On-site portable toilet was located on slope. | | |

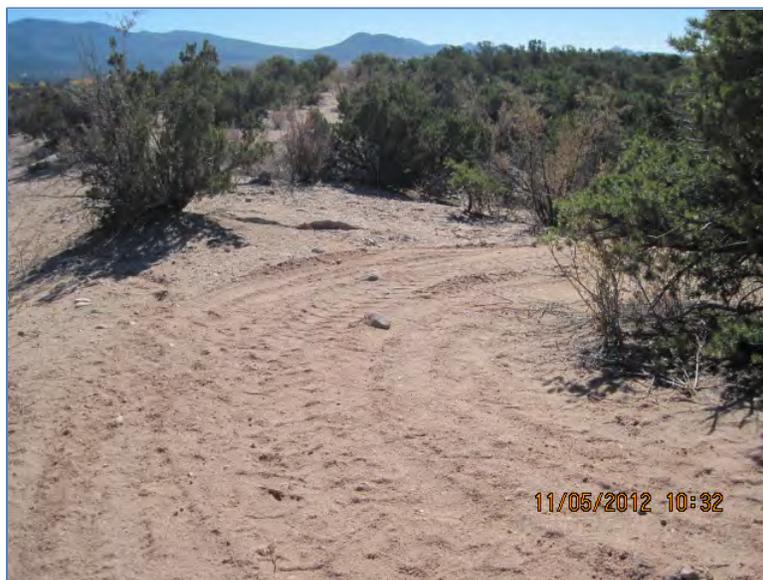
| NMED/SWQB Official Photograph Log Photo # 2 | | |

were observed. Areas of the lot (near the ridge above the residence) appeared to have been disturbed with vehicle traffic. This vehicle traffic disturbance may have occurred prior to the current operators taking control of the site and this disturbed area had not been stabilized.

| NMED/SWQB Official Photograph Log Photo # 2 | | |
|--|---|---|
| Subject: Disturbed area near ridge above residence was not stabilized. | | |

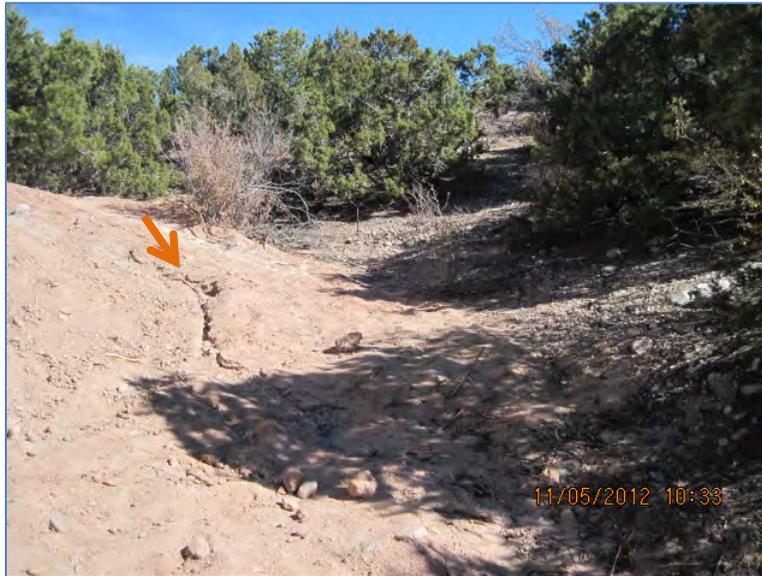
| NMED/SWQB Official Photograph Log Photo # 3 | | |

| NMED/SWQB Official Photograph Log Photo # 3 | | |
|--|---|---|
| Subject: Arrow points to an erosion rill on disturbed area above natural drainage channel. | | |

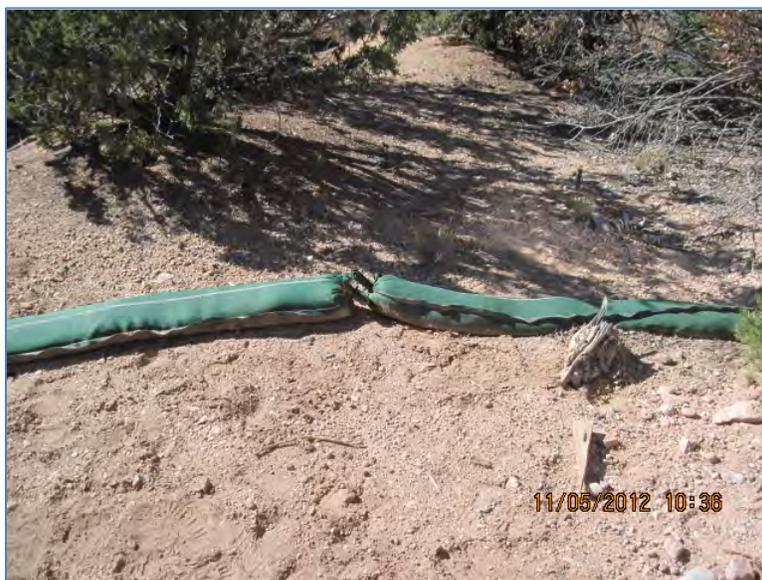
| NMED/SWQB Official Photograph Log Photo # 4 | | |

- Three rows of temporary erosion and sediment control sock had been placed below a water spigot to minimize erosion from non-stormwater use on site according to the operator's on-site representative. However, this and other sock observed on site were not secured (e.g., staked) and did not appear maintained (e.g., portions of sock were partially buried). Sections of sock had gaps (i.e., were not overlapped). Some sock did not appear to be located in areas to effectively minimize erosion or control sediment from entering the on-site stream and/or drainage channels (e.g., a row of sock crossed a natural drainage channel).

| NMED/SWQB Official Photograph Log Photo # 4 | | |
|--|---|---|
| Subject: Example of erosion and sediment control sock gap (not overlapped). Sock was not staked. | | |

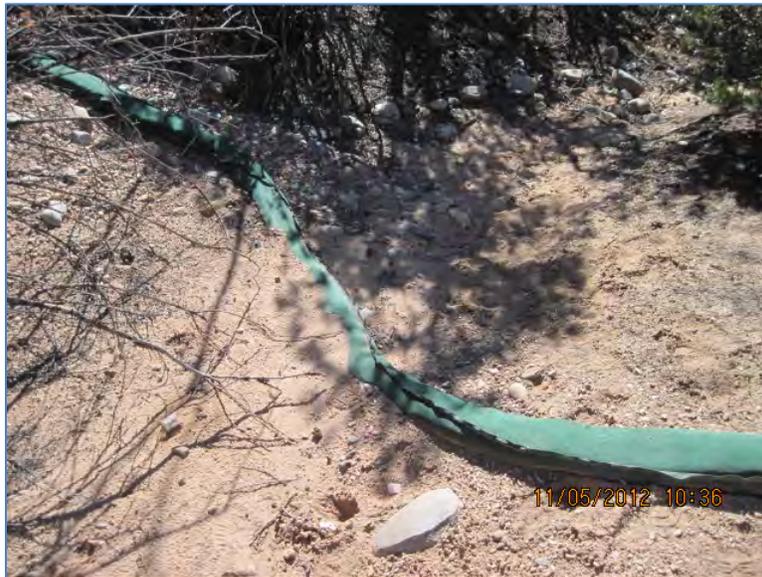
| NMED/SWQB Official Photograph Log Photo # 5 | | |

| Subject: Sock crossed on-site natural drainage channel. Sock location would not be effective in minimizing sediment from entering tributary. Accumulated sediment is over 1/2 the height of the sock. Sock was not staked. | | |

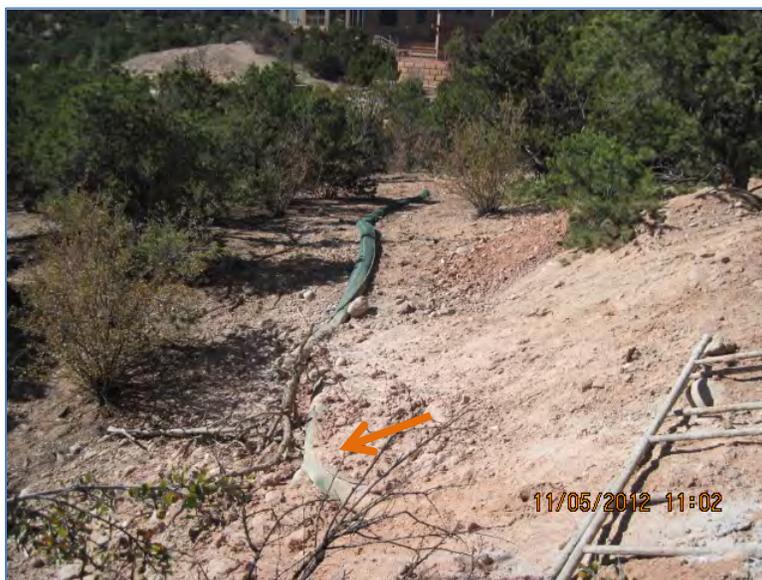
| NMED/SWQB Official Photograph Log Photo # 6 | | |

| Subject: Arrow points to example of partially buried sock. | | |

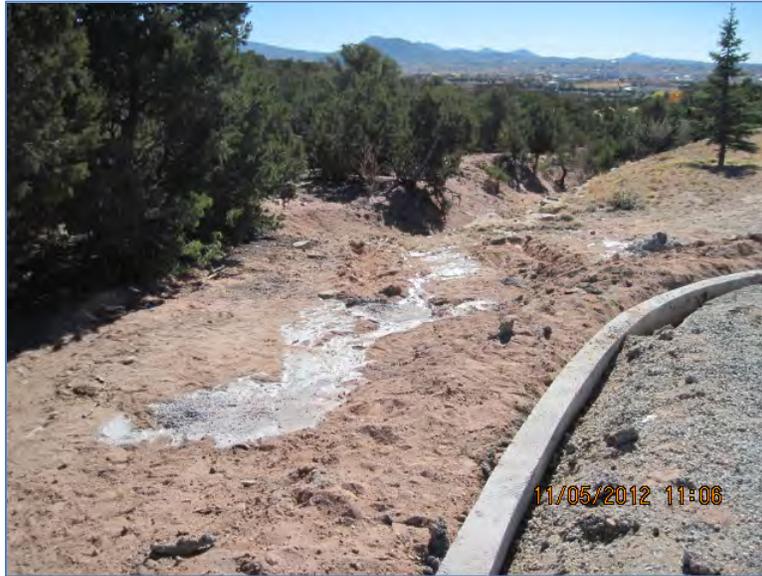
| NMED/SWQB Official Photograph Log Photo # 7 | | |

- There were no on-site concrete or other material washout controls observed. Washout on the ground was observed to have flowed toward the on-site stream channel and drainage along Ridge Canyon street.

| Subject: Example of concrete washout on ground that had flowed toward drainage near Ridge Canyon street. | | |

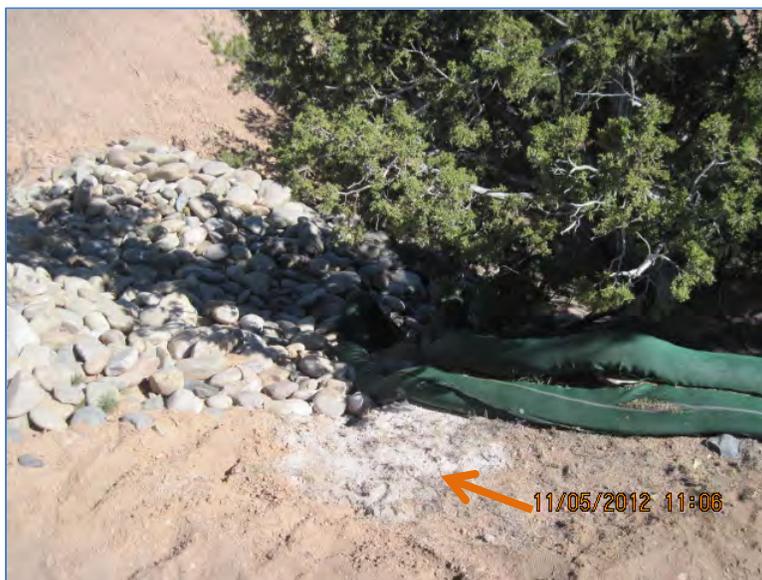
| NMED/SWQB Official Photograph Log Photo # 8 | | |

| Subject: Arrow points to example of material washout on ground that flowed toward cobble stone above on-site stream channel. | | |

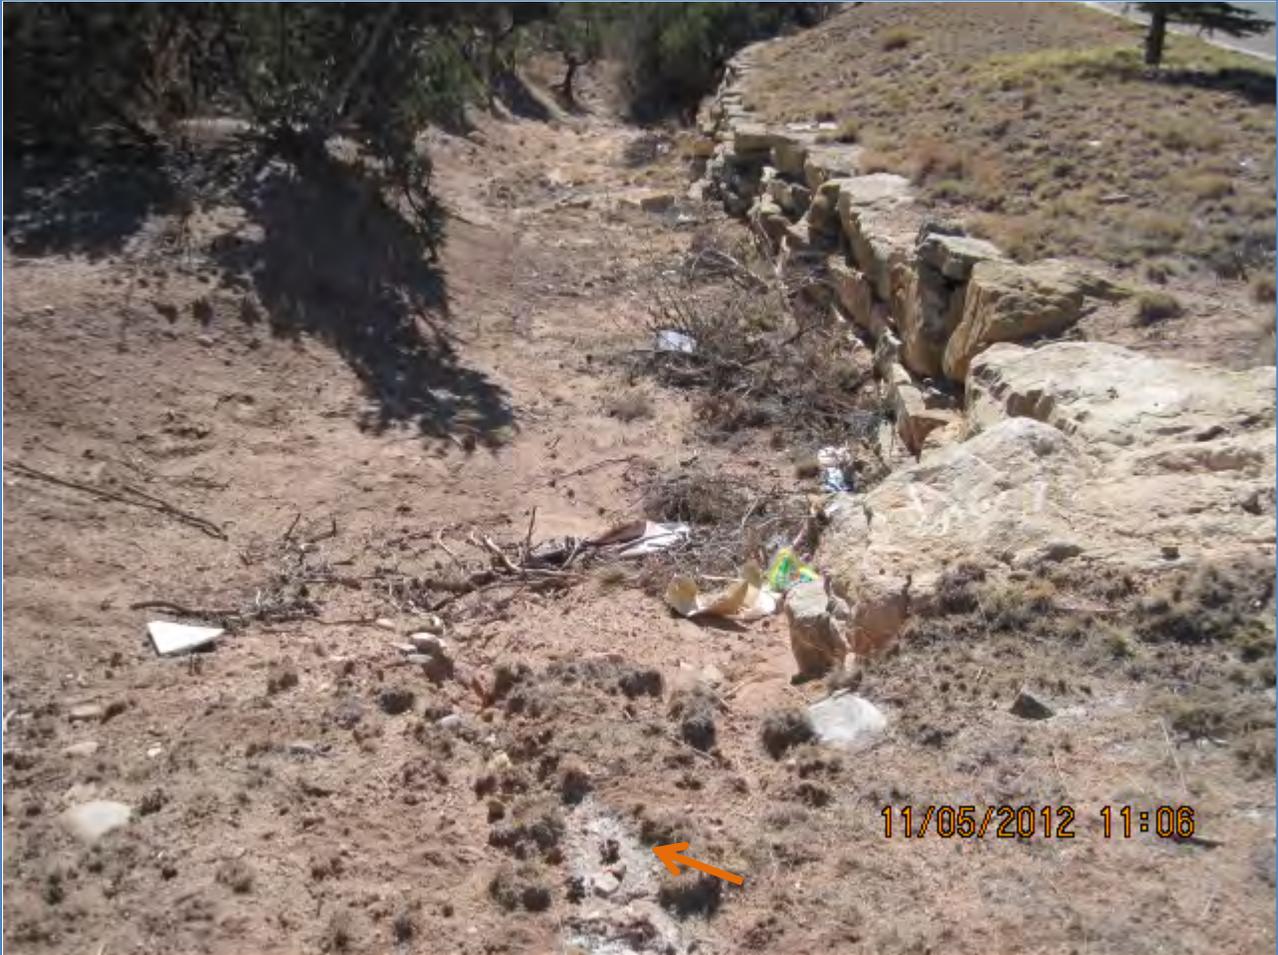
| NMED/SWQB Official Photograph Log Photo # 9 | | |

- Construction waste controls (roll off container) were observed on site. The waste container appeared to be located in an area protected from wind near the residence, and was not overflowing on the day of this inspection. However, the roll off was not covered. Also, construction waste and litter was observed along the property boundary and drainage along Ridge Canyon street.

| Subject: Arrow points to concrete washout and shallow erosion rill above drainage near property boundary along Ridge Canyon street. Construction trash (styrofoam) and other litter is also shown in photo. | | |
