RE: Industrial Storm Water; SIC 5093; NPDES Compliance Evaluation Inspection; Taos Recycling Center; NPDES Permit NMU001828; December 13, 2012

NPDES Compliance Inspection Report

Town of Taos Recycling Center
NMU001828
December 13, 2012

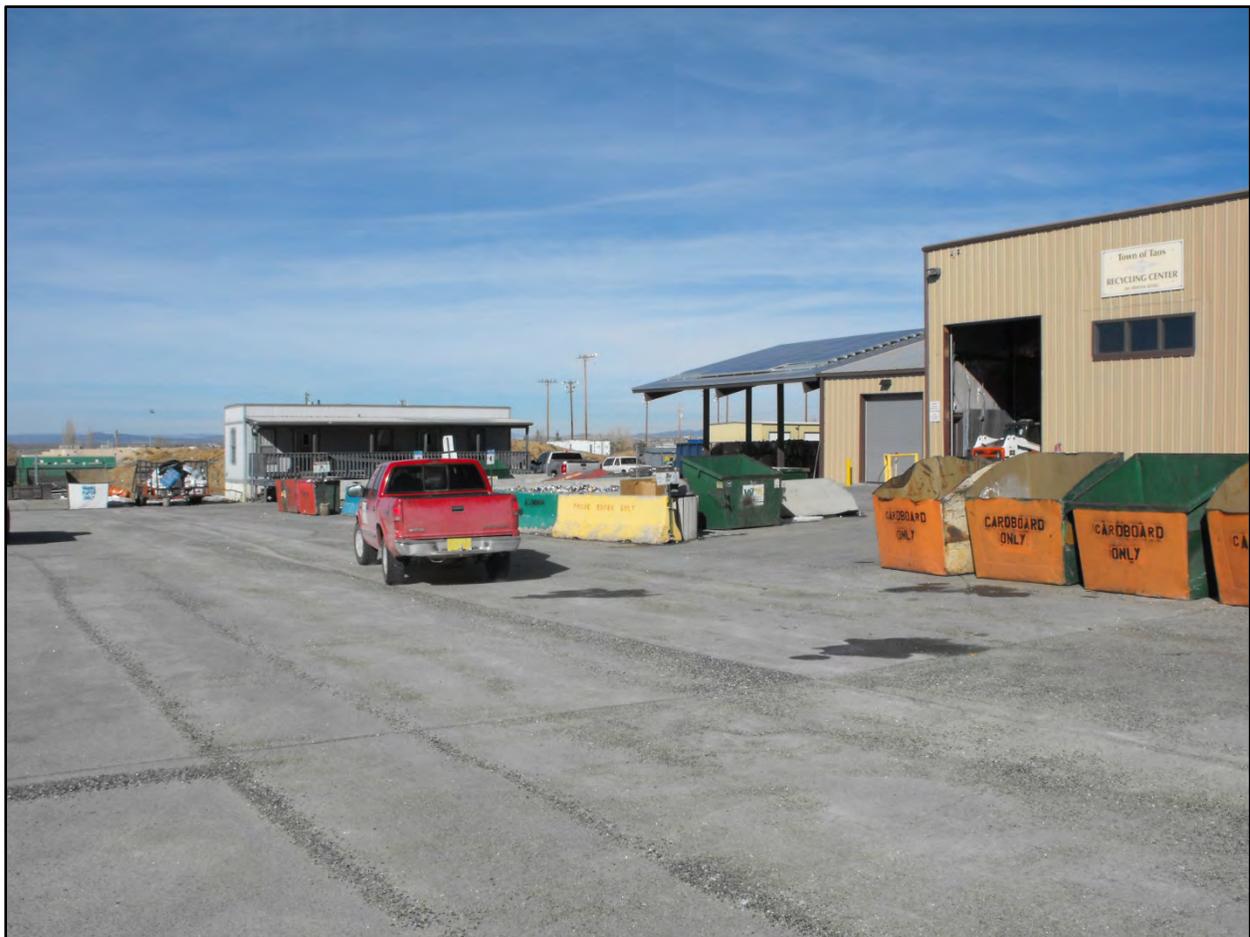
Photo # 1

Photographer: Daniel Valenta	Date: 12/13/2012	Time: 1114 hours
City/County: Taos/ Taos County		
Location: 201 Bertha Street, Taos, New Mexico, facing north.		
Subject: Drop off area for recycling.

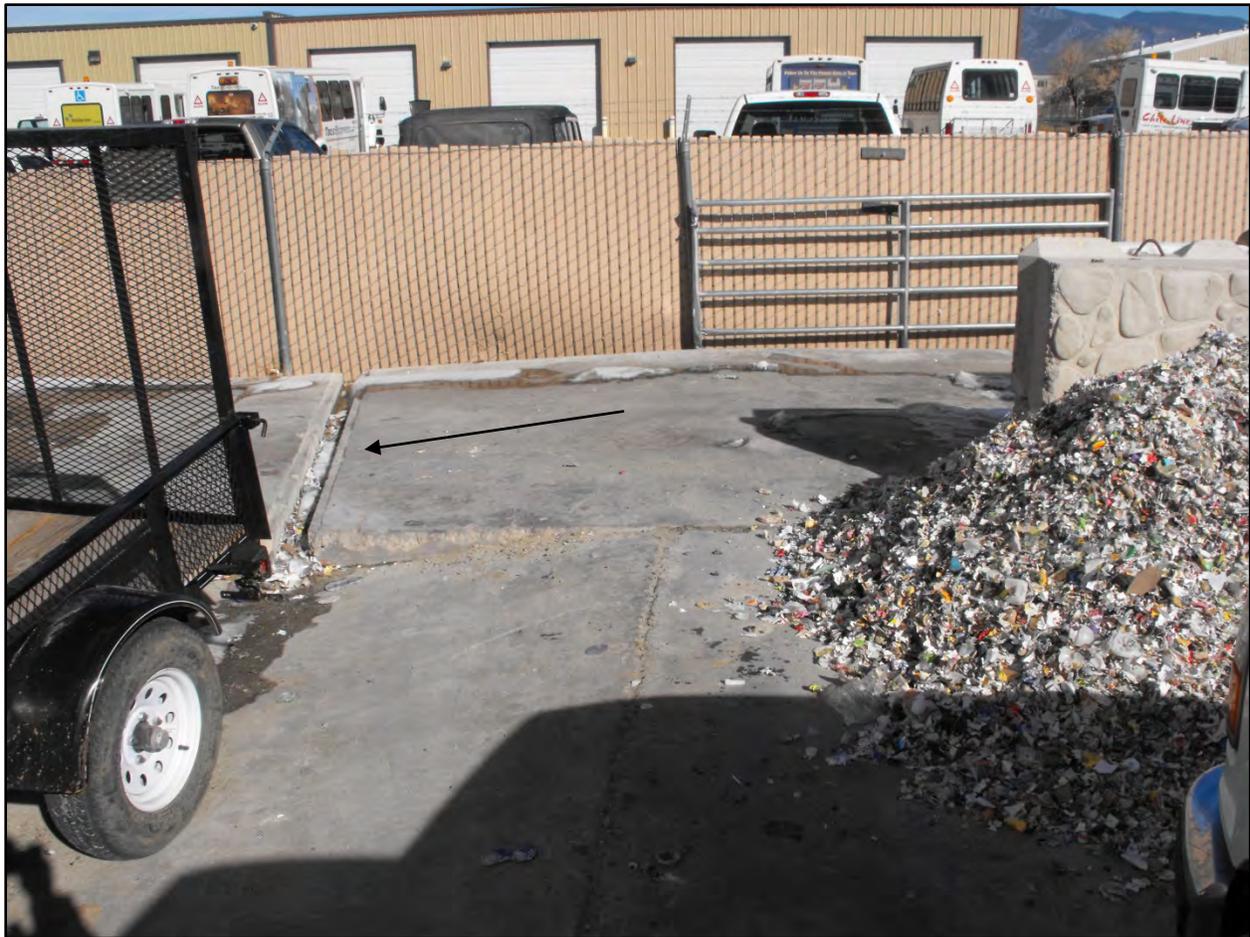
Photo # 2

The site appeared to be fairly level with the front side of the property sloping to the northwest. The back side of the property appeared to slope to the northeast. There were no berms to contain runoff or BMP's in place. Mr. Espinoza knows of the need for a MSGP and said they were in the process of working with a consultant to prepare the necessary BMP's and SWPPP.

Photographer: Daniel Valenta	Date: 12/13/2012	Time: 1128 hours
City/County: Taos/ Taos County		
Location: 201 Bertha Street, Taos, New Mexico, facing north.		
Subject: Back of property where it appeared water drains off site.
