Re: Minor Non-Municipal, SIC 1442, NPDES Compliance Evaluation Inspection, Russell Sand & Gravel, Company, Inc., Permit NMU001831, December 6, 2012

**Compliance Evaluation Inspection
Russell Sand & Gravel Company, Inc.
NPDES Permit No. NMU001831
December 6, 2012**

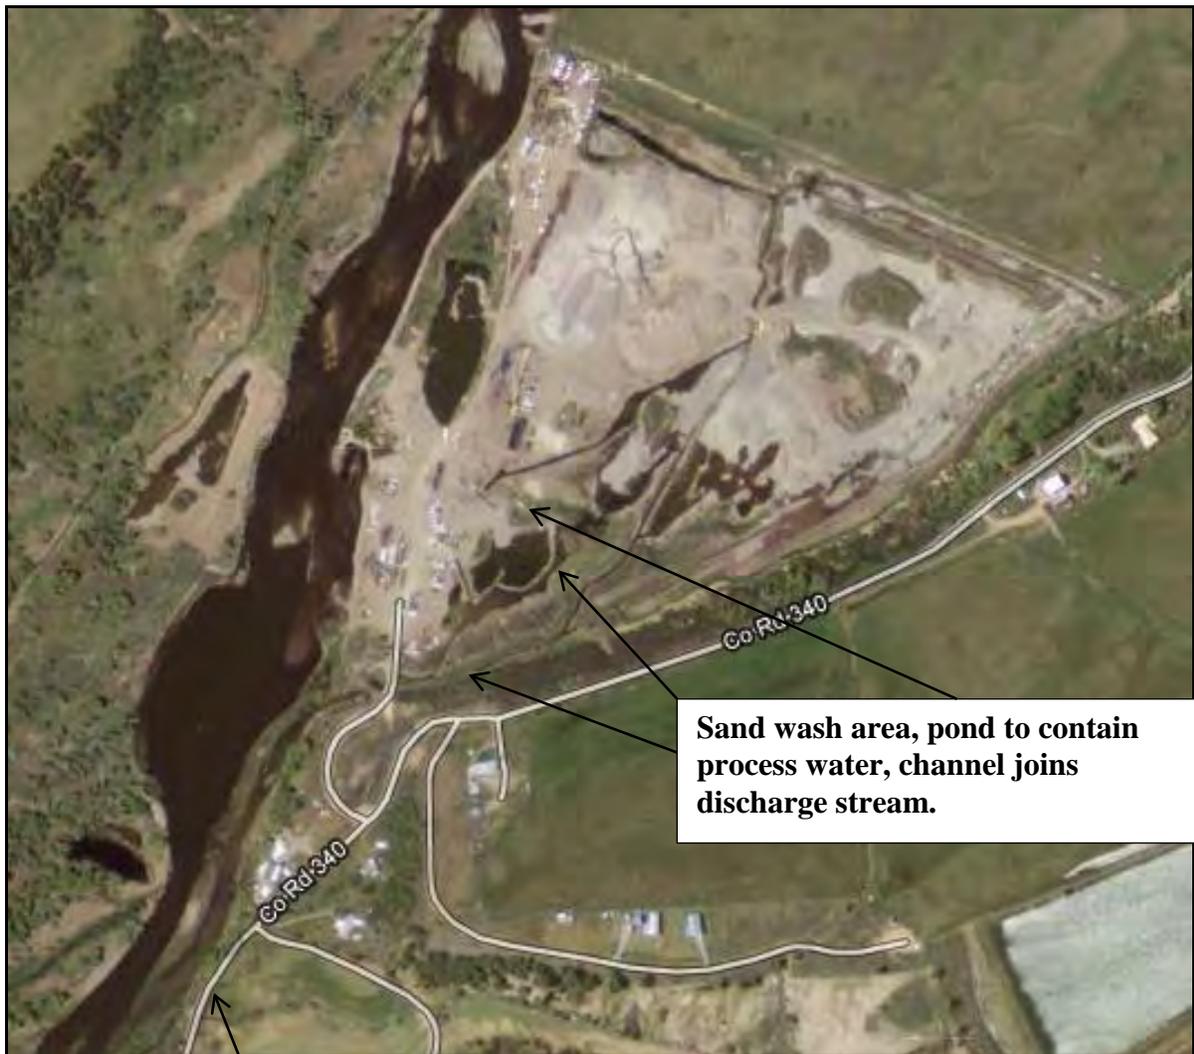
Site Overview

City/County: Los Ojos/Rio Arriba County	
Location: Russell Sand & Gravel, Company, 150 County Rd. 340, Los Ojos, NM	
Subject: Overview of the facility.

Sand wash area, pond to contain process water, channel joins discharge stream.

Discharge enters Rio Chama

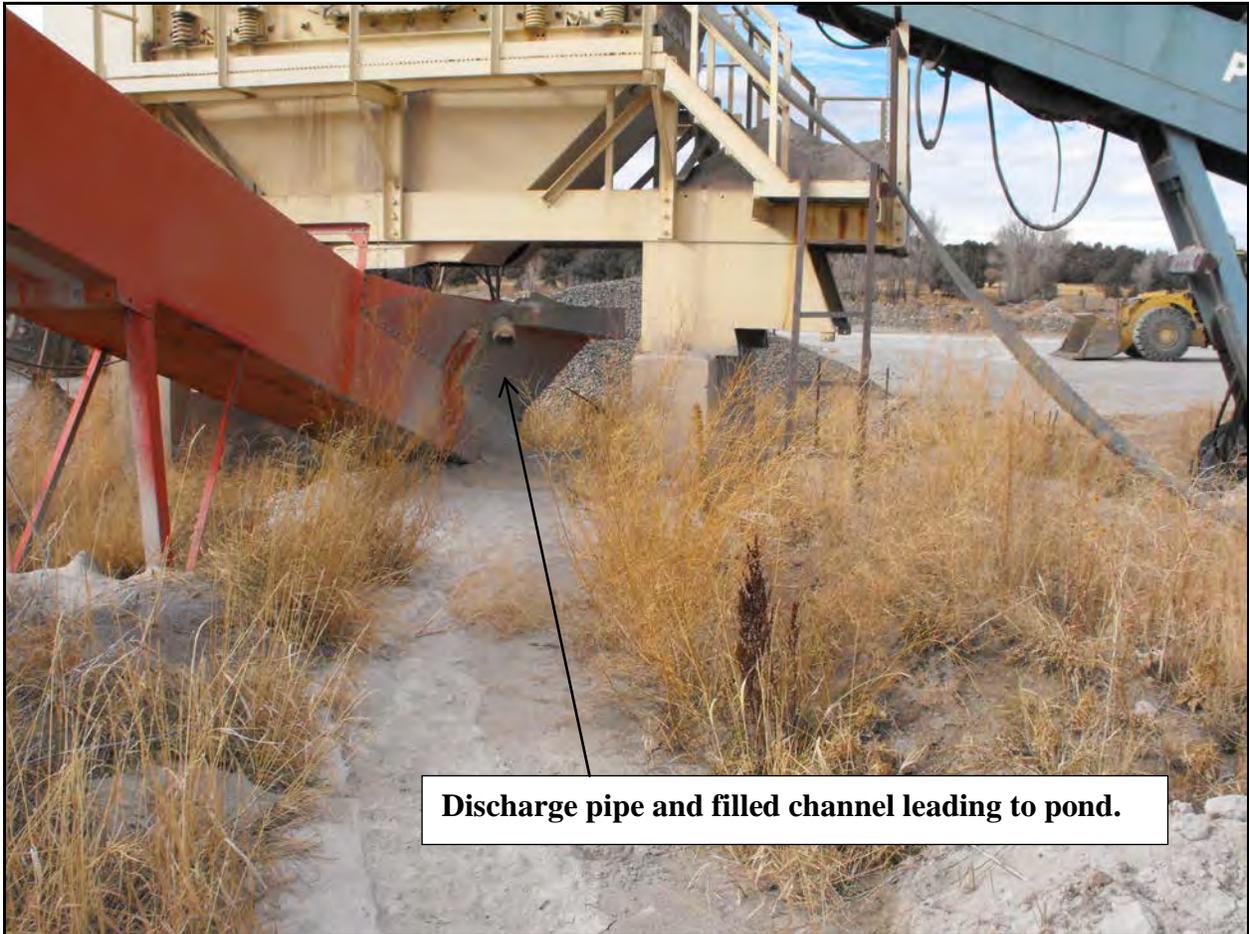
Photo # 1

Photographer: Daniel Valenta	Date: 12/6/2012	Time: 1252
City/County: Los Ojos/Rio Arriba County		
Location: Russell Sand & Gravel, Company, 150 County Rd. 340, Los Ojos, NM, facing west.		
Subject: Fixed sand wash unit, discharge pipe of process water into channel to retention pond.

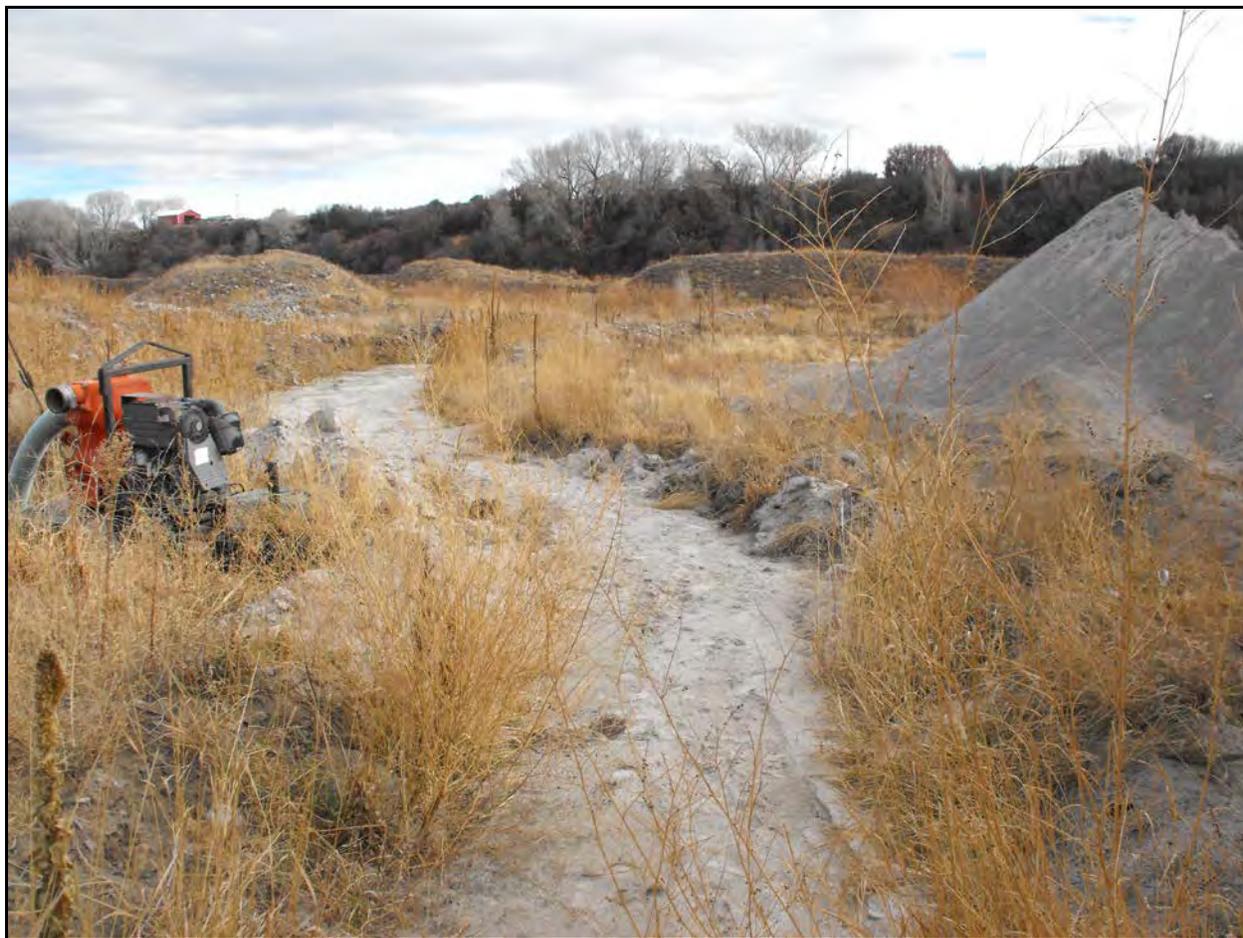
Photo # 2

The process water discharge channel has filled up and needs to be cleaned out. The holding pond retention berms appeared to be breached. The majority of flow into the channel leading to the river appeared to be from the retention pond and ground water, see photos.

Photographer: Daniel Valenta	Date: 12/6/2012	Time: 1252
City/County: Los Ojos/Rio Arriba County		
Location: Russell Sand & Gravel, Company, 150 County Rd. 340, Los Ojos, NM, facing southeast.		
Subject: Channel to pond.

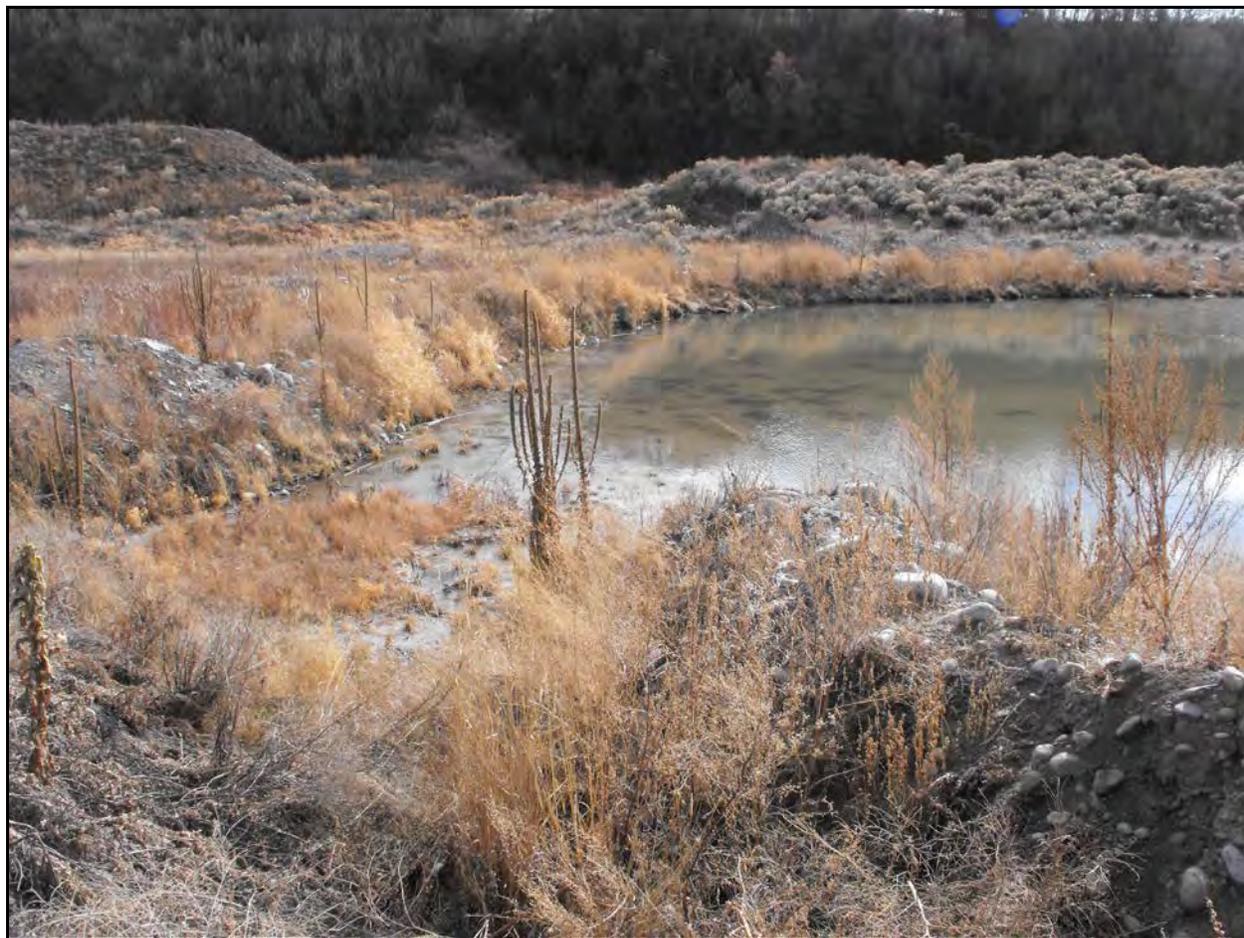
Photo # 3

Photographer: Daniel Valenta	Date: 12/6/2012	Time: 1255
City/County: Los Ojos/Rio Arriba County		
Location: Russell Sand & Gravel, Company, 150 County Rd. 340, Los Ojos, NM, facing southeast.		
Subject: Discharge from channel to pond

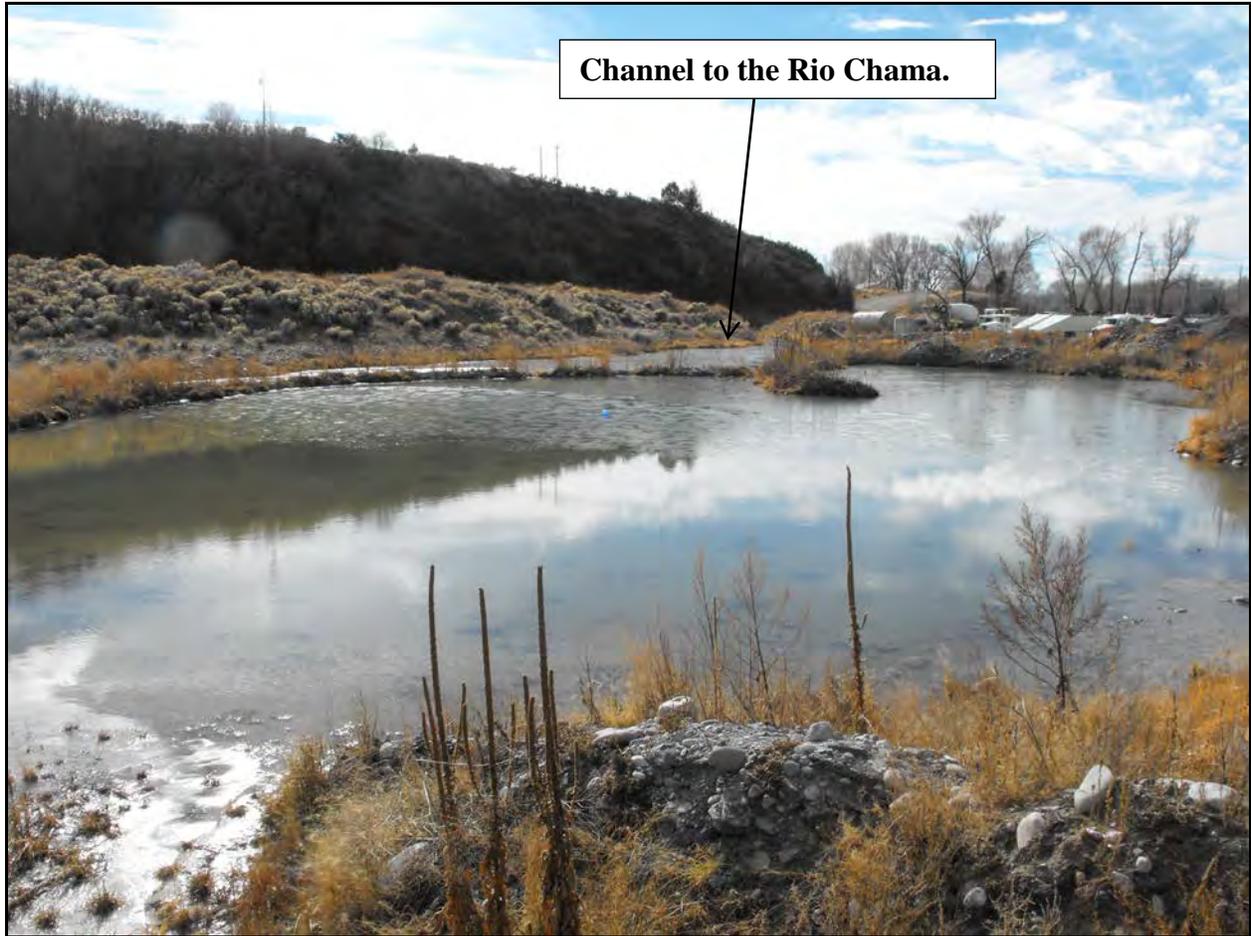
Photo # 4

Photographer: Daniel Valenta	Date: 12/6/2012	Time: 1255
City/County: Los Ojos/Rio Arriba County		
Location: Russell Sand & Gravel, Company, 150 County Rd. 340, Los Ojos, NM, facing southwest.		
Subject: Sediment pond is alongside discharge channel to river.

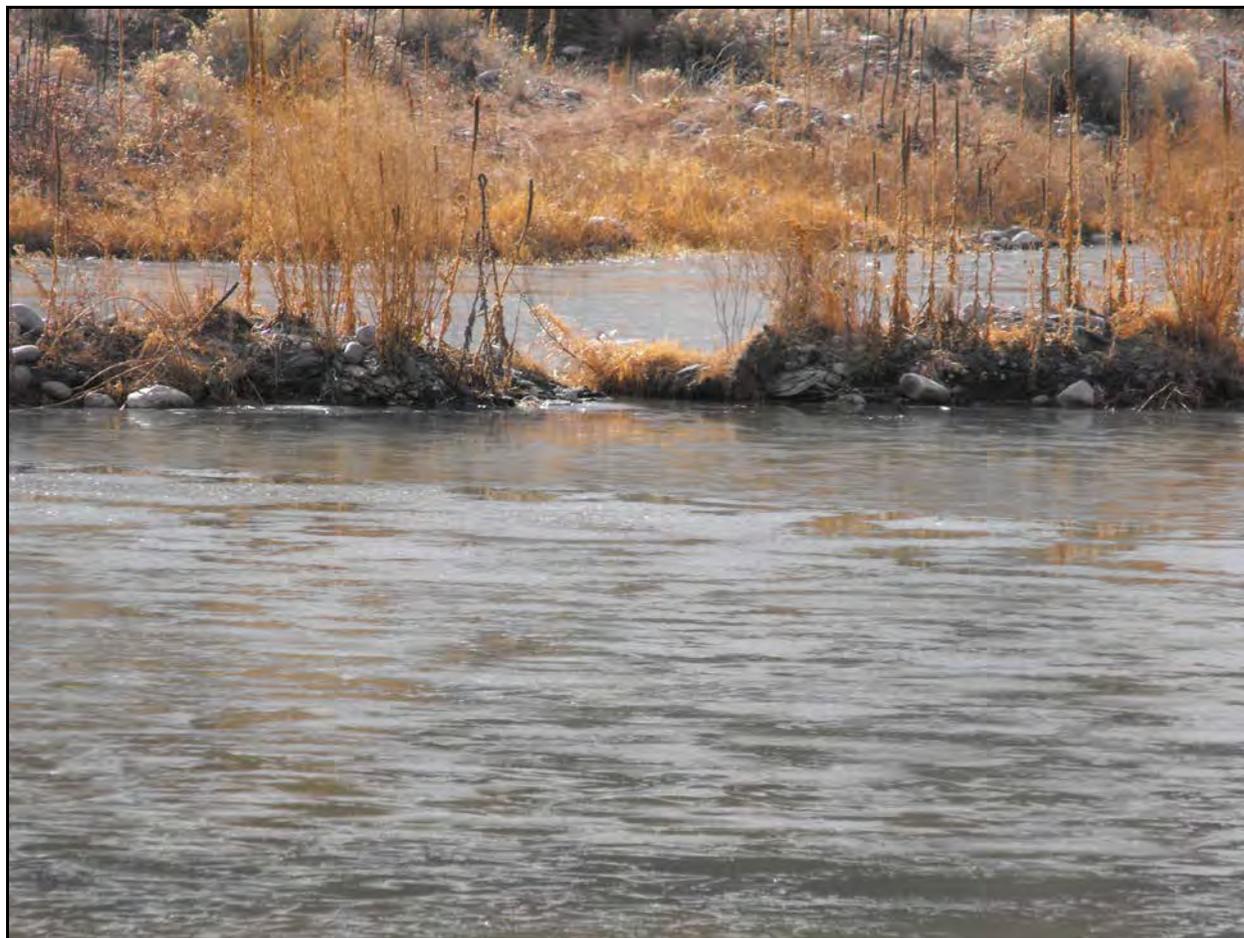
Photo # 5

Photographer: Daniel Valenta	Date: 12/6/2012	Time: 1256
City/County: Los Ojos/Rio Arriba County		
Location: Russell Sand & Gravel, Company, 150 County Rd. 340, Los Ojos, NM, facing southwest.		
Subject: Sediment pond appeared to be flowing into the discharge channel.

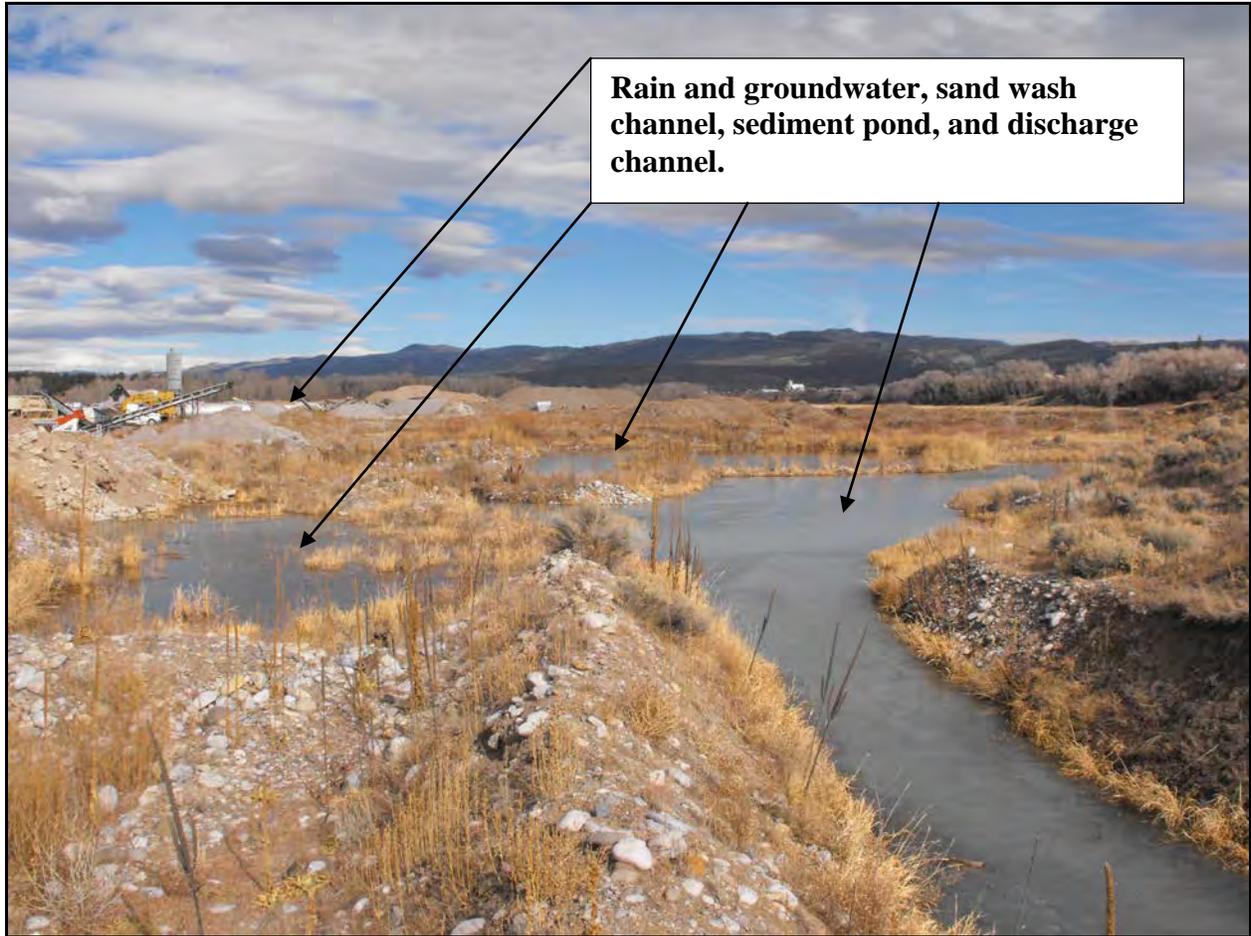
Photo # 6

Photographer: Daniel Valenta	Date: 12/6/2012	Time: 1231
City/County: Los Ojos/Rio Arriba County		
Location: Russell Sand & Gravel, Company, 150 County Rd. 340, Los Ojos, NM, facing southeast.		
Subject: View of area before flowing to discharge point.

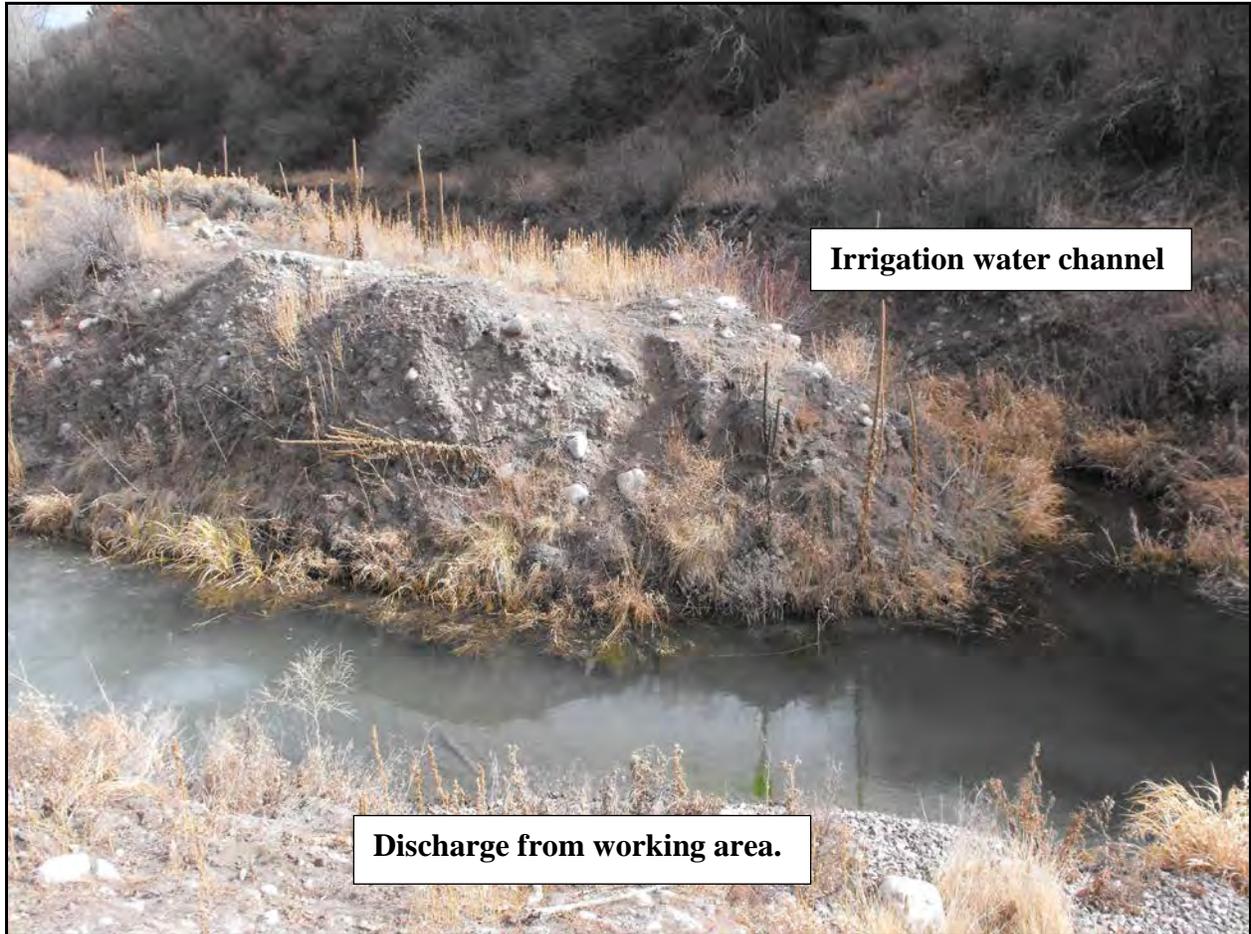
Photo # 7

Photographer: Daniel Valenta	Date: 12/6/2012	Time: 1228
City/County: Los Ojos/Rio Arriba County		
Location: Russell Sand & Gravel, Company, 150 County Rd. 340, Los Ojos, NM, facing southeast.		
Subject: The irrigation bypass channel joins the channel that drains the above working area.

Irrigation water channel

Discharge from working area.

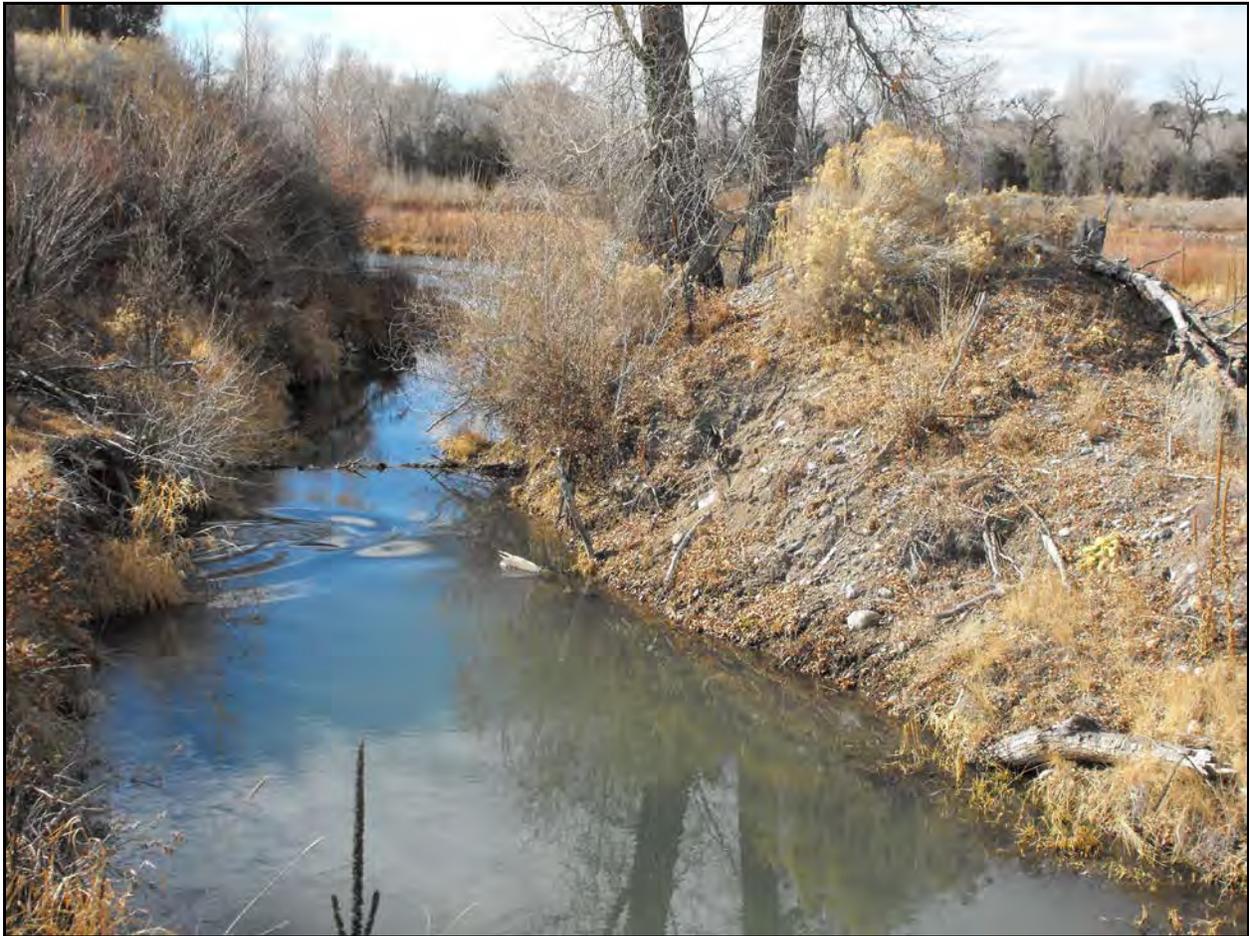
Photo # 8

Photographer: Daniel Valenta	Date: 12/6/2012	Time: 1217
City/County: Los Ojos/Rio Arriba County		
Location: Russell Sand & Gravel, Company, 150 County Rd. 340, Los Ojos, NM, facing west.		
Subject: Channel discharges to the Rio Chama, see overview.
