RE: Industrial Storm Water, SIC 1442, NPDES Compliance Evaluation Inspection, James Hamilton Construction Co. / Caballo Offsite Aggregate Mine, NMU001838, January 31, 2013

NPDES Compliance Inspection Report

**James Hamilton Construction Co. / Caballo Offsite Aggregate Mine
Compliance Evaluation Inspection – Industrial Stormwater
NPDES Tracking No. NMU001838
January 31, 2013**

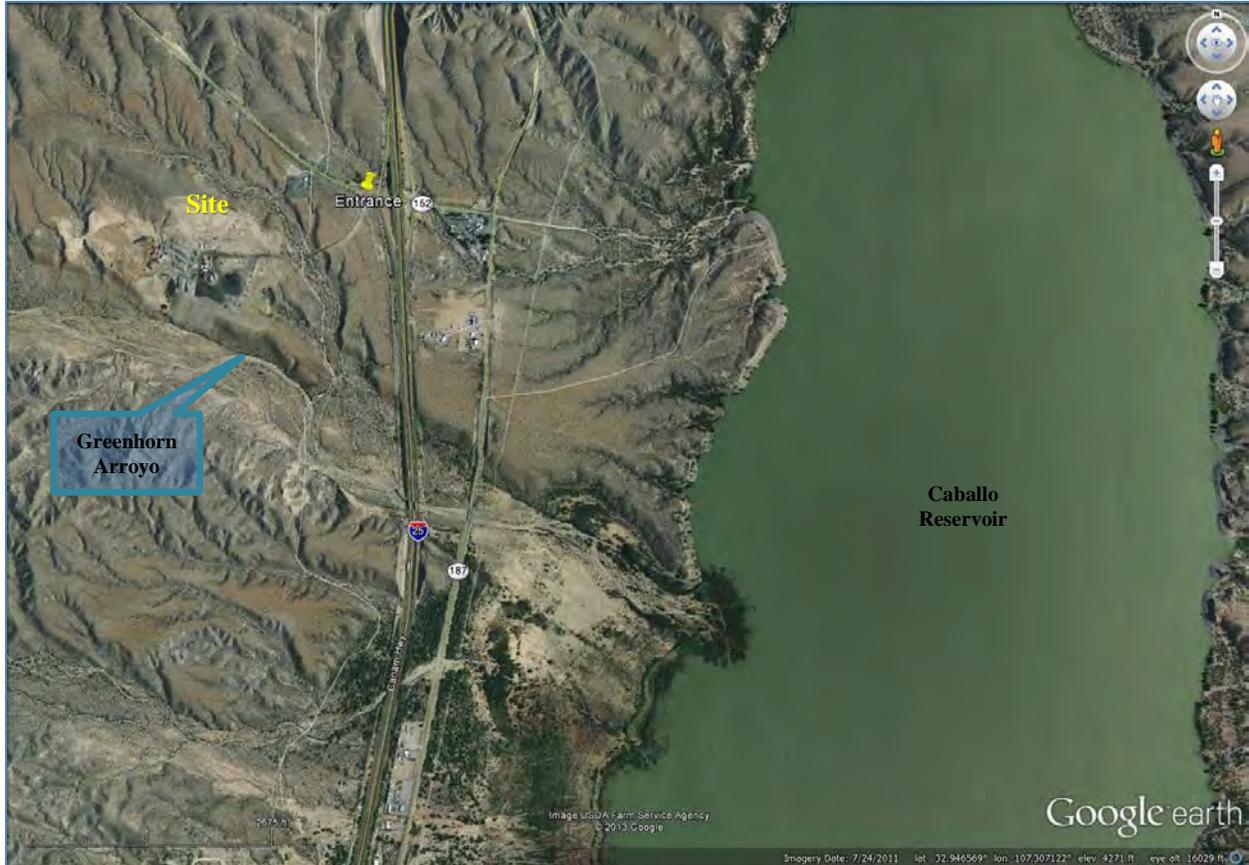
NMED/SWQB
Historic Site Imagery

On the day of this inspection, most of the dark materials shown in areas of the site on an image dated 07/24/2011 were not observed except at the active crusher and base course stockpile. An on-site mobile crusher was in operation. According to the on-site operator representative, on-site materials were being processed to meet NMDOT base course specifications; the activities were not associated with an active construction project; and the materials would be used in other James Hamilton Construction Co. construction project(s) and/or sold to other entities.

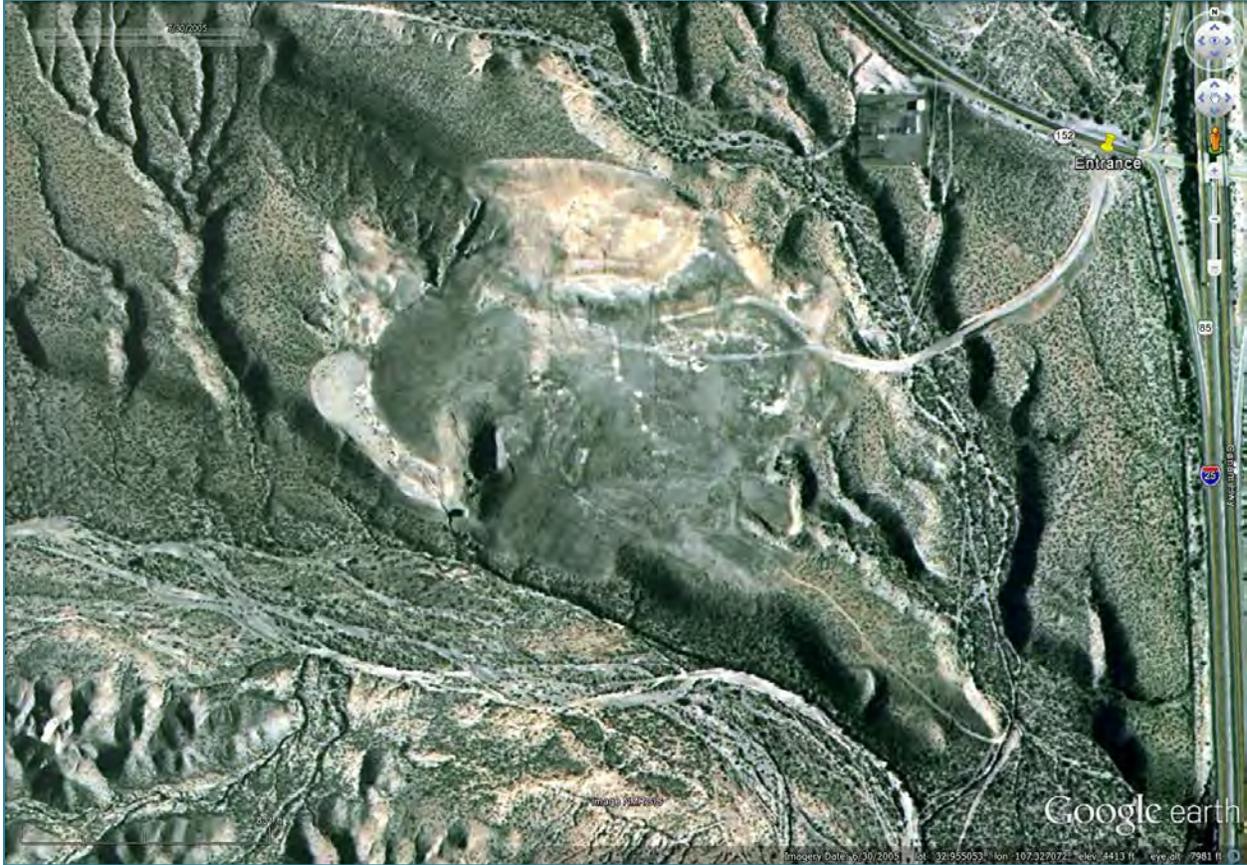
Description: Area southwest of I-25 and NM 152 interchange in 2005. Visible disturbance is prior to James Hamilton Construction Co three year lease.

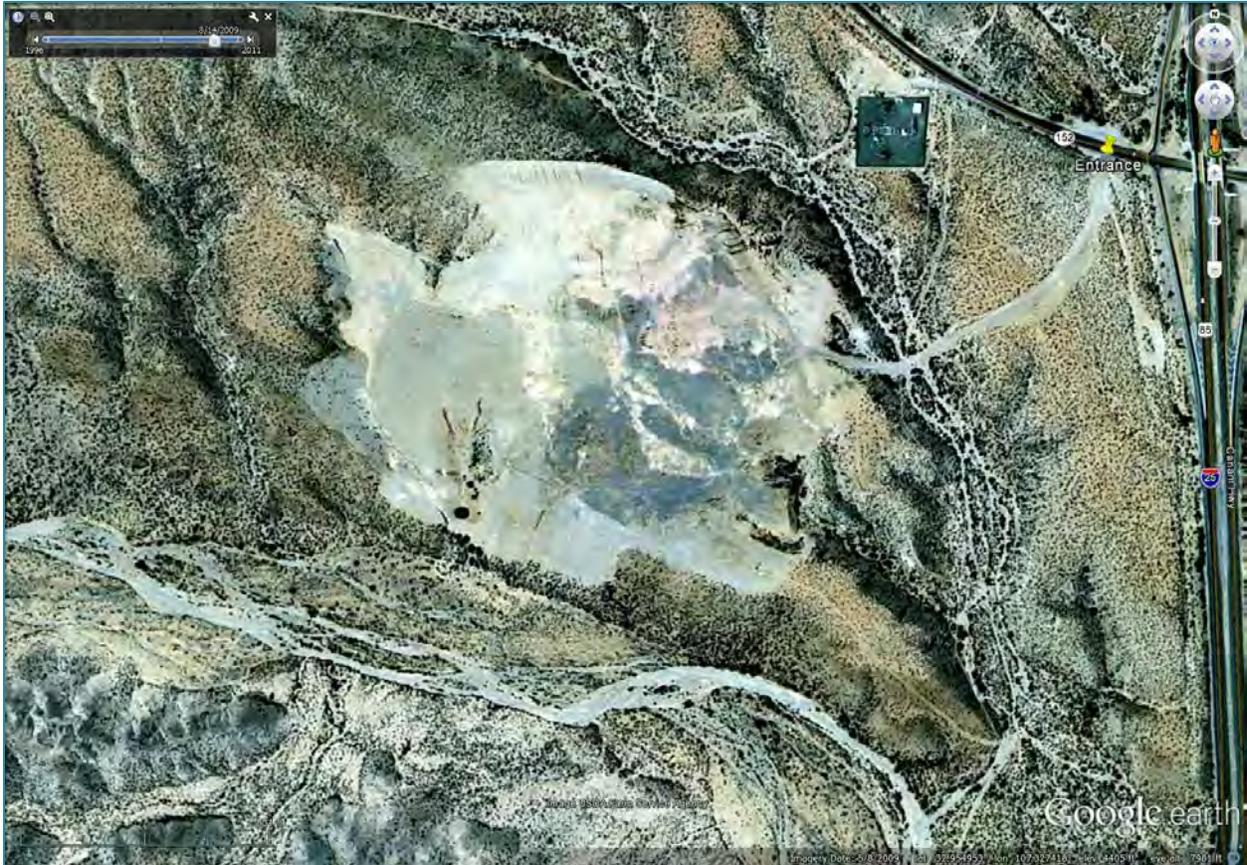
NMED/SWQB
Historic Site Imagery

Description: Area southwest of I-25 and NM 152 interchange in 2009. Visible disturbance is prior to James Hamilton Construction Co three year lease.

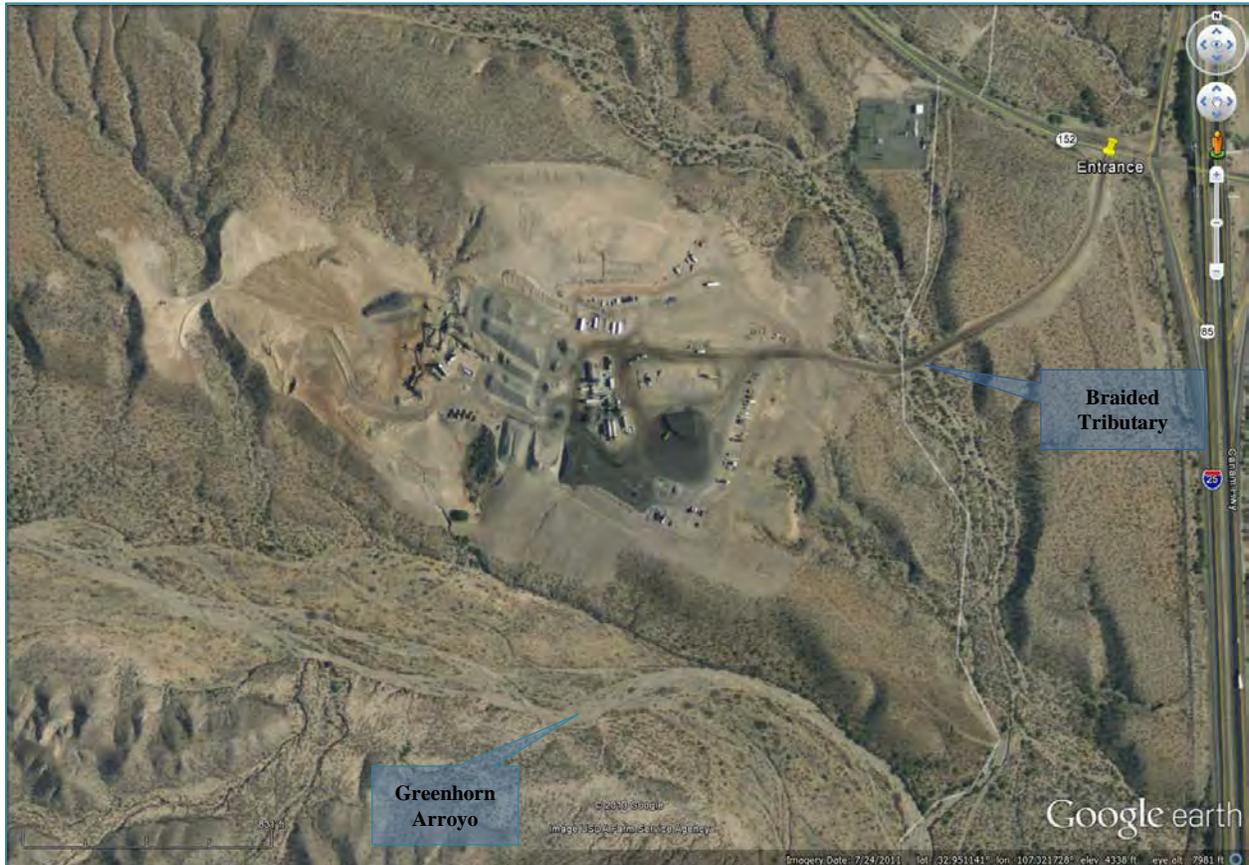
NMED/SWQB
Historic Site Imagery

Description: Activities (additional disturbance, equipment, vehicles, and stockpiles) southwest of I-25 and NM 152 interchange in 2011. Much of the materials and activities shown in this photo including dark material had been removed on the day of this inspection.

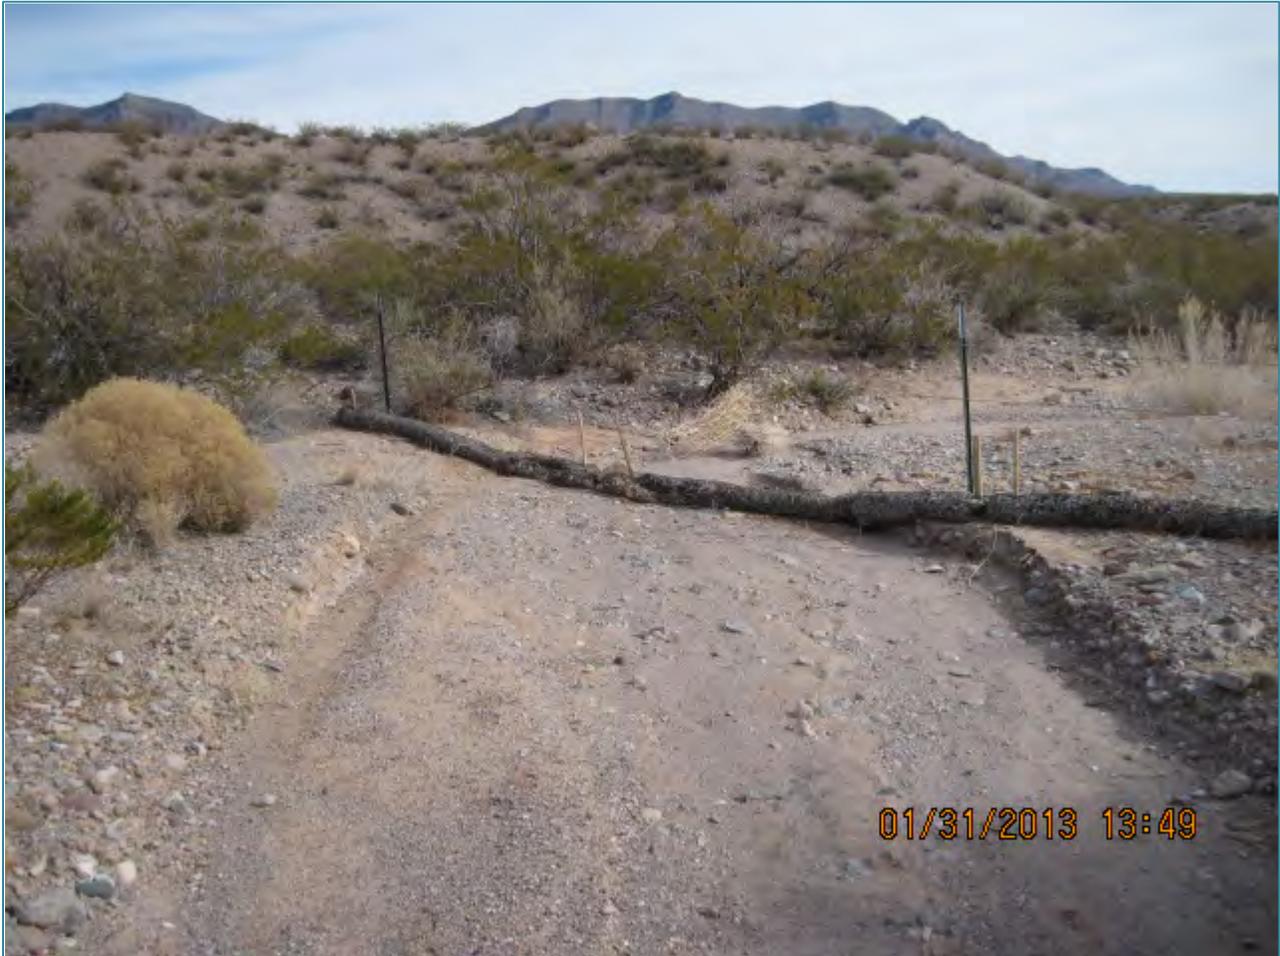
NMED/SWQB Official Photograph Log Photo # 1		
Photographer: Erin Trujillo	Date: 01/31/2013	Time: 1349 hours
City/County: South of Truth or Consequences / Sierra County		State: New Mexico
Location: James Hamilton Construction Co. / Caballo Offsite Aggregate Mine, Southwest of I-25 and NM 152		
Subject: Example of staked wood mulch wattle in braided tributary downstream of facility entrance road

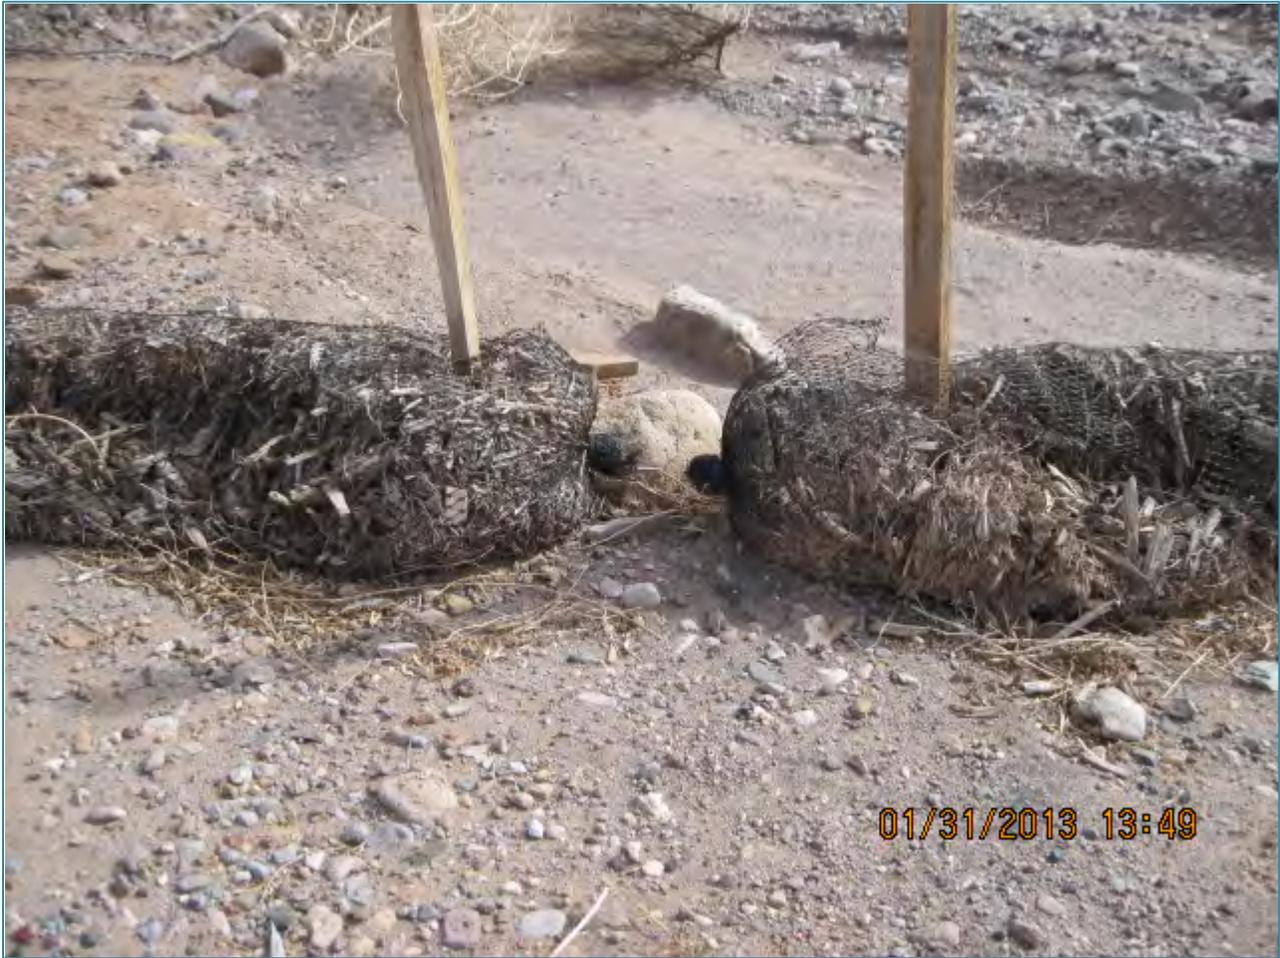
NMED/SWQB Official Photograph Log Photo # 2		
Photographer: Erin Trujillo	Date: 01/31/2013	Time: 1349 hours
City/County: South of Truth or Consequences / Sierra County		State: New Mexico
Location: James Hamilton Construction Co. / Caballo Offsite Aggregate Mine, Southwest of I-25 and NM 152		
Subject: Damage in mulch wattle in braided tributary downstream of facility entrance road.

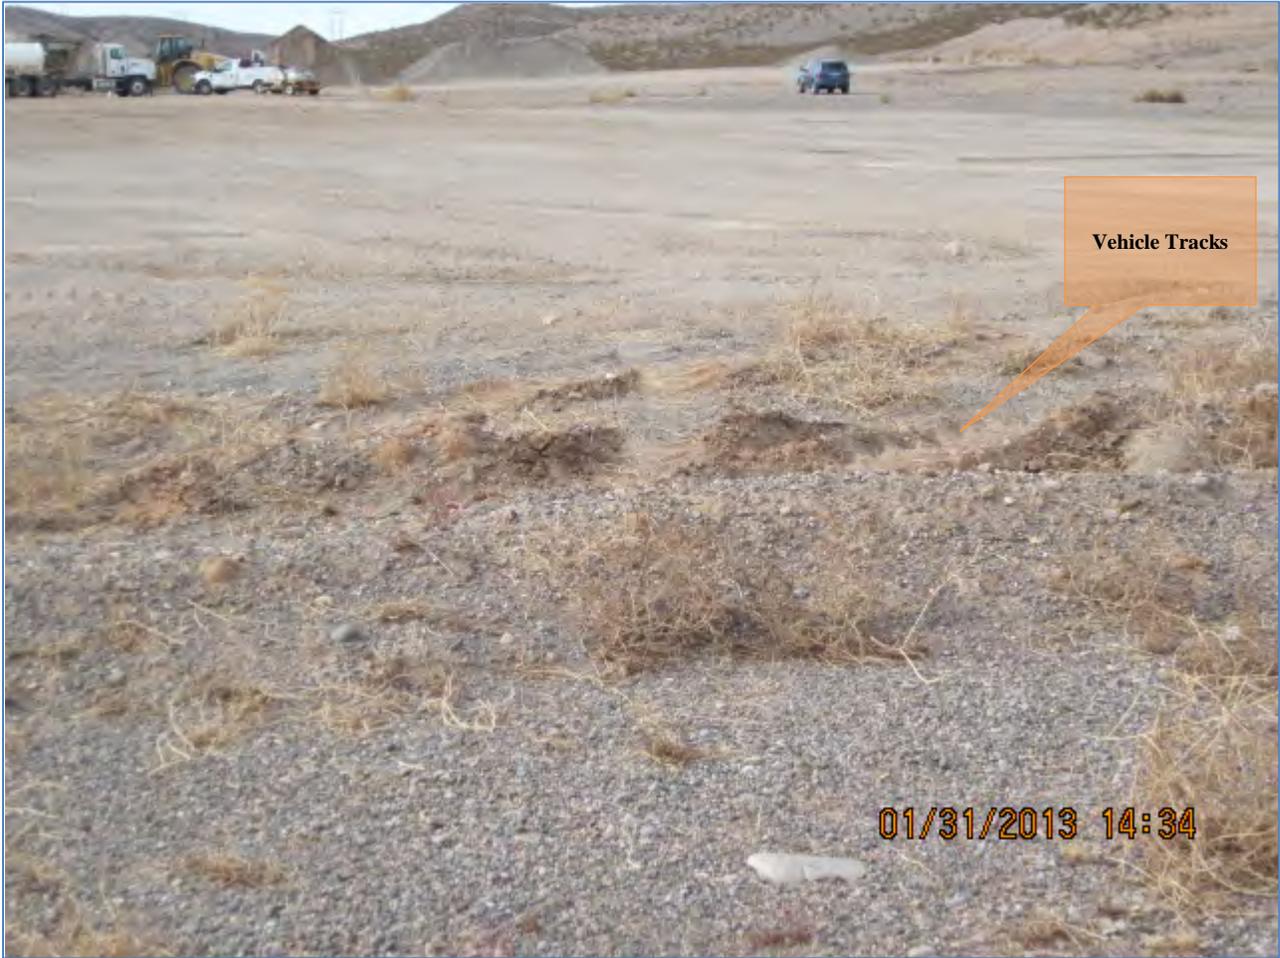
NMED/SWQB Official Photograph Log Photo # 3		
Photographer: Erin Trujillo	Date: 01/31/2013	Time: 1434 hours
City/County: South of Truth or Consequences / Sierra County		State: New Mexico
Location: James Hamilton Construction Co. / Caballo Offsite Aggregate Mine, Southwest of I-25 and NM 152		
Subject: According to the on-site operator representative, a ditch had been excavated in eastern portion of the site as a stormwater control measure. Vehicle tracks observed across the excavated ditch and associated low earth berm appeared to reduce the effectiveness of the control measure in this area.

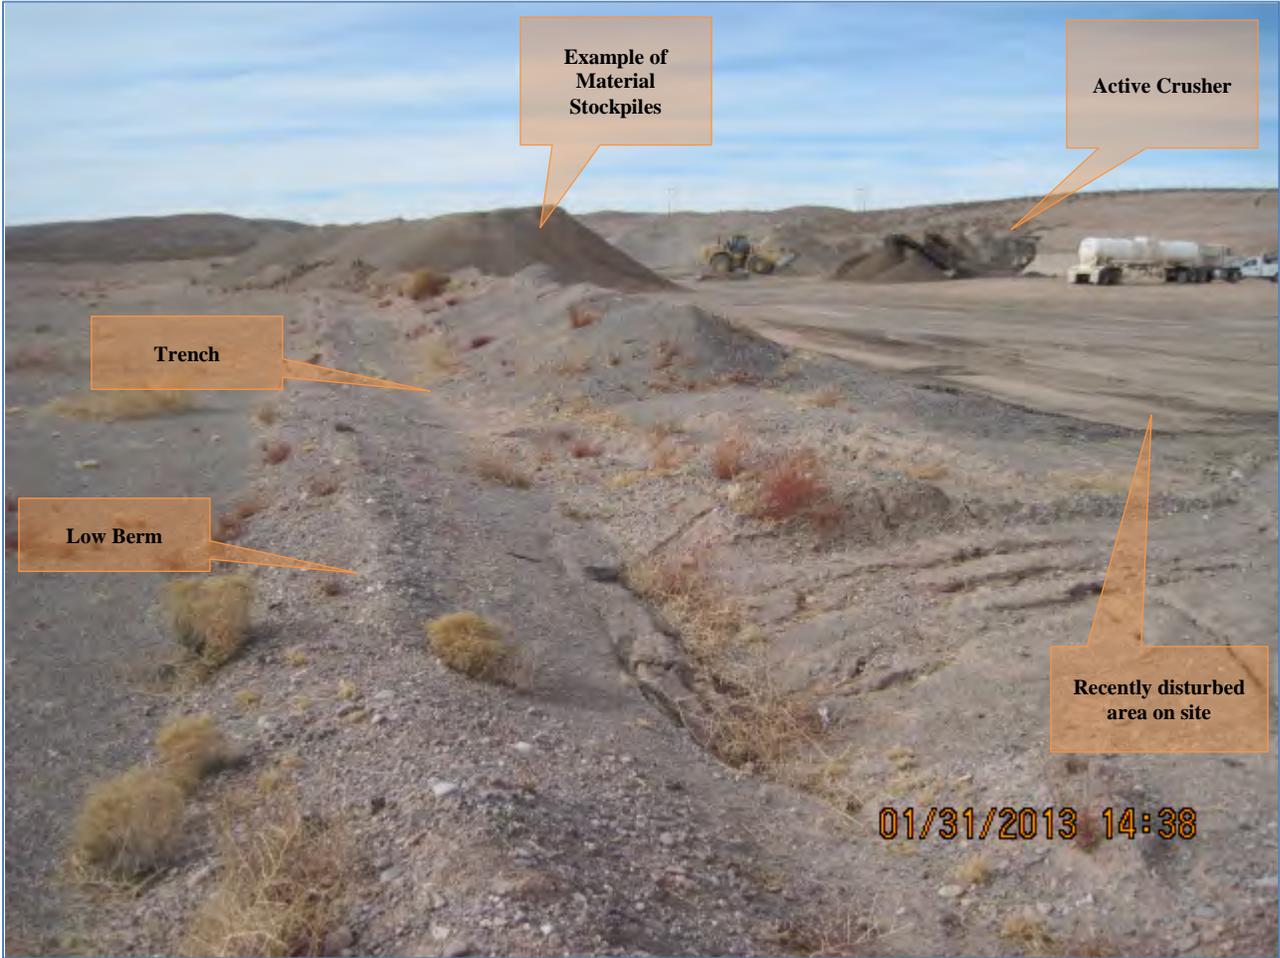
NMED/SWQB Official Photograph Log Photo # 4		
Photographer: Erin Trujillo	Date: 01/31/2013	Time: 1438 hours
City/County: South of Truth or Consequences / Sierra County		State: New Mexico
Location: James Hamilton Construction Co. / Caballo Offsite Aggregate Mine, Southwest of I-25 and NM 152		
Subject: Photo shows recently disturbed area (vehicle tracks), excavated trench and associated berm, active crushing area, and material stockpiles. Erosion rills shown in foreground of this photo did not continue past shown trench, berm or off site.

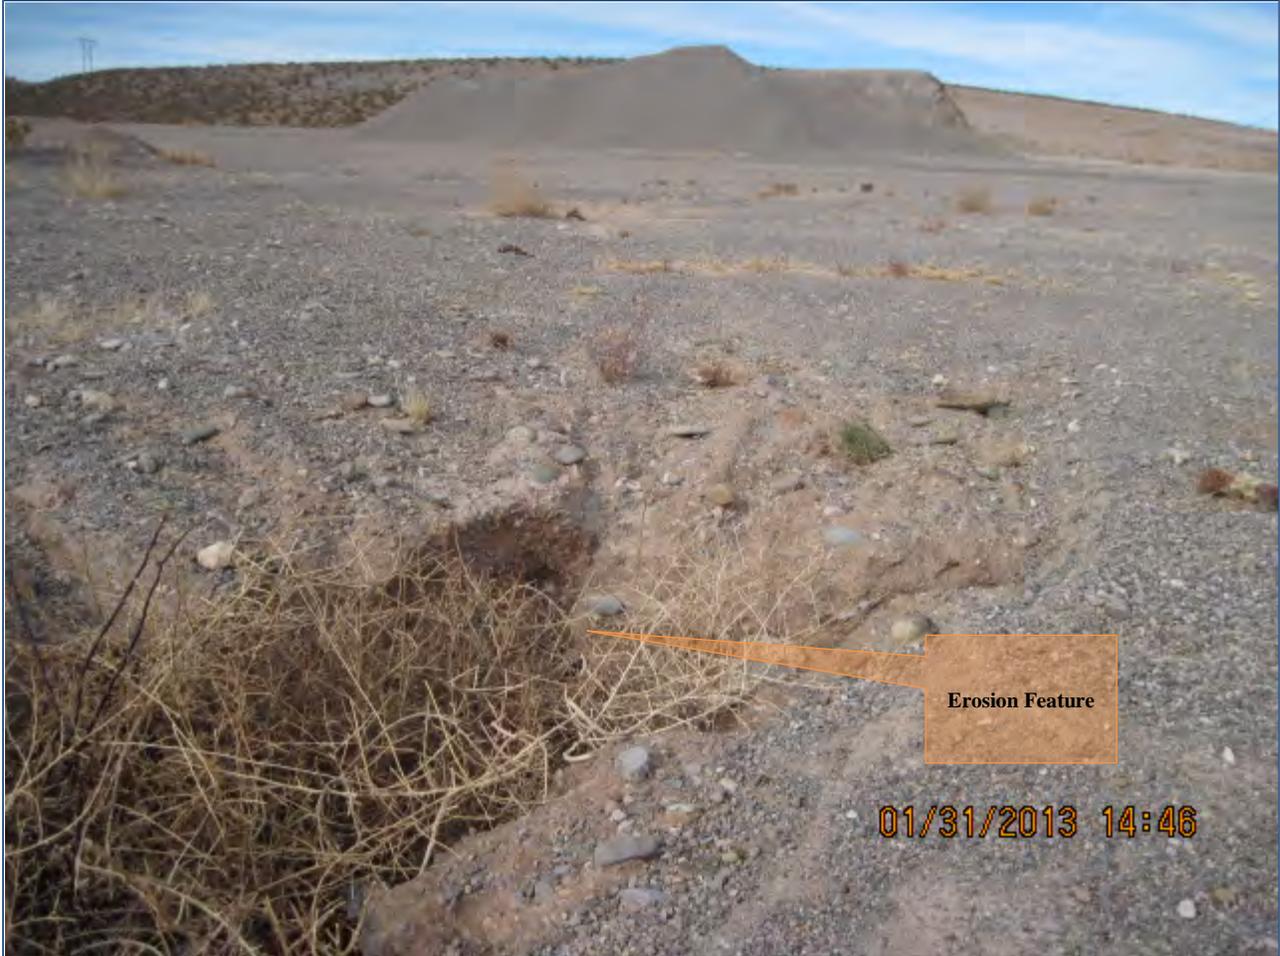
NMED/SWQB Official Photograph Log Photo # 5		
Photographer: Erin Trujillo	Date: 01/31/2013	Time: 1446 hours
City/County: South of Truth or Consequences / Sierra County		State: New Mexico
Location: James Hamilton Construction Co. / Caballo Offsite Aggregate Mine, Southwest of I-25 and NM 152		
Subject: Example of erosion feature "headcut" at top of slope. Length of slope is not shown in photo, but continues toward on-site low area or pond. Pond at site boundary is shown in the next photo.

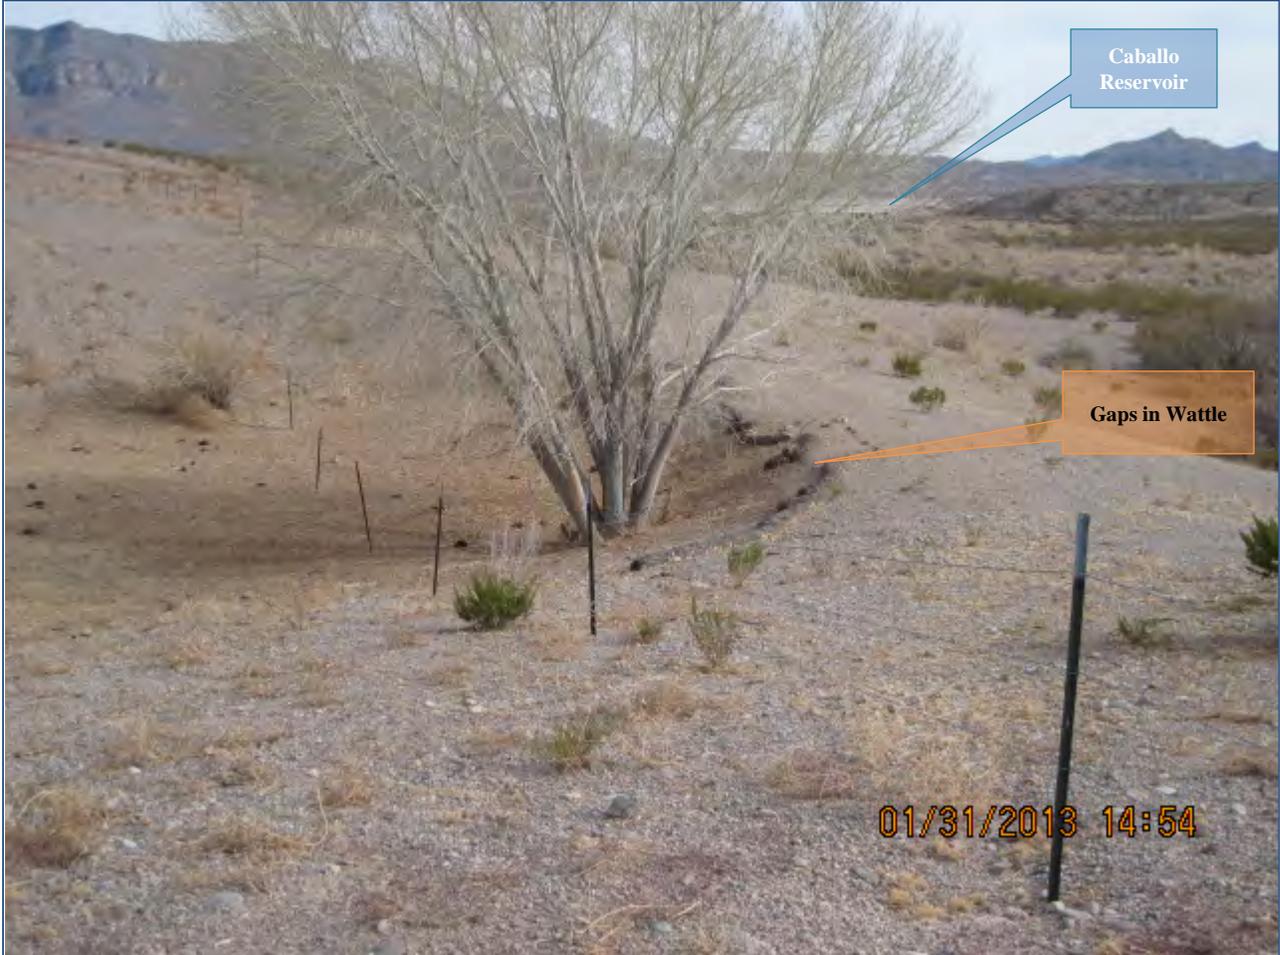
NMED/SWQB Official Photograph Log Photo # 6		
Photographer: Erin Trujillo	Date: 01/31/2013	Time: 1454 hours
City/County: South of Truth or Consequences / Sierra County		State: New Mexico
Location: James Hamilton Construction Co. / Caballo Offsite Aggregate Mine, Southwest of I-25 and NM 152		
Subject: Gaps in wattle, but no erosion was observed on the slope below the pond in this area. As described by on-site operator representative, damage to the wattle was most likely caused by livestock.

Some plastic material or sheeting was observed in the north-east portion of the site. Remaining plastic waste needed to be properly disposed. Some on-site structural controls had been damaged, and wattle with accumulated sediment to the top of the control measure needed to be maintained. Erosion was observed at site boundaries and slopes, including slopes of the disturbed mine area with smaller sized aggregate material from mining operations. Additional, alternative and/or modified structural controls appeared needed in areas that wattles or straw bale were damaged. As evidence by the damage, the use of straw materials in an area also used for livestock range and/or areas with wildlife needed to be evaluated. Additional controls above channels or in uplands appeared to be needed to minimize erosion or control sediment at site boundaries. Initiation and/or additional stabilization of disturbed slopes and areas also appeared needed.

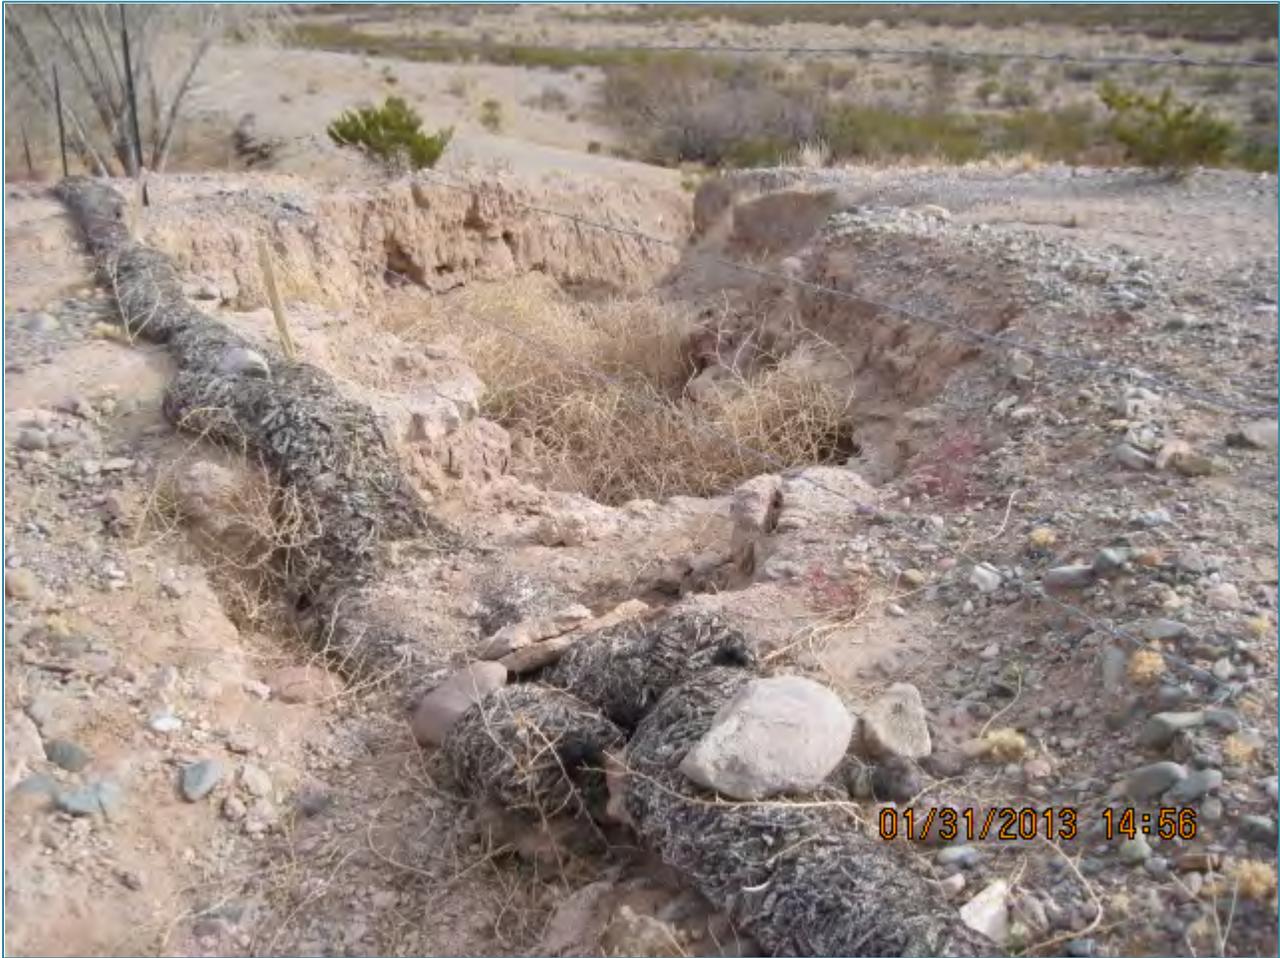
NMED/SWQB Official Photograph Log Photo # 7		
Photographer: Erin Trujillo	Date: 01/31/2013	Time: 1456 hours
City/County: South of Truth or Consequences / Sierra County		State: New Mexico
Location: James Hamilton Construction Co. / Caballo Offsite Aggregate Mine, Southwest of I-25 and NM 152		
Subject: Tributary channel at site boundary. This channel is located below area shown in next photo.

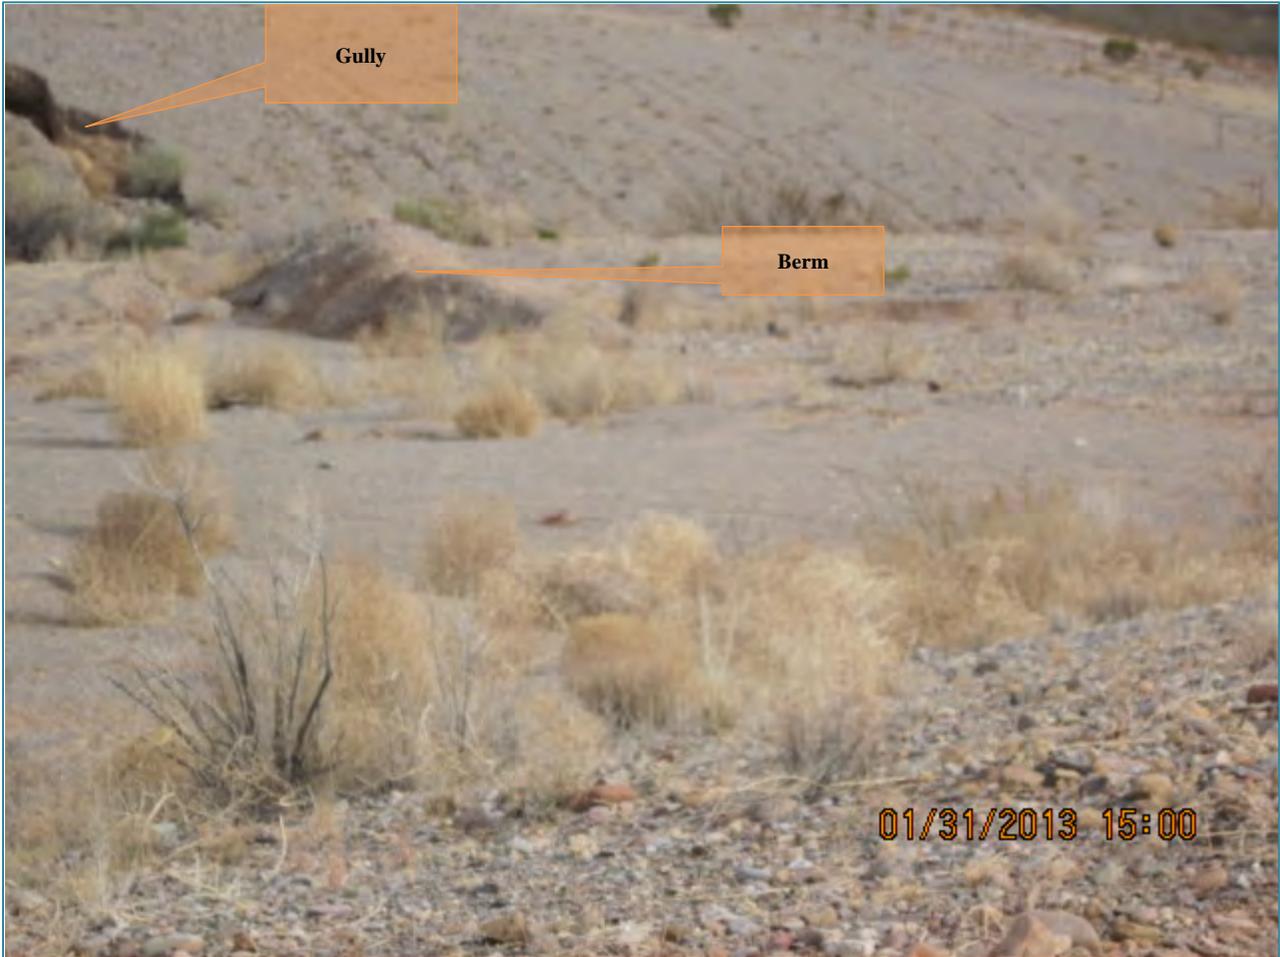
NMED/SWQB Official Photograph Log Photo # 8		
Photographer: Erin Trujillo	Date: 01/31/2013	Time: 1500 hours
City/County: South of Truth or Consequences / Sierra County		State: New Mexico
Location: James Hamilton Construction Co. / Caballo Offsite Aggregate Mine, Southwest of I-25 and NM 152		
Subject: Erosion gully and rills in background of photo are in a disturbed area that drains toward pond at site boundary shown in Photo #6. According to the on-site operator representative, the berm in this photo previously continued across the disturbed area in foreground, and a portion of the berm was damaged (washed out) during a previous rain event.

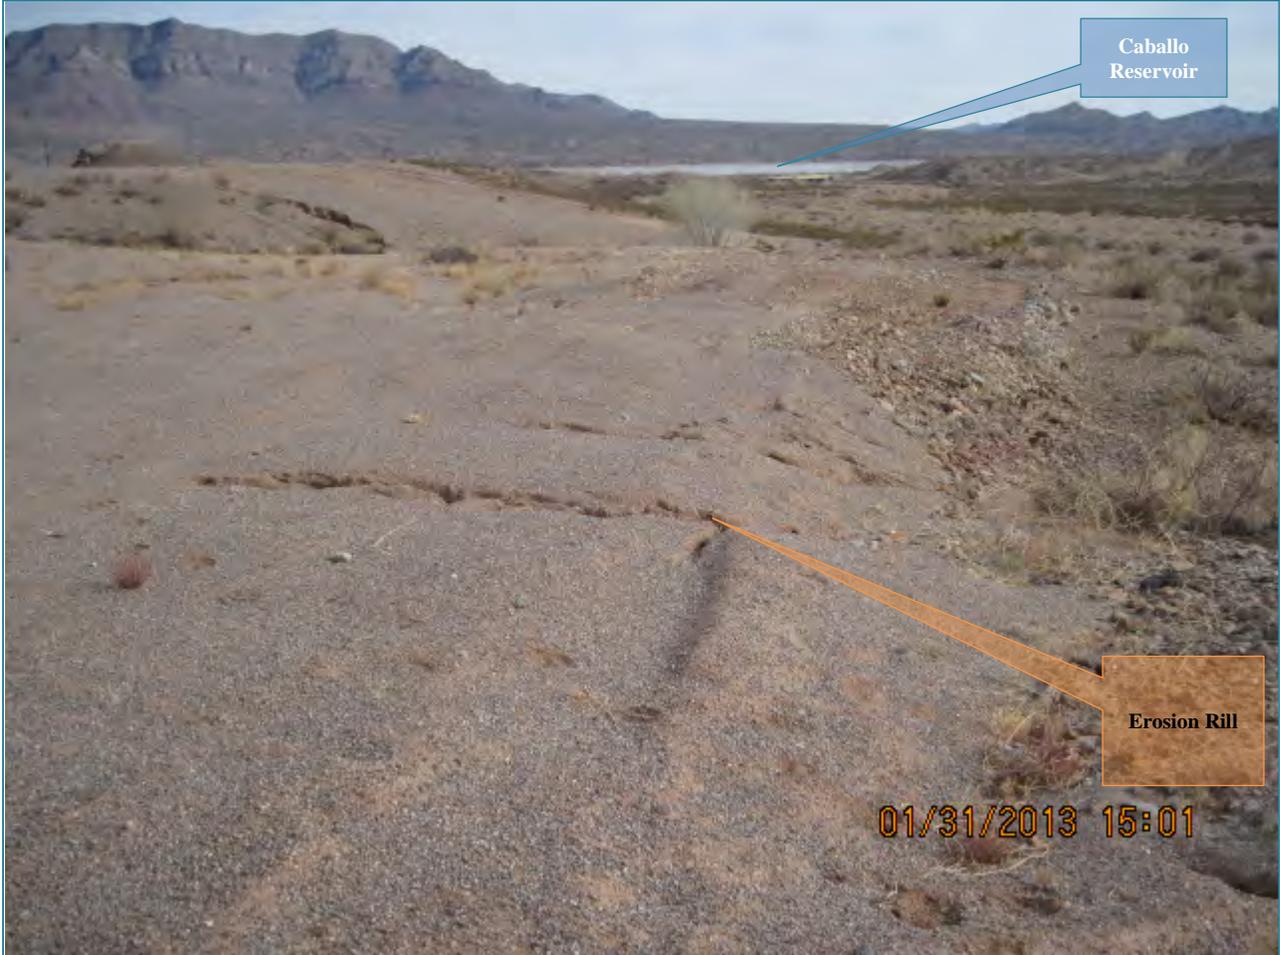
NMED/SWQB Official Photograph Log Photo # 9		
Photographer: Erin Trujillo	Date: 01/31/2013	Time: 1501 hours
City/County: South of Truth or Consequences / Sierra County		State: New Mexico
Location: James Hamilton Construction Co. / Caballo Offsite Aggregate Mine, Southwest of I-25 and NM 152		
Subject: Erosion (rills) at slope where small sized aggregate material from the mining operation was used in disturbed areas.

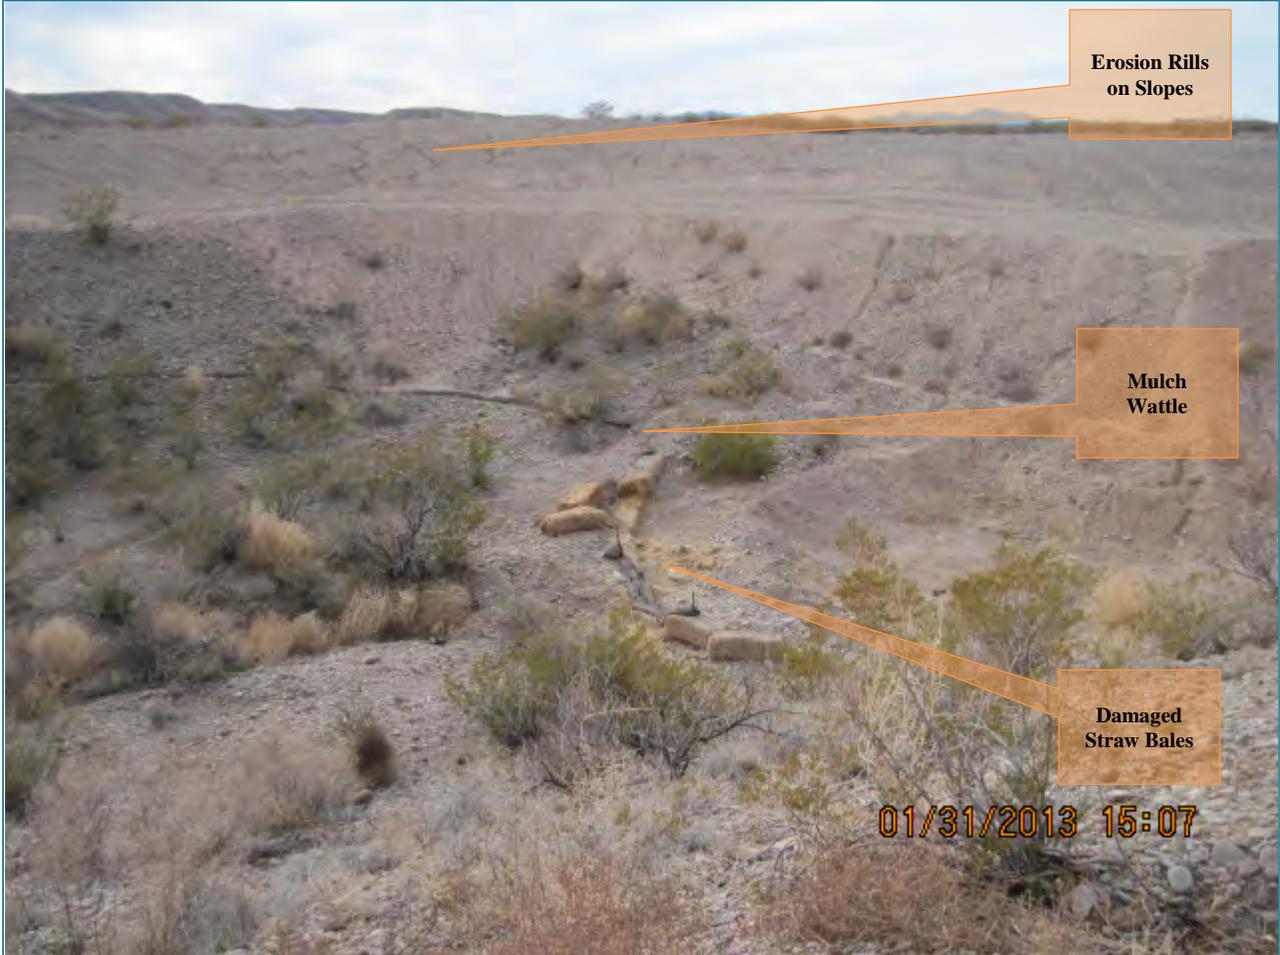
NMED/SWQB Official Photograph Log Photo # 10		
Photographer: Erin Trujillo	Date: 01/31/2013	Time: 1507 hours
City/County: South of Truth or Consequences / Sierra County		State: New Mexico
Location: James Hamilton Construction Co. / Caballo Offsite Aggregate Mine, Southwest of I-25 and NM 152		
Subject: Looking southwest at erosion and control measures in inactive mine area. As described by on-site operator representative, damage to the straw bale was most likely caused by livestock.

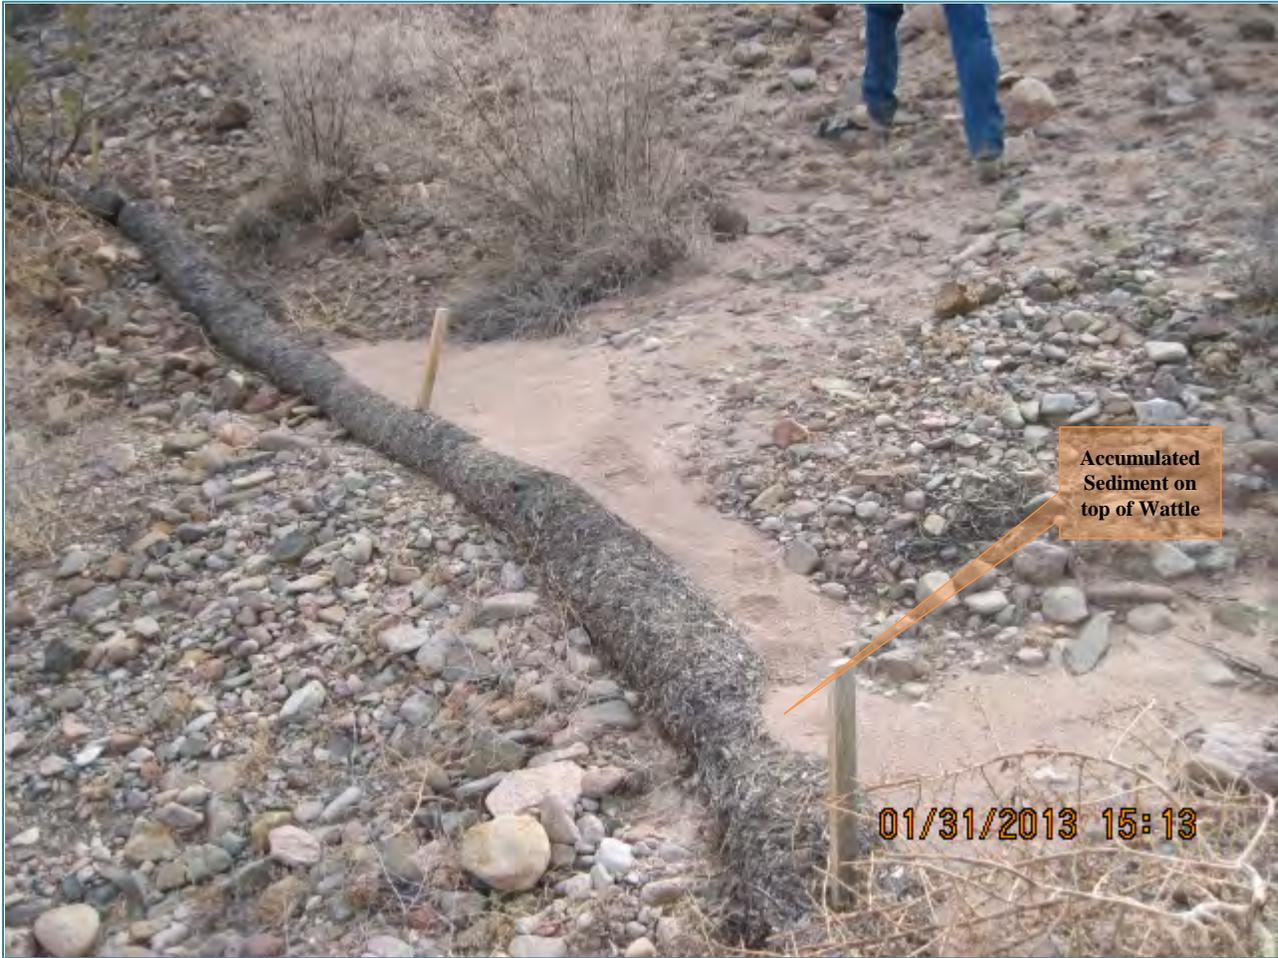
NMED/SWQB Official Photograph Log Photo # 11		
Photographer: Erin Trujillo	Date: 01/31/2013	Time: 1513 hours
City/County: South of Truth or Consequences / Sierra County	State: New Mexico	
Location: James Hamilton Construction Co. / Caballo Offsite Aggregate Mine, Southwest of I-25 and NM 152		
Subject: Accumulated sediment above mulch wattle shown in previous photo.

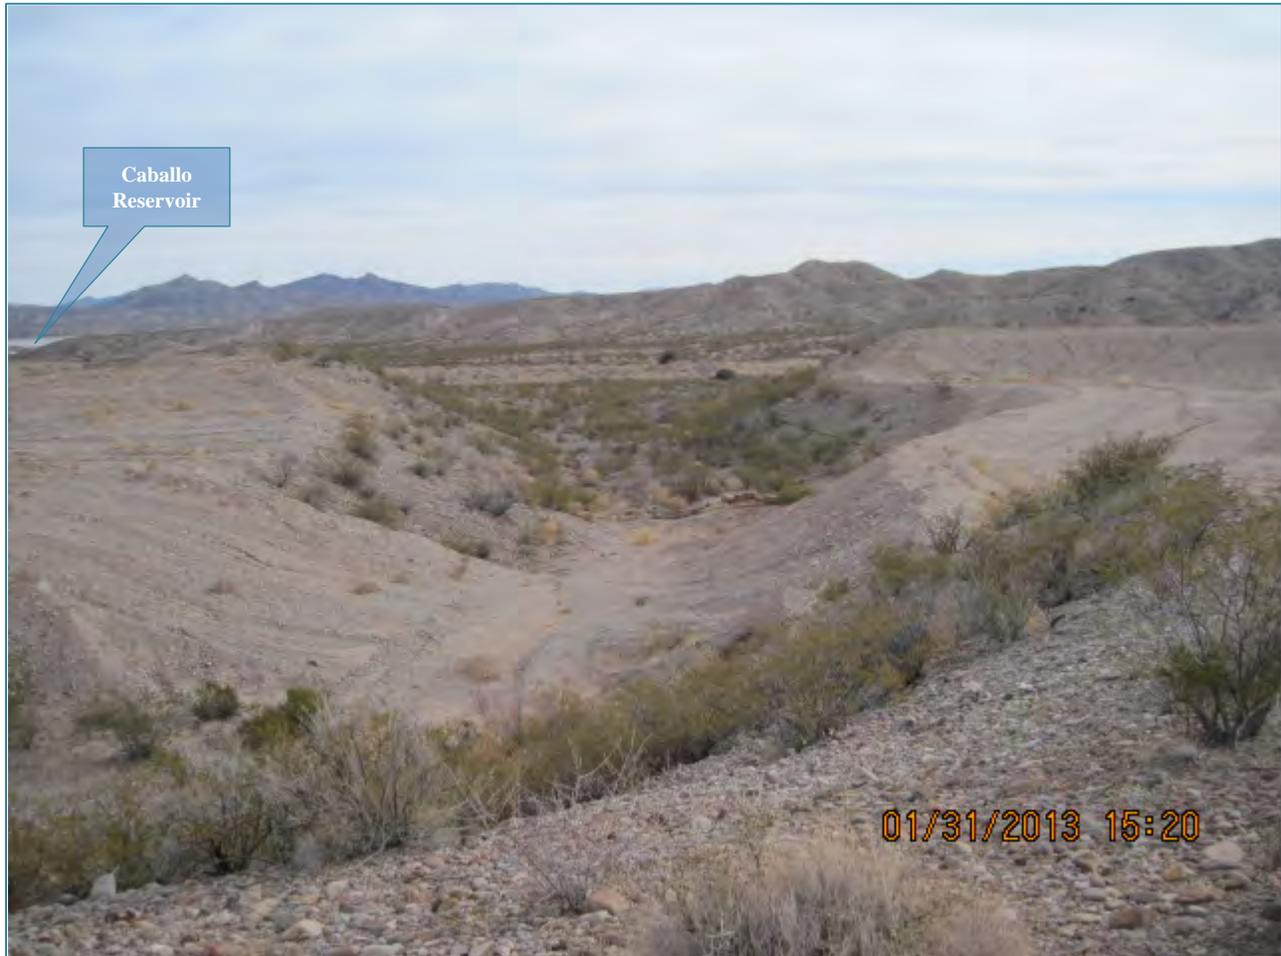
NMED/SWQB Official Photograph Log Photo # 12		
Photographer: Erin Trujillo	Date: 01/31/2013	Time: 1520 hours
City/County: South of Truth or Consequences / Sierra County		State: New Mexico
Location: James Hamilton Construction Co. / Caballo Offsite Aggregate Mine, Southwest of I-25 and NM 152		
Subject: Looking southwest at disturbance in inactive mine area shown in Photo #10.

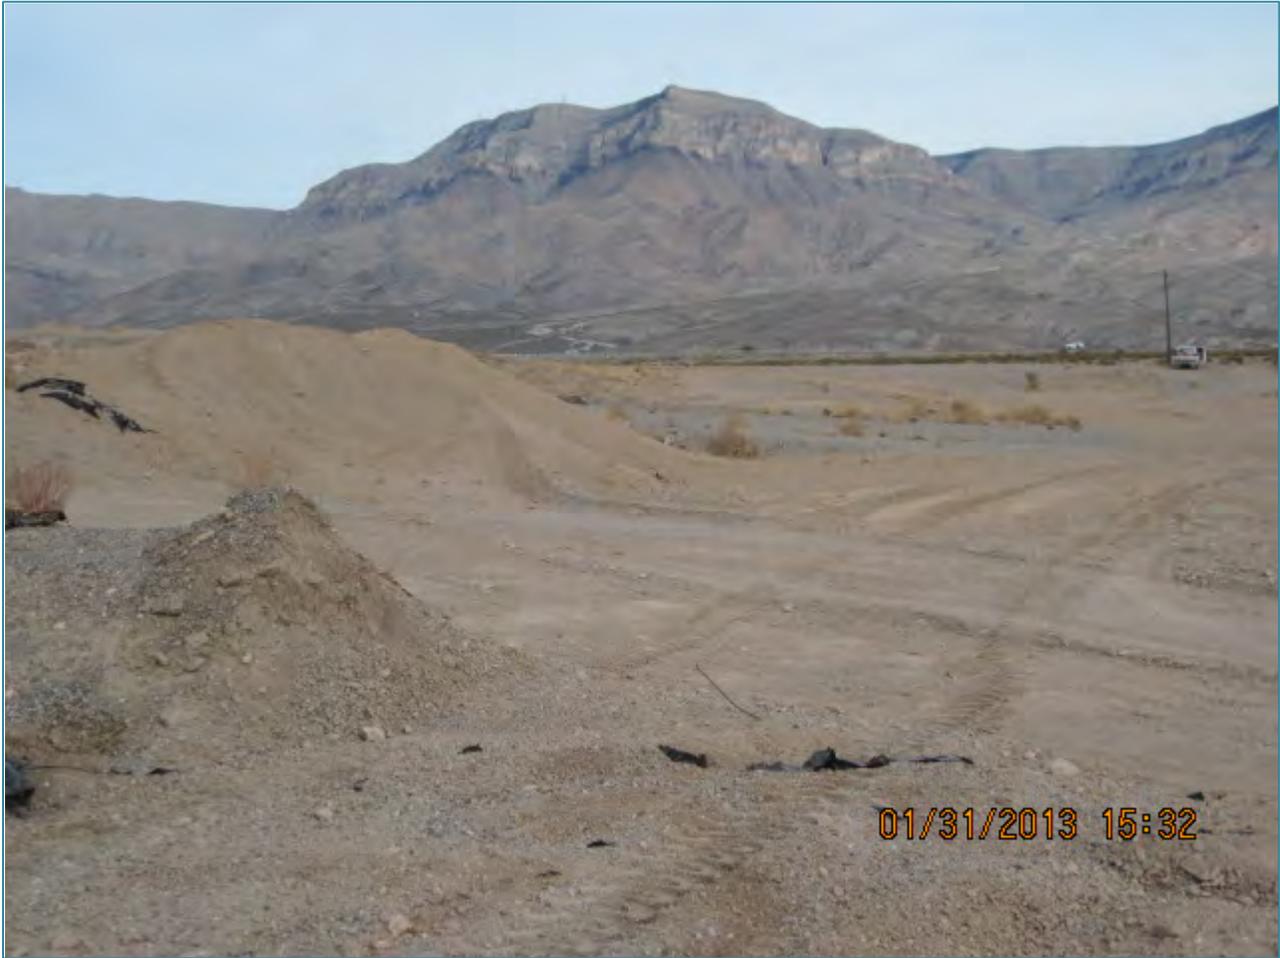
NMED/SWQB Official Photograph Log Photo # 13		
Photographer: Erin Trujillo	Date: 01/31/2013	Time: 1532 hours
City/County: South of Truth or Consequences / Sierra County		State: New Mexico
Location: James Hamilton Construction Co. / Caballo Offsite Aggregate Mine, Southwest of I-25 and NM 152		
Subject: Recent vehicle tracks at material stockpile and plastic in north-east portion of disturbed mine area.
