Re: Industrial Storm Water, SIC 2653, NPDES Compliance Evaluation Inspection, Georgia Pacific Corrugated, NMU001843, January 29, 2013

NPDES Compliance Inspection Report

Compliance Evaluation Inspection
General Pacific Corrugated, Sector B
NPDES Permit #NMU001843, January 29, 2013

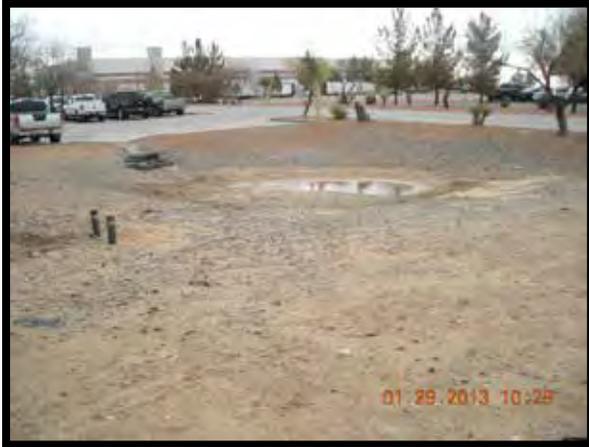
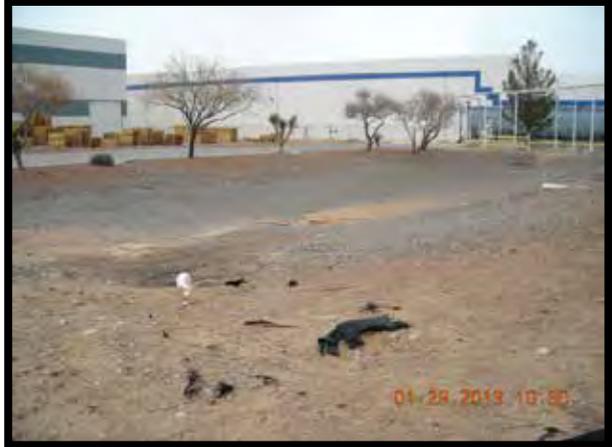
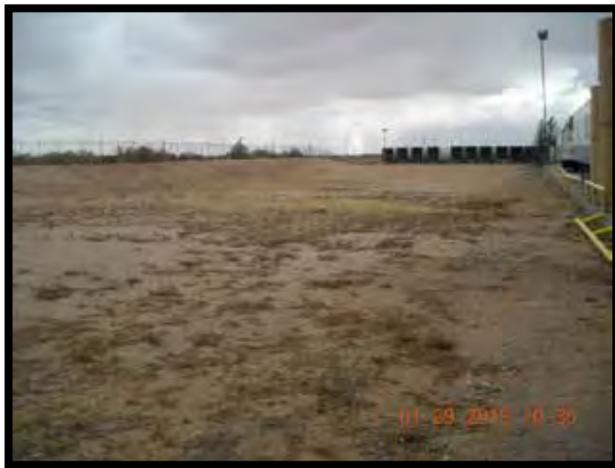
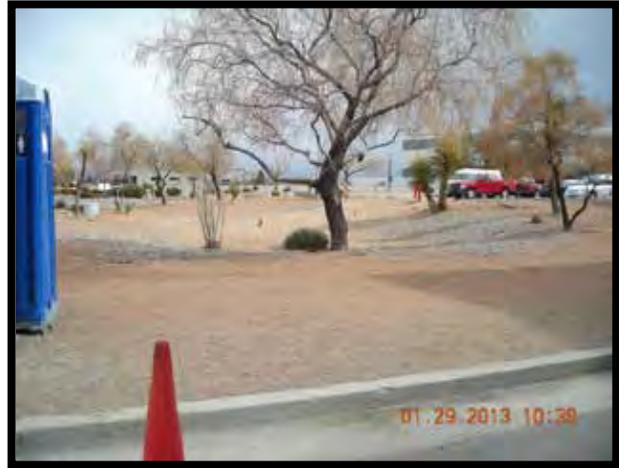
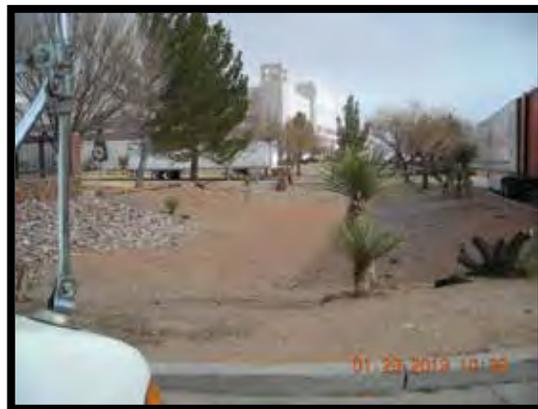
Official Photograph Log
Photo # 1-5

Photographer: Sarah Holcomb	Date: 1-29-2013	Time: 1029-1039 hours
City/County: Santa Teresa, Doña Ana County		
Location: General Pacific Corrugated, Kitty Hawk Blvd. (near Airport Rd.)		
Subject: The five retention ponds located on the facility's grounds.

On February 8, 2013, the inspector was provided with engineering calculations showing that the on-site ponds were designed to retain a 100 year storm. According to these documents, the 100 year storm for the Santa Teresa area is calculated as 3.8 inches. Going back through rainfall records in Santa Teresa, June and September 2009 appear to be close, but there were no 100 year events during this particular time frame. Copies of these documents are included with this report as Appendix A.

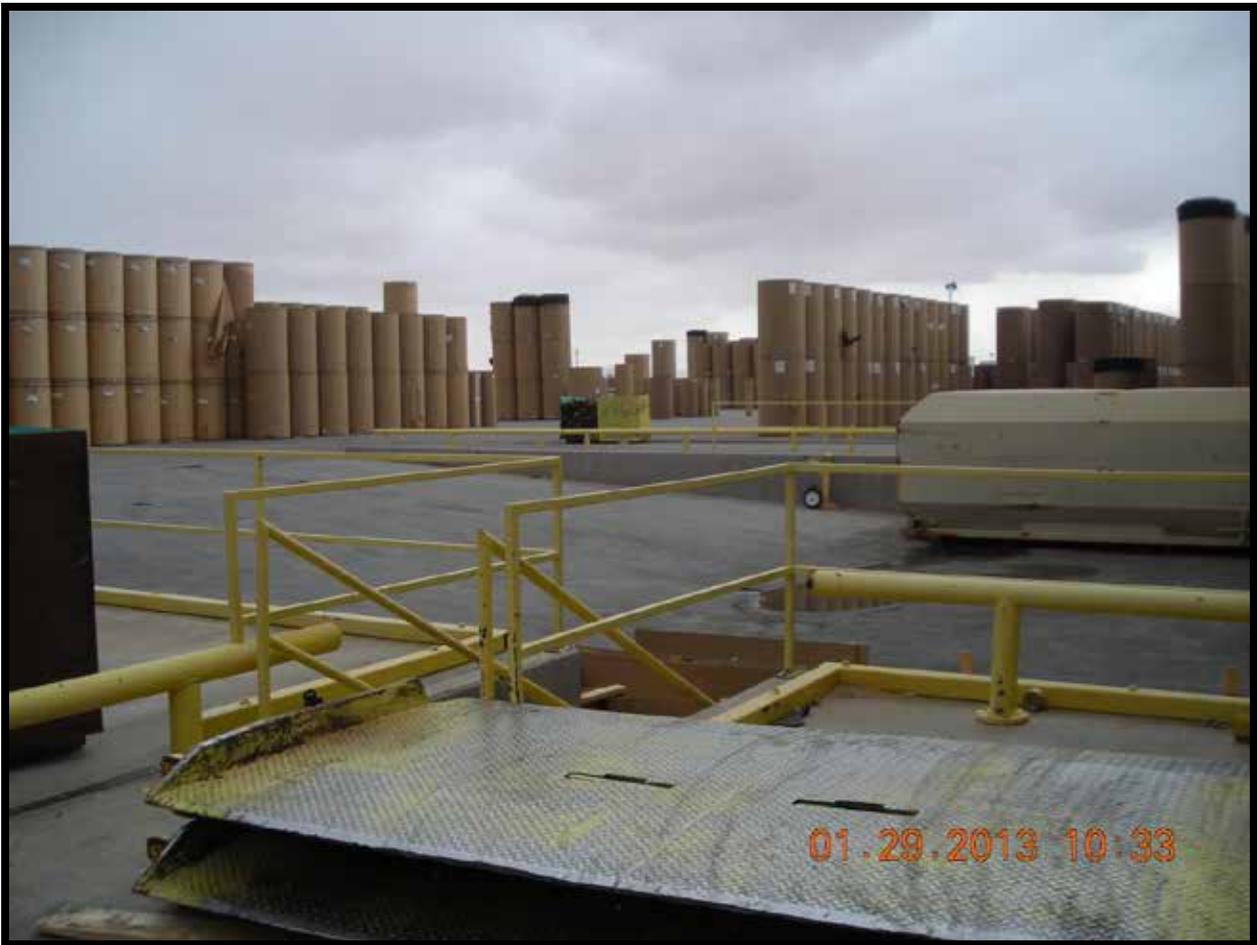
Photo # 6

On the day of the inspection, some pollutant sources observed on site that were exposed outside and could potentially come into contact with storm water included: 1) outdoor storage of raw materials (please see Photo #6), and 2) loading areas (although these generally appeared to be under cover). The materials stored outside were numerous rolls of raw paper used in the manufacturing process.

Photographer: Sarah Holcomb	Date: 1-29-2013	Time: 1033 hours
City/County: Santa Teresa, Doña Ana County		
Location: General Pacific Corrugated, Kitty Hawk Blvd. (near Airport Rd.)		
Subject: Raw paper outdoor storage area and loading dock.

An exit interview to discuss the preliminary findings of this inspection was conducted onsite with Ms. Vega and Mr. Ives at approximately 1100-1110 hours. The inspector also spoke with Mr. Sam Barket, Regional EHS Manager for General Pacific, over the phone regarding permitting requirements. Mr. Barket informed the inspector that GP did not obtain permit coverage for this particular facility because of the presence of five detention ponds at the site. However, the inspector inquired as to the availability of engineering calculations to show the size of storm that the ponds were designed to hold, and Mr. Barket indicated on 2-7-2013 that he was unable to find any engineering calculations for those ponds. The inspector informed the facility representatives of the requirements under the NPDES storm water program regarding permitting requirements, preparation of a SWPPP and installation of appropriate storm water runoff control practices (per the SWPPP). The inspector also discussed the availability of the No Exposure Certification, if all of the outdoor storage was under cover.

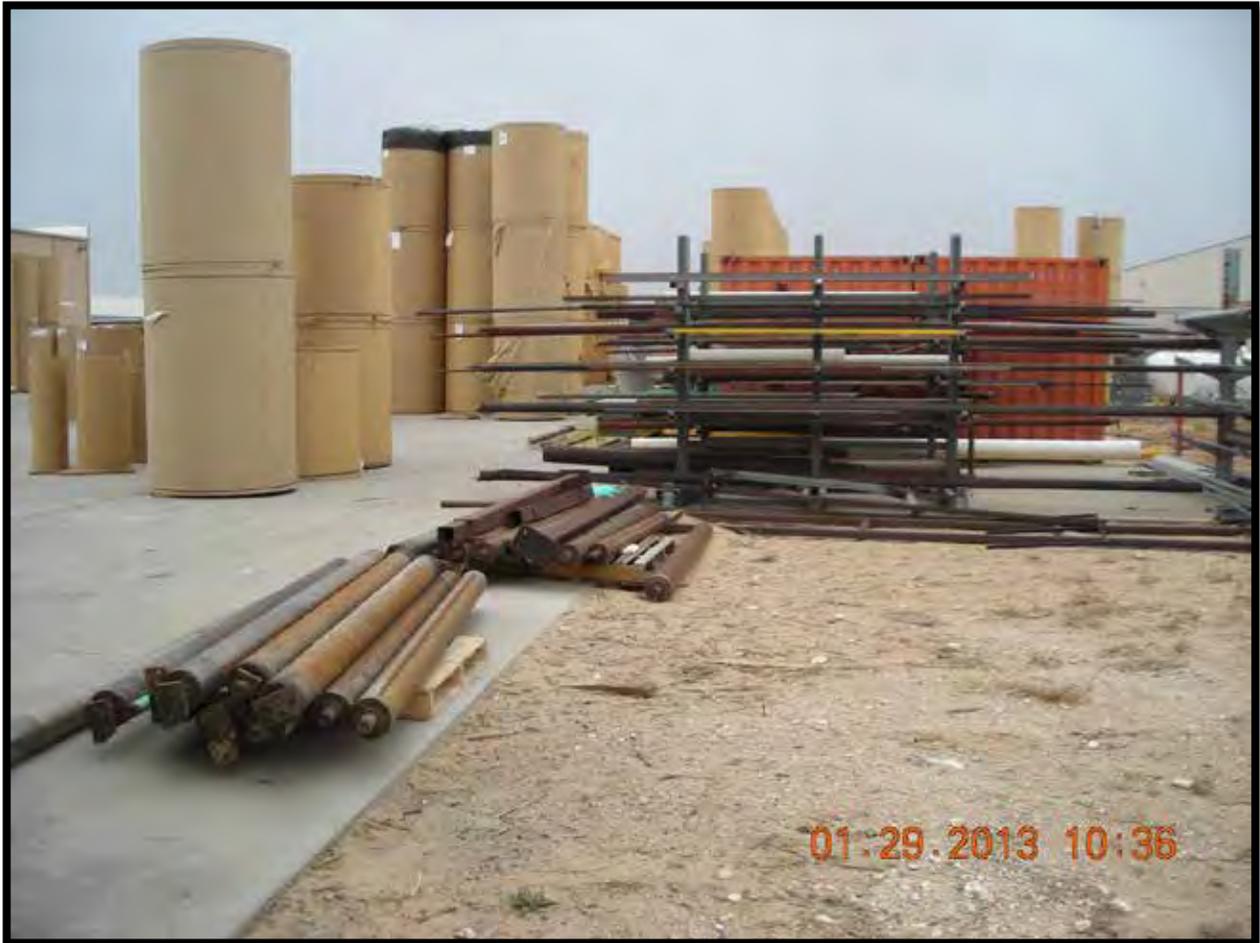
Photo # 7

Photographer: Sarah Holcomb	Date: 1-29-2013	Time: 1036 hours
City/County: Santa Teresa, Doña Ana County		
Location: General Pacific Corrugated, Kitty Hawk Blvd. (near Airport Rd.)		
Subject: The facility's boneyard – materials kept for equipment maintenance purposes.

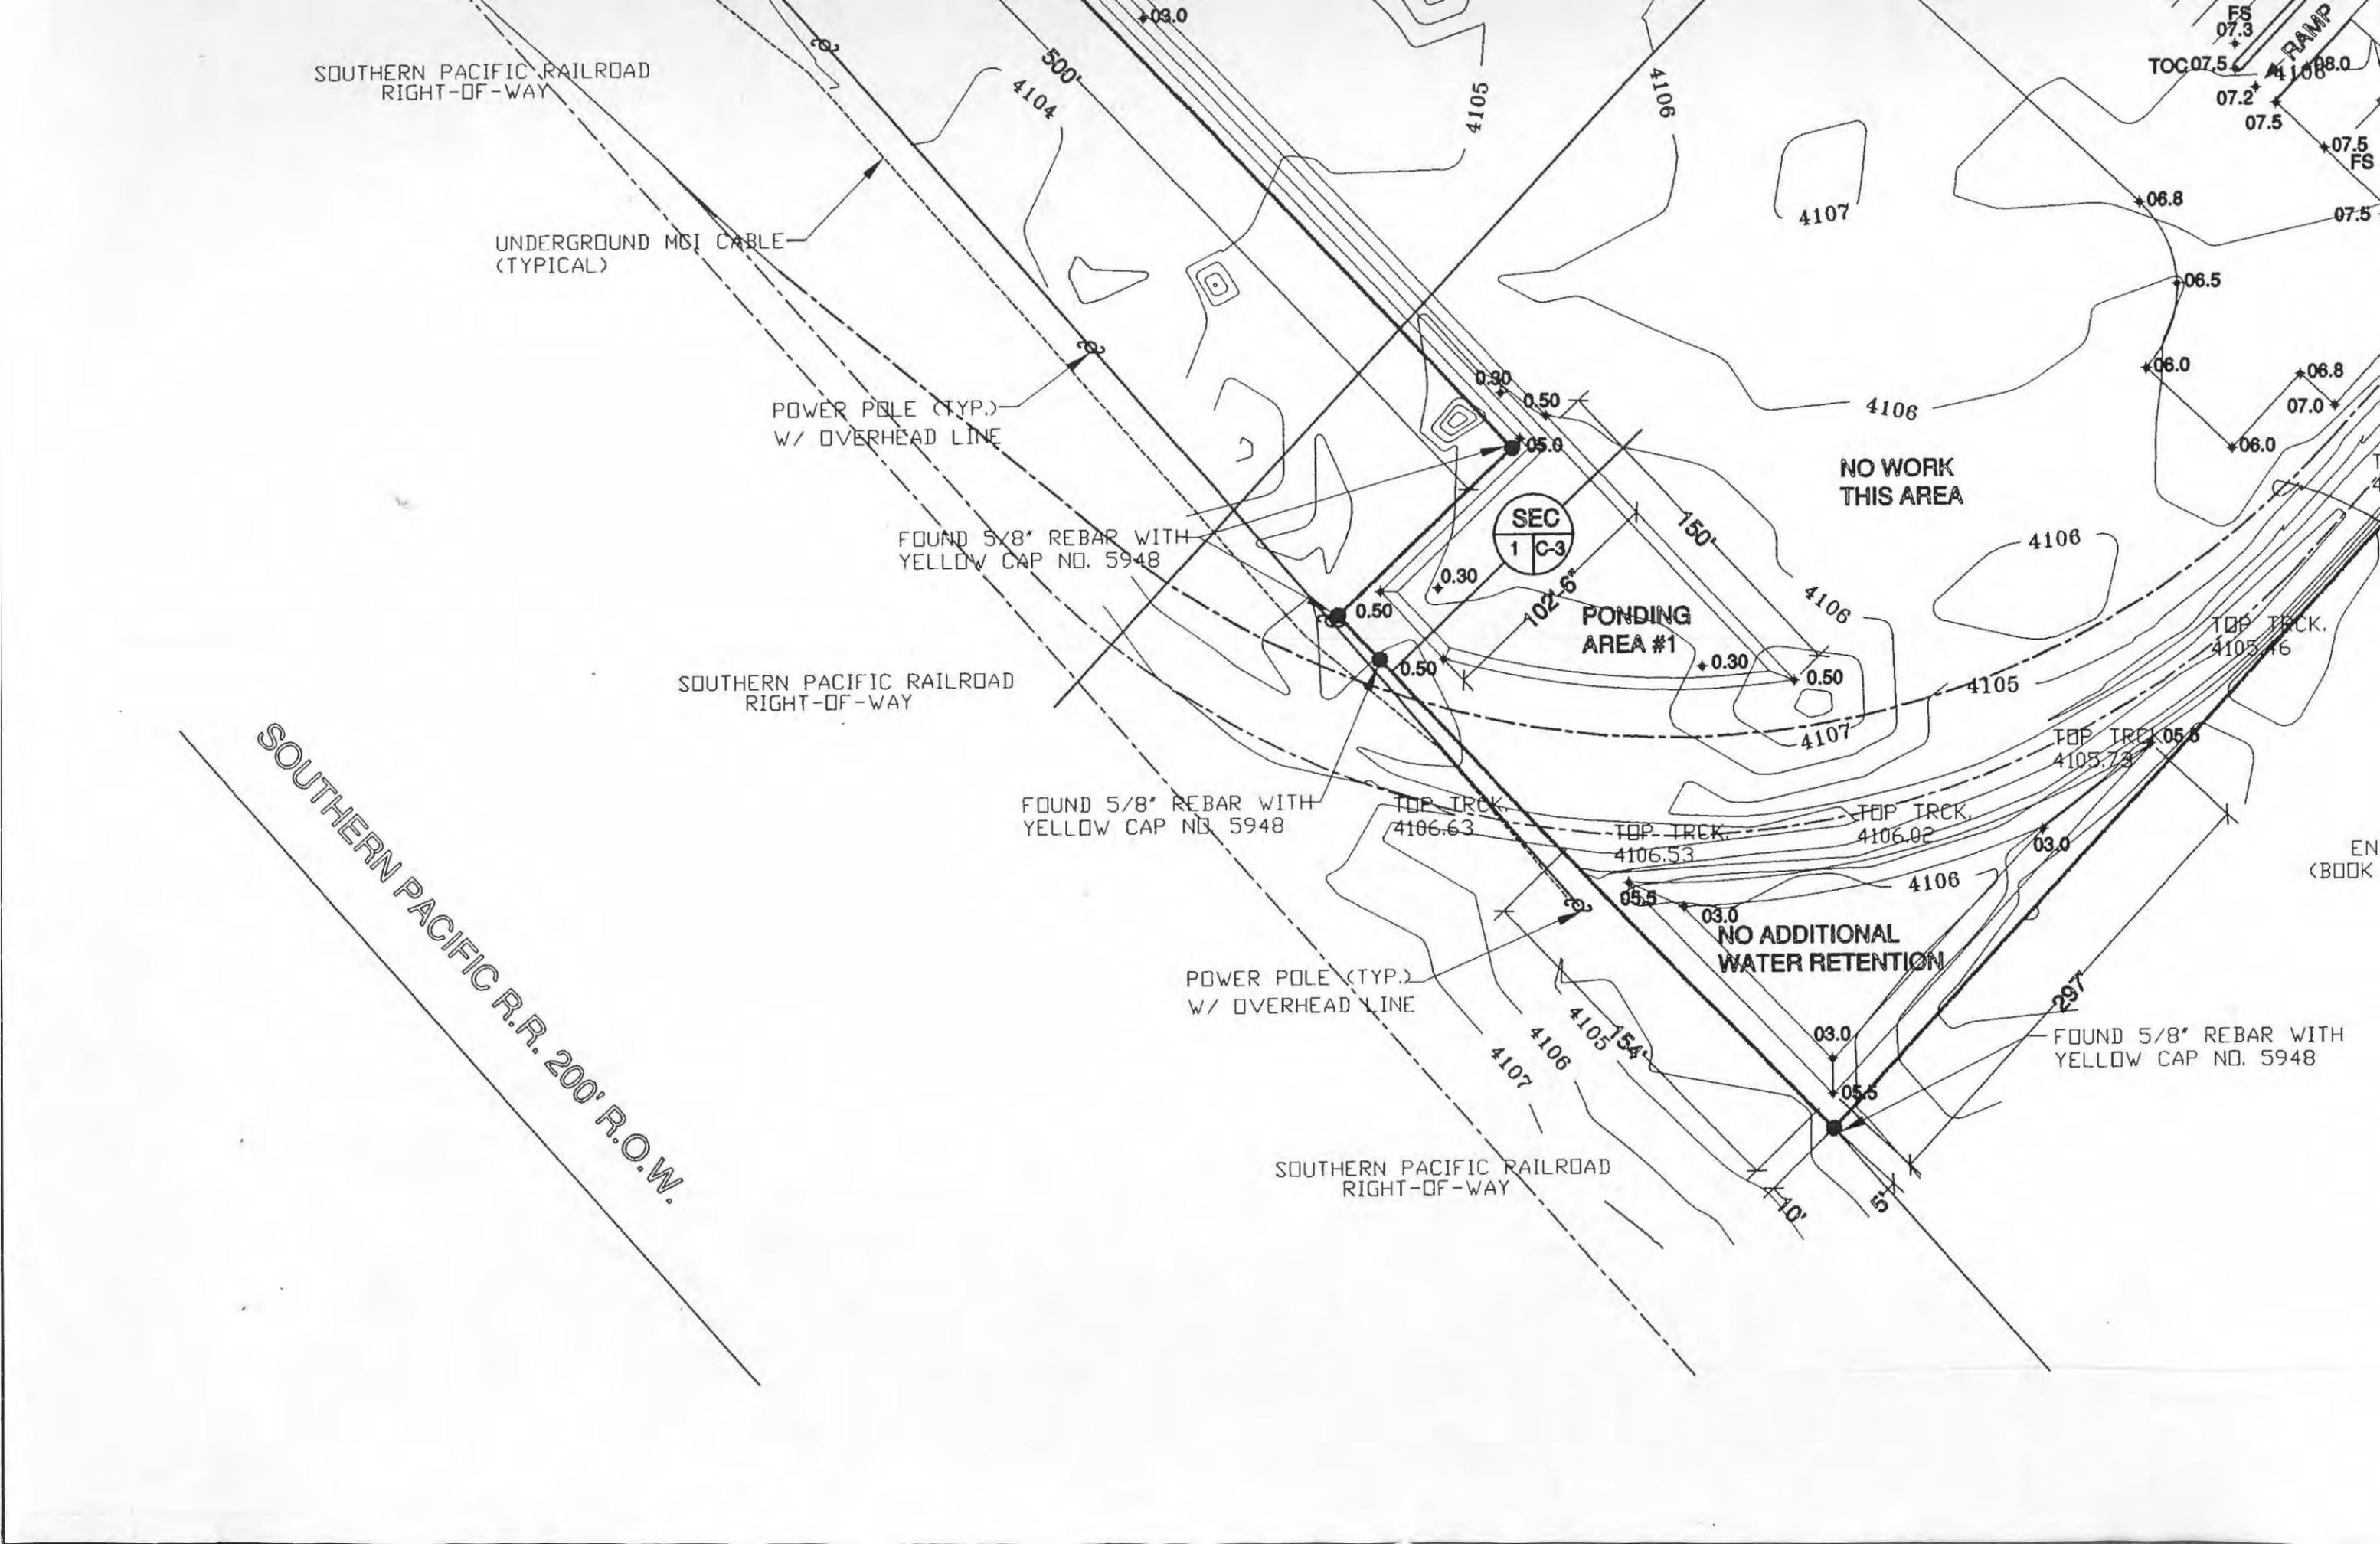
GRADING PLAN
 SCALE 1" = 60'-0"

Please find enclosed a site drawing for the Georgia-Pacific Corrugated III LLC (GP) facility located in Santa Teresa, NM. Please note that the drawing shows the design of the on-site storm water retention ponds, and indicates the engineering calculations completed to demonstrate that the ponds should capture and retain runoff from a 100-year event.
