Re: Minor Non-Municipal; SIC 4941; NPDES Compliance Evaluation Inspection; Vallecitos MDWCA; Permit NMU001854; May 2, 2013

NPDES Compliance Inspection Report

**Compliance Evaluation Inspection
Vallecitos MDWCA
NMU001854
May 2, 2013**

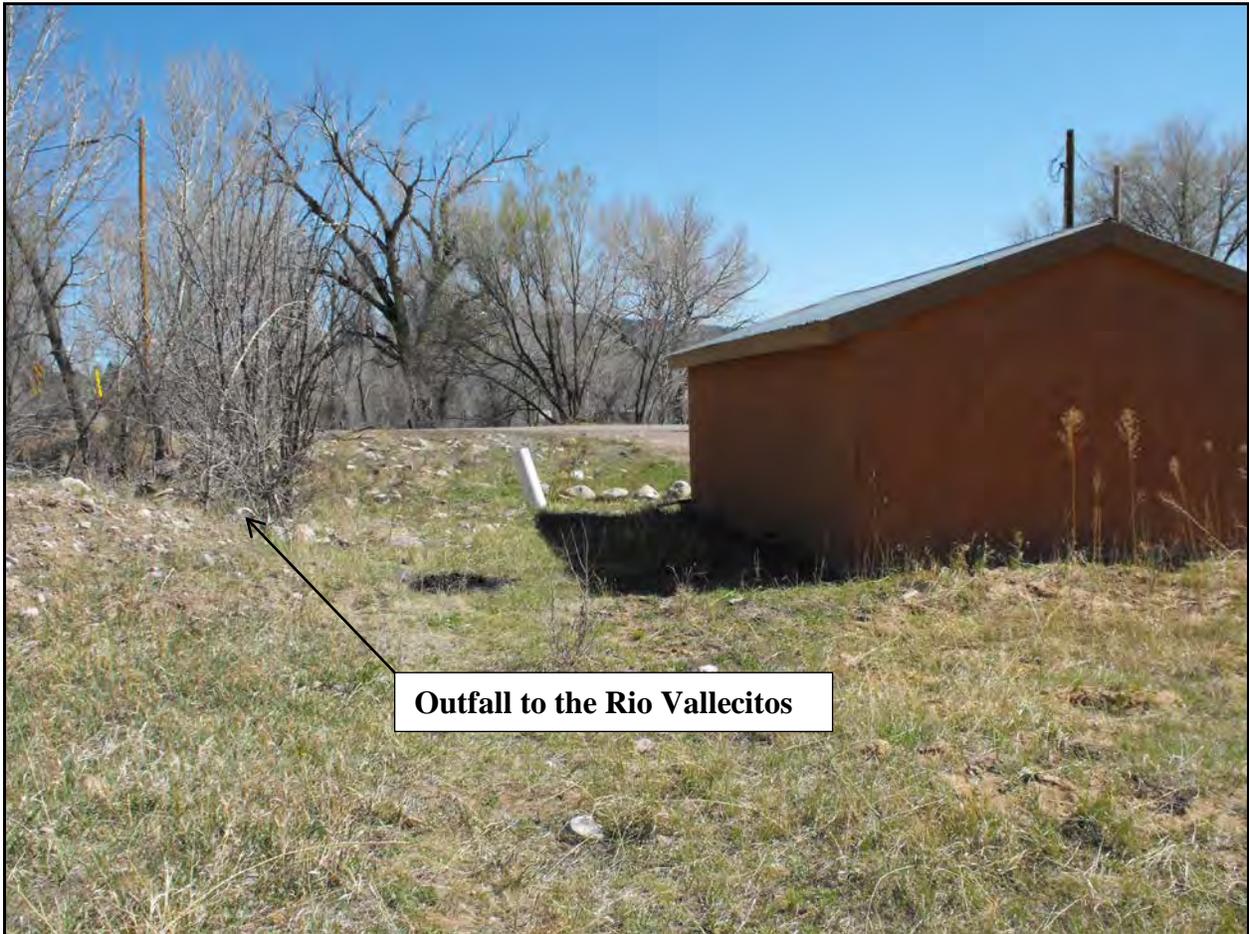
Photo # 1

Photographer: Daniel Valenta	Date: 5/2/2013	Time: 1547
City/County: Vallecitos/Rio Arabia		
Location: Village of Vallecitos Water Treatment Facility facing south.		
Subject: Vallecitos MDWCA filter/equipment house next to the river.

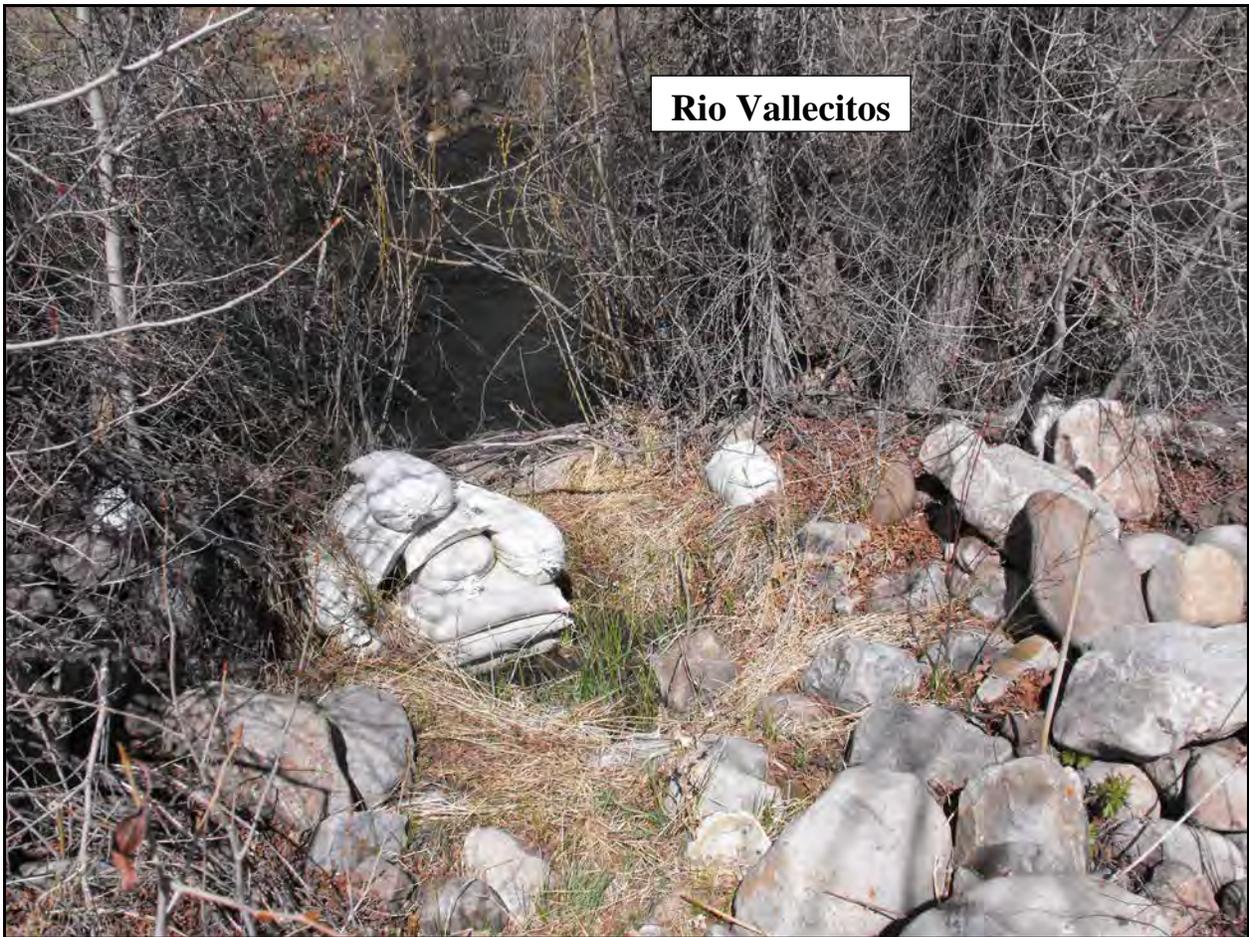
Photo # 2

When the filters need back flushing a one way valve is opened manually allowing the chlorinated water from the storage tank to back flow through the filters and out a discharge pipe to the river. The volume of discharge is not measured and the amount of chlorinated water used in the process depends on the length of time the manual valve is left open. No records of backflow events were available for review. The operators are unpaid volunteers who live in the village.

The Vallecitos MDWCA does not have NPDES permit coverage for the discharge of chlorinated wastewater into the Rio Vallecitos.

Photographer: Daniel Valenta	Date: 5/2/2013	Time: 1542
City/County: Vallecitos/Rio Arabia		
Location: Village of Vallecitos Water Treatment Facility facing east.		
Subject: Discharge outfall of chlorinated back flush water from the Vallecitos MDWCA.

At the present time the Vallecitos MDWCA is working with an engineering consultant firm and the New Mexico Construction Program Bureau to build a new system for the village. The discharge from the present system appears to require permit coverage. The USEPA Region 6 NPDES Permit Coordinator can be contacted for more information on how to submit an application for discharges of pollutants under the federal Clean Water Act.

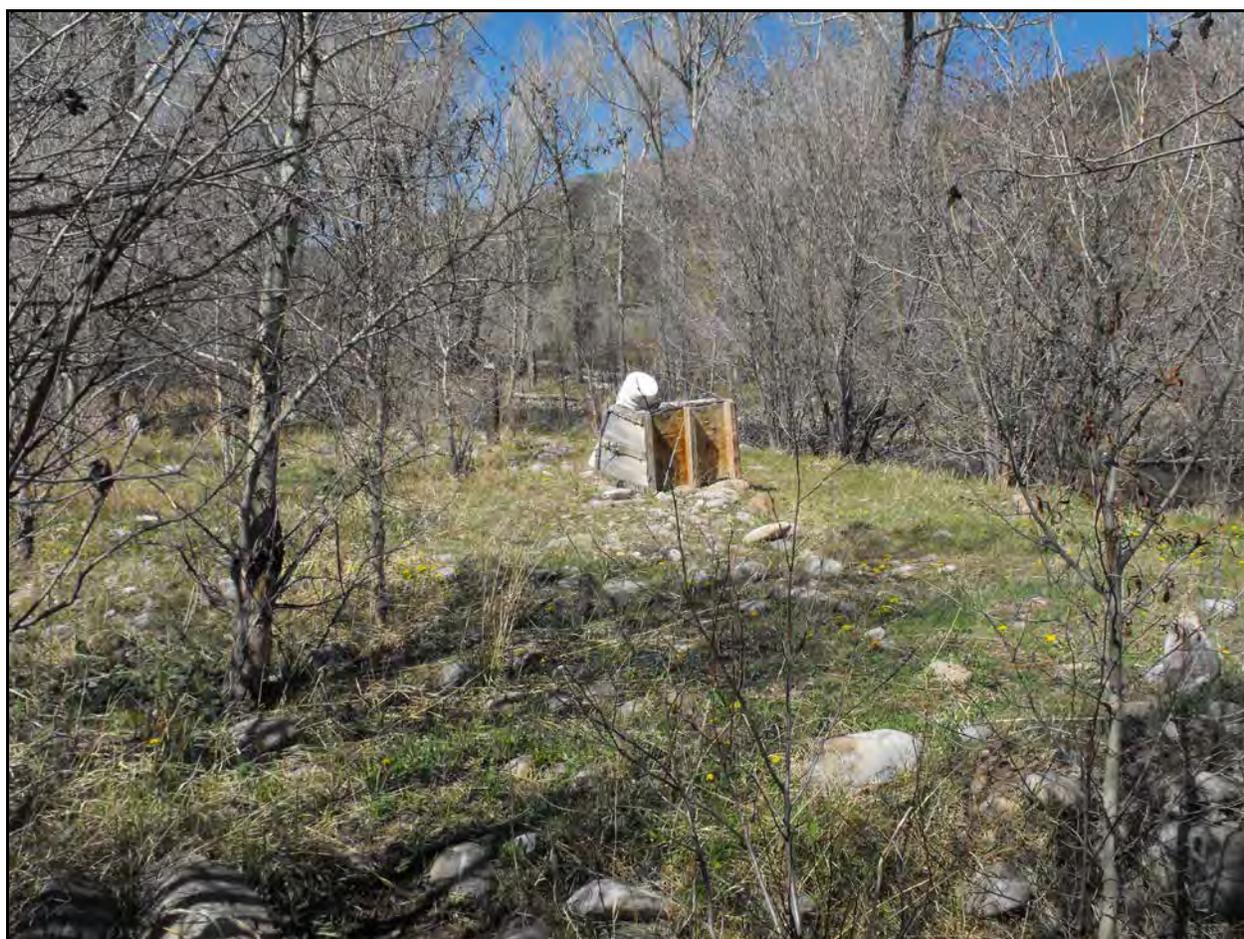
Photo # 3

Photographer: Daniel Valenta	Date: 5/2/2013	Time: 1544
City/County: Vallecitos/Rio Arabia		
Location: Village of Vallecitos Water Treatment Facility facing north.		
Subject: Pump house over the infiltration galleria next to the Rio Vallecitos.
