Re: Industrial Storm Water, SIC 3272, NPDES Compliance Evaluation Inspection, Mesa Verde Concrete Batch Plant, NMU001859, July 23, 2013

Compliance Evaluation Inspection  
Mesa Verde, Inc., Sector E  
NPDES Permit #NMU001859, July 23, 2013

**Official Photograph Log**

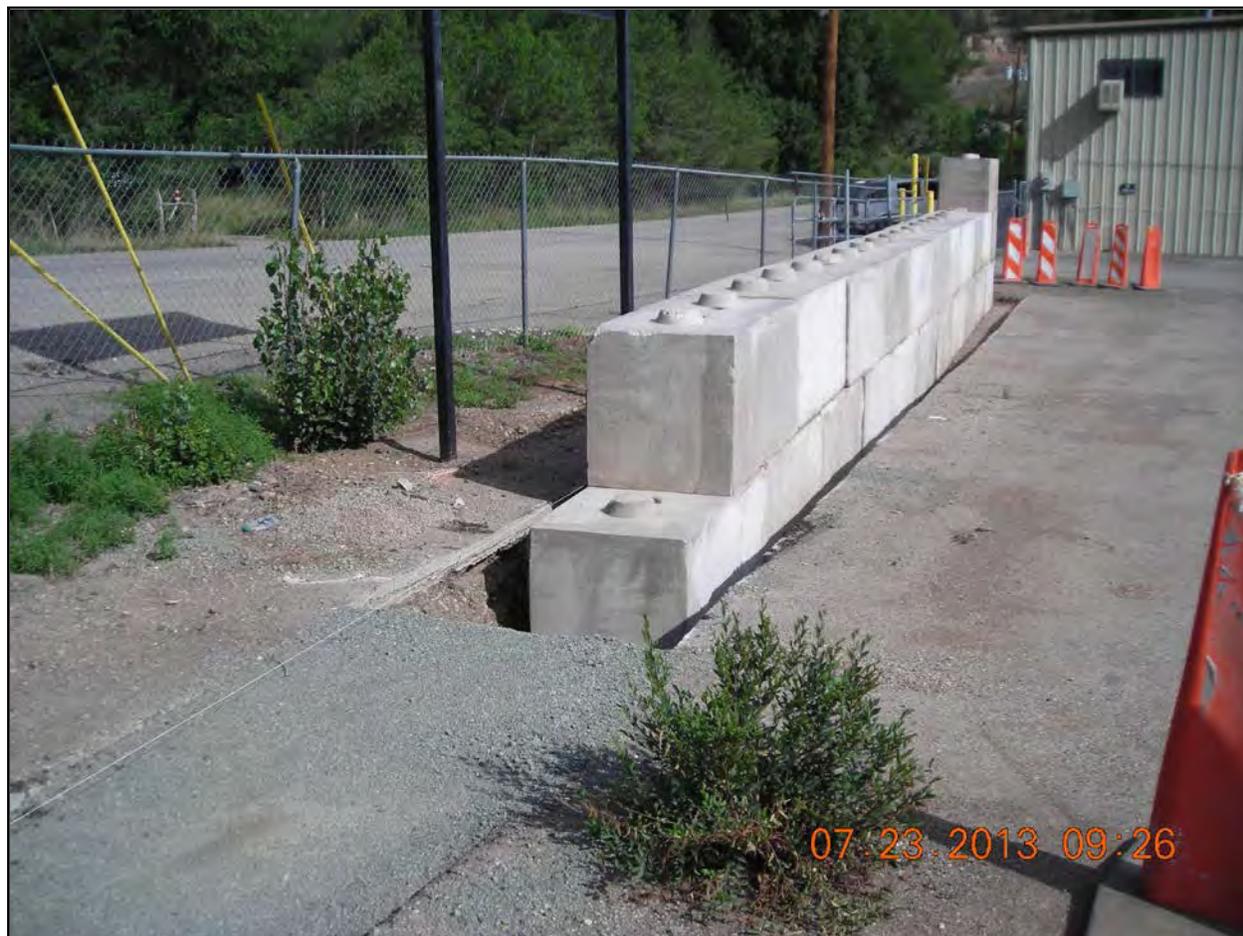
Photo # 1

Photographer: Sarah Holcomb	Date: 7-23-2013	Time: 0926 hours
City/County: Ruidoso, Lincoln County		
Location: Mesa Verde concrete batch plant yard, Ruidoso, NM		
Subject: Facility is working to erect a concrete wall to prevent run-on from entering the site.

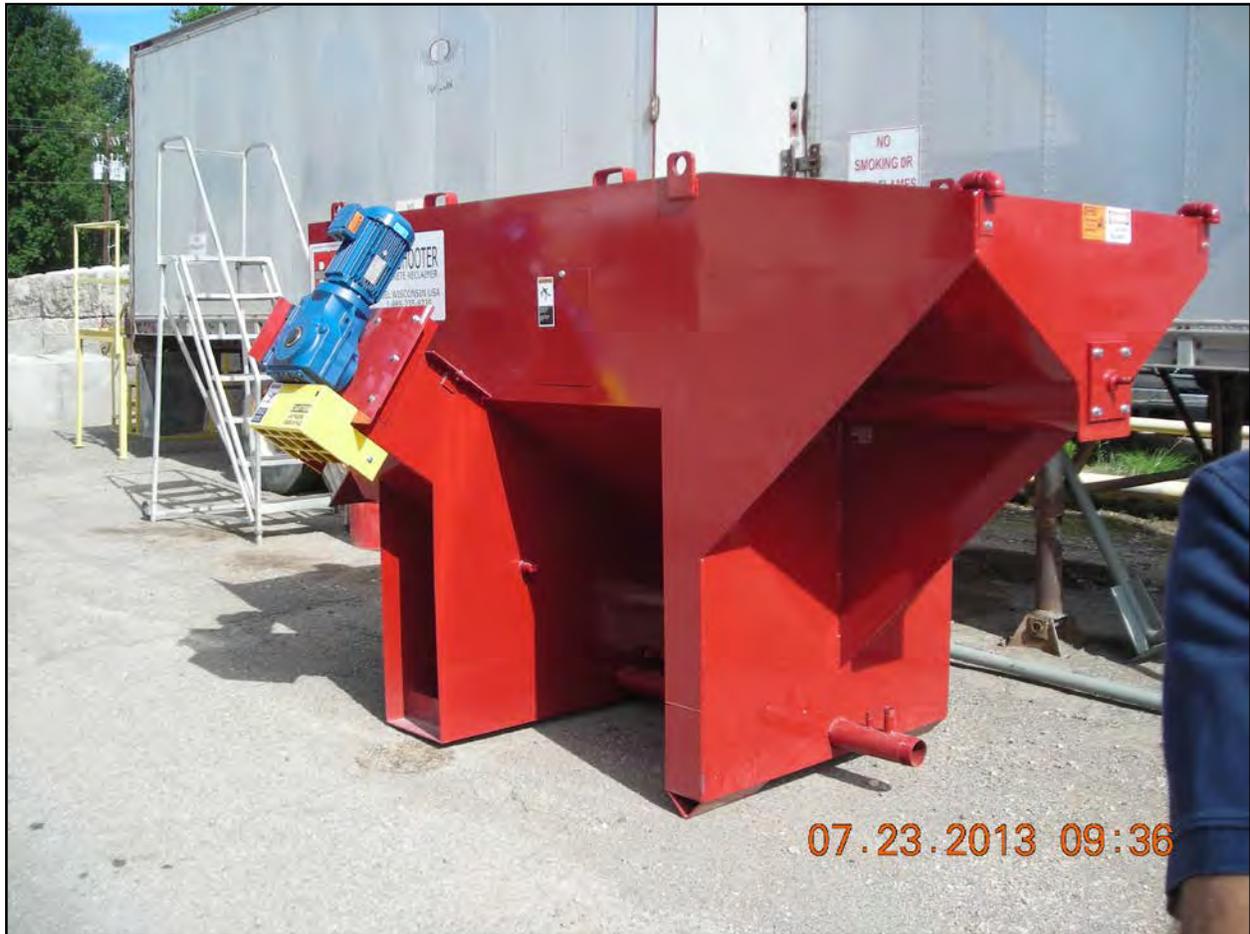
Photo # 2

Photographer: Sarah Holcomb	Date: 7-23-2013	Time: 0936 hours
City/County: Ruidoso, Lincoln County		
Location: Mesa Verde concrete batch plant yard		
Subject: Mechanical concrete reclaimer to be installed in the current concrete washout pit on site.

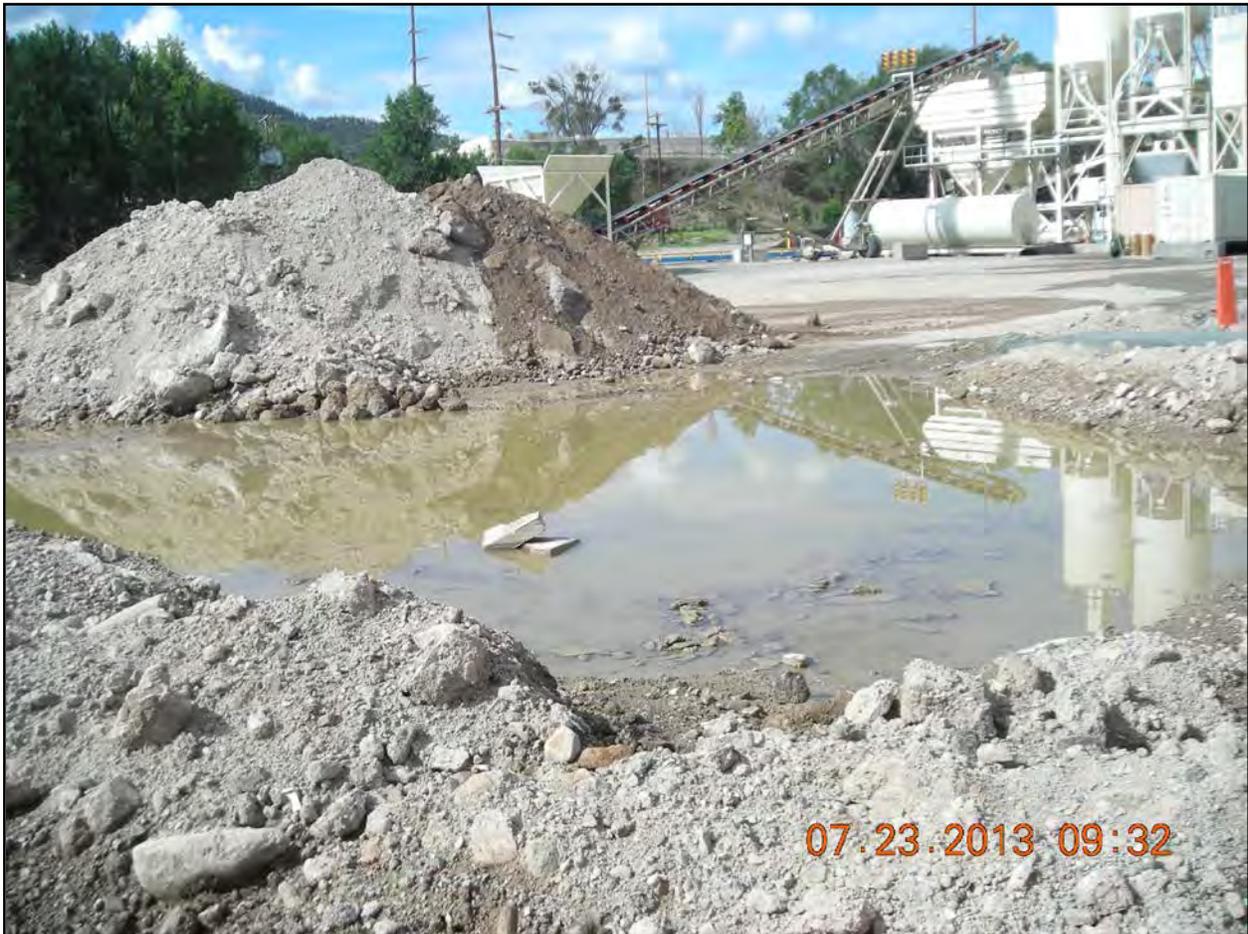
Photo # 3

Photographer: Sarah Holcomb	Date: 7-23-2013	Time: 0932 hours
City/County: Ruidoso, Lincoln County		
Location: Mesa Verde concrete batch plant yard		
Subject: Temporary concrete washout pit.
