Re: Industrial Storm Water, SIC 4173, NPDES Compliance Evaluation Inspection, Village of Ruidoso Maintenance Yard, NMU001860, July 23, 2013

NPDES Compliance Inspection Report

Compliance Evaluation Inspection
Village of Ruidoso Maintenance Yard, Sector P
NPDES Permit #NMU001860, July 23, 2013

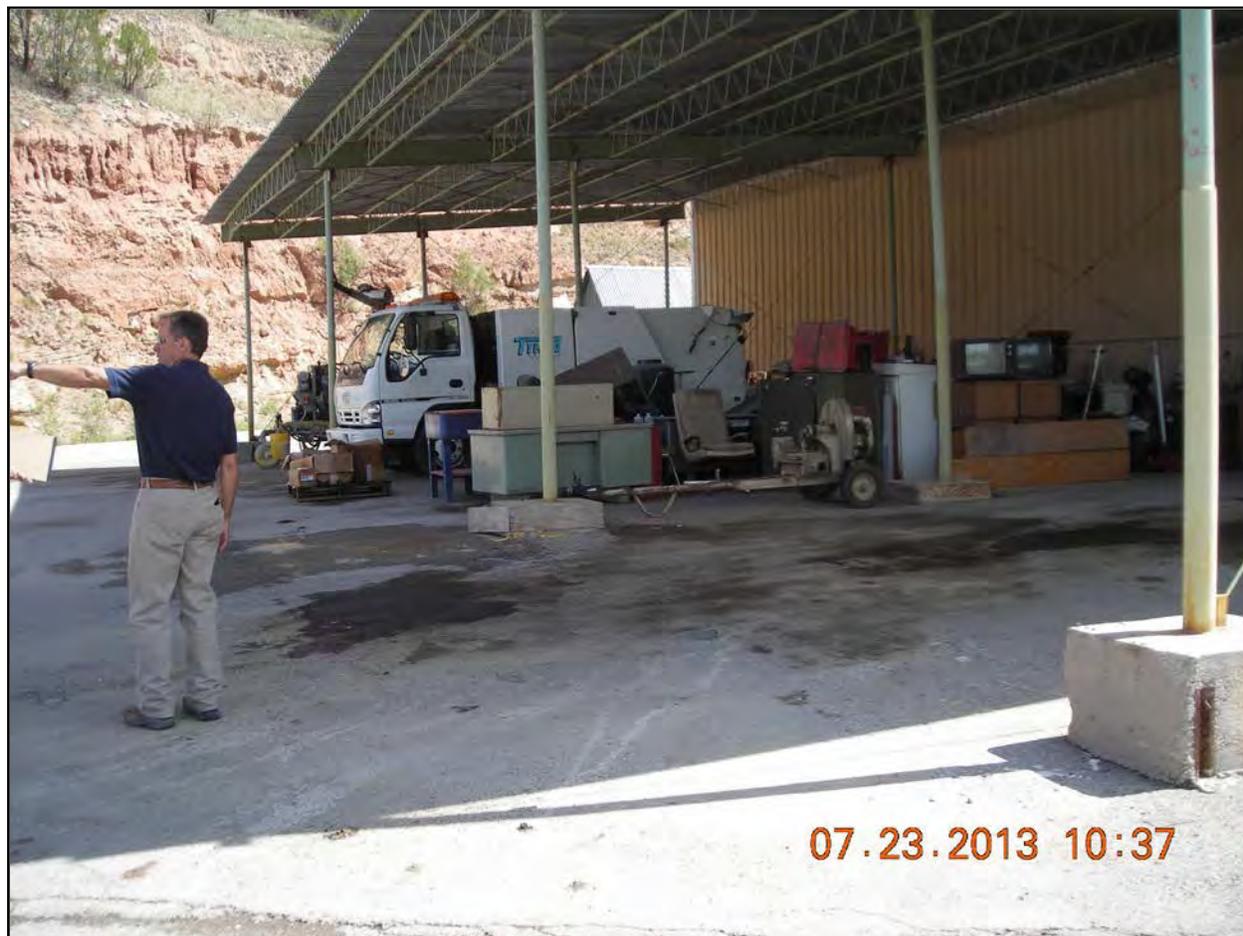
Photo # 1

On the day of the inspection, some pollutant sources observed on site that were exposed outside and could potentially come into contact with storm water included: 1) aggregate piles, 2) the asphalt batch plant, and 3) spilled/leaked oil in the maintenance area.

Photographer: Sarah Holcomb	Date: 7-23-2013	Time: 1037 hours
City/County: Ruidoso, Lincoln County		
Location: Village Maintenance Yard near US 70 and Close Rd., Ruidoso, NM		
Subject: Spilled oil in the maintenance area of the yard.

An exit interview to discuss the preliminary findings of this inspection was conducted onsite with Mr. Prieto at approximately 1050 hours. The inspector informed Mr. Prieto of the requirements under the NPDES storm water program regarding permitting requirements, preparation of a SWPPP and installation of appropriate storm water runoff control practices (per the SWPPP).

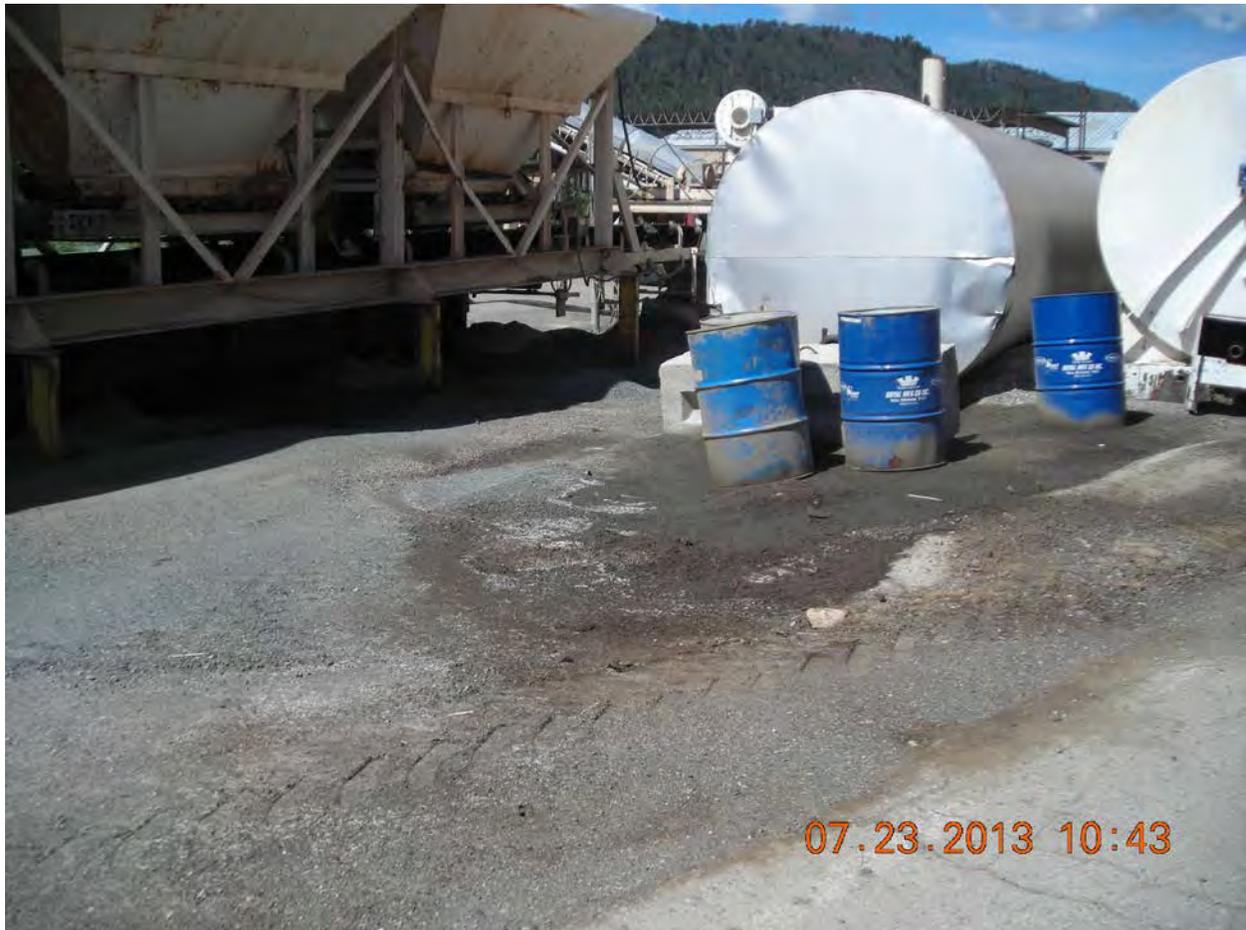
Photo # 2

Photographer: Sarah Holcomb	Date: 7-23-2013	Time: 1043 hours
City/County: Ruidoso, Lincoln County		
Location: Village Maintenance Yard near US 70 and Close Rd., Ruidoso, NM		
Subject: More spilled oil in the area of the asphalt batch plant.
