Appendix B

Level 1 Hydrology Protocol Results
for B Drainage

Cover Sheet
Hydrology Protocol Use Attainability Analysis
for an Ephemeral Stream¹

B-Drainage Photographs (B-7 Reach) – Total HP score of 2 (ephemeral stream)

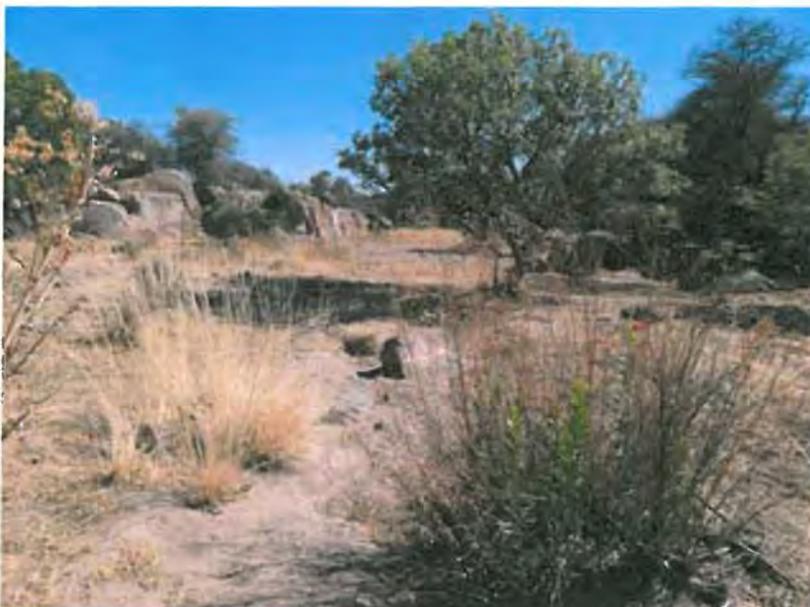
B7-1: Photographic reference for indicators 1.1 through 1.6. Photograph of stream bed. Typical rooted vegetation across channel and banks relatively consistently dispersed throughout channel length. Indicator 1.6 scored as 1 - rooted upland plants consistently dispersed in streambed. No water or biotic indicators of water observed along survey reach.

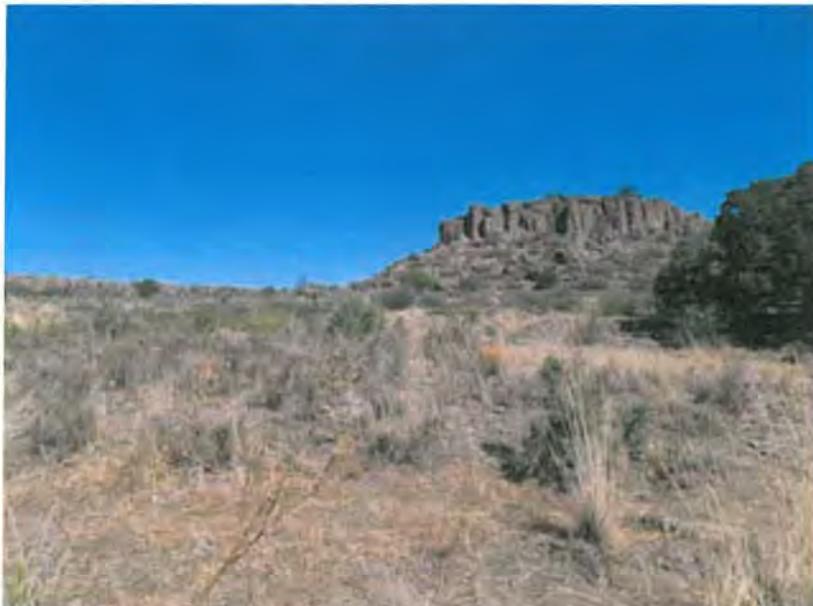
B7-2: Photographic reference for indicator 1.5. Photograph of bank and upland area. Indicator 1.5 scored as 1 - evident variation in vegetative density but no dramatic difference in composition. No distinct riparian zone observed.

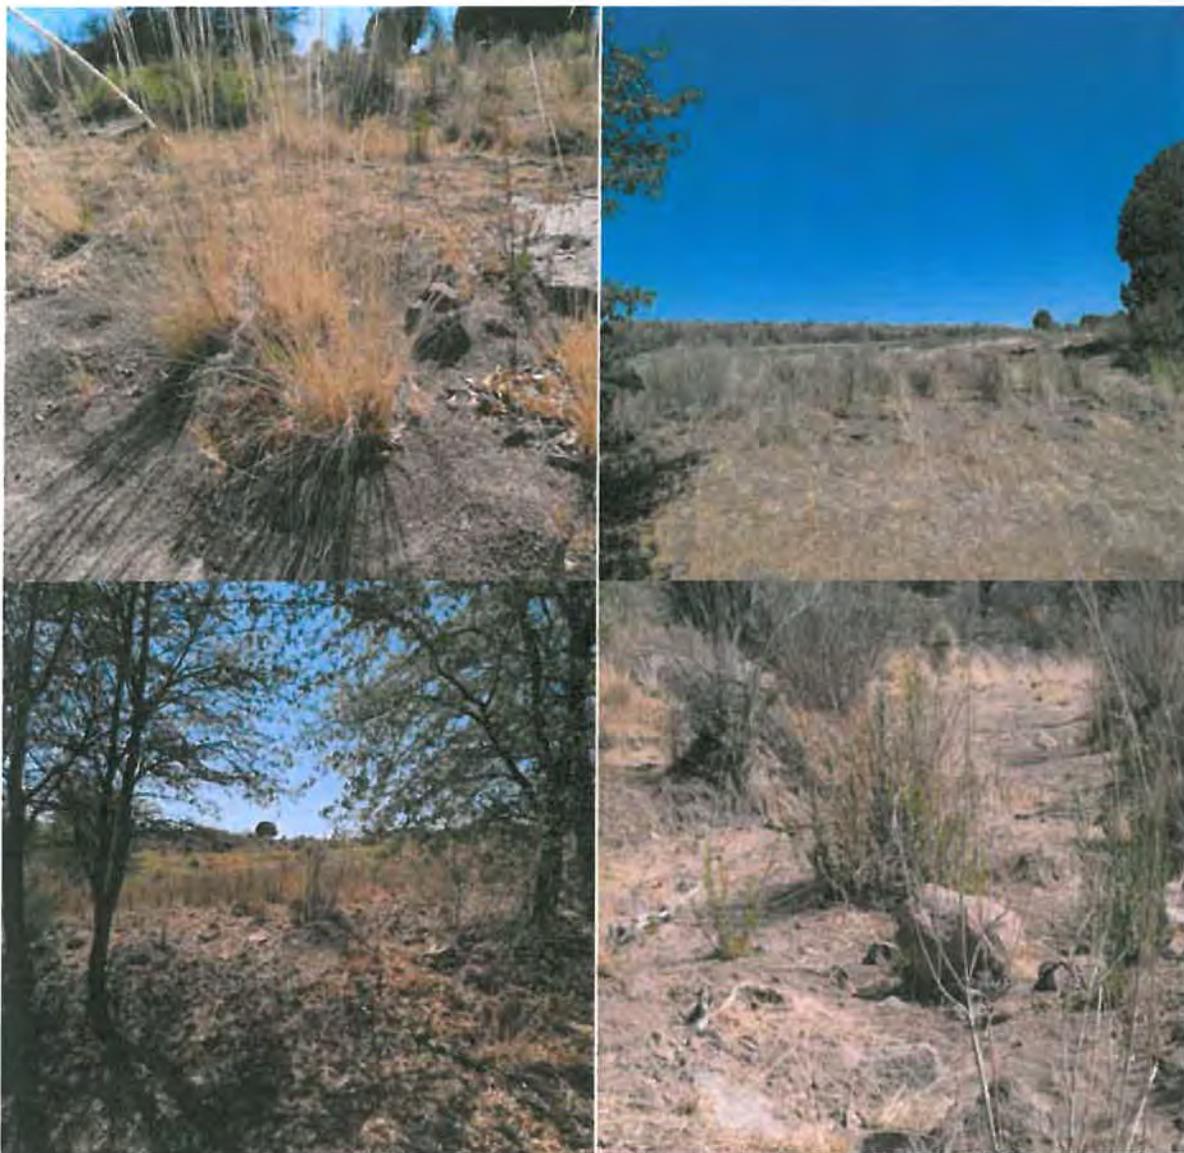
B7-3: Photographic reference for indicators 1.5 and 1.6. Photographs of bank/upland area and rooted in channel vegetation. There is a variation in vegetative density but no dramatic difference in composition. Rooted vegetation consistent across channel and banks.

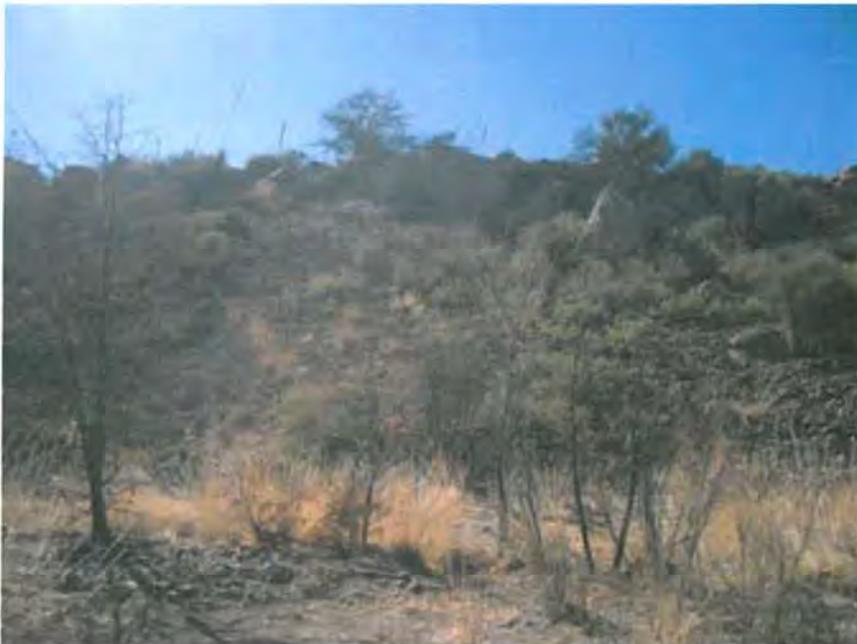
B7 DS-2: Photographic reference for indicator 1.5. Photograph of the overbank area and uplands. Indicator 1.5 scored as 1 - evident variation in vegetative density but no dramatic difference in composition. No distinct riparian zone observed.

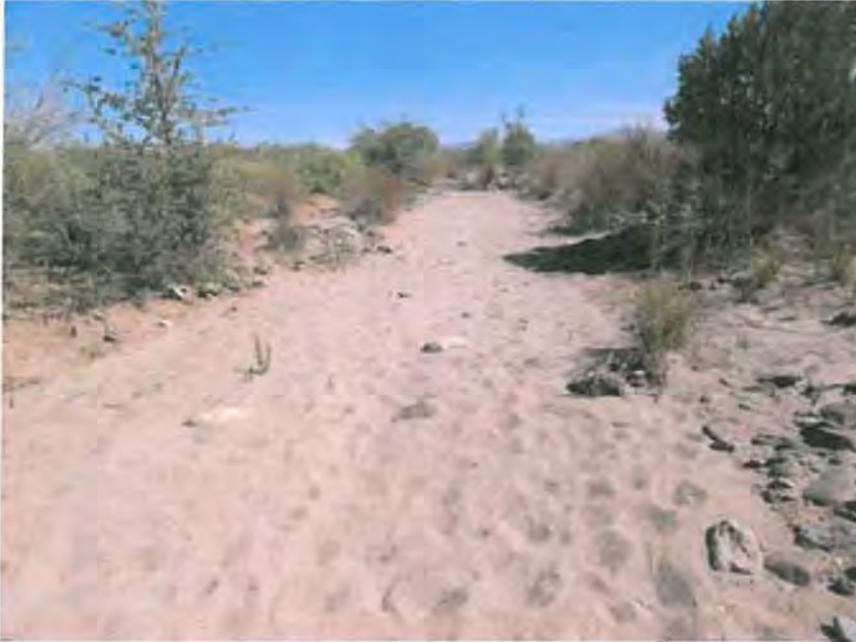
B8-4: Photographic reference for indicator 1.8 and 1.10. Photograph of the cross-section for measurement of the floodplain and channel dimensions. Indicator 1.8 scored 1.5 based on measurements taken - moderate confinement and presence of inactive floodplain.

Indicator 1.10 scored as 1.5. Channel bed material is medium to coarse sand, which is consistent but noticeably courser than the bank and over bank area. Little to no substrate sorting is observable.
