Appendix C

Level 1 Hydrology Protocol Results
for C Drainage

Cover Sheet
Hydrology Protocol Use Attainability Analysis
for an Ephemeral Stream¹

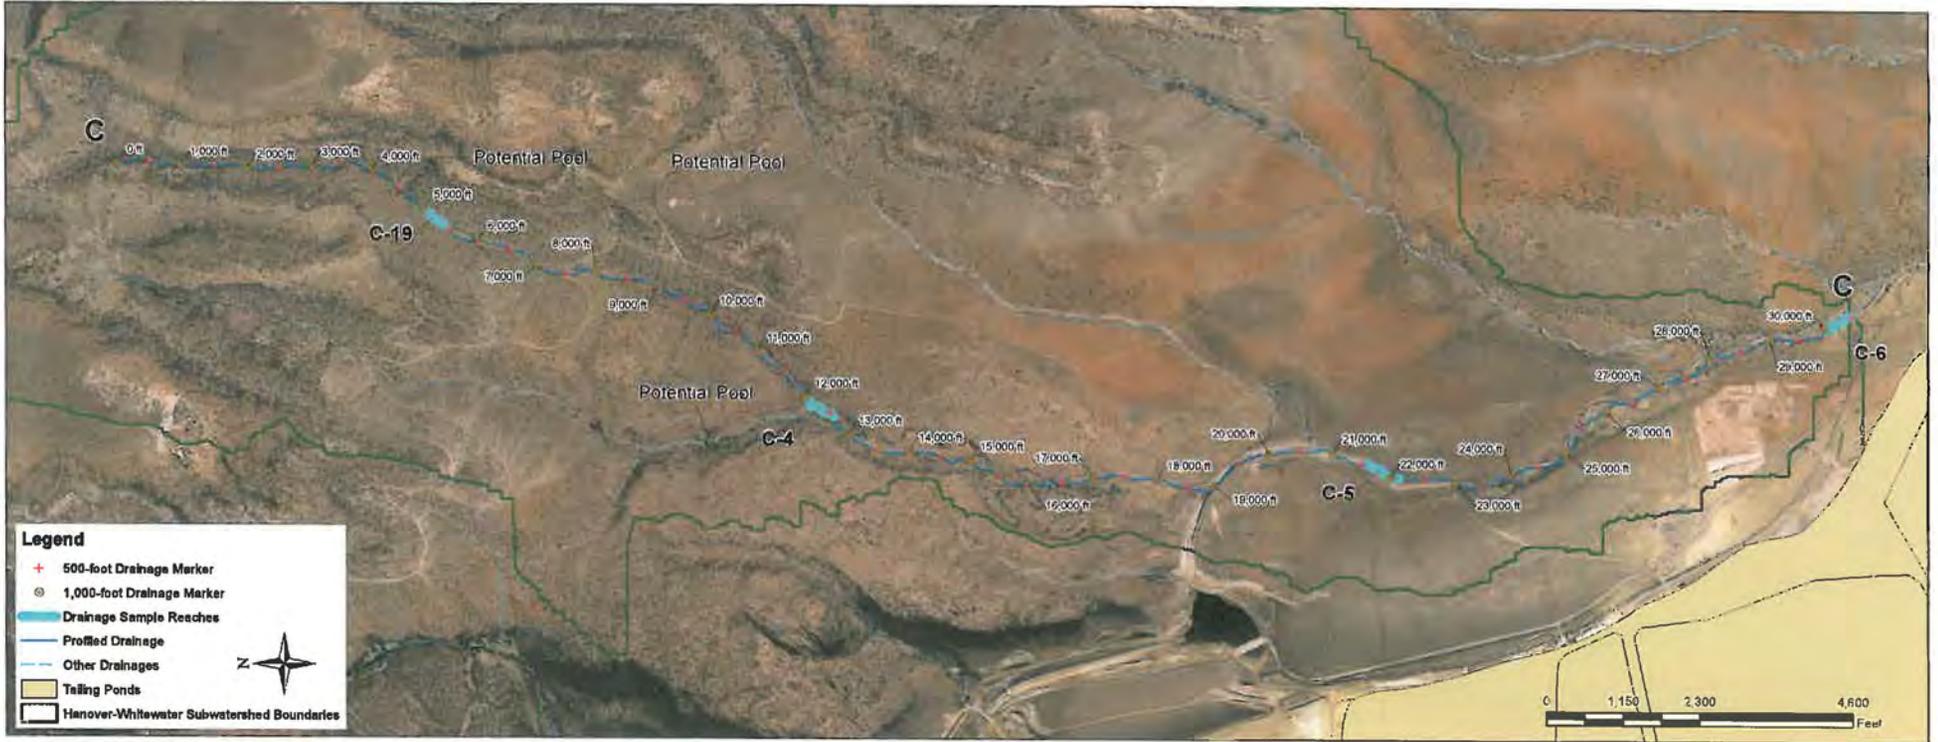
FIGURE C-1: DRAINAGE PROFILE FOR SUBWATERSHED C

Additional Comments:
<p>Four assessment units were identified within sub-watershed C (Figure C-1 below). Starting at the upstream end, these assessment units are identified as C-19, C-4, C-5, and C-6. The most upstream assessment unit (C-19) was selected to represent the headwater portions of this, and other, sub-watersheds within this portion of the AOC. Assessment unit C-4 was located at a significant change in basin slope downstream of tributary inflow. The lower two assessment units (C-5 and C-6) are located within the downstream portions of sub-watershed C intended to represent hydrologic processes of larger watersheds within this portion of the AOC.</p> <p>As shown in the plan and profile plots presented below the basin slope progressively decreases, as expected, in the downstream direction. Similarly, the degree of valley confinement decreases in the downstream direction. These trends in channel slope and confinement are typical and represent the relative dominance of colluvial versus alluvial channel forming processes and are reflected in the composition of the channel bed itself. That is, the upstream reaches of sub-watershed C (C-19 and C-4) are bedrock and cobble dominated stream channels indicative hill slope processes (Photos C19-1 and C4-2) whereas the downstream assessment units (C-5 and C-6) are a mixture of sand/gravel/cobble (Photos C5-1 and C6-3) and reflect the dominance of riverine processes. However, despite the influence of riverine processes within the lower assessment units we find throughout sub-watershed C that the channel is dominated by sand, cobbles and bedrock with very little difference between the "riparian" and upland vegetation. Furthermore, at all assessment units we observed that rooted upland plants occurred, with varying degrees of density, throughout the stream channel. The weight of evidence clearly indicates that sub-watershed C is an ephemeral channel that flows only in direct response to significant rainfall events.</p>

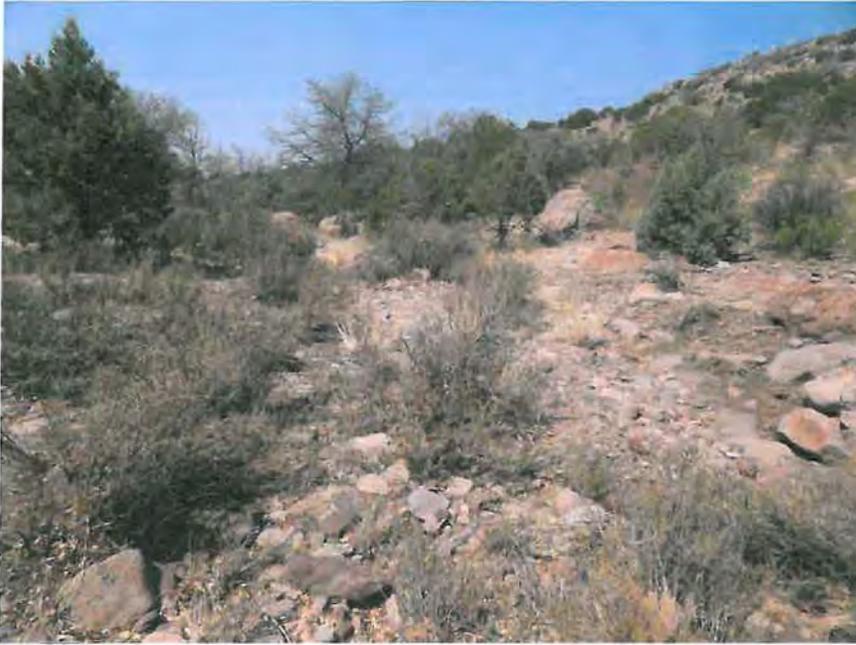
C19-1: Photographic reference to representative channel bottom characteristics.

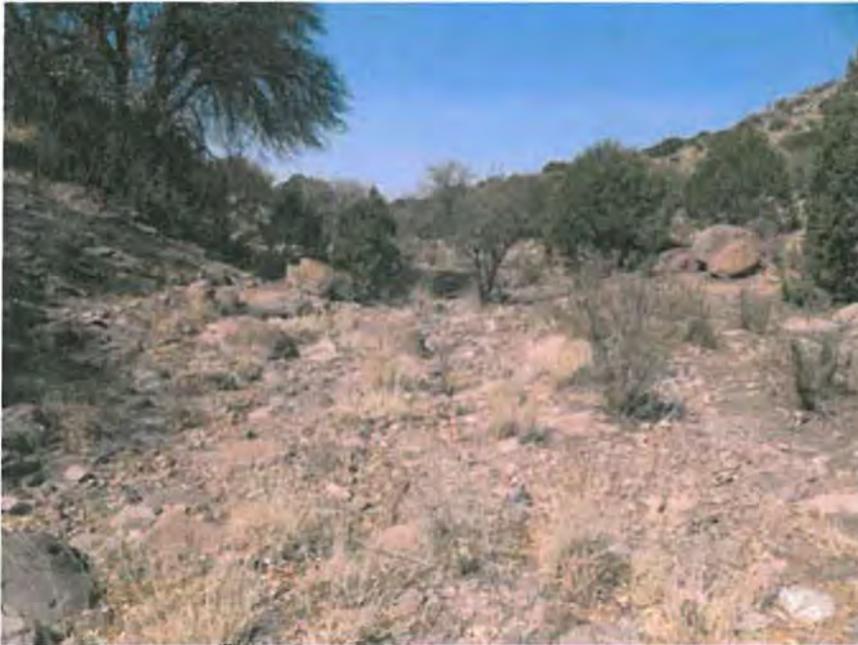
C19-2: Photographic reference for indicators 1.1 through 1.6. Photograph from upper extent of survey reach facing downstream. Rooted vegetation present in channel is present but inconsistent (see subsequent photograph). No water or biotic indicators of water observed along survey reach.

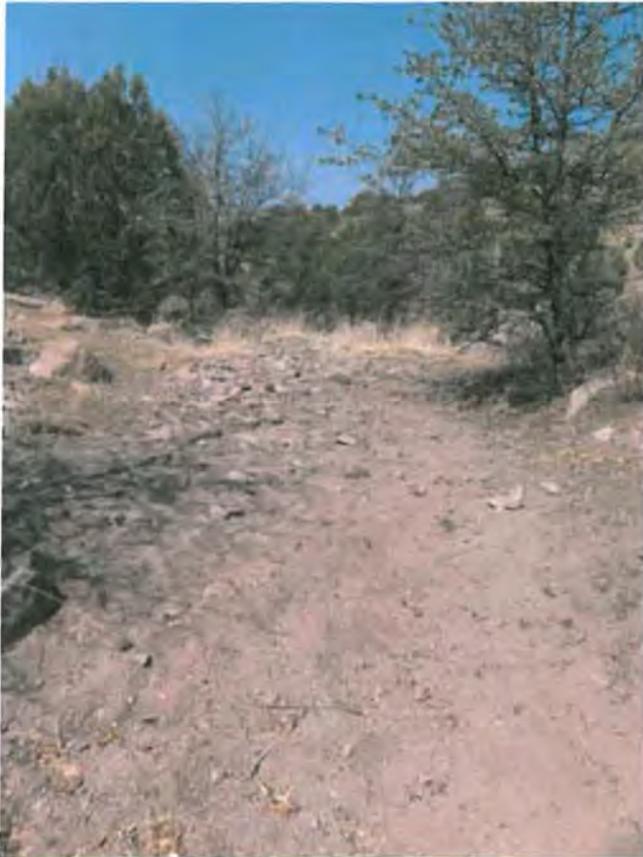
C19-3: Photographic reference for indicator 1.6. Portions of the survey reach devoid of vegetation as a result of bed material and lack of moisture rather than an indicator of persistence of flow. Indicator 1.6 scored as 1 – few rooted plants present in streambed.

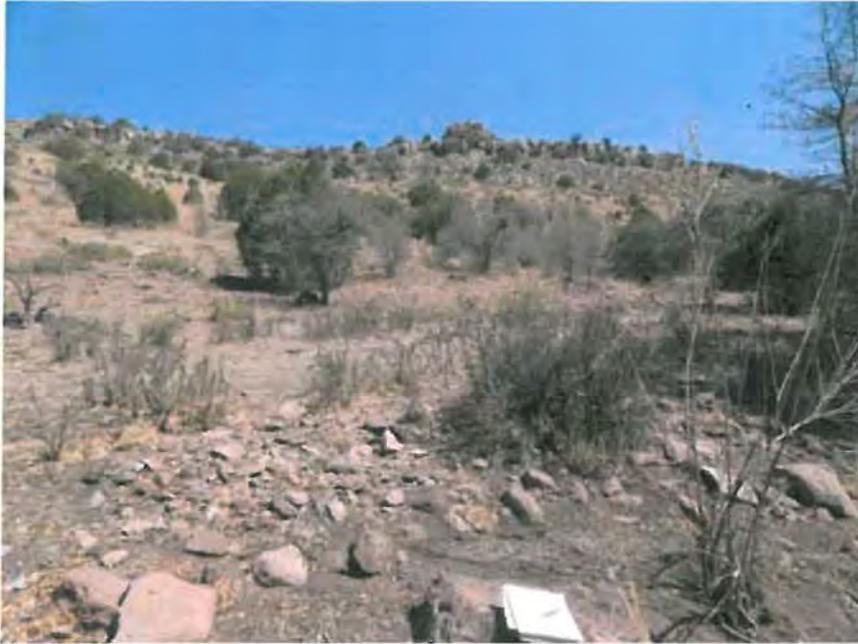
C19-4: Photographic reference for indicator 1.5. Photograph of upland area and upland vegetation. Indicator 1.5 scored as 1 - evident variation in vegetative density but no dramatic difference in composition. No distinct riparian zone observed.

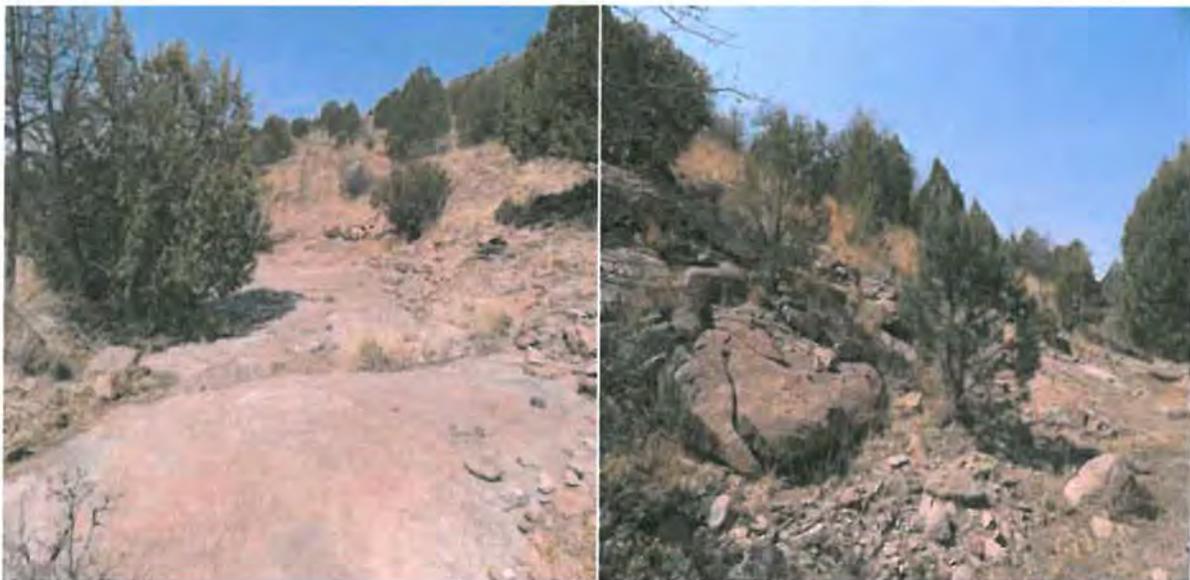
C19-5: Photographic reference for indicators 1.5 and 1.6. There is a variation in vegetative density but no dramatic difference in composition. Portions of the survey reach few rooted plants present in streambed as a result of bed rock in channel.

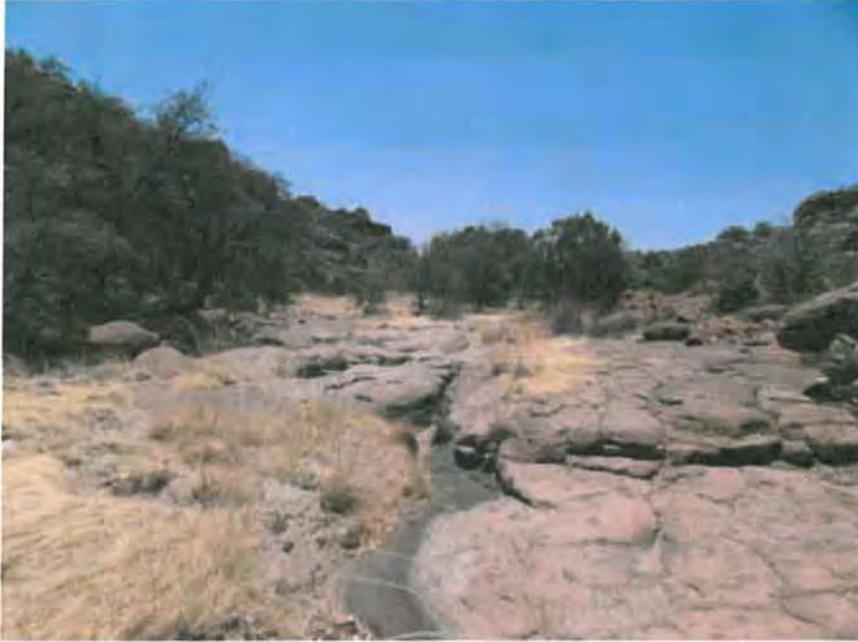
C4-1: Photographic reference for indicator 1.1 to 1.6. Streambed is predominantly bedrock. Vegetation present where deposition has occurred. No water or biotic indicators of water observed along survey reach.

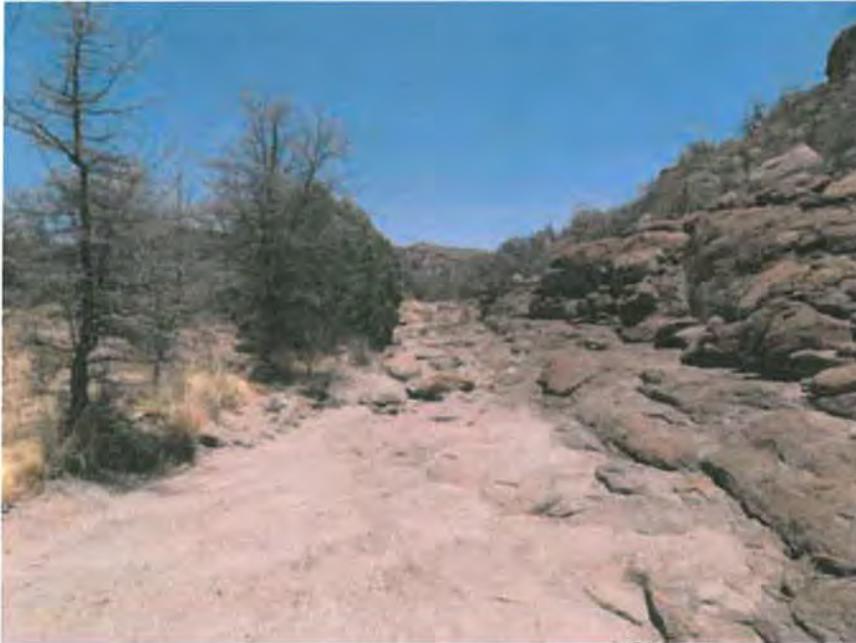
C4-2: Photographic reference for indicator 1.6. Indicator 1.6 scored as 2 – few rooted upland plants present in streambed. Lack of vegetation present in streambed likely result of flow regime and presence of bedrock rather than result of persistent water.

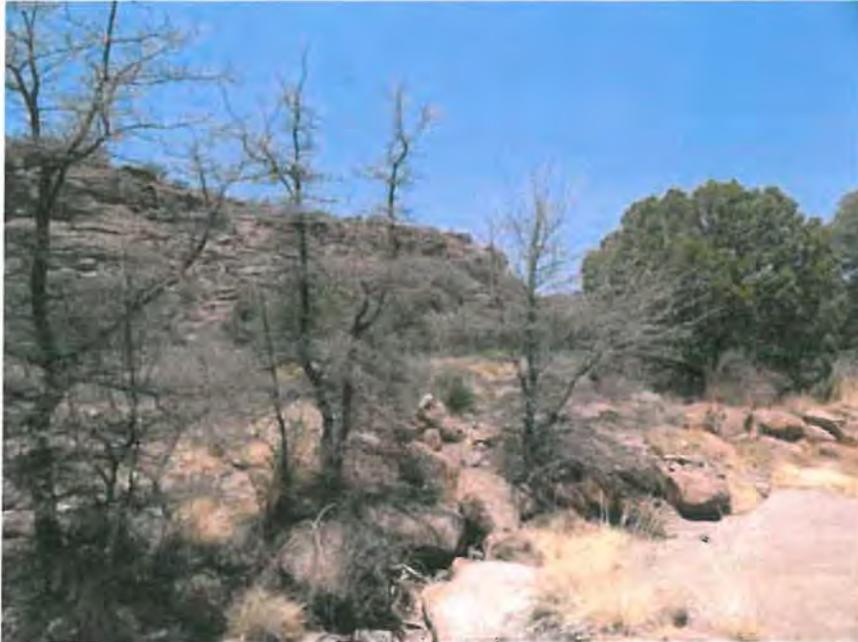
C4-3: Photographic reference for indicator 1.5. Photograph of bank and upland vegetation. Indicator 1.5 scored as 1 - evident variation in vegetative density but no dramatic difference in composition. No distinct riparian zone observed.

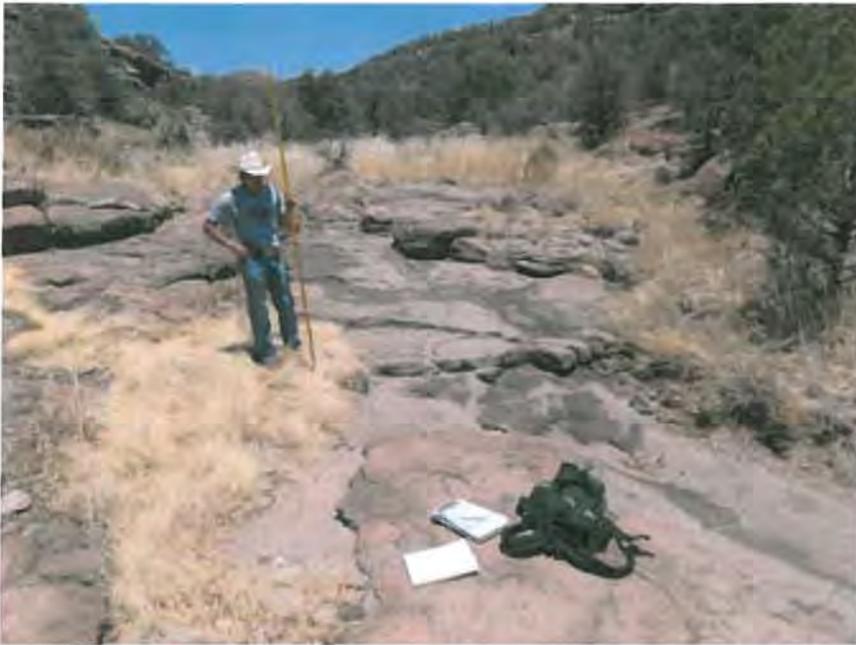
C4-4: Photographic reference for indicators 1.8 through 1.10. Photograph of the entrenchment transect location. Indicator 1.8 scored as 1.5 - stream is somewhat confined with an inactive floodplain.

Indicator 1.9 scored as 0 - no riffle-pool sequence observed (also refer to other photos).

Indicator 1.10 scored as 1.5 - particle sizes within the channel are similar to upland material but are noticeably larger (primarily sands and gravels where bedrock is not present).

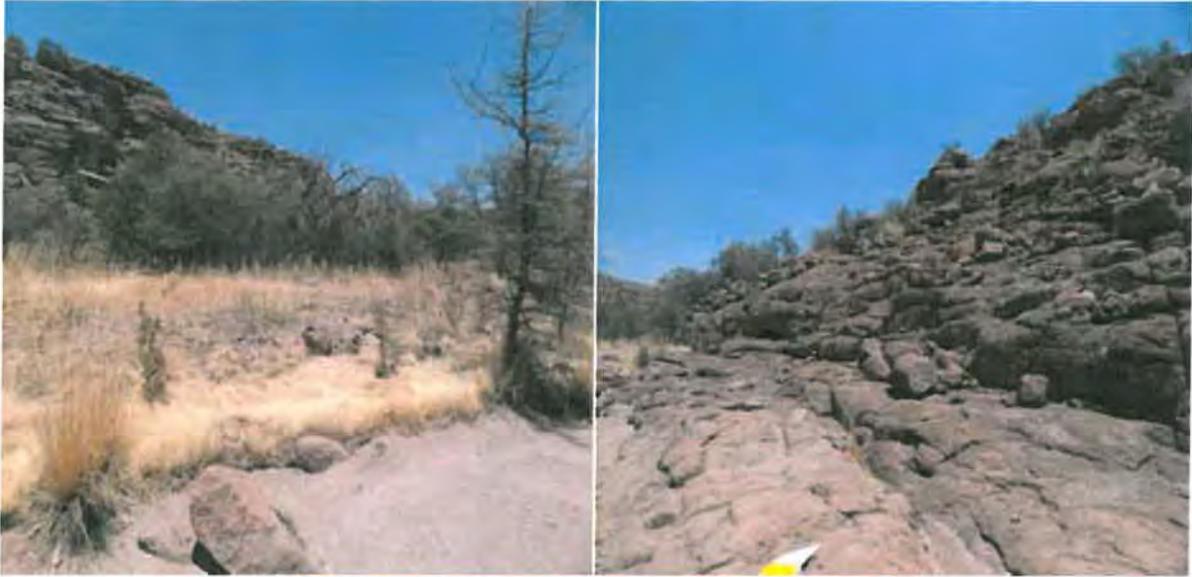
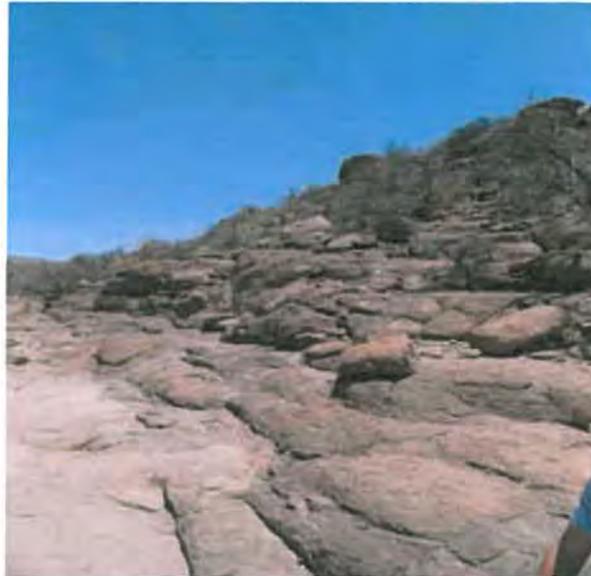
C4-5: Photographic reference for indicator 1.5. Photographs of bank and upland vegetation. Evident variation in vegetative density but no dramatic difference in composition. There is no distinct riparian vegetation corridor.

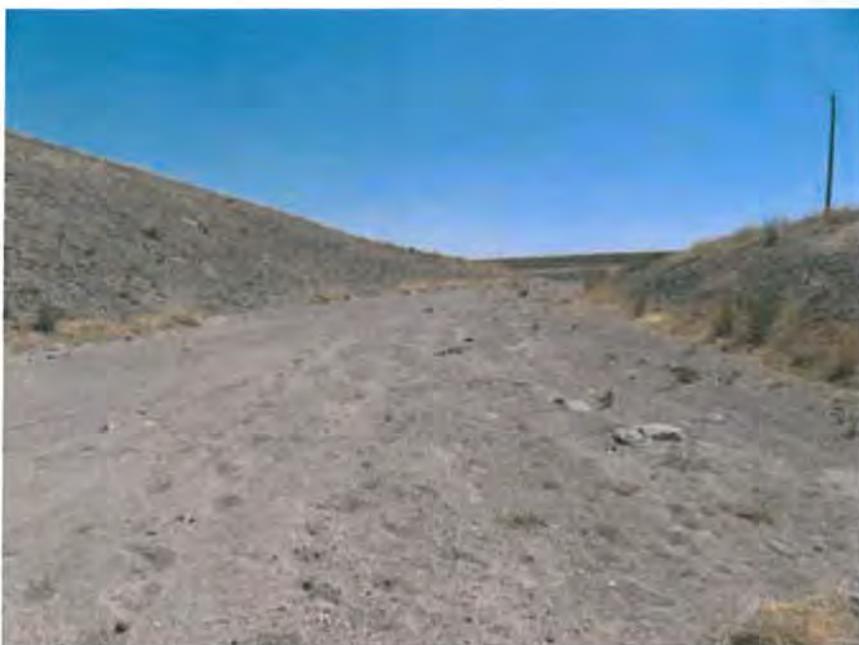
C5-1: Photographic reference for indicators 1.1 through 1.6. Indicator 1.6 scored as 2 – few rooted plants in the streambed. Lack of rooted plants is likely the result of the flow regime and granular bed material present rather than persistence of flow. No water or biotic indicators of water observed.

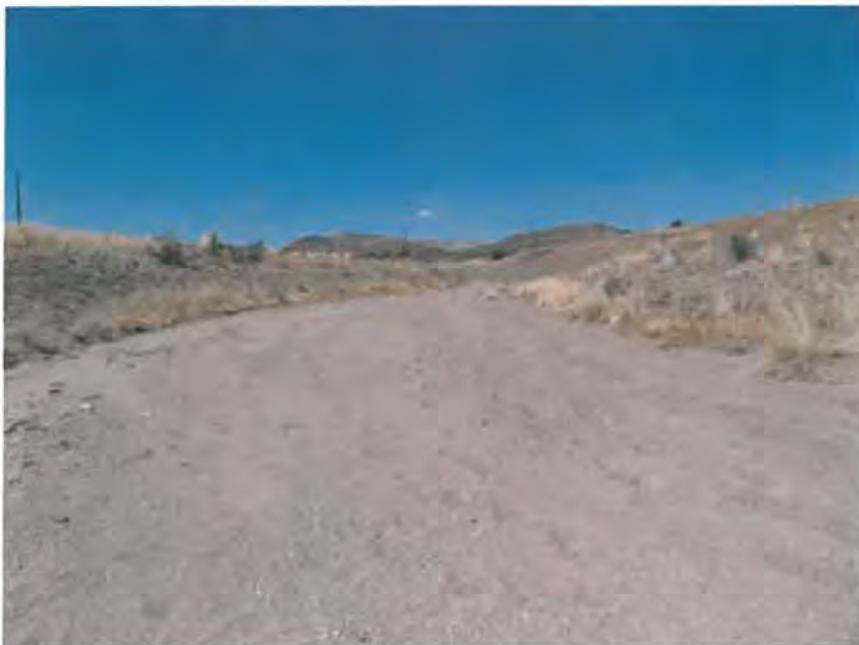
C5-2: Photographic reference for indicator 1.5. Indicator 1.5 scored as 0. Vegetation along streambank and uplands is sparse but consistent with no compositional or density differences between the two areas observed. Also refer to previous photograph.

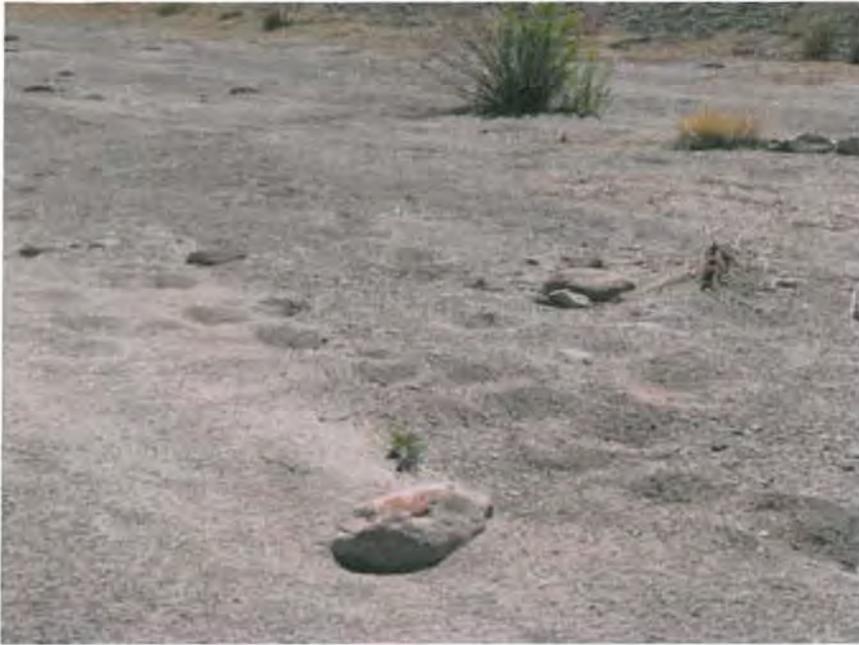
C5-3: Photographic reference for indicator 1.6. Few rooted plants in the streambed: Lack of rooted plants is likely the result of granular bed material present.

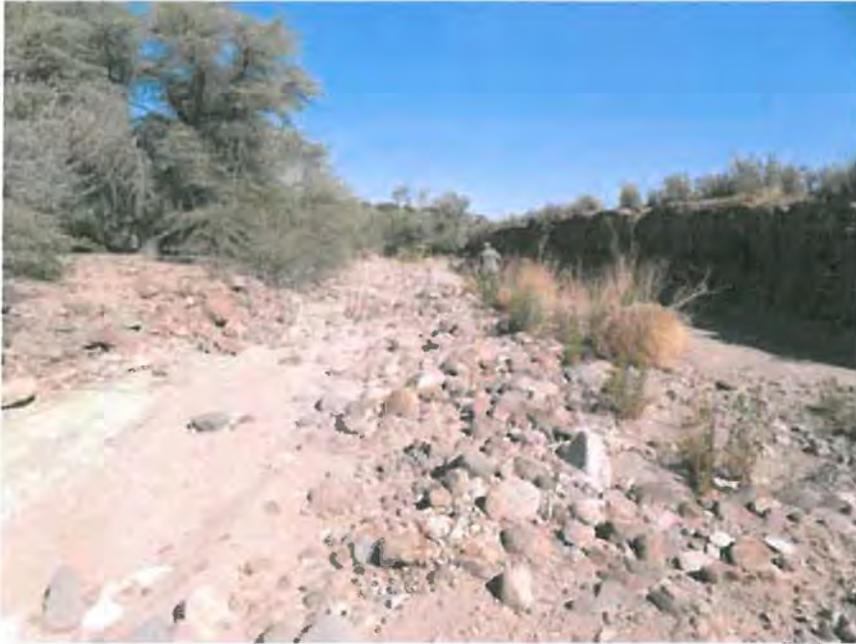
C6-1: Photographic reference for indicators 1.1 through 1.6. Indicator 1.6 scored as 2. Few rooted plants present in the streambed but inconsistently present. Lack of rooted plants is likely the result of the flow regime and granular bed material present rather than persistence of flow. No water or biotic indicators of water observed along survey reach.

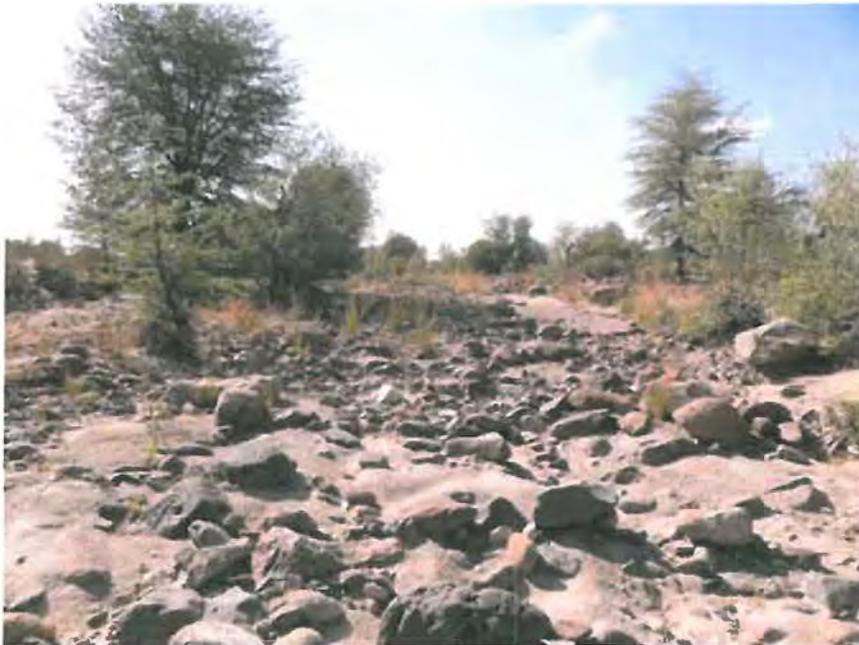
C6-2: Photographic reference for indicator 1.5. Indicator 1.5 scored as 1 - evident variation in vegetative density but no dramatic difference in composition. No distinct riparian zone observed.

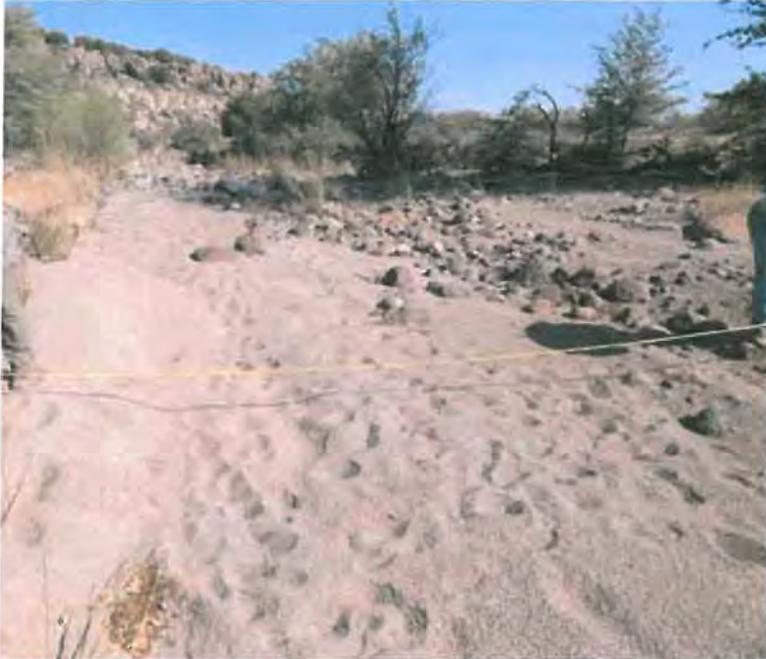
C6-3: Photographic reference for indicator 1.8. Location of transect shown. Indicator 1.8 scored as 1.5. Stream is somewhat confined with an inactive floodplain.

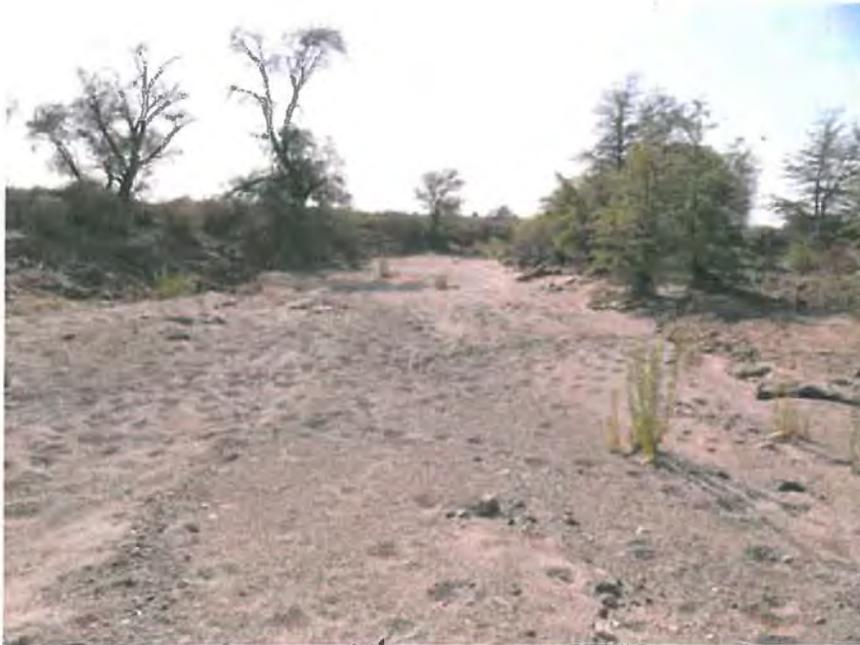
C6-4: Photographic reference for indicator 1.9 and 1.10. Indicator 1.9 scored as 0 - riffle-pool sequence not observable along survey reach. Indicator 1.10 scored as 1.5 - particle sizes of the channel bed material is primarily coarse sand and gravel which is similar to but coarser than the material of the upland area. Substrate sorting not evident.

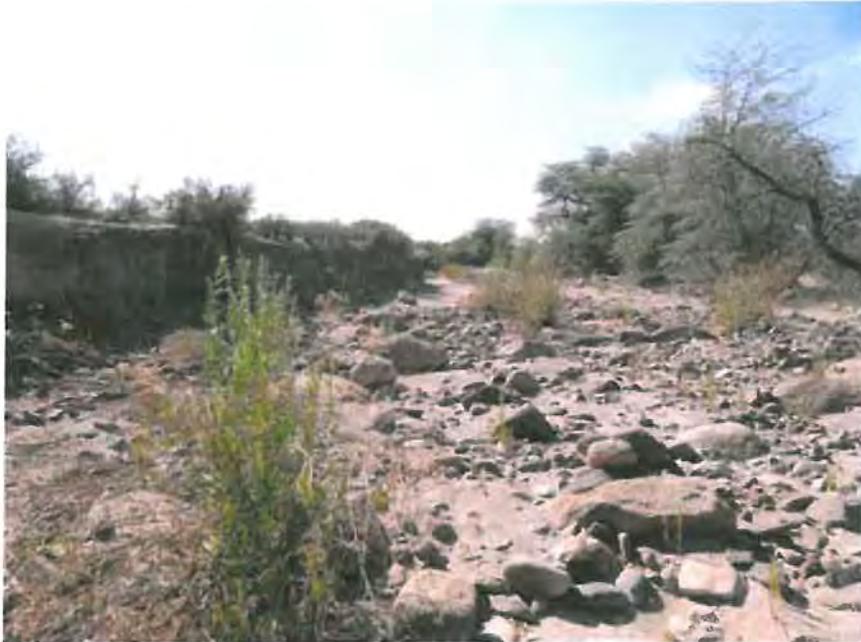
C6-5: Photographic reference for indicator 1.6. Few rooted plants present in the streambed but inconsistently present. Lack of rooted plants is likely the result of granular bed material present.
