Appendix D

Level 1 Hydrology Protocol Results
for D Drainage

Cover Sheet
Hydrology Protocol Use Attainability Analysis
for an Ephemeral Stream¹

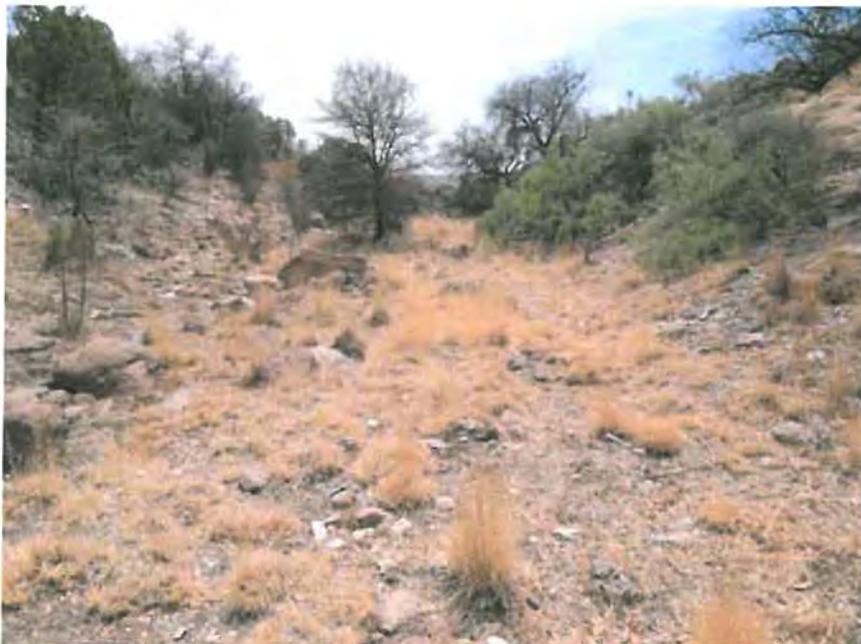
D1-1: Photographic reference of representative channel bottom characteristics. Note large boulders and cobbles in stream channel, similar to those observed on hillside.

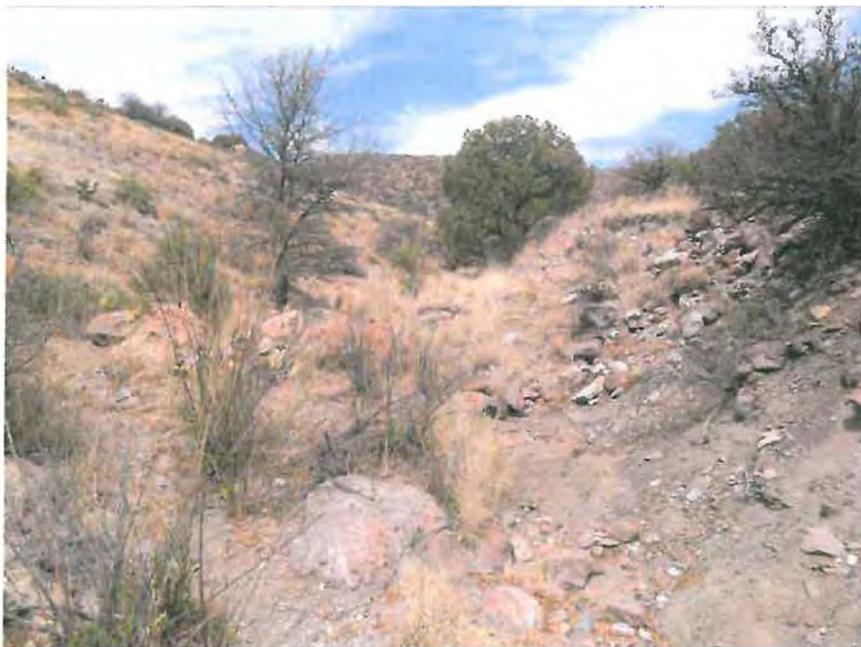
D1-2: Photographic reference of representative channel bottom characteristics. Note large boulders and cobbles in stream channel, similar to those observed on hillside.

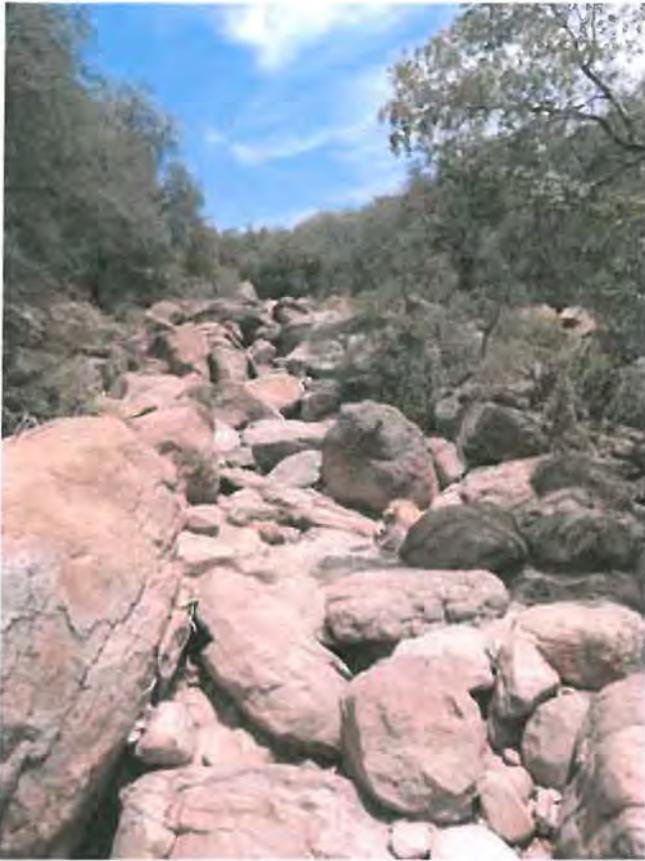
D2-3: Photographic reference for indicators 1.1 through 1.6. Indicator 1.6 scored as 2 – few rooted plants present in the streambed. Lack of instream vegetation most likely a result of the bed material present (boulders) rather than an indicator of flow persistence. No water or biotic indicators of water observed along survey reach.

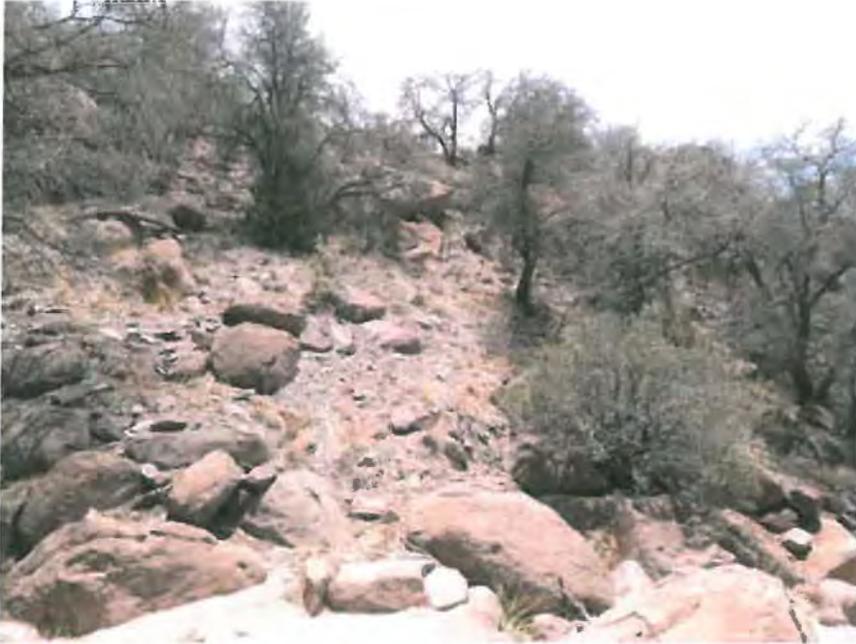
D2-4: Photographic reference for indicator 1.5. Photograph of bank vegetation (also observable in previous photograph) and the upland vegetation. Indicator 1.5 scored as 0. No vegetative compositional or density differences observed between the banks and the upland area.

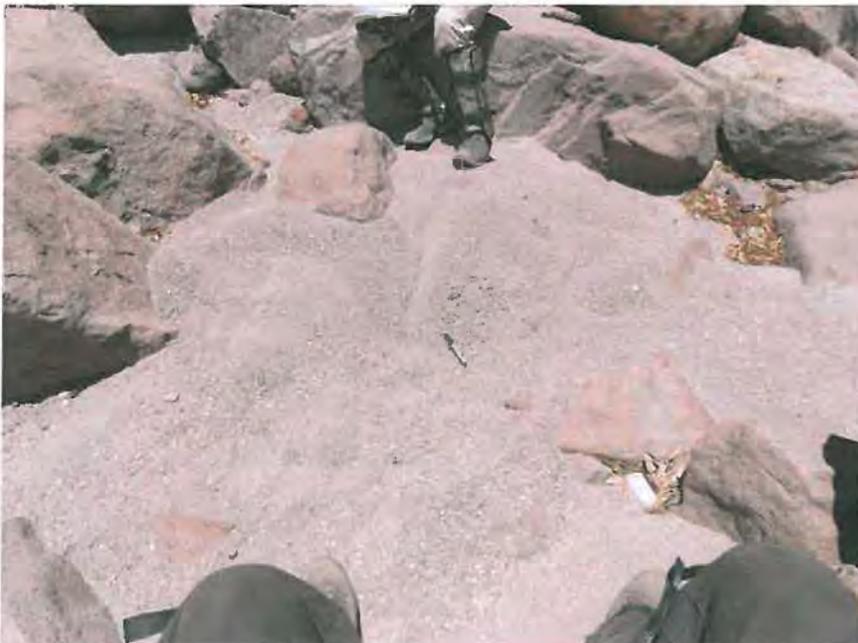
D2-5: Photographic reference for indicator 1.6. Lack of in-stream vegetation indicative of coarse mineral sediments and complete lack of moisture. Assessment unit representative of channel bottom characteristics. Note dry material sand sediments within channel.

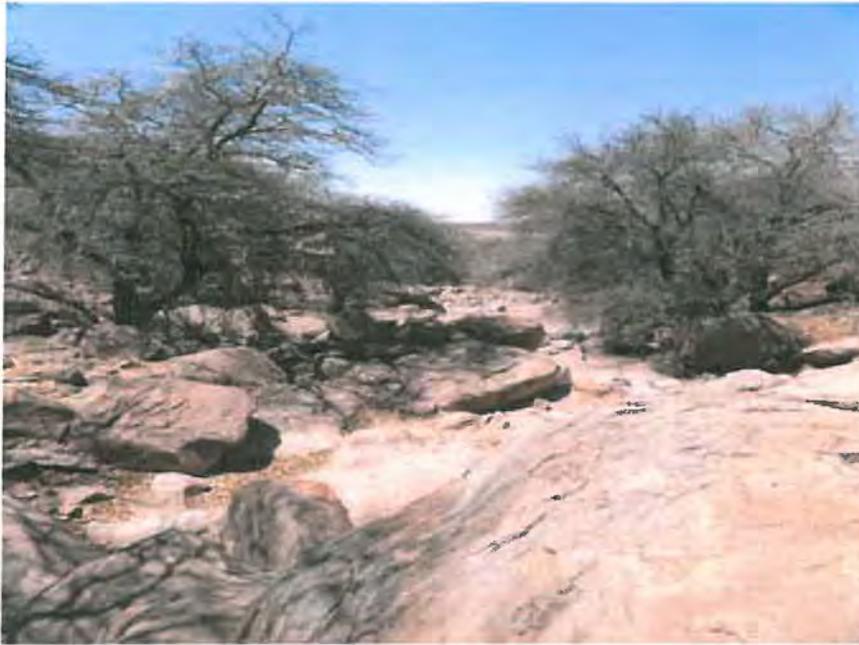
D3-1: Photographic reference of representative channel bottom characteristics. Note large boulders and cobbles in stream channel, similar to those observed on hillside. Note confining nature of hillside.

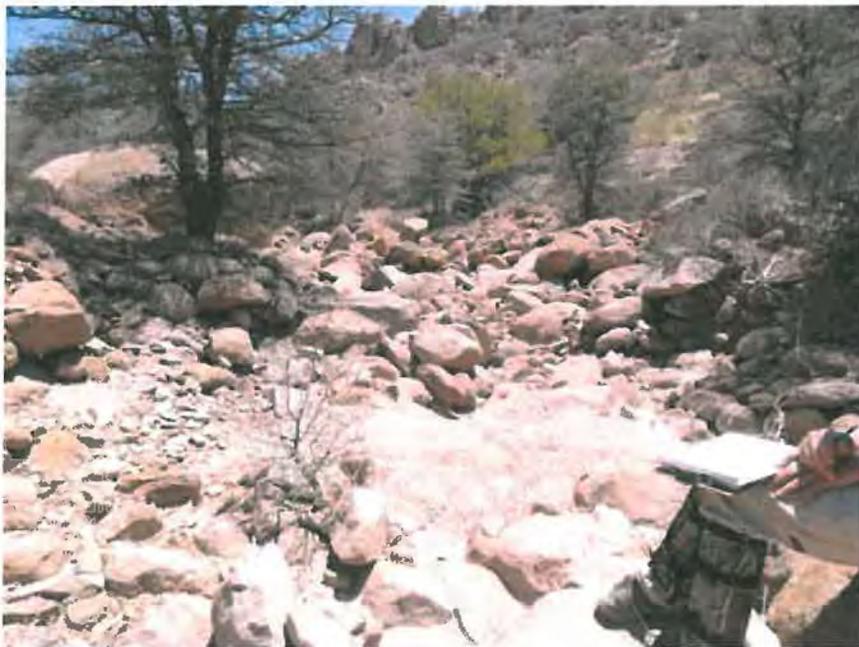
D3-2: Photographic reference for indicator 1.1 through 1.6. Photograph of stream bed. Indicator 1.6 scored as 2 – few rooted plants present in the streambed. Lack of instream vegetation most likely a result of the bed material present (boulders) rather than an indicator of flow persistence. No water or biotic indicators of water observed along survey reach.

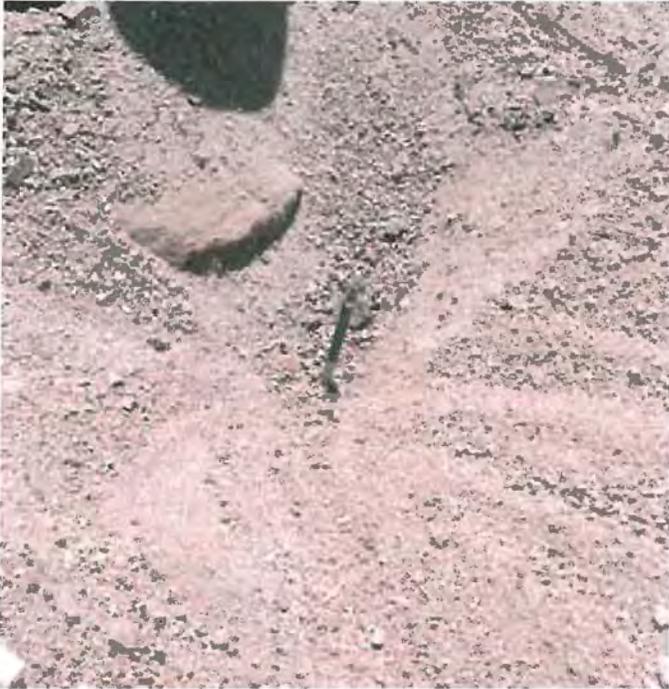
D3-3: Photographic reference for indicator 1.6. Photograph of 7 inch hole excavated in-channel. There is a complete lack of soil structure and moisture. Assessment unit is representative of channel bottom characteristics. Note dry mineral, sand sediments within channel.

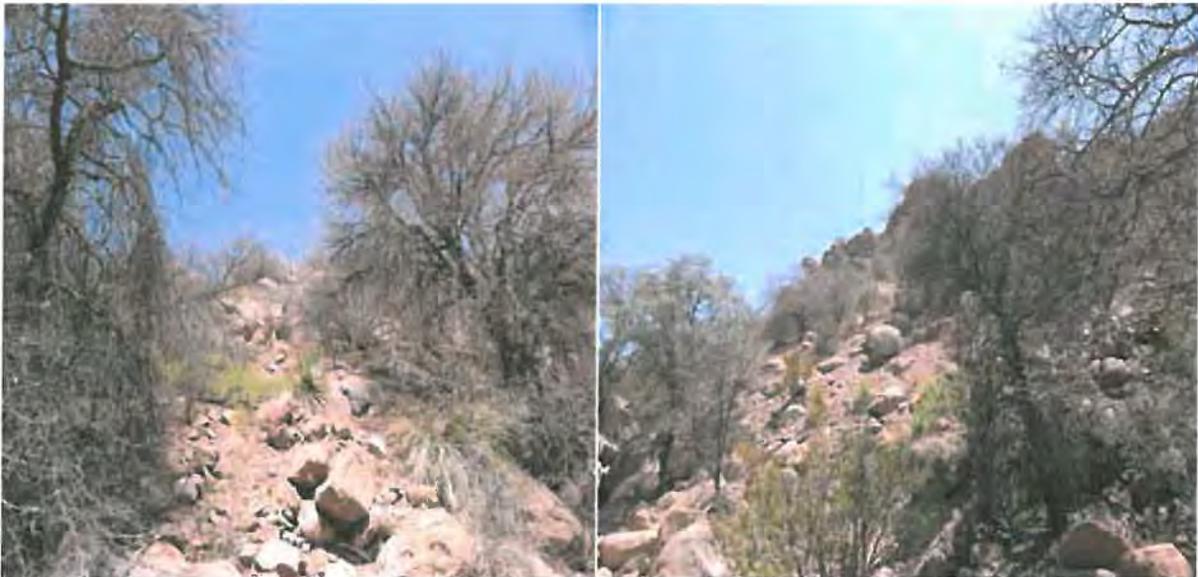
D3-4: Photographic reference for indicator 1.5. Photographs of stream bank and upland vegetation. Indicator 1.5 scored as 0. No vegetative compositional or density differences observed between the banks and the upland area.
