Appendix E

Level 1 Hydrology Protocol Results
for E Drainage

Cover Sheet
Hydrology Protocol Use Attainability Analysis
for an Ephemeral Stream¹

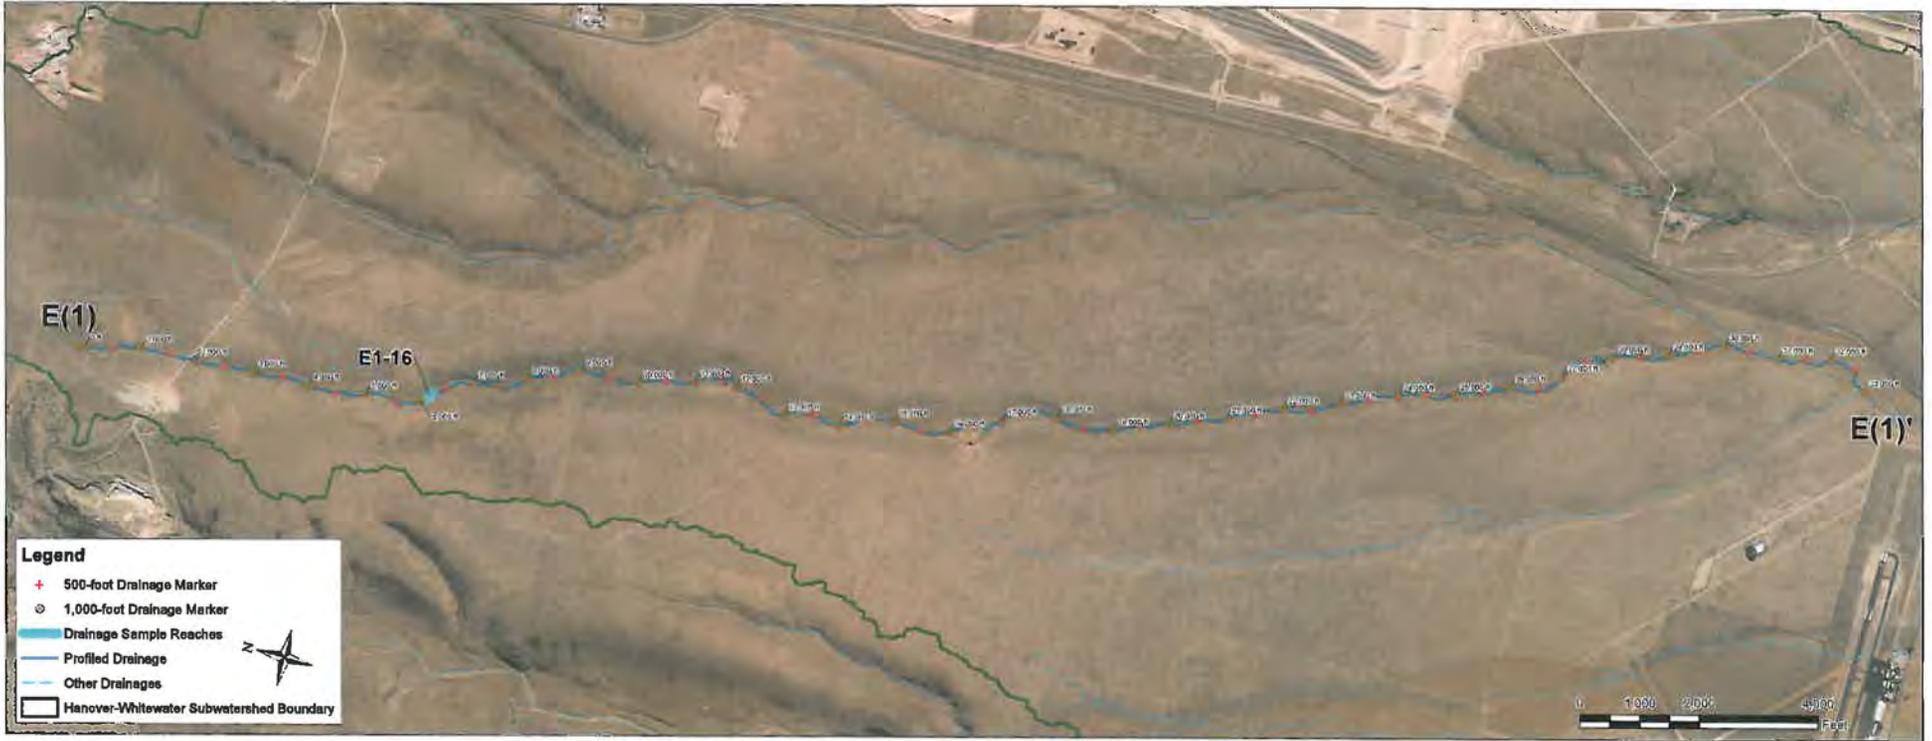
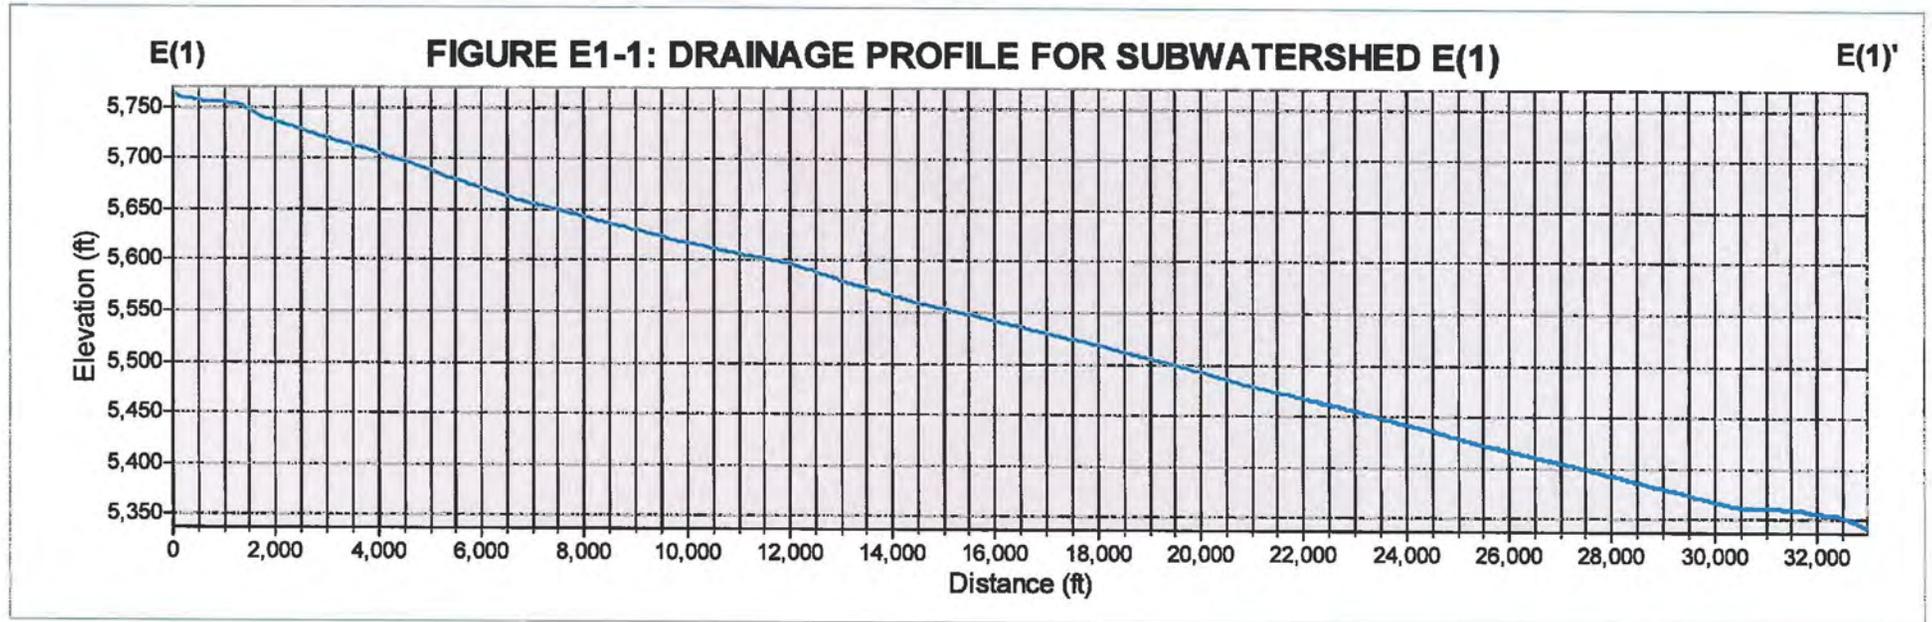
Additional Comments:
A single assessment unit (E1-16) was identified within sub-watershed E1 (Figure E-1 below). As shown in the plan and profile plots presented below (Figure E-1) both the basin slope (approximately 1%) and degree of valley confinement is relatively constant along its entire length. The constant valley slope and complete lack of compositional or density differences between the stream banks and uplands (Photos E1-1 and E1-2) suggest that fluvial processes, including sediment sorting and channel construction, are extremely rare within sub-watershed E1 and that this drainage is appropriately classified as an ephemeral channel.

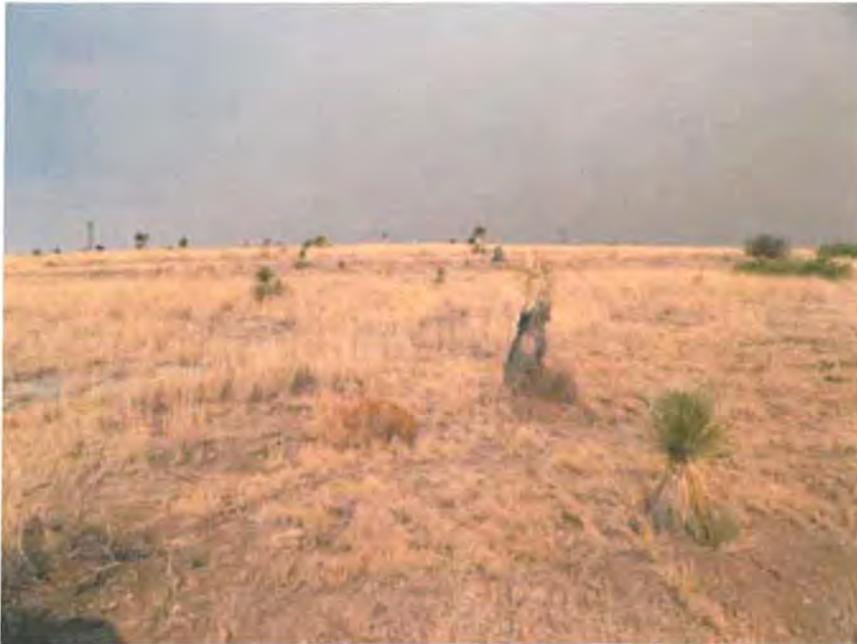
E1-3: Photographic reference for indicator 1.5. Photograph of the stream bank and upland areas. Indicator 1.5 scored as 0 - no vegetative compositional or density differences observed between the banks and the upland area.

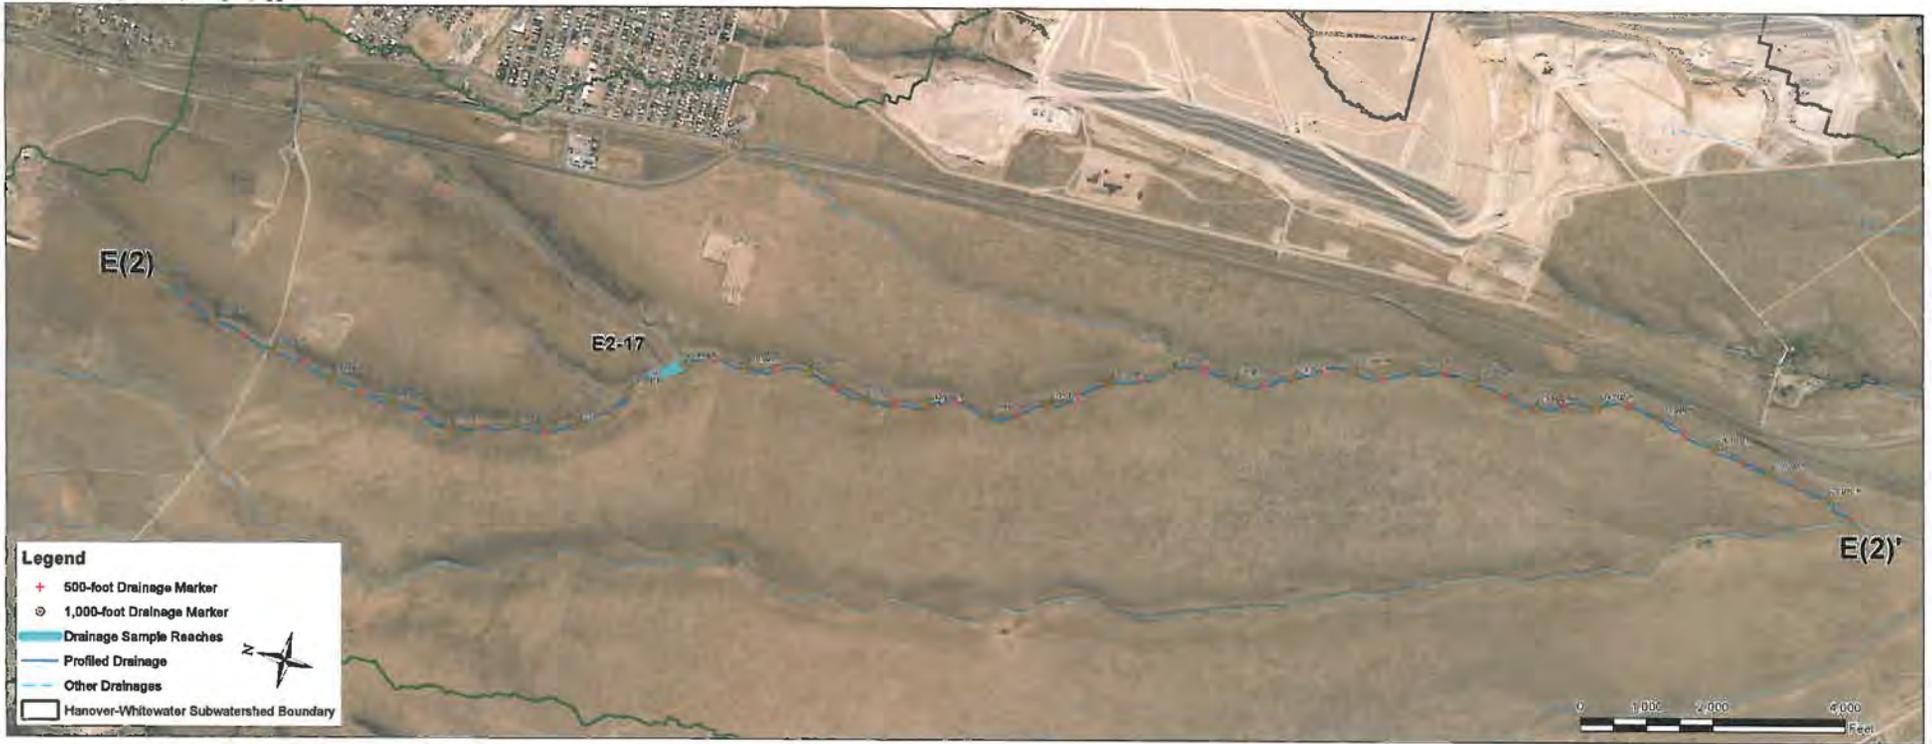
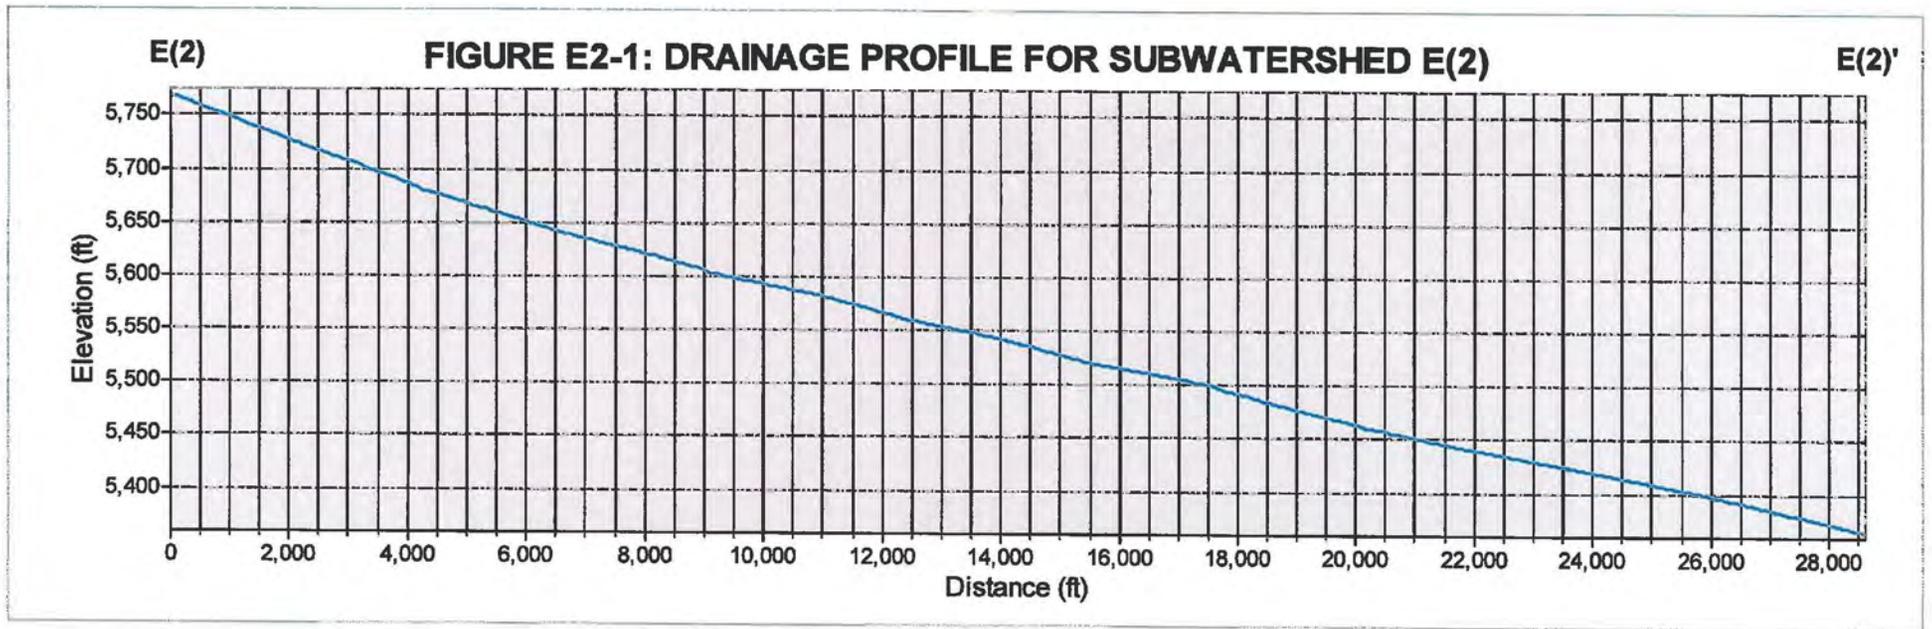
Similar to sub-watershed E1, a single assessment unit (E2-17) was identified within sub-watershed E2 (Figure E2-1). As shown in the plan and profile plots presented below (Figure E2-1) both the basin slope (approximately 1.5%) and degree of valley confinement is relatively constant along its entire length. Unlike sub-watersheds E1 and E3, a distinct channel bed can be observed within this assessment unit (Photo E2-1), however, no distinct compositional or density difference was observed between the stream bank and upland vegetation characteristics (Photos E2-1 and E2-2) and rooted vegetation was observed consistently within the channel bottom throughout this assessment unit (Photos E2-3 and E2-4). Based on the observed characteristics of this representative assessment unit, fluvial processes within sub-watershed E2 occur in direct response to rainfall events with enough frequency to have constructed a definable channel bottom and banks but without the necessary duration or magnitude to maintain or construct a complex stream channel free of rooted vegetation. Sub-watershed E2 is appropriately classified as an ephemeral channel.

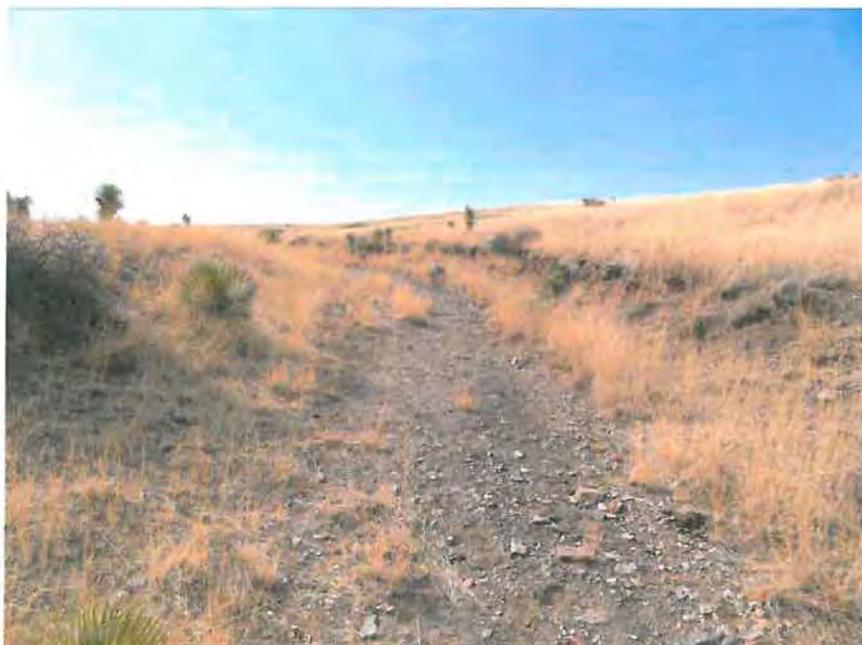
E2-2: Photographic reference of channel bed and bank.

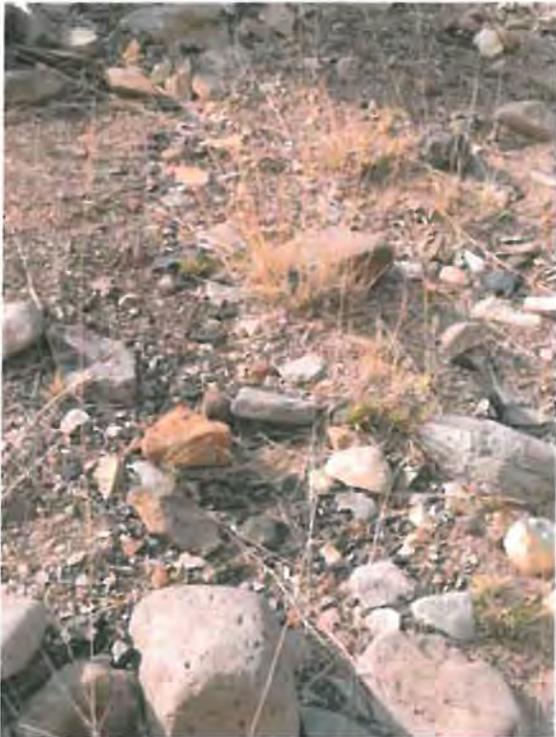
E2-4: Photographic reference for indicator 1.6. Indicator 1.6 scored as 1. Rooted upland plants (grasses) are present in the streambed and consistently dispersed but are not prevalent throughout the channel.

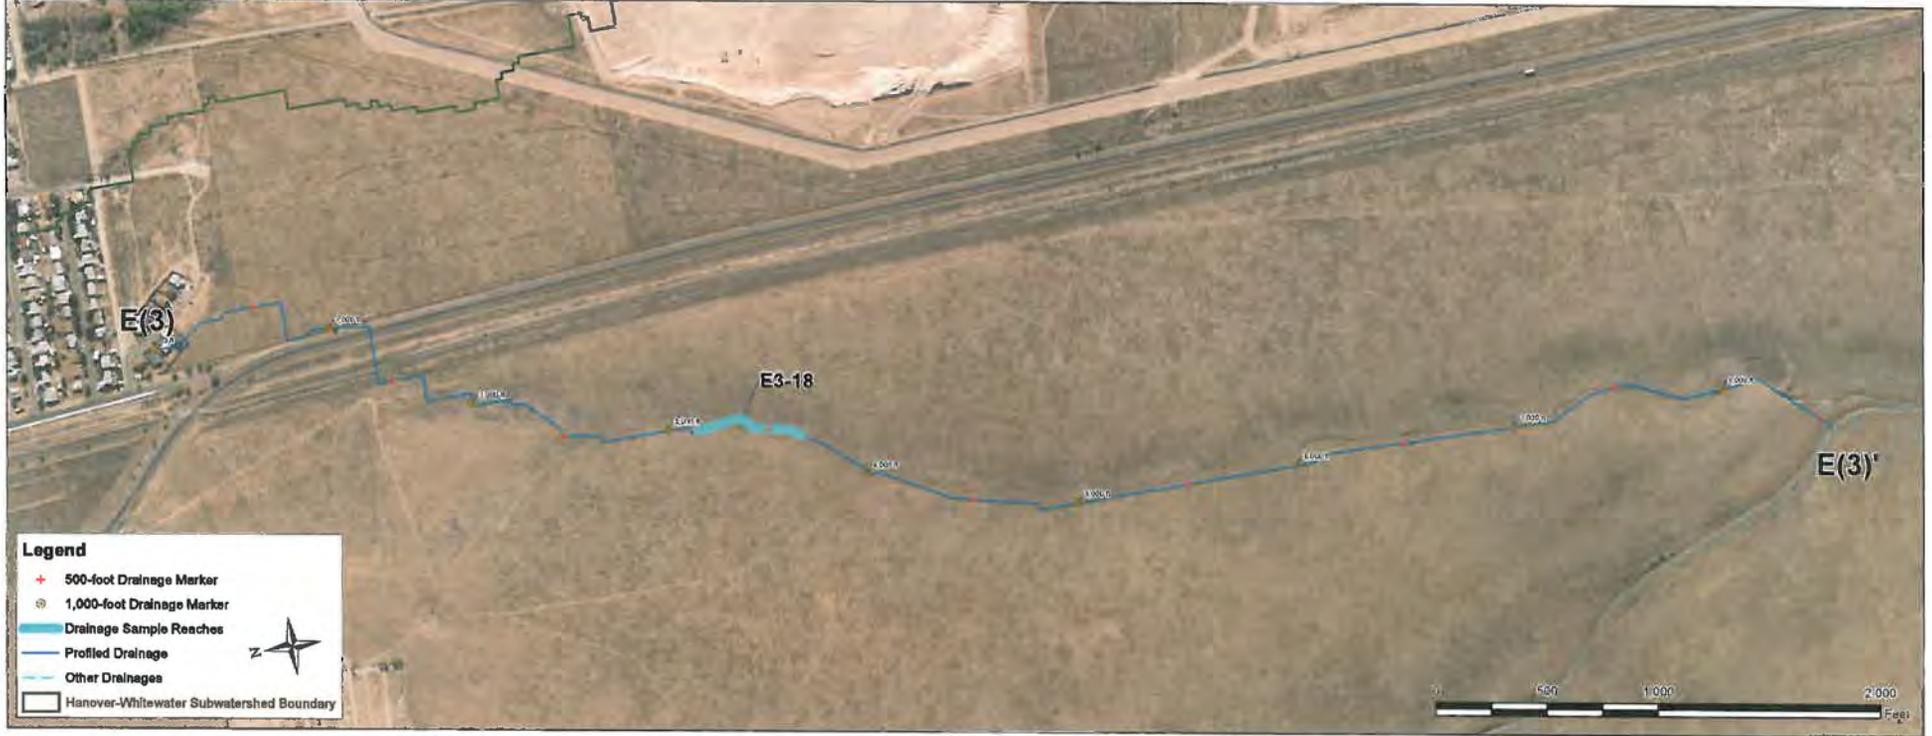
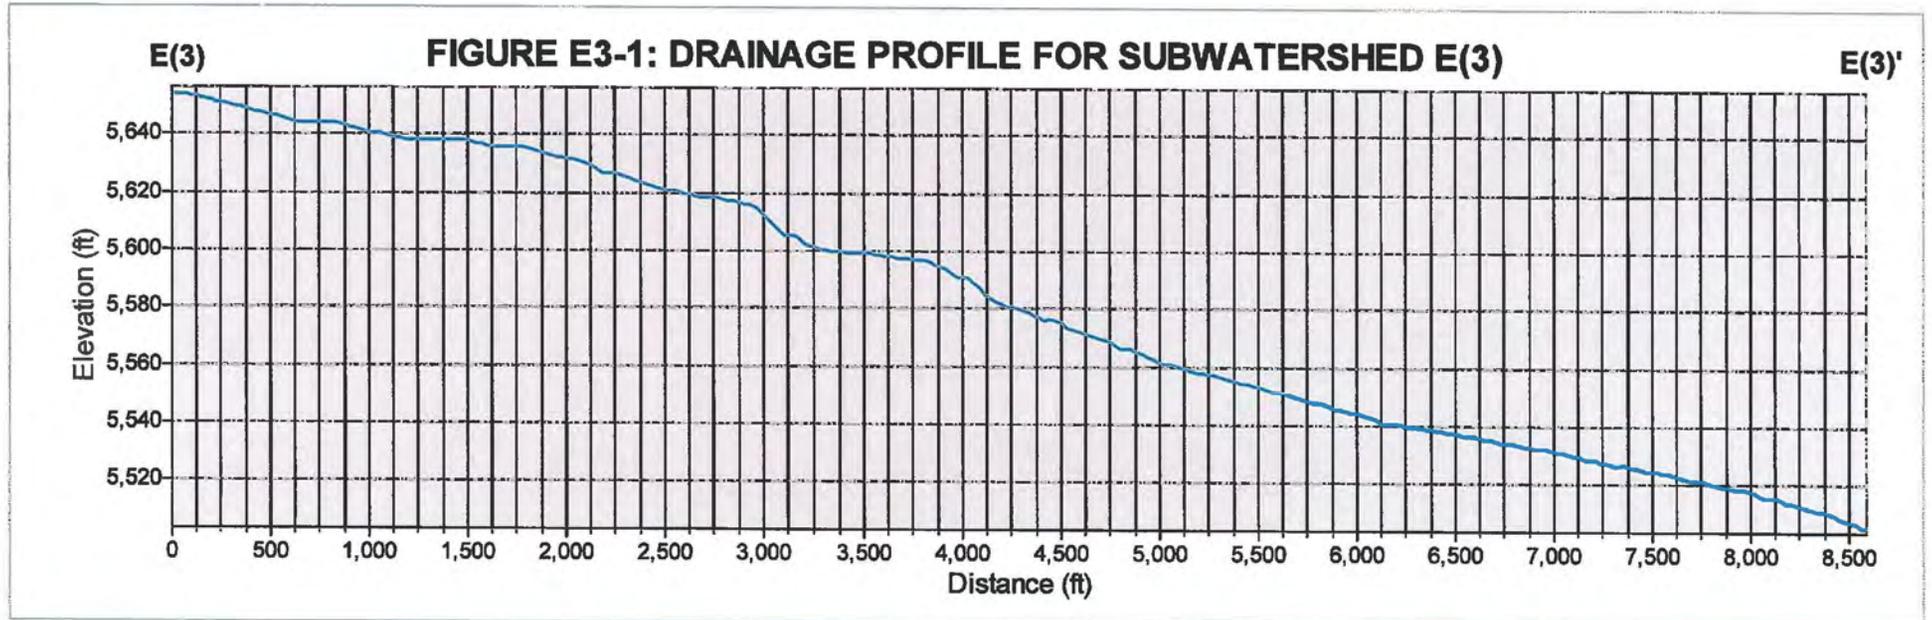
Additional Comments:
 A single assessment unit (E3-18) was identified within sub-watershed E3 (Figure E3-1). The longitudinal profile of sub-watershed E3 shows slightly more variation than either E1 or E2; however much of this variability is in response to impacts associated with the road crossing. Within this assessment unit no defined channel was observed with very little, if any, evidence of fluvial processes (Photos E3-1 and E3-2). This drainage is appropriately classified as an ephemeral channel.
