Appendix F

Level 1 Hydrology Protocol Results
for Martin Canyon Drainage

Cover Sheet
Hydrology Protocol Use Attainability Analysis
for an Ephemeral Stream¹

Martin Canyon Photographs (MC-11 Reach) – Total HP score of 2 (ephemeral stream)

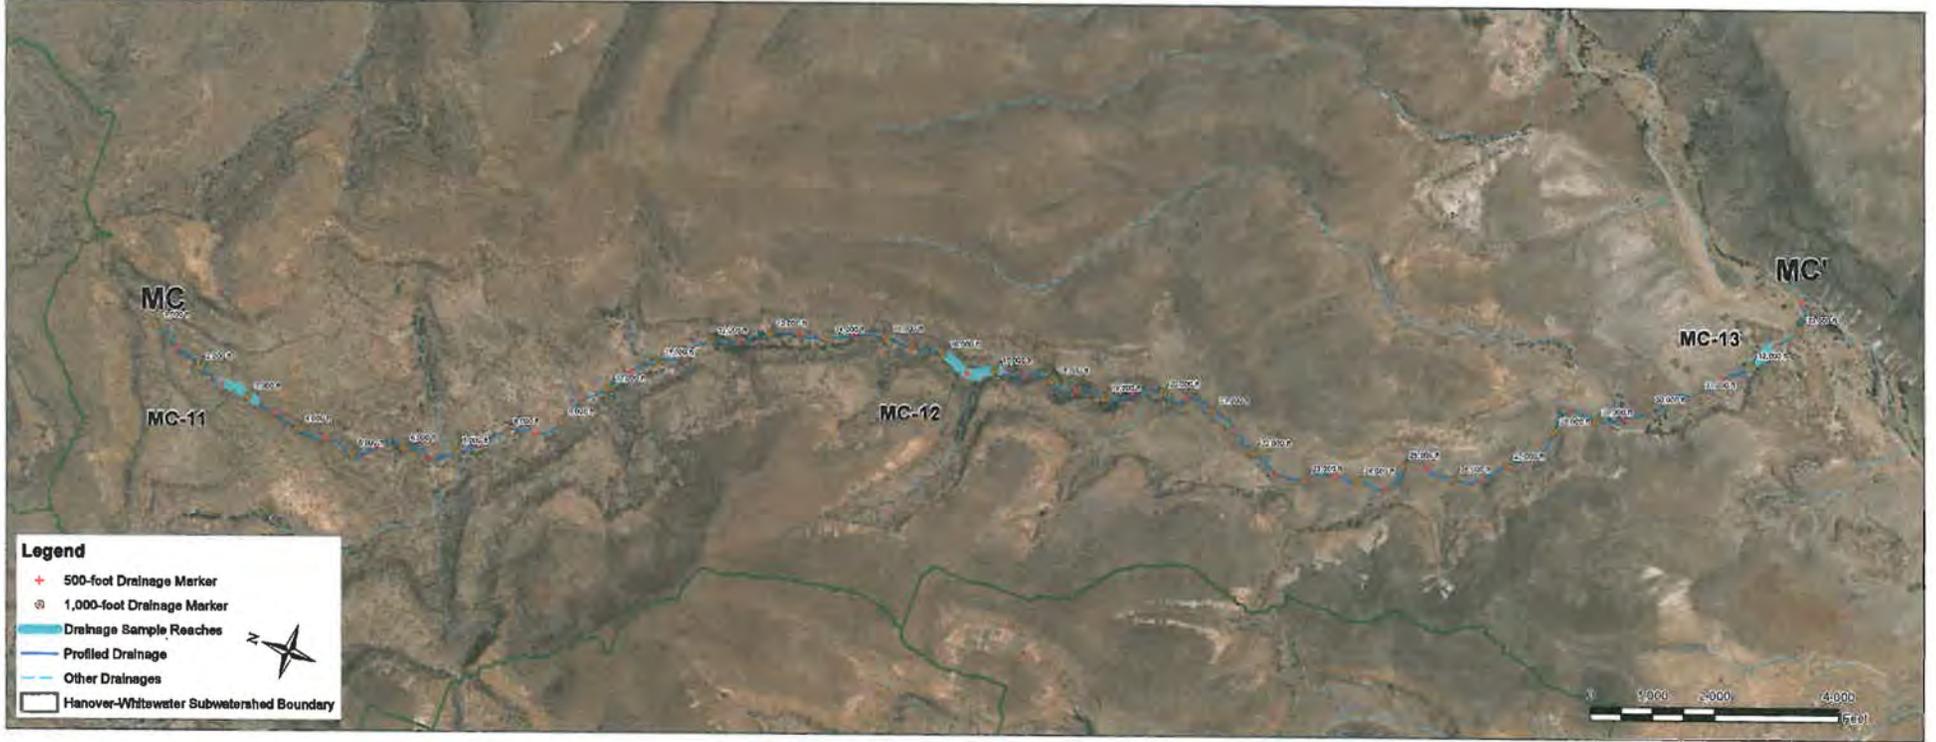
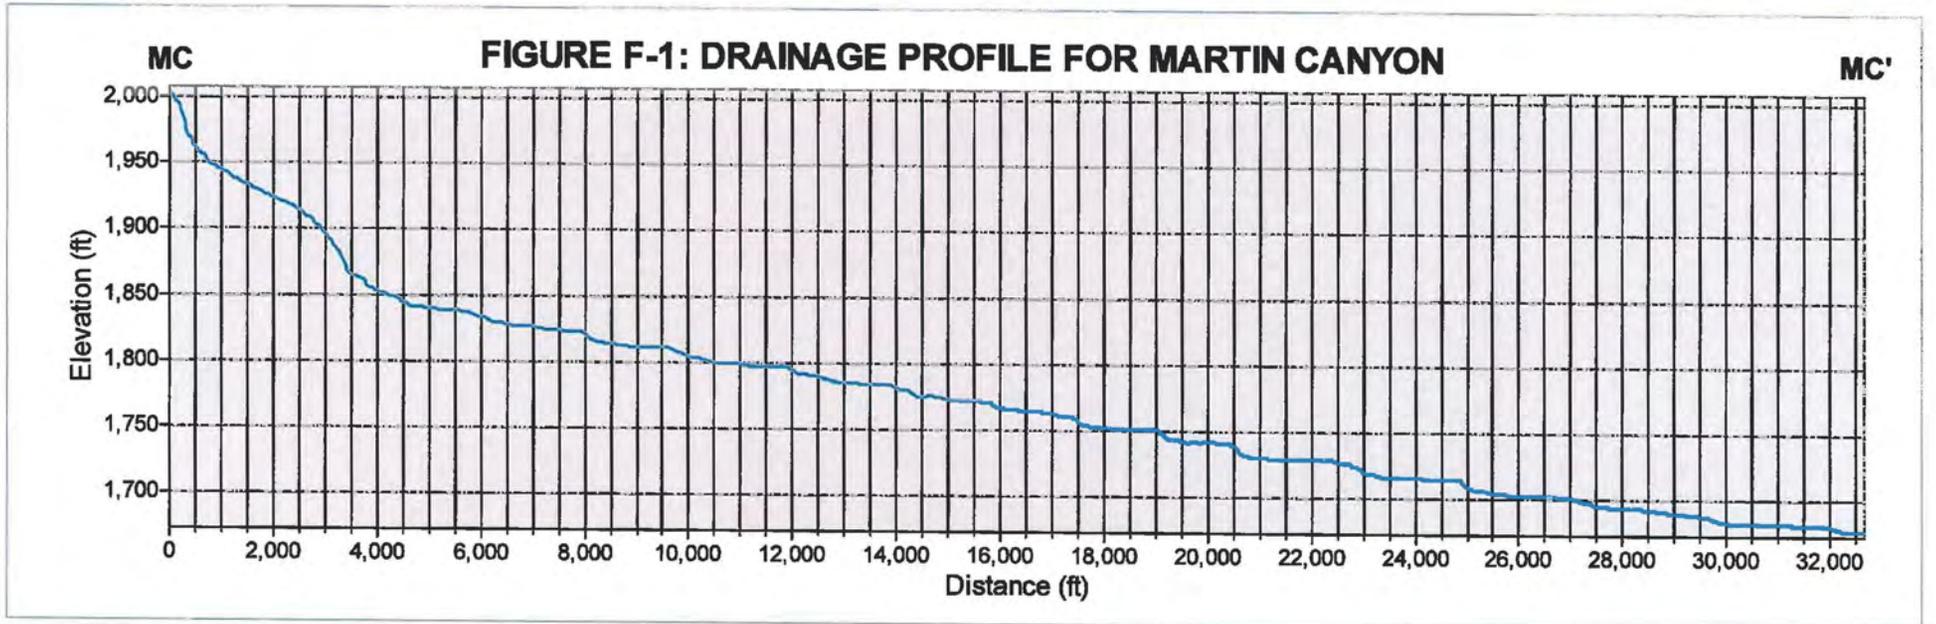
Additional Comments:
<p>Three assessment units were identified within the Martin Canyon sub-watershed (Figure F-1 below). Starting at the upstream end, these assessment units are identified as MC-11, MC-12 and MC-13. The most upstream assessment unit (MC-11) was selected to represent the headwater portions of this sub-watershed. Assessment unit (MC-12) was located in a flatter gradient section with more prominent vegetation. The lower downstream assessment unit (MC-12) was selected to capture the entire basin drainage area.</p> <p>As shown in the plan and profile plot presented below the basin slope progressively decreases, as expected, in the downstream direction. The upstream reaches of the Martin Canyon sub-watershed (MC-11) is a bedrock and cobble dominated stream channel (Photos MC11-1 and MC11-3) whereas the middle assessment unit (MC-12) is predominantly boulders, gravel, and sand (Photos MC12-1 and MC12-3) and the downstream assessment unit (MC-13) is a mixture of cobble and unconsolidated sand (Photos MC13-1 and MC13-3). The downstream assessment units reflect riverine processes. However, despite the influence of riverine processes within the lower assessment units seen throughout the Martin Canyon sub-watershed the channel is dominated by sand and cobble with very little difference between the "riparian" and upland vegetation. At all the assessment units we observed that rooted upland plants occurred, with varying degrees of density, throughout the stream channel. The weight of evidence clearly indicates that the Martin Canyon sub-watershed is an ephemeral channel that flows only in direct response to significant rainfall events.</p> <p>Based on comments received from NMED, Chiricahua Leopard Frog (CLF) tadpoles have been historically documented in pools along portions of the Martin Canyon drainage, although no official USFWS habitat designation has been made for any portion of Martin Canyon, and CLF frogs have not been documented in any portion of Martin Canyon during more recent surveys (Jennings, 2007). Evidence of pools were not observed during the Level 1 field evaluation; however, based on comments received from NMED regarding historic observations of CLF in Martin Canyon, a formal classification or re-classification of Martin Canyon is not currently proposed</p>

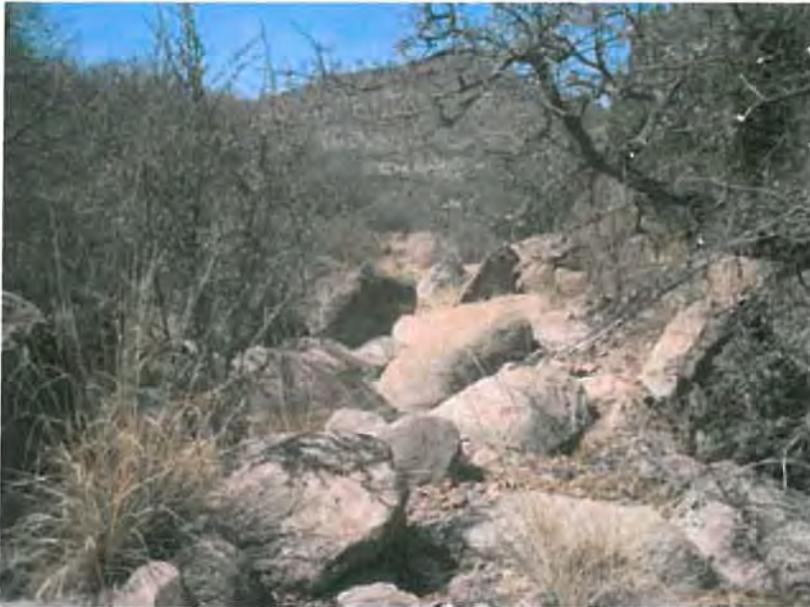
MC11-1: Photographic reference for indicators 1.1 through 1.6. Indicator 1.6 scored as 1. Vegetation in the channel bed is consistently dispersed throughout the streambed between the boulders and where deposition of finer grained material has occurred. No water or biotic indicators of water observed along survey reach.

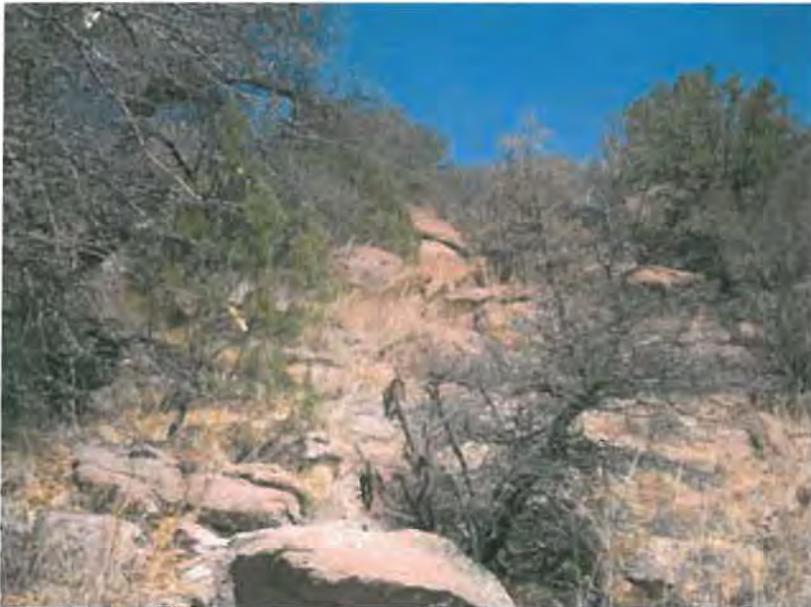
MC11-2: Photographic reference for indicator 1.5. Photograph of the bank and upland area. Indicator 1.5 scored as 1. Vegetation is similar in composition with some slight variation in density between the bank and the upland area.

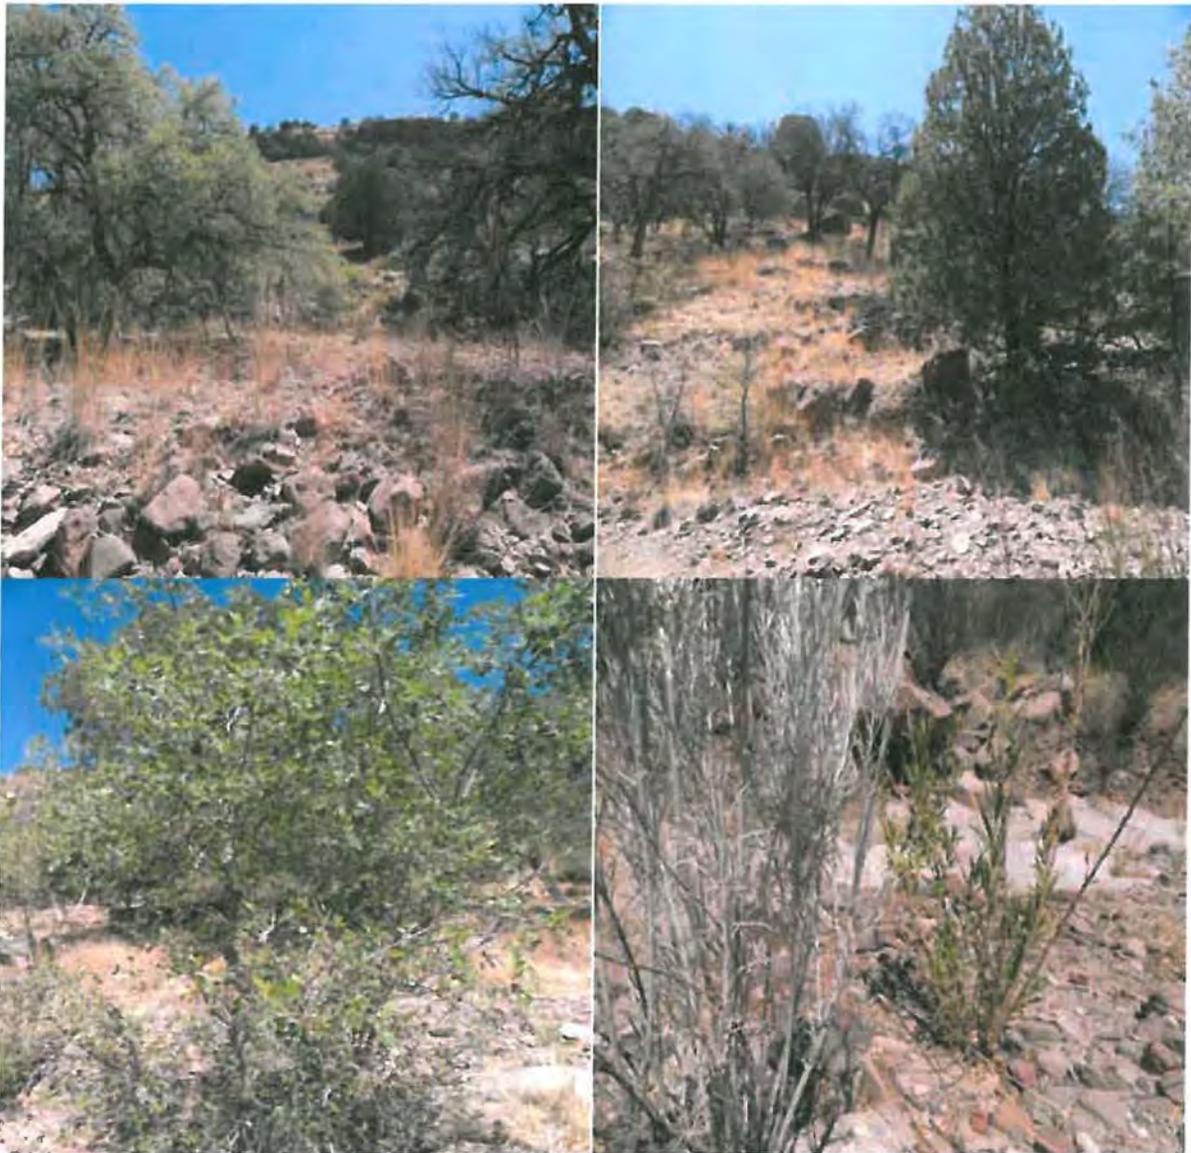
MC12-4: Photographic reference for indicators 1.5 and 1.6. Photographs of the bank/upland area and rooted in channel vegetation. Vegetation is similar in composition between the bank and the upland area. Vegetation is consistently dispersed throughout the channel.
