**Application of the Hydrology
Protocol to STSIU Drainages**

Chino Mines, Vanadium, New Mexico

**Application of Hydrology
Protocol to STSIU Drainages**

Date:
November 2012

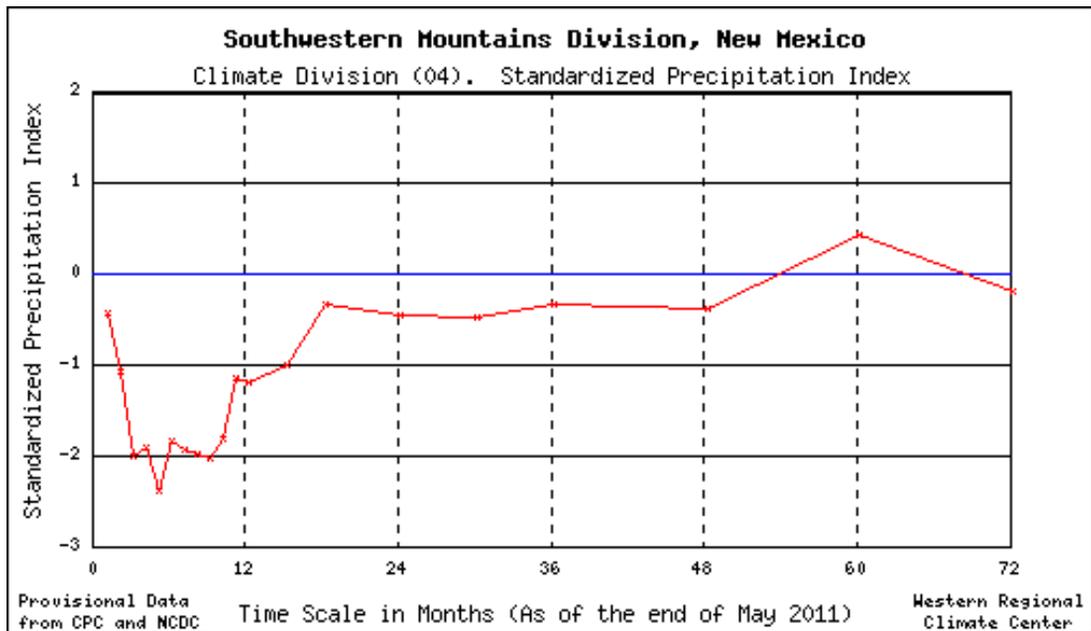
12-MONTH STANDARDIZED PRECIPITATION INDEX (SPI)
OBSERVED DURING HP APPLICATION

During the field application of the HP (June 2011), the 12-month SPI value for the Site area was -1.1 (Figure 1), indicating dry conditions but within the SPI range recommended by NMED (2011) for HP application.

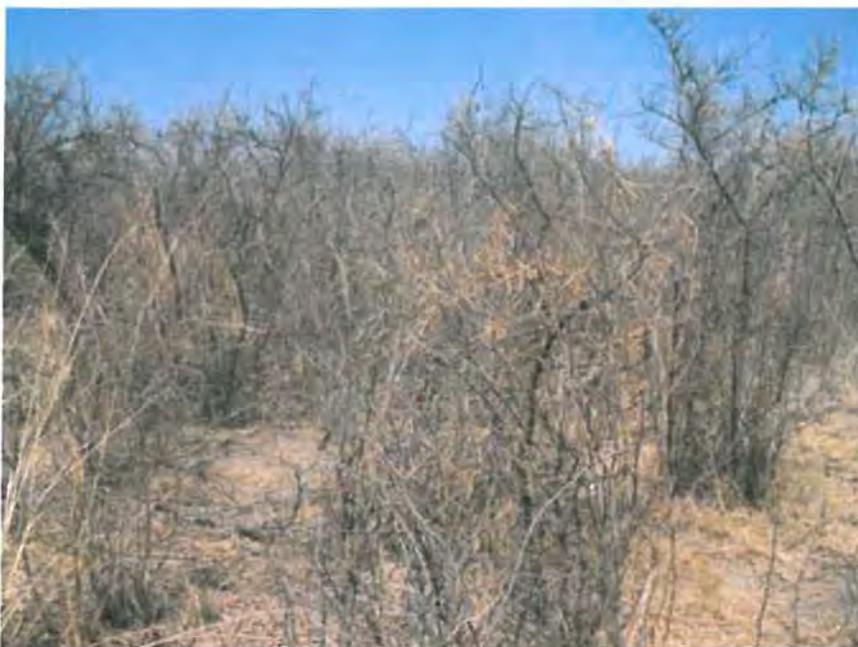
A9-1: Photographic reference for indicators 1.1 through 1.6. Photograph of channel area. Typical densely rooted vegetation within the channel. No water or biotic indicators of water observed along survey reach. Indicator 1.6 scored as 0 - rooted upland plants prevalent in streambed.

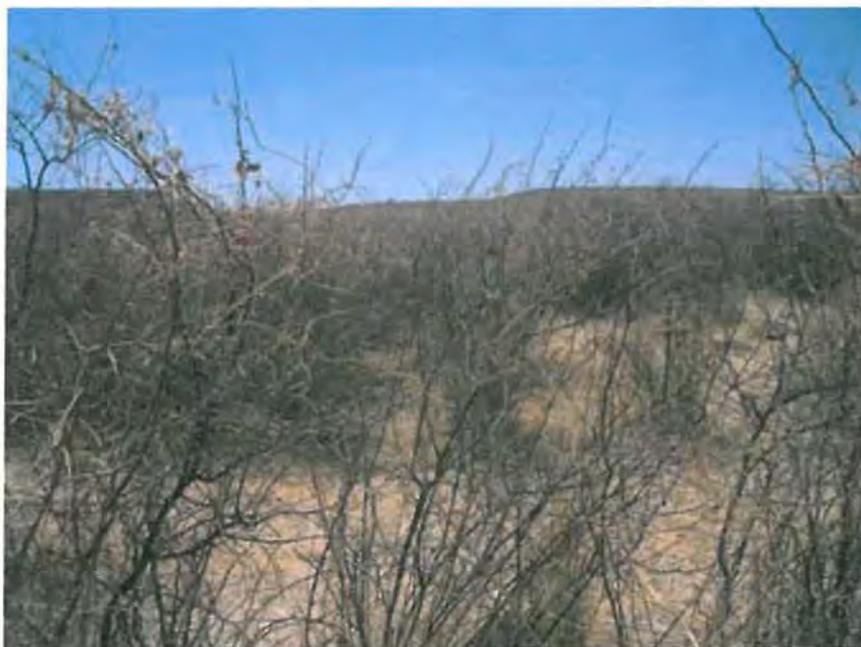
A9-2: Photographic reference for indicator 1.5. Photograph of upslope and overbank area. Vegetation within, and adjacent to channel, occurred at slightly greater densities but was consistent with vegetation growing in adjacent upland areas (mostly bunch grass and cat claw).

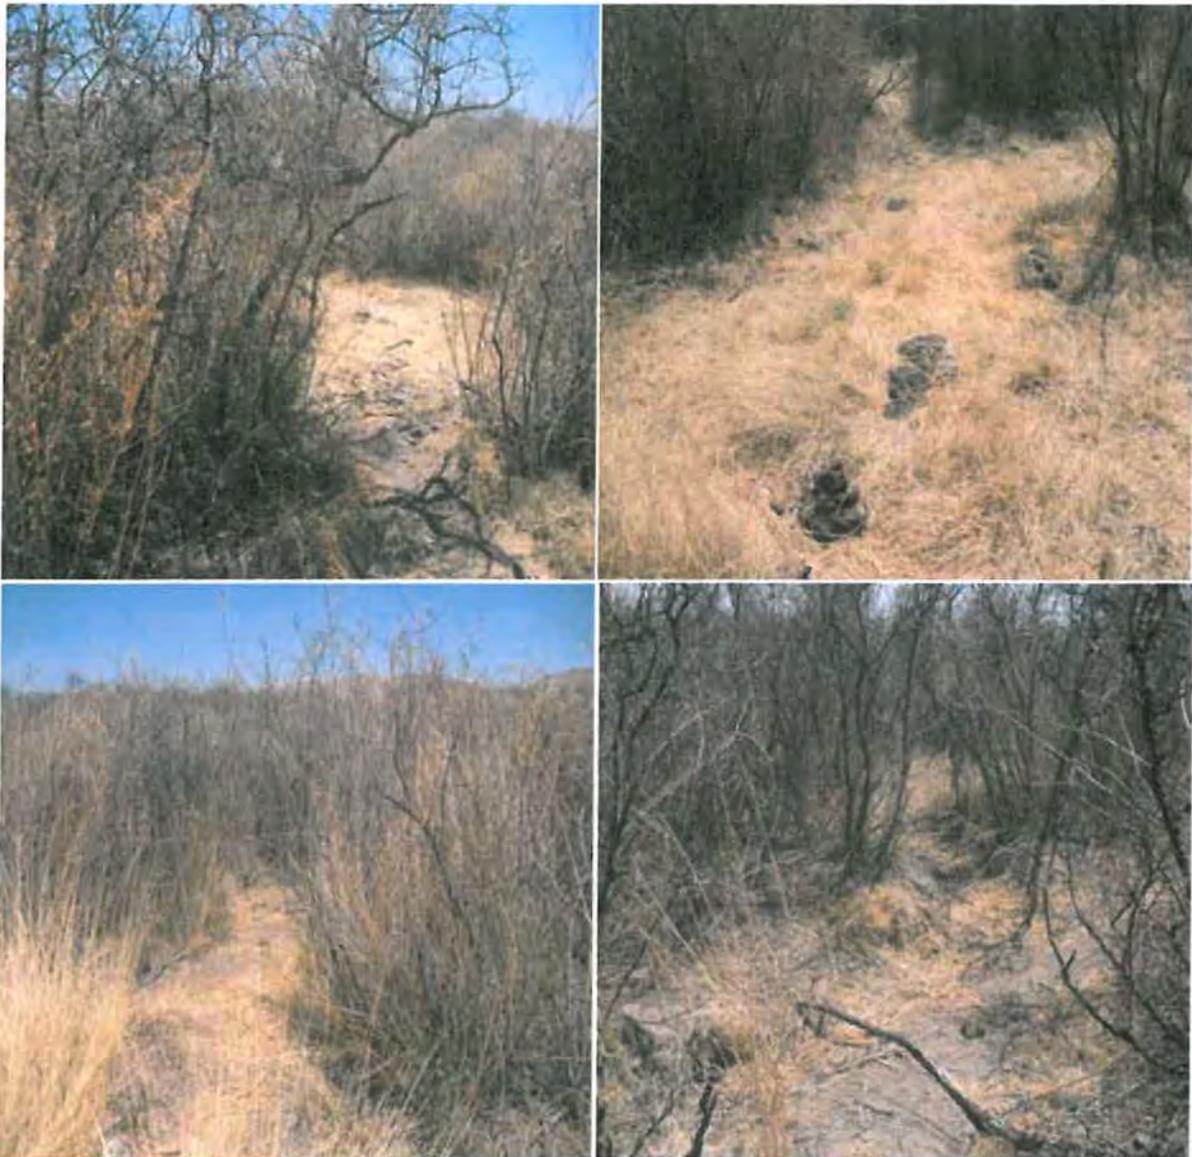
A9-3: Photographic reference for indicators 1.5 and 1.6. Photographs of vegetation. Typical densely rooted vegetation within the channel. No compositional differences were observed between vegetation growing around the channel and adjacent uplands, but upland species did occur at greater densities within and around the channel.

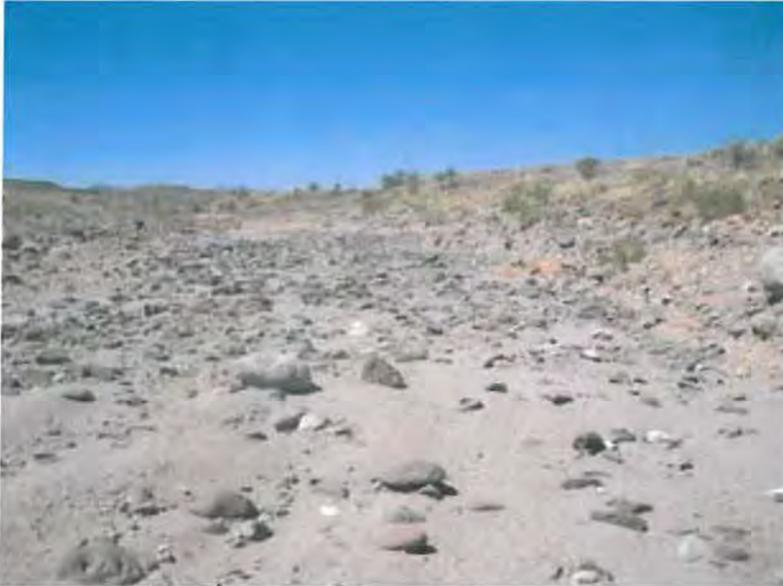
A10-1: Photographic reference for indicators 1.1 through 1.6. Typical view of stream bed and banks. Indicators 1.1 through 1.4 scores of 0 - no water or biotic indicators of water observed along survey reach.

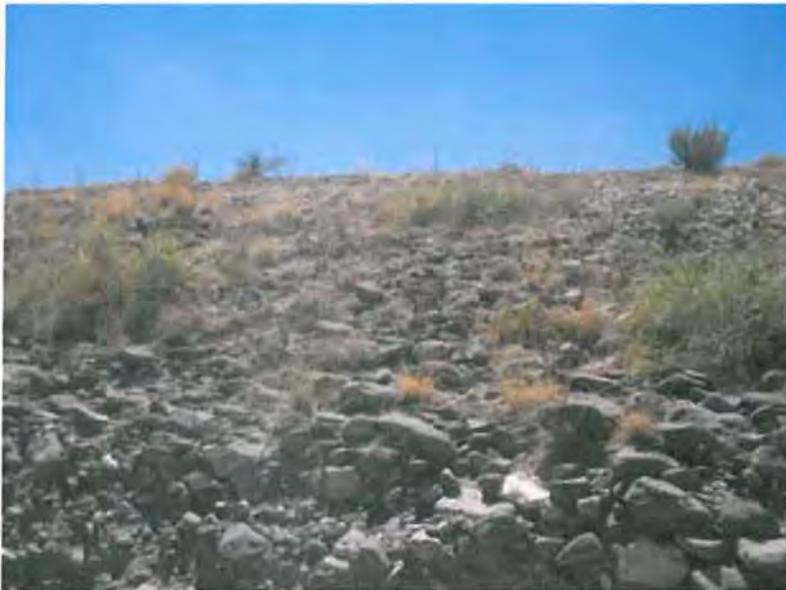
A10-2: Photographic reference for indicator 1.5. Photograph of typical stream bank and over bank vegetation (also observed in other photos provided). No significant compositional or density differences between bank and adjacent uplands and no riparian zone present. Indicator 1.5 score of 0 - no vegetative differences between banks and uplands.

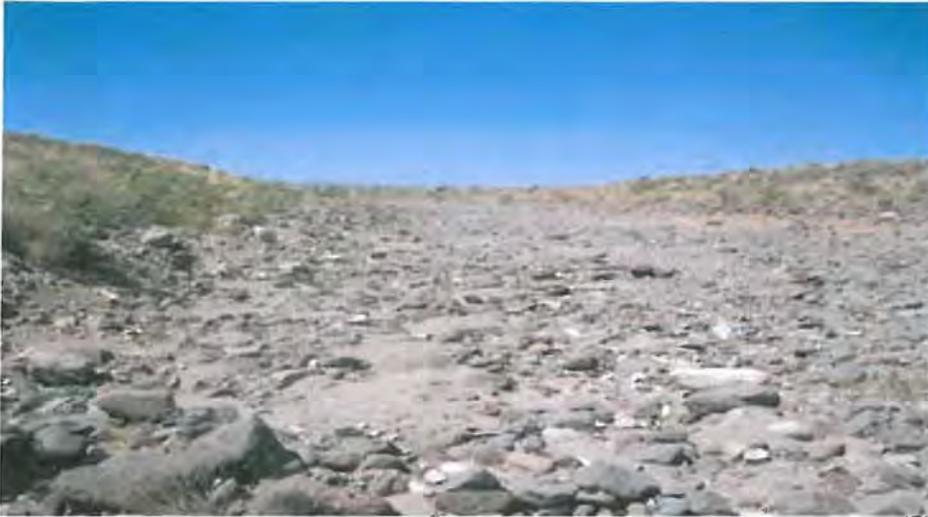
A10-3: Photographic reference for indicator 1.6. Most of the streambed is relatively devoid of vegetation most likely as a result of flow regime and bed material (course sands, gravel and boulders). Indicator 1.6 scored as 2 -- a few upland rooted plants were observed growing within the channel (see below pictures), although they were mostly (but not entirely) absent presumably as a result of substrate limitations.

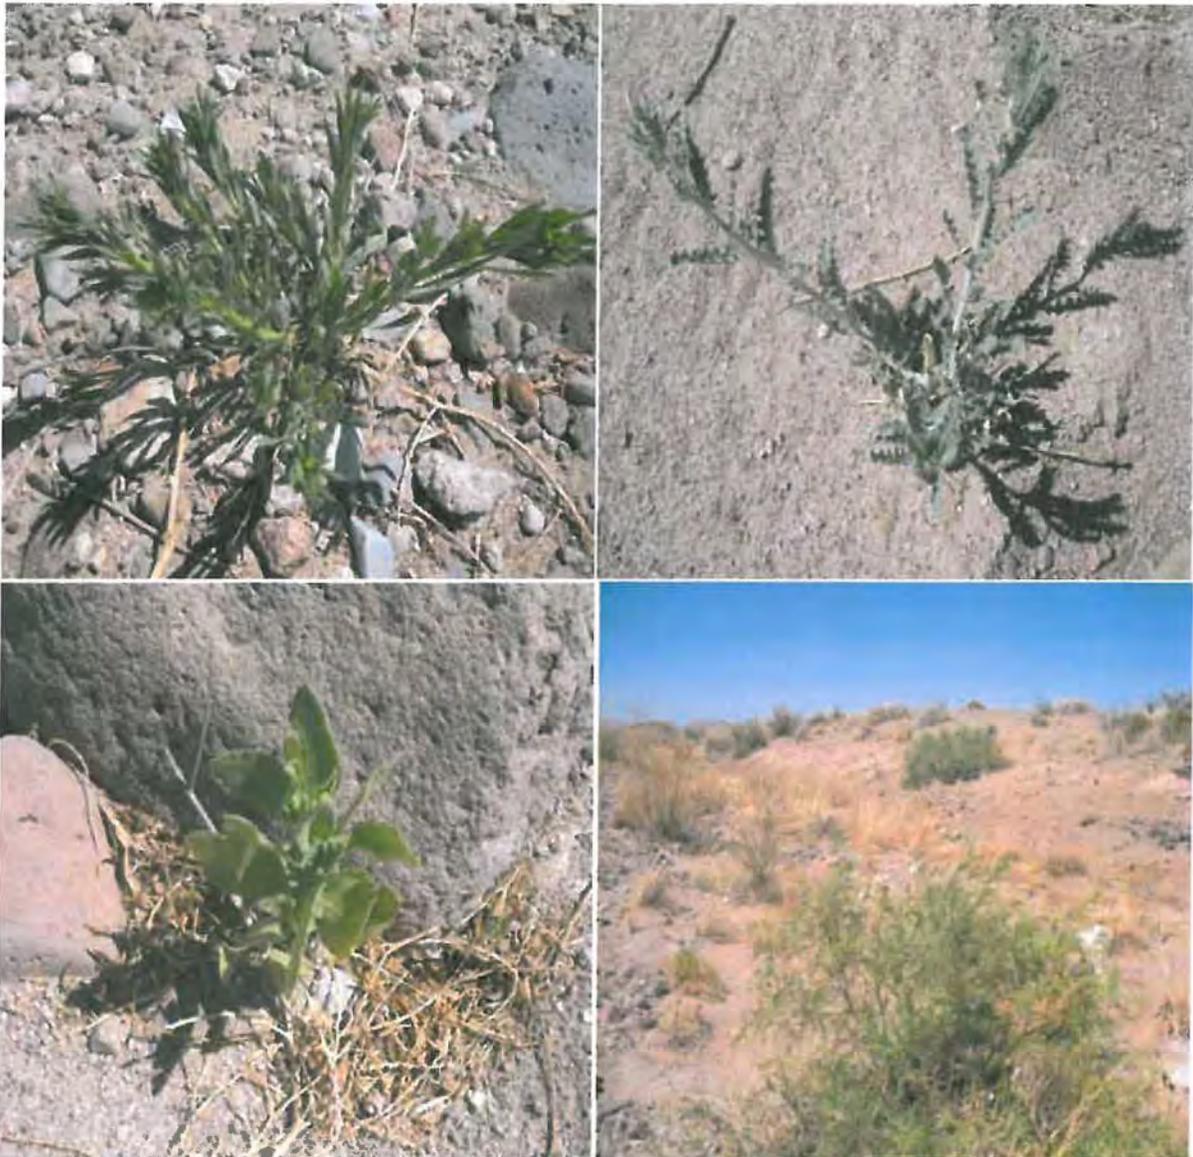
A10-4: Photographic reference for indicators 1.5 and 1.6. Photographs of in stream rooted plants and overbank/upland areas. Typical rooted vegetation noted within the channel. No significant compositional or density differences between bank and adjacent uplands.

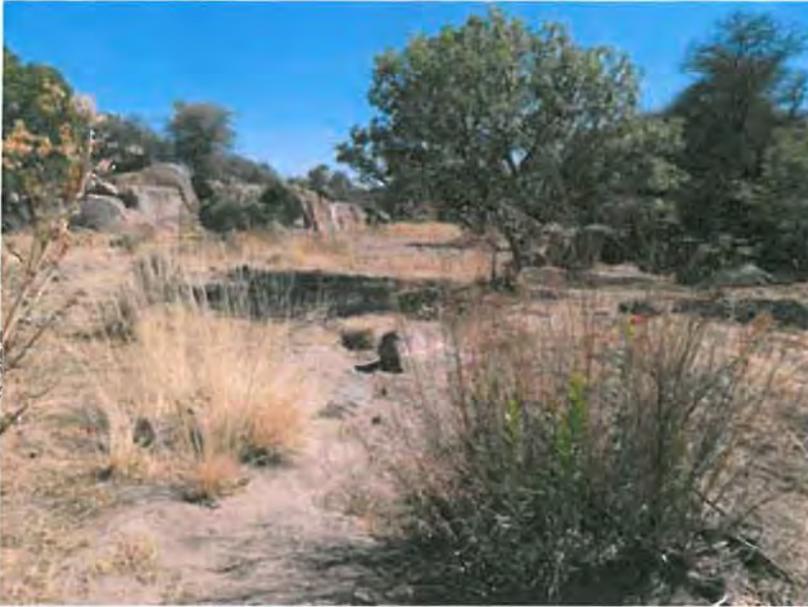
B7-1: Photographic reference for indicators 1.1 through 1.6. Photograph of stream bed. Typical rooted vegetation across channel and banks relatively consistently dispersed throughout channel length. Indicator 1.6 scored as 1 - rooted upland plants consistently dispersed in streambed. No water or biotic indicators of water observed along survey reach.

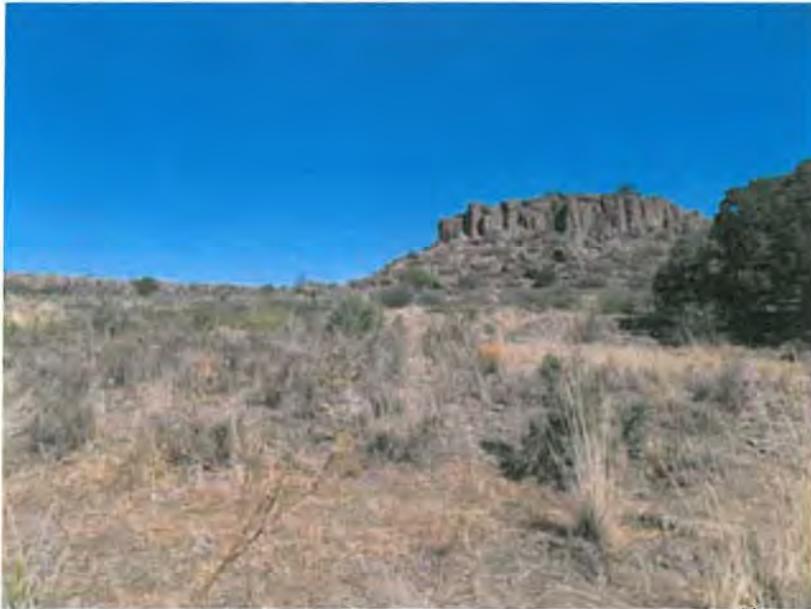
B7-2: Photographic reference for indicator 1.5. Photograph of bank and upland area. Indicator 1.5 scored as 1 - evident variation in vegetative density but no dramatic difference in composition. No distinct riparian zone observed.

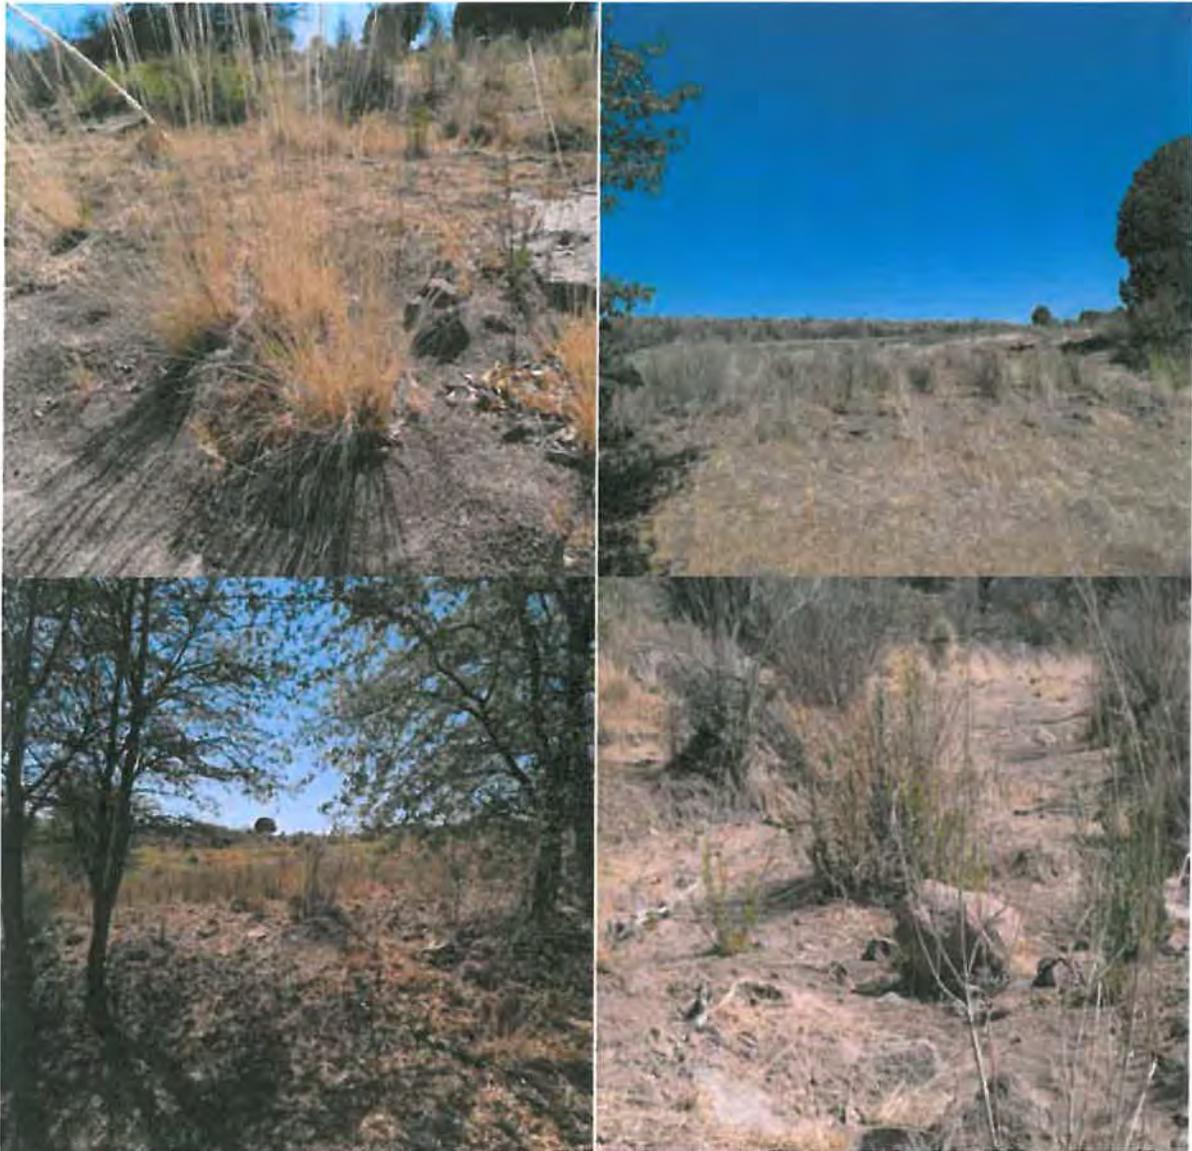
B7-3: Photographic reference for indicators 1.5 and 1.6. Photographs of bank/upland area and rooted in channel vegetation. There is a variation in vegetative density but no dramatic difference in composition. Rooted vegetation consistent across channel and banks.

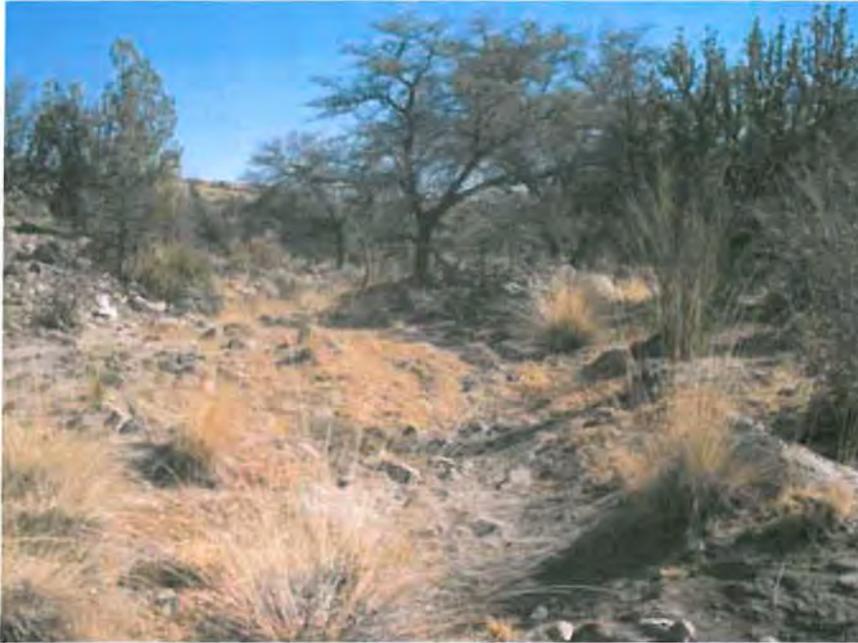
B7 DS-1: Photographic reference for indicator 1.1 through 1.6. Indicator 1.6 scored as 1 - rooted vegetation along the stream bed is consistently dispersed. No water or biotic indicators of water observed along survey reach.

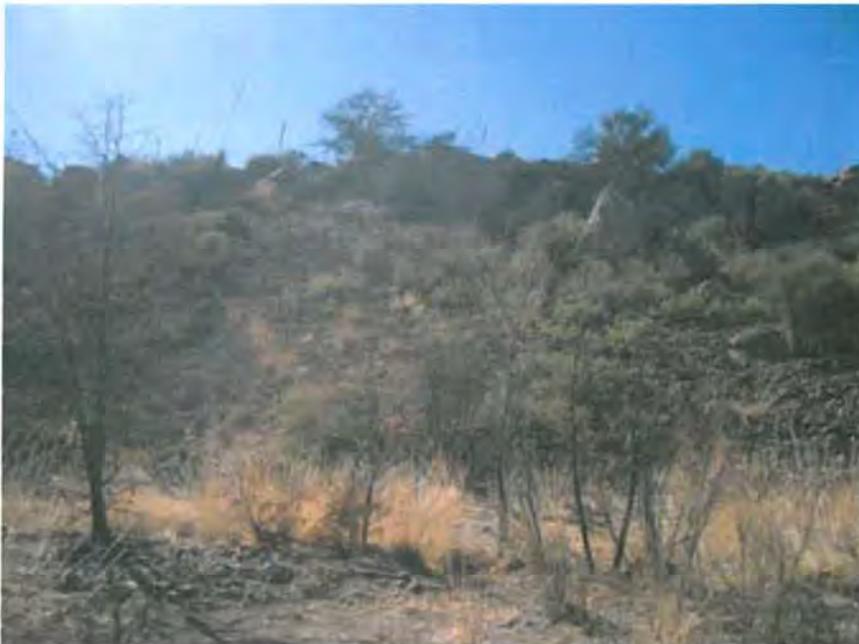
B7 DS-2: Photographic reference for indicator 1.5. Photograph of the overbank area and uplands. Indicator 1.5 scored as 1 - evident variation in vegetative density but no dramatic difference in composition. No distinct riparian zone observed.

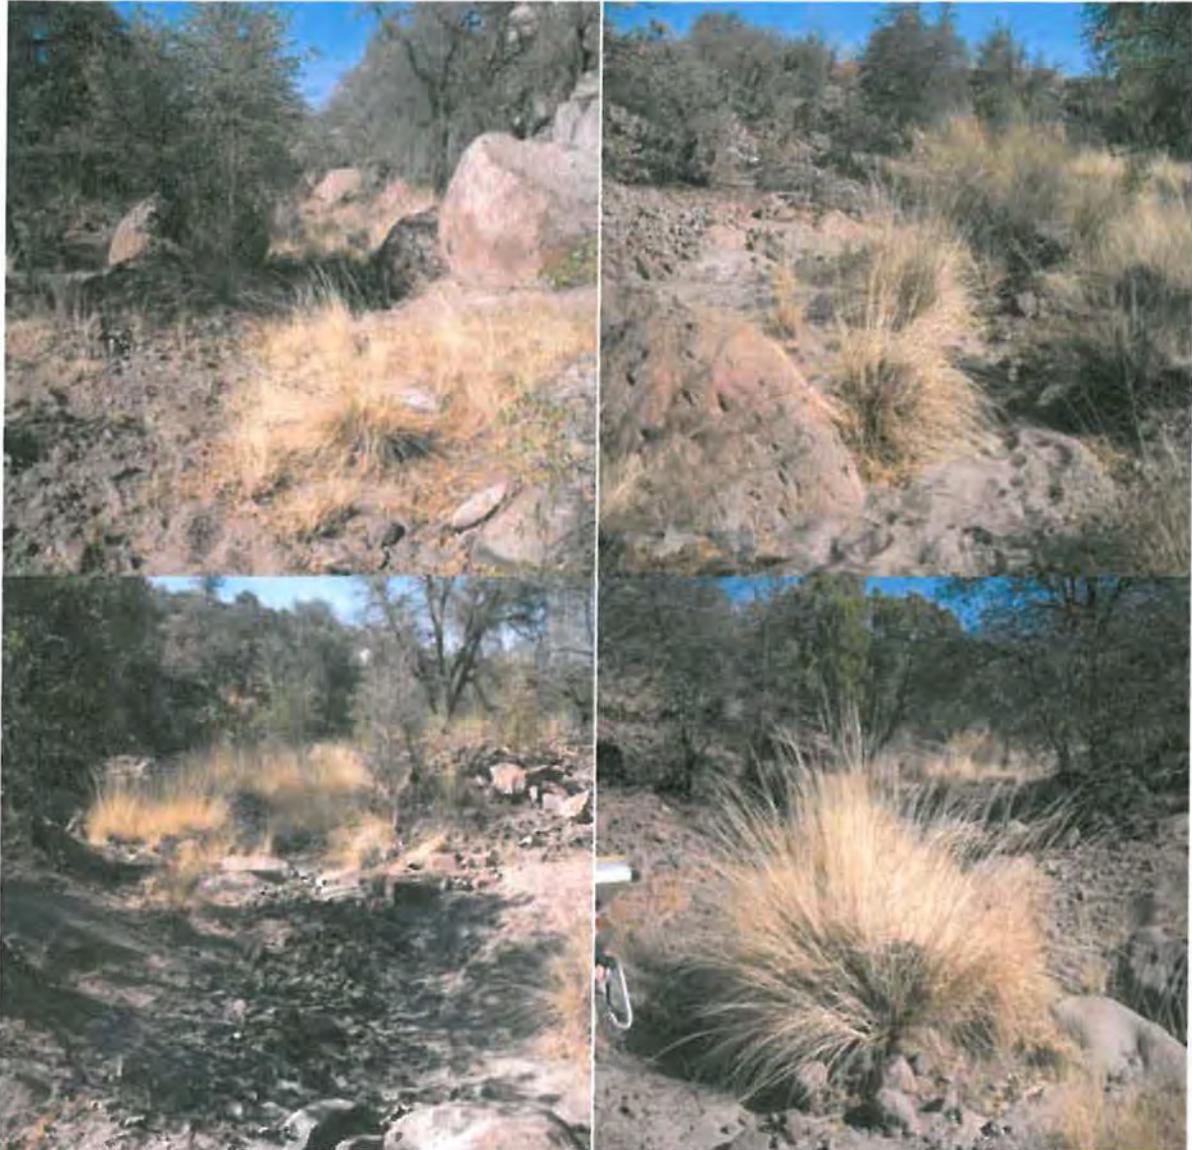
B7 DS-3: Photographic reference for indicators 1.5 and 1.6. Photographs of in stream rooted plants and overbank/upland areas. Evident variation in vegetative density but no dramatic difference in composition and rooted vegetation along the stream bed is consistently dispersed.

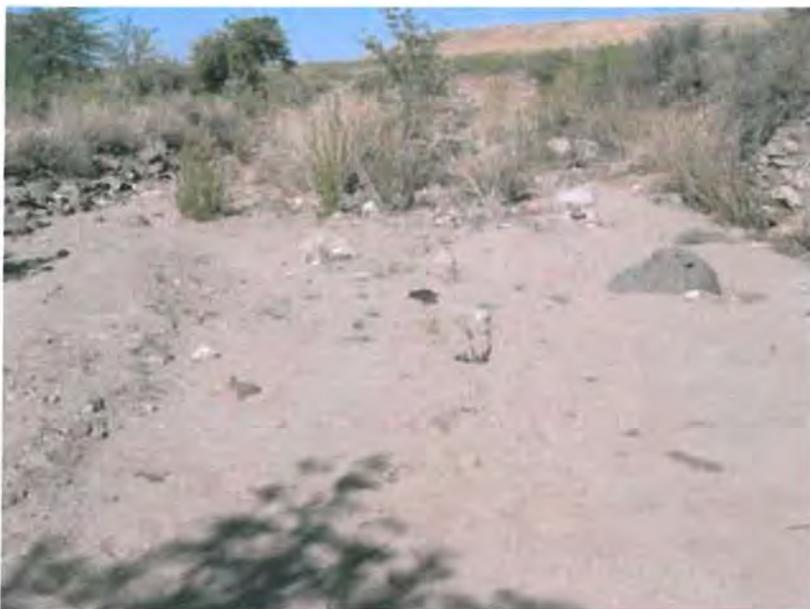
B8-1: Photographic reference for indicator 1.1 through 1.6. Photograph of typical channel bed and channel banks. Indicator 1.6 scored as 2 - rooted vegetation inconsistently present in stream bed. No water or biotic indicators of water observed along survey reach.

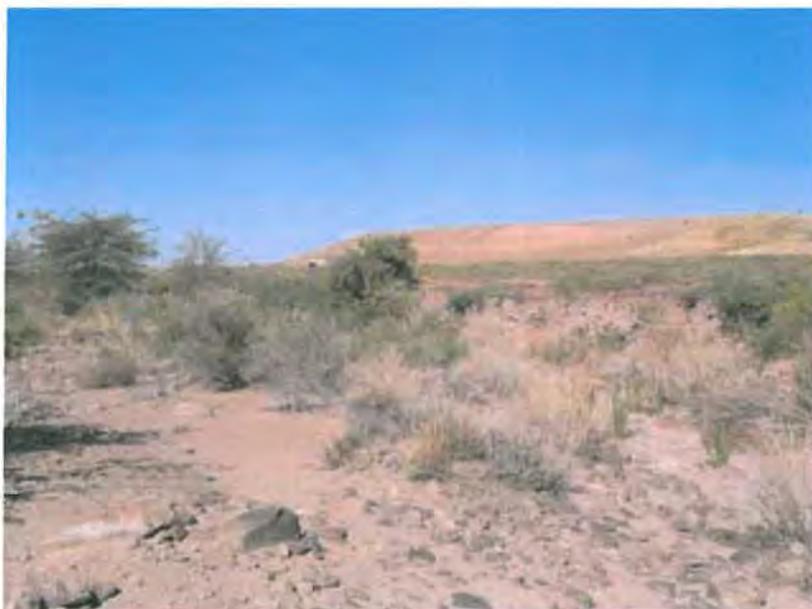
B8-2: Photographic reference for indicator 1.5. Photograph of bank and upland area. No dramatic differences between channel bank vegetation and upland vegetation. Indicator 1.5 scored as 1 - evident variation in vegetative density but no dramatic difference in composition. No distinct riparian zone present.

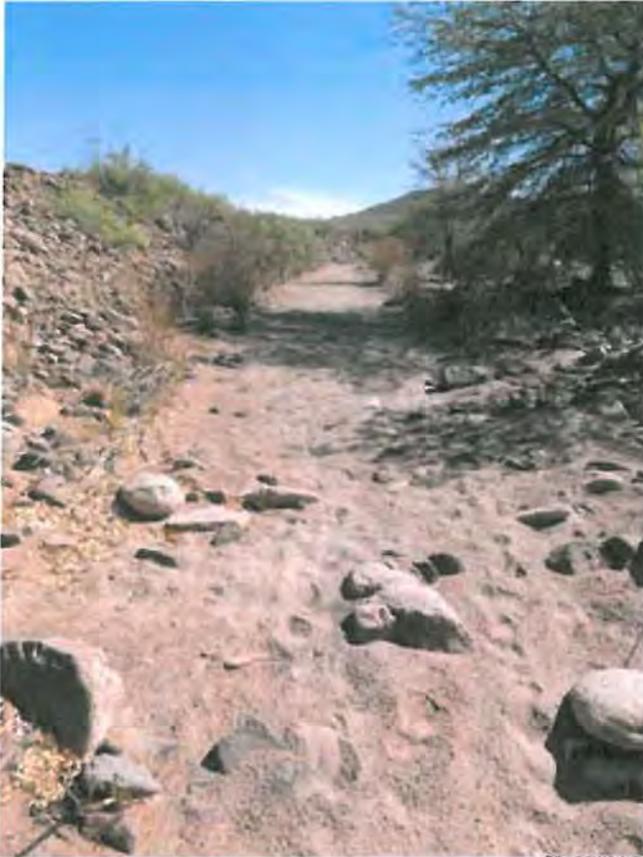
B8-3: Photographic reference for indicator 1.6 and 1.9. Portions of the stream bed along the reach are devoid of vegetation while other portions are vegetated (see previous photograph). Lack of vegetation is likely the result of the flow regime and the bed material rather than an indicator of water persistence. Indicator 1.6 scored as 2 - few rooted upland plants present along streambed.

Indicator 1.9 scored as 0 - no riffle-pool sequence observable.

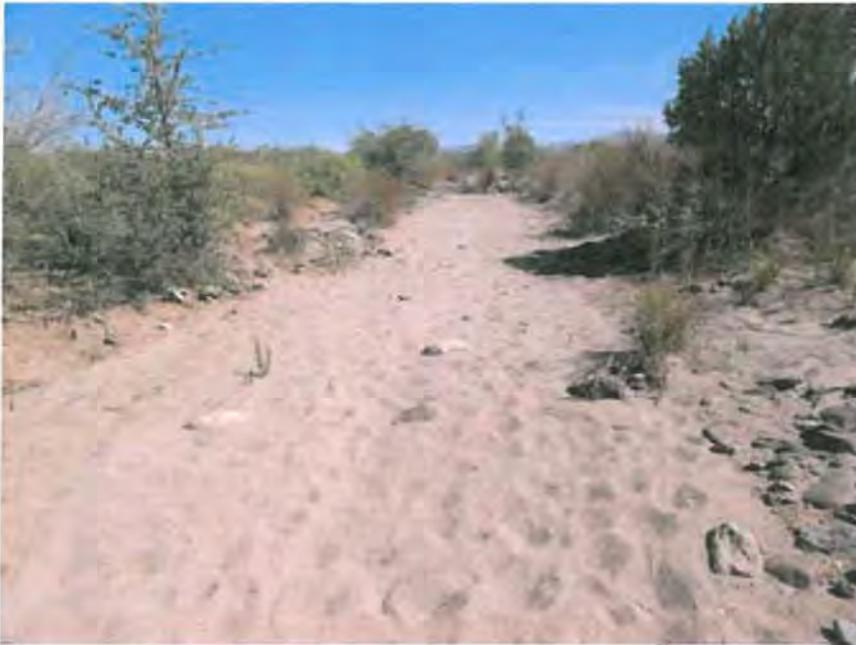
B8-4: Photographic reference for indicator 1.8 and 1.10. Photograph of the cross-section for measurement of the floodplain and channel dimensions. Indicator 1.8 scored 1.5 based on measurements taken - moderate confinement and presence of inactive floodplain.

Indicator 1.10 scored as 1.5. Channel bed material is medium to coarse sand, which is consistent but noticeably courser than the bank and over bank area. Little to no substrate sorting is observable.

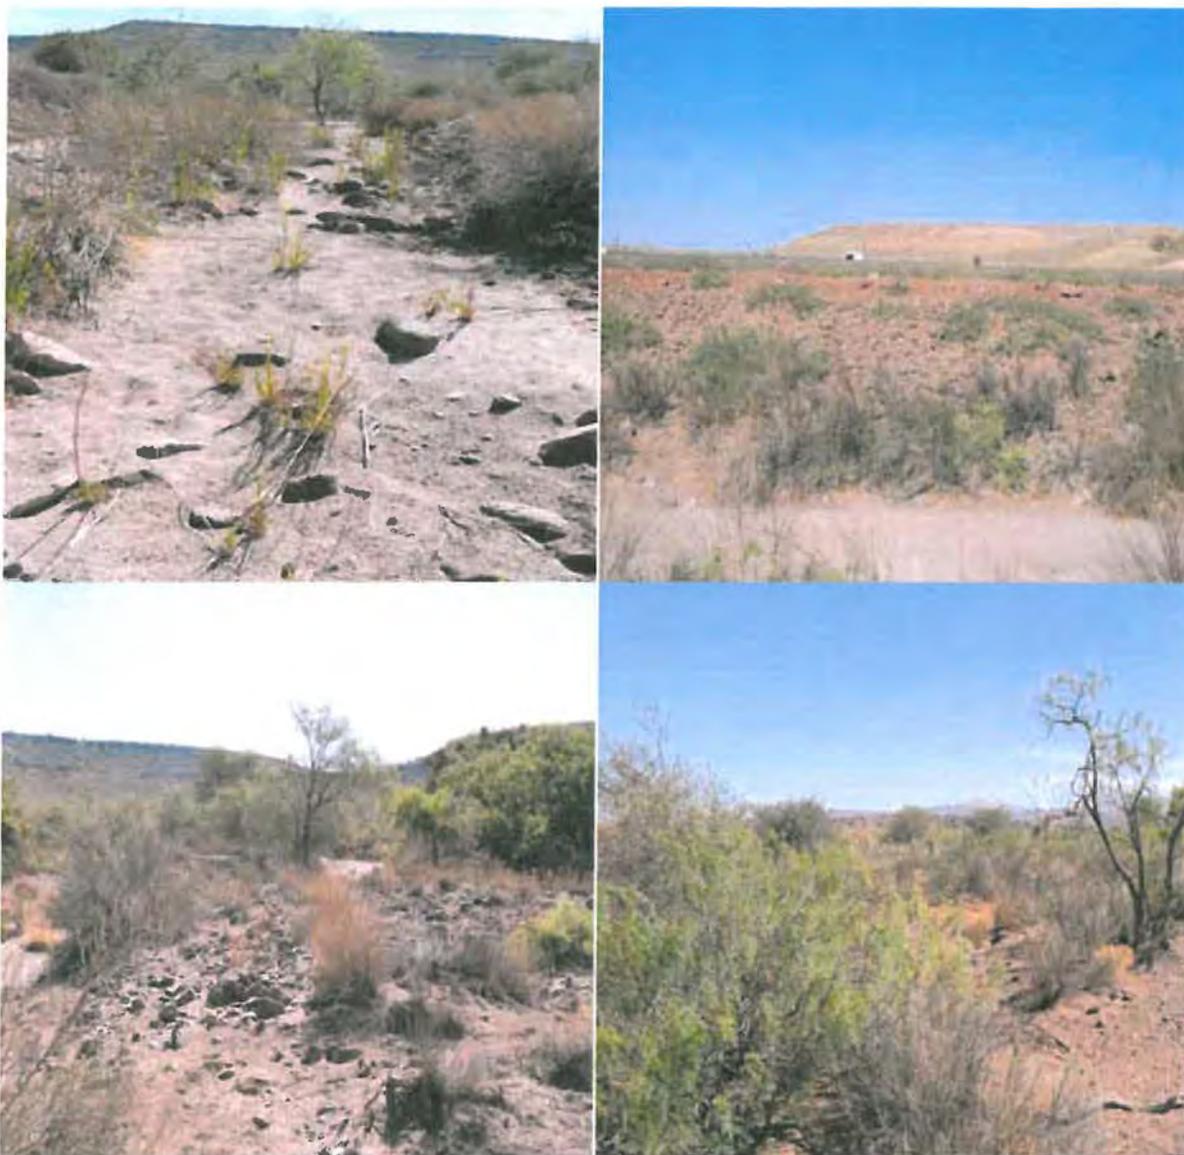
B8-5: Photographic reference for indicators 1.5 and 1.6. Photographs of bank/upland area and rooted in channel vegetation. There is a variation in vegetative density but no dramatic difference in composition. Rooted vegetation inconsistent across channel and banks.

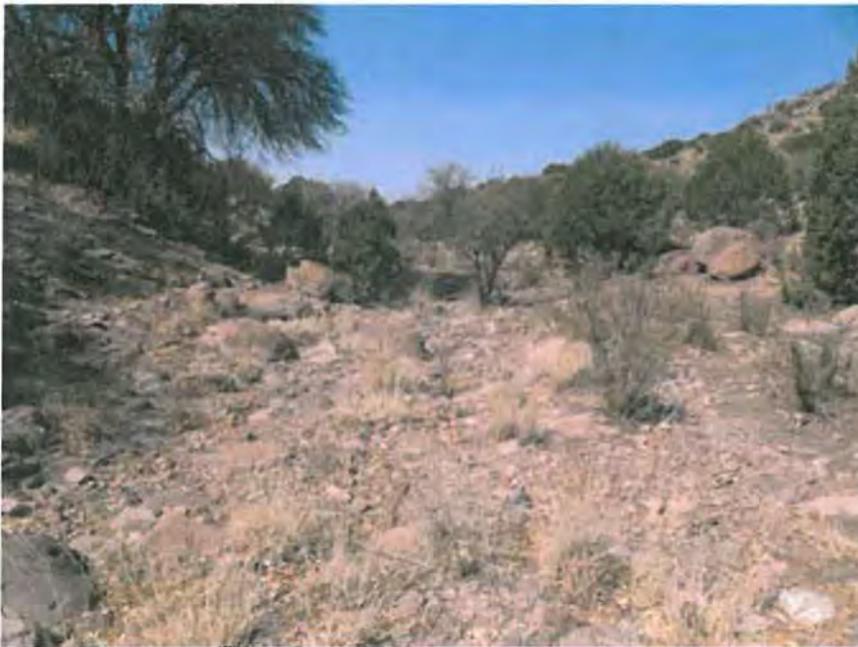
C19-2: Photographic reference for indicators 1.1 through 1.6. Photograph from upper extent of survey reach facing downstream. Rooted vegetation present in channel is present but inconsistent (see subsequent photograph). No water or biotic indicators of water observed along survey reach.

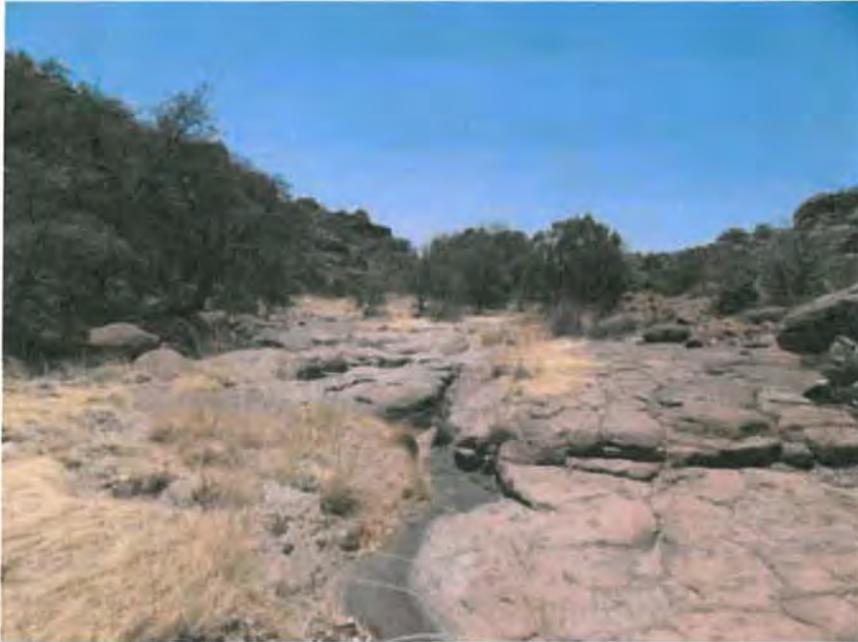
C4-1: Photographic reference for indicator 1.1 to 1.6. Streambed is predominantly bedrock. Vegetation present where deposition has occurred. No water or biotic indicators of water observed along survey reach.

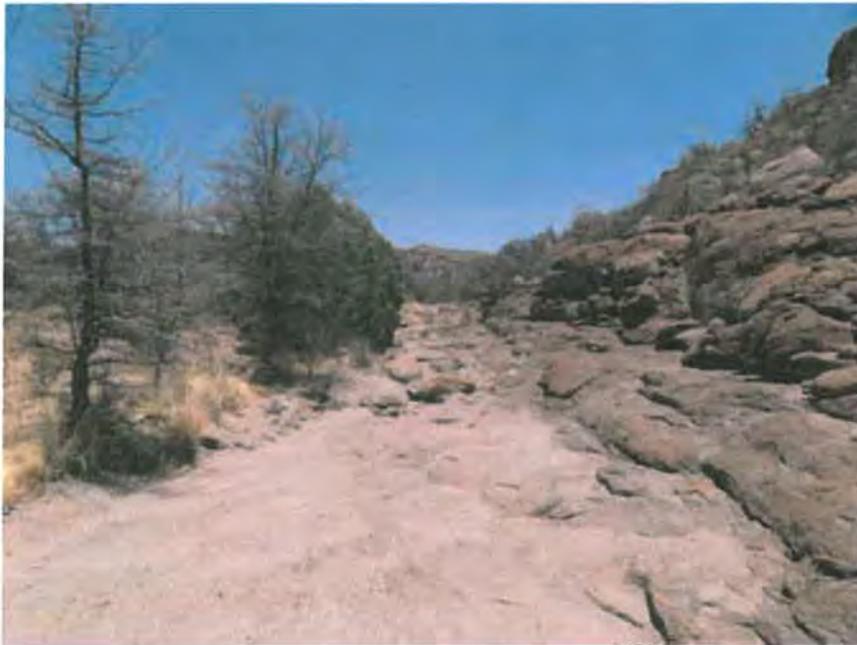
C4-2: Photographic reference for indicator 1.6. Indicator 1.6 scored as 2 – few rooted upland plants present in streambed. Lack of vegetation present in streambed likely result of flow regime and presence of bedrock rather than result of persistent water.

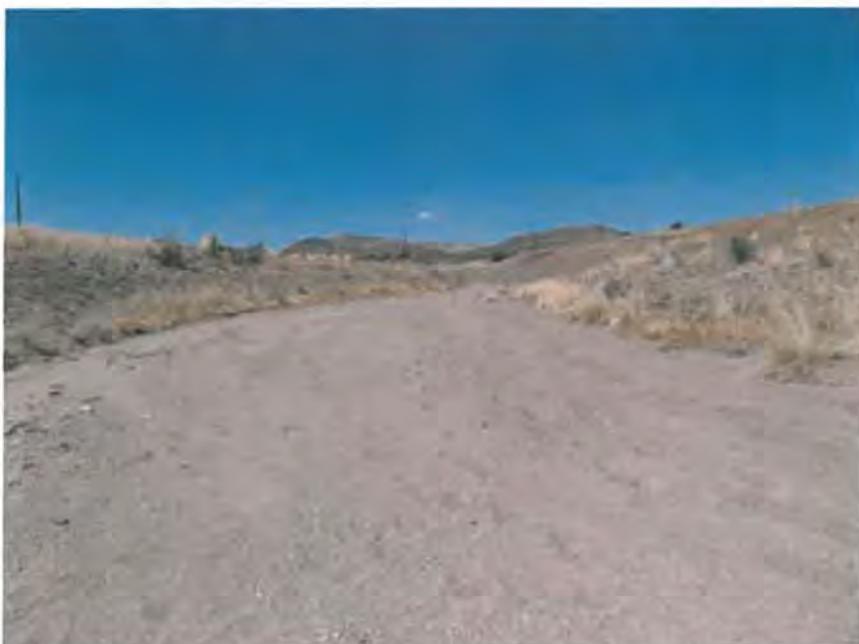
C5-2: Photographic reference for indicator 1.5. Indicator 1.5 scored as 0. Vegetation along streambank and uplands is sparse but consistent with no compositional or density differences between the two areas observed. Also refer to previous photograph.

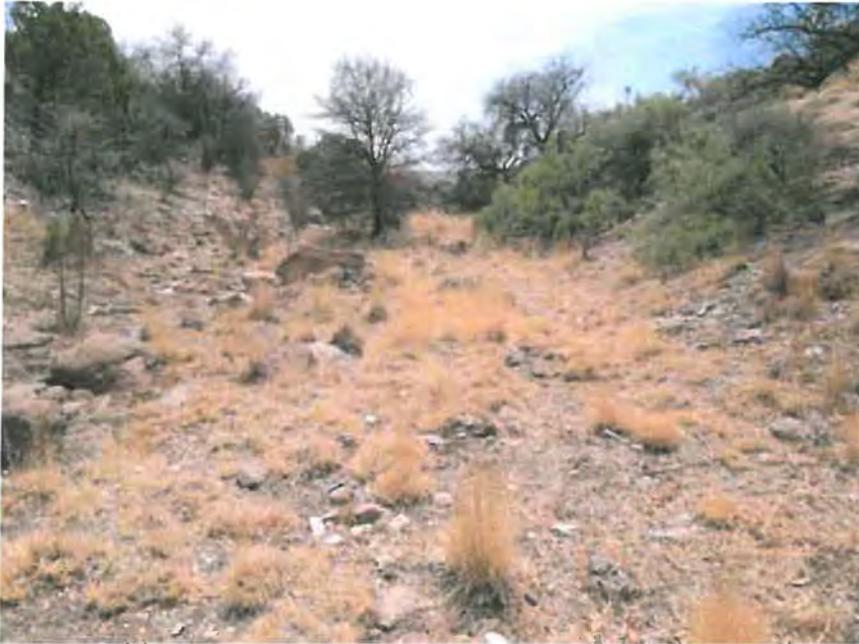
D1-1: Photographic reference of representative channel bottom characteristics. Note large boulders and cobbles in stream channel, similar to those observed on hillside.

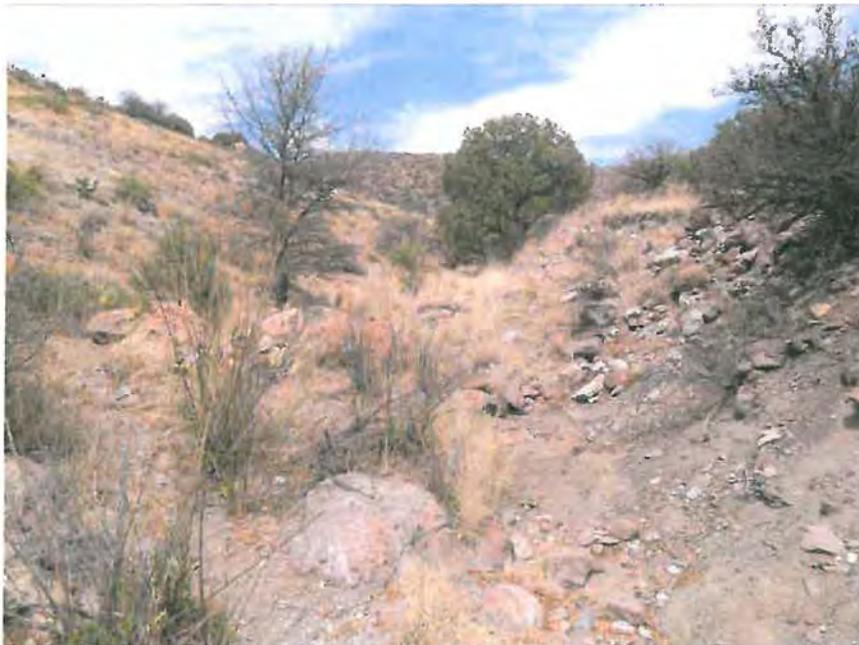
D1-2: Photographic reference of representative channel bottom characteristics. Note large boulders and cobbles in stream channel, similar to those observed on hillside.

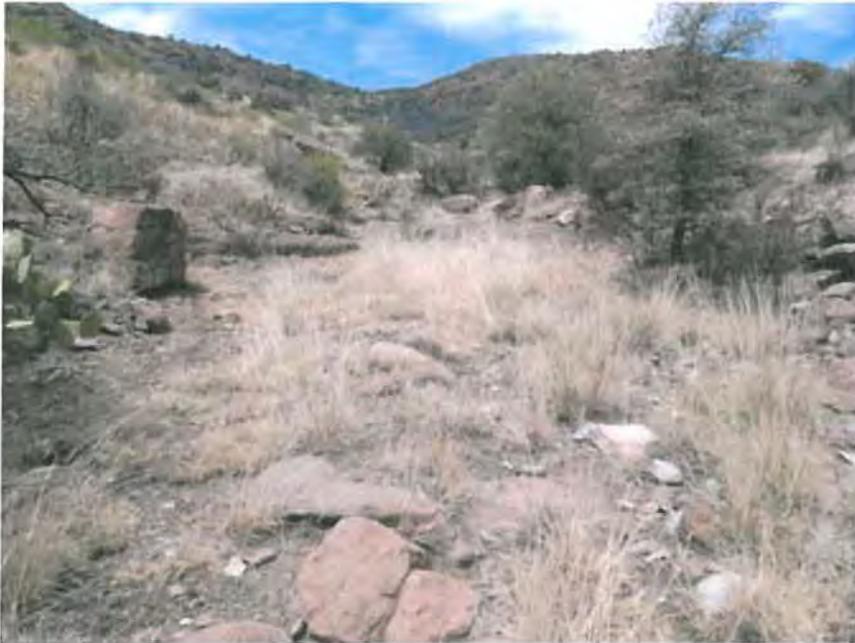
D1-3 Photographic reference for indicator 1.1 through 1.6. Typical view of stream bed and banks. Indicator 1.6 scored as 1 - rooted plants are prevalent and consistently dispersed in the streambed. No water or biotic indicators of water observed along survey reach.

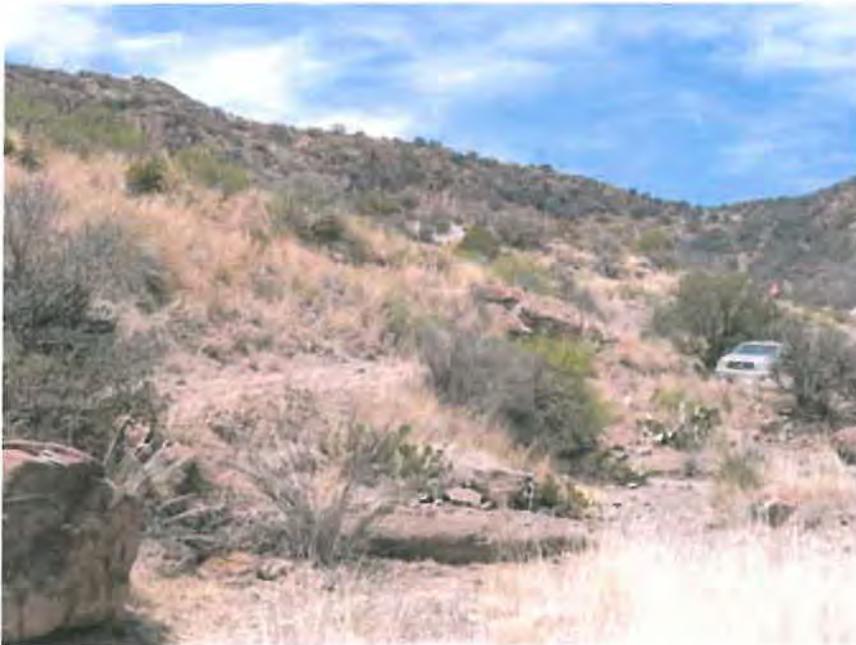
D1-4: Photographic reference for indicator 1.5. Photograph of typical vegetation in the upland region of the survey reach. Indicator 1.5 scored as 0. Upland vegetation composition and density similar to stream and stream banks shown in previous photograph.

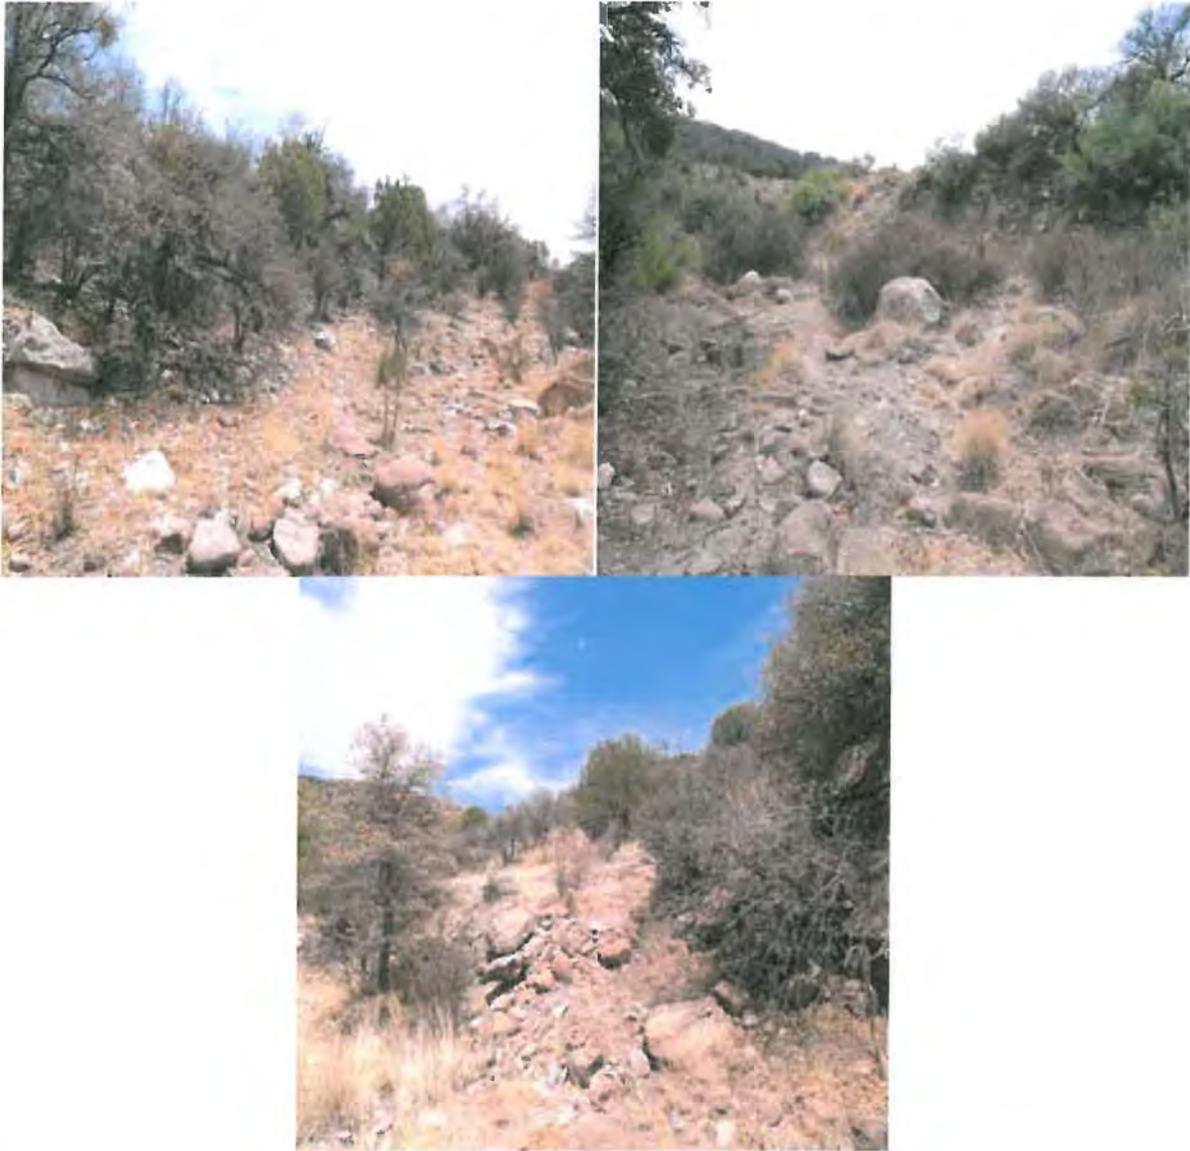
D1-5: Photographic reference for indicators 1.5 and 1.6. Photographs of stream bed, the bank/upland area and rooted in channel vegetation. Upland vegetation composition and density similar to stream and stream banks. Rooted plants are prevalent and consistently dispersed in the streambed.

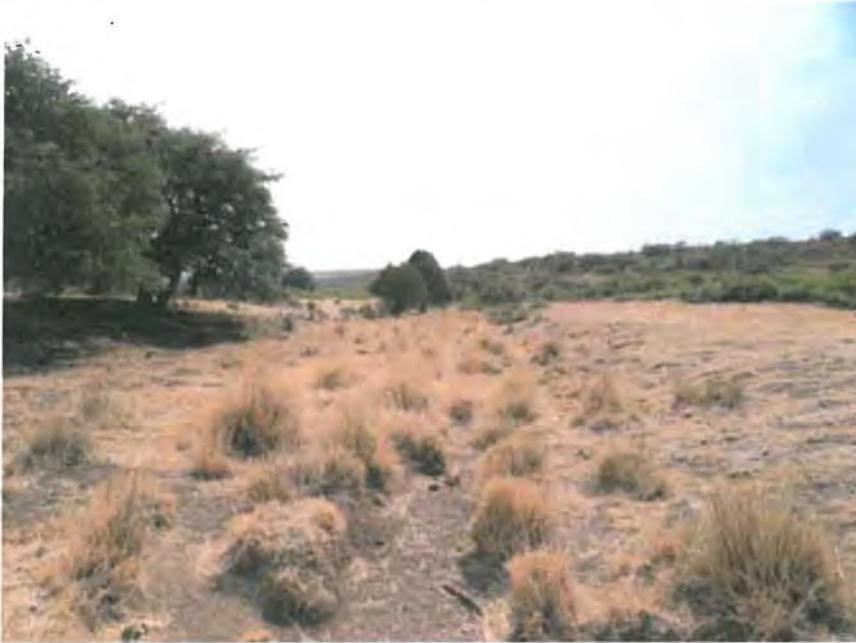
D1-2-1: Photographic reference for indicator 1.1 through 1.6. Indicator 1.6 scored as 0. Rooted plants present in the channel bed and are prevalent at similar density as the upslope area. No water or biotic indicators of water observed along survey reach.
