**Application of the Hydrology
Protocol to STSIU Drainages**

Chino Mines, Vanadium, New Mexico

**Application of Hydrology
Protocol to STSIU Drainages**

Date:
November 2012

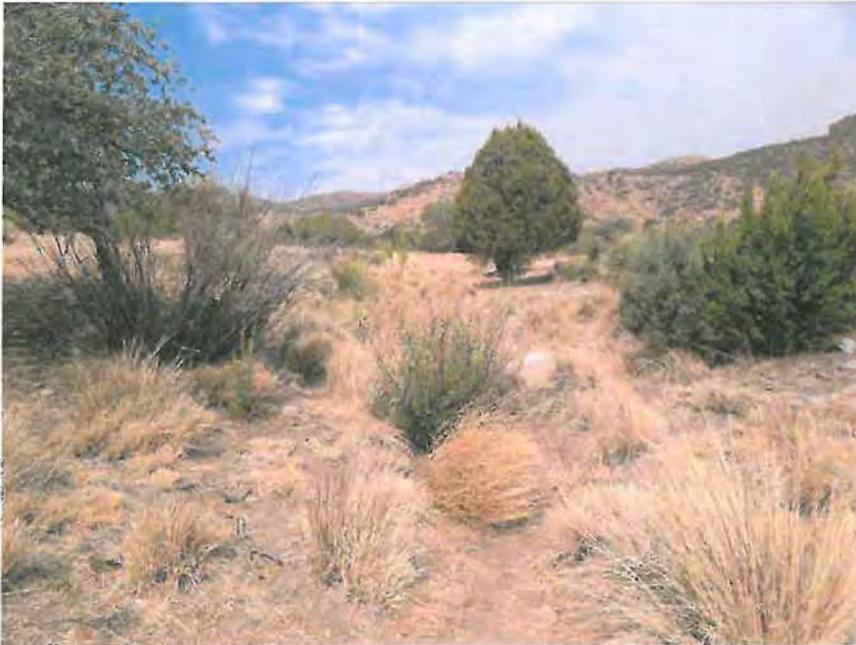
D1-2-2: Photographic reference of representative channel bottom characteristics. Note sand/gravel channel bottom with prevalent rooted upland plants throughout.

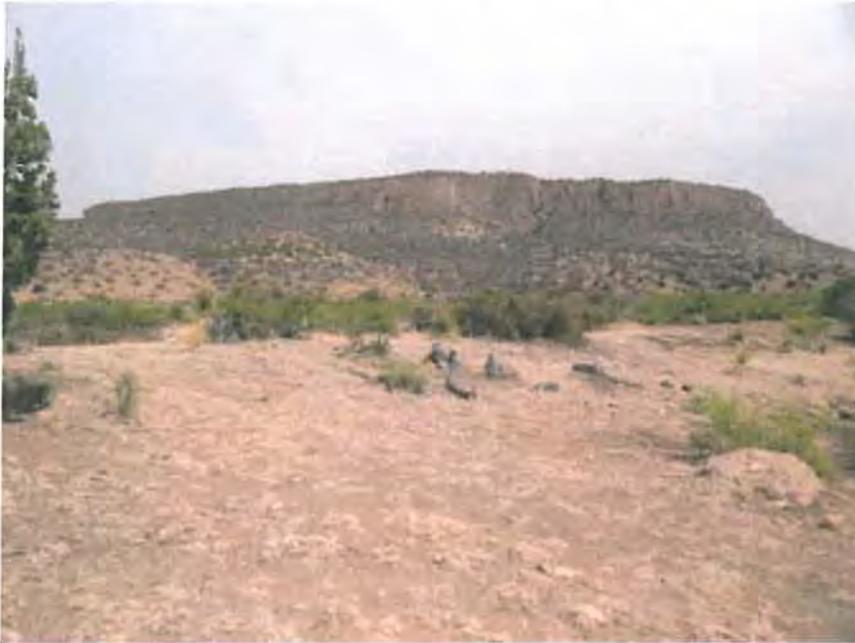
D1-2-3: Photographic reference for indicator 1.5. Photograph of the overbank and upland area. Indicator 1.5 scored as 1 - evident variation in vegetative density but no dramatic difference in composition. No distinct riparian zone observed.

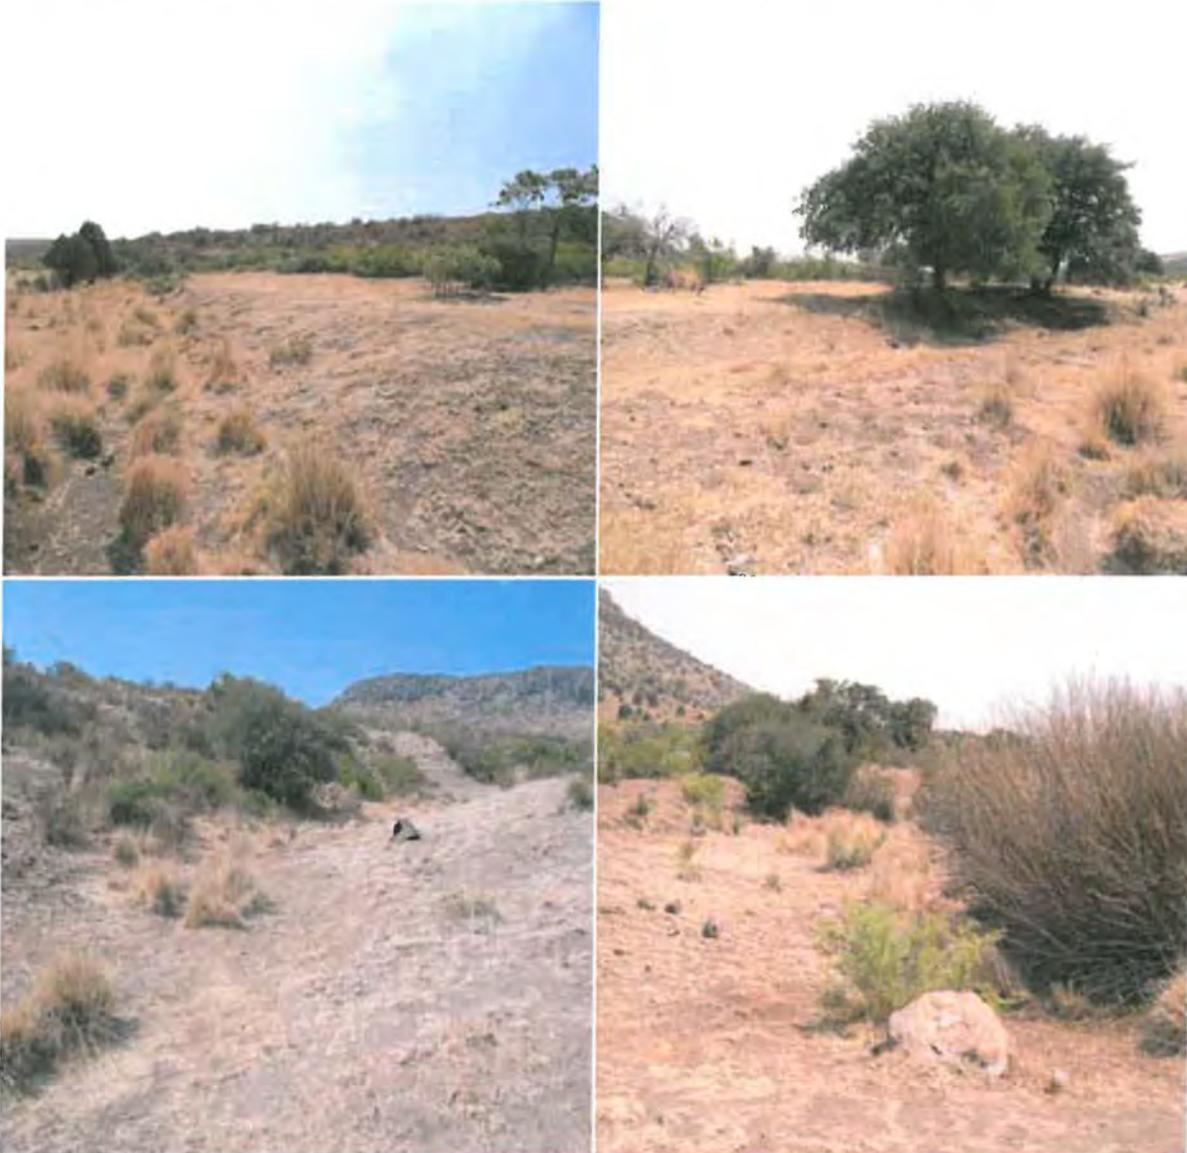
D1-2-4: Photographic reference for indicators 1.5 and 1.6. Photographs of stream bed, the bank/upland area and rooted in channel vegetation. There is an evident variation in vegetative density but no dramatic difference in composition. Rooted plants present in the channel bed and are prevalent at similar density as the upslope area.

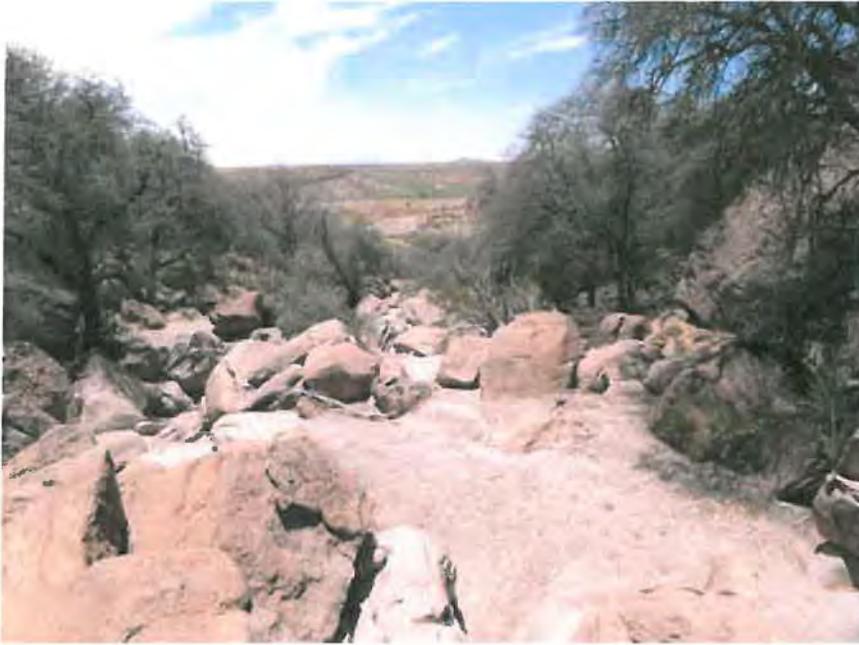
D2-1: Photographic reference of representative channel bottom characteristics. Note large boulders and cobbles in stream channel, similar to those observed on hillside. Note confining nature of hillsides.

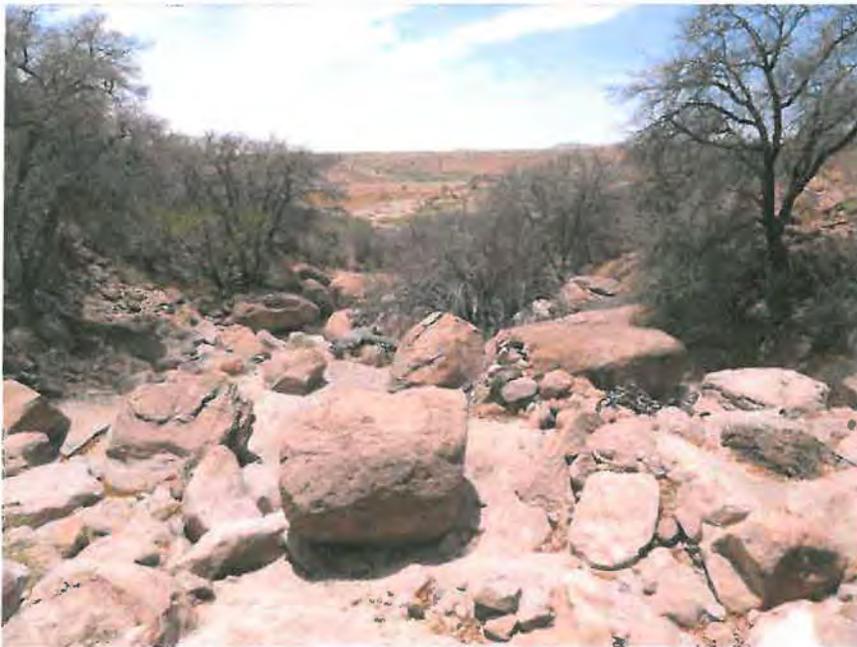
D2-2: Photographic reference of representative channel bottom characteristics. Note large boulders and cobbles in stream channel, similar to those observed on hillside. Note confining nature of hillsides.

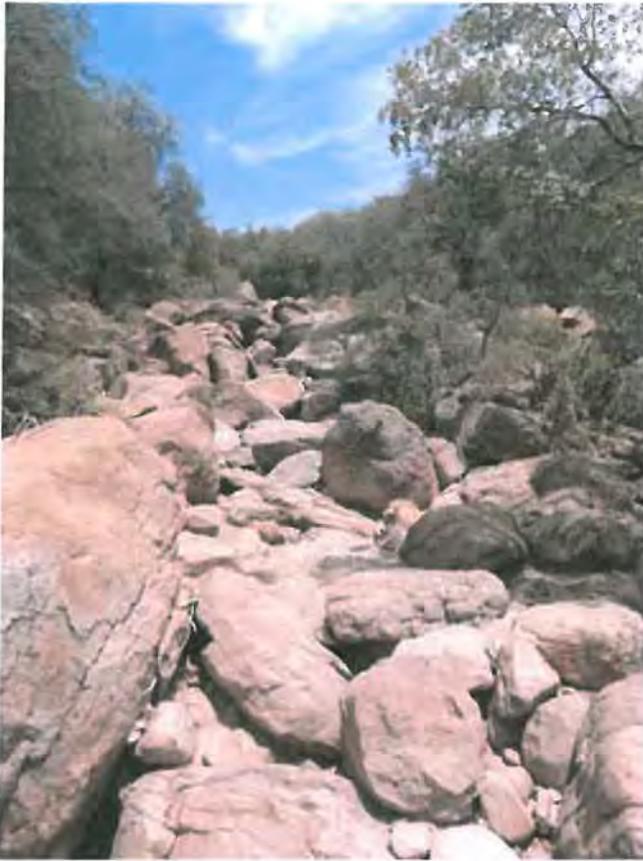
D2-3: Photographic reference for indicators 1.1 through 1.6. Indicator 1.6 scored as 2 – few rooted plants present in the streambed. Lack of instream vegetation most likely a result of the bed material present (boulders) rather than an indicator of flow persistence. No water or biotic indicators of water observed along survey reach.

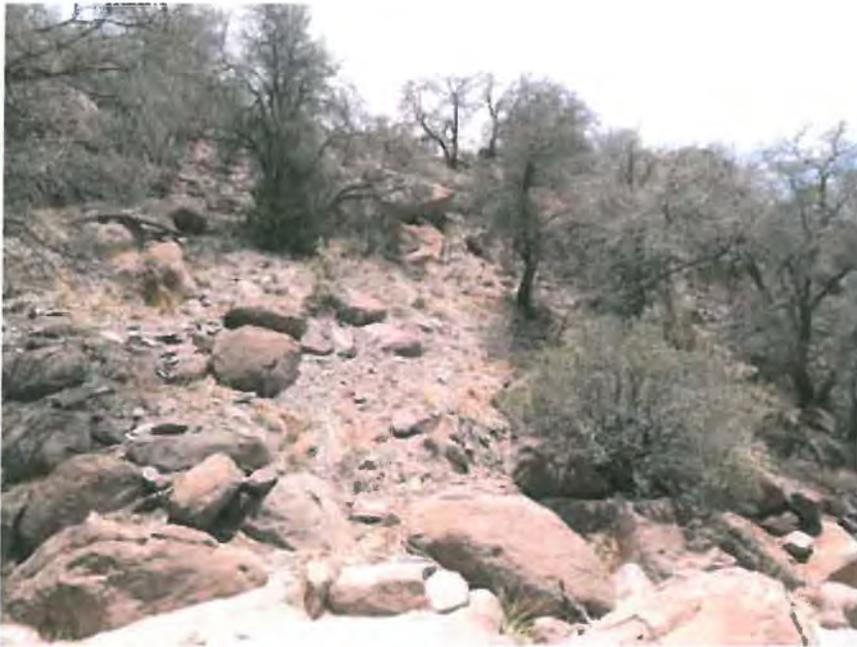
D2-4: Photographic reference for indicator 1.5. Photograph of bank vegetation (also observable in previous photograph) and the upland vegetation. Indicator 1.5 scored as 0. No vegetative compositional or density differences observed between the banks and the upland area.

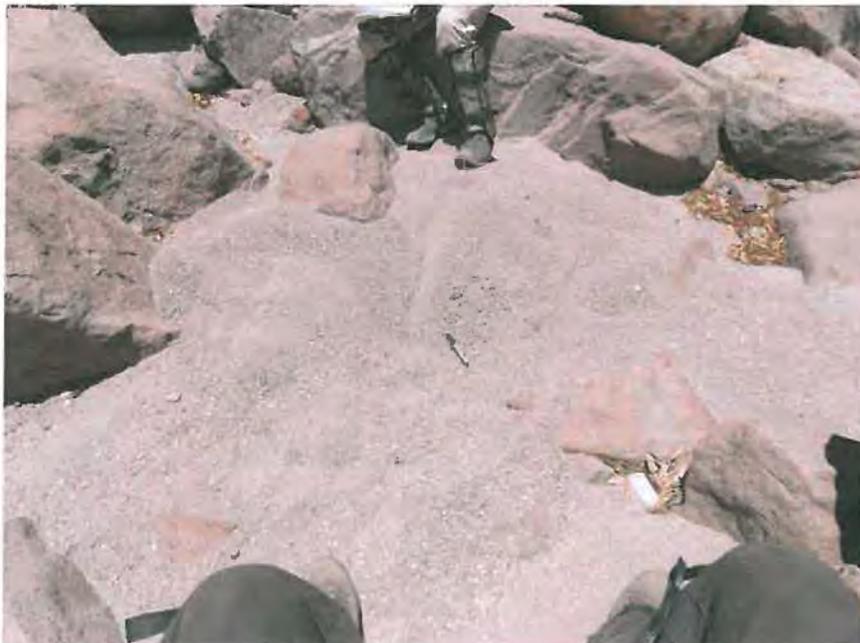
D2-5: Photographic reference for indicator 1.6. Lack of in-stream vegetation indicative of coarse mineral sediments and complete lack of moisture. Assessment unit representative of channel bottom characteristics. Note dry material sand sediments within channel.

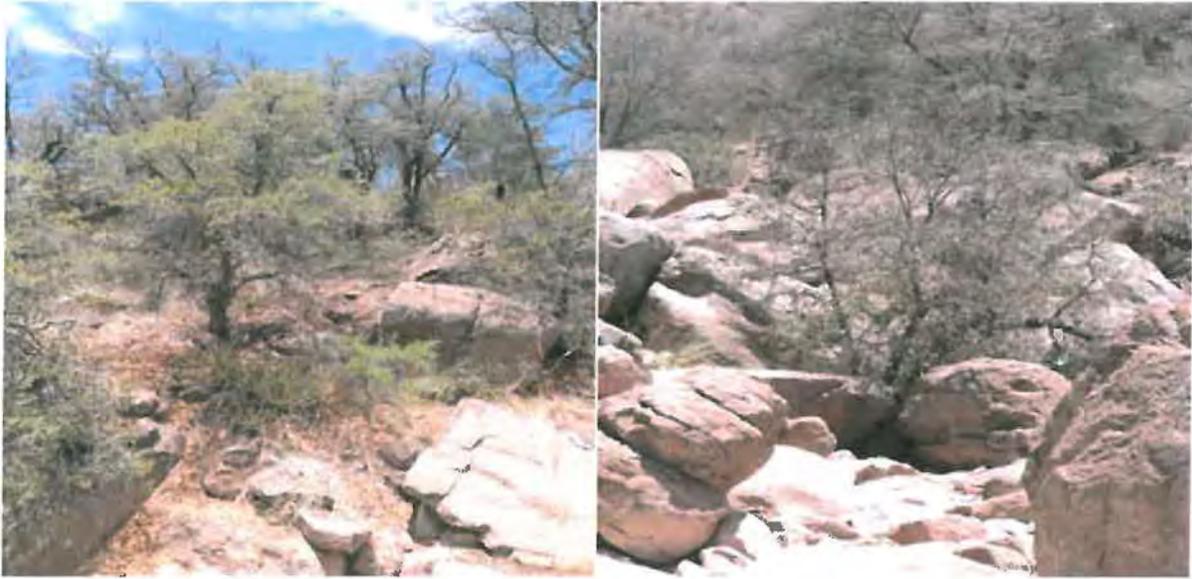
D2-6: Photographic reference for indicator 1.5. Photographs of stream bed, the bank/upland area and rooted in channel vegetation. There is no composition difference in vegetation between the bank and the upland area.

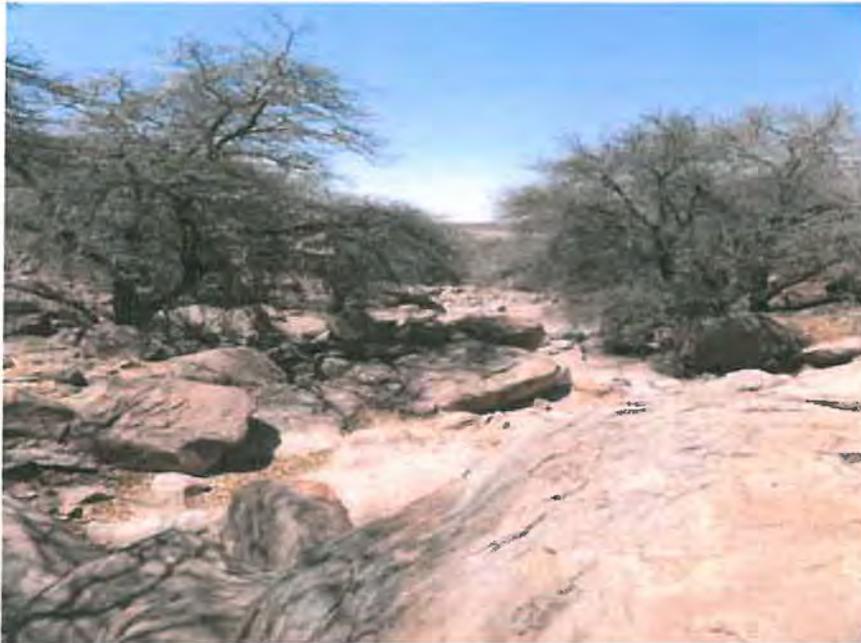
D3-1: Photographic reference of representative channel bottom characteristics. Note large boulders and cobbles in stream channel, similar to those observed on hillside. Note confining nature of hillside.

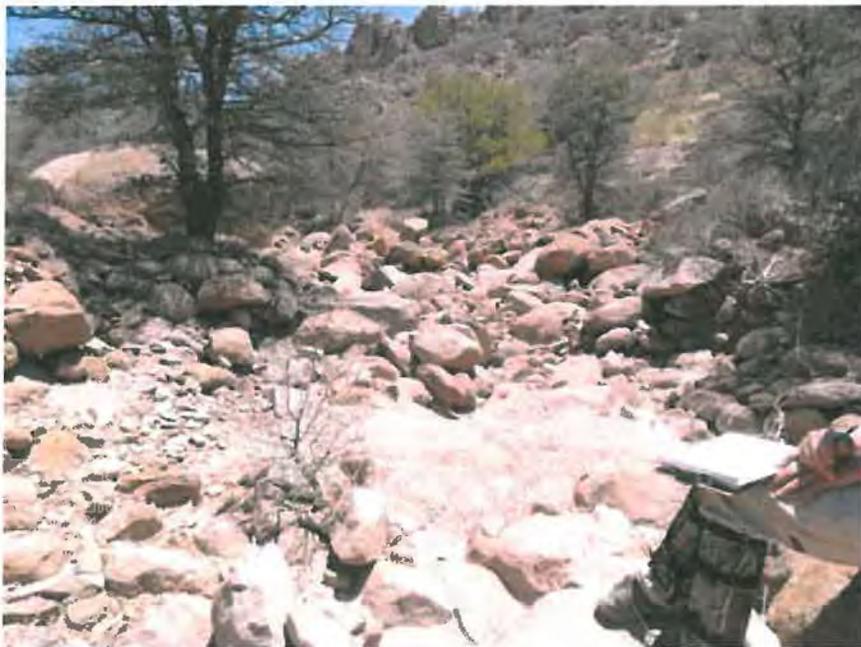
D3-2: Photographic reference for indicator 1.1 through 1.6. Photograph of stream bed. Indicator 1.6 scored as 2 – few rooted plants present in the streambed. Lack of instream vegetation most likely a result of the bed material present (boulders) rather than an indicator of flow persistence. No water or biotic indicators of water observed along survey reach.

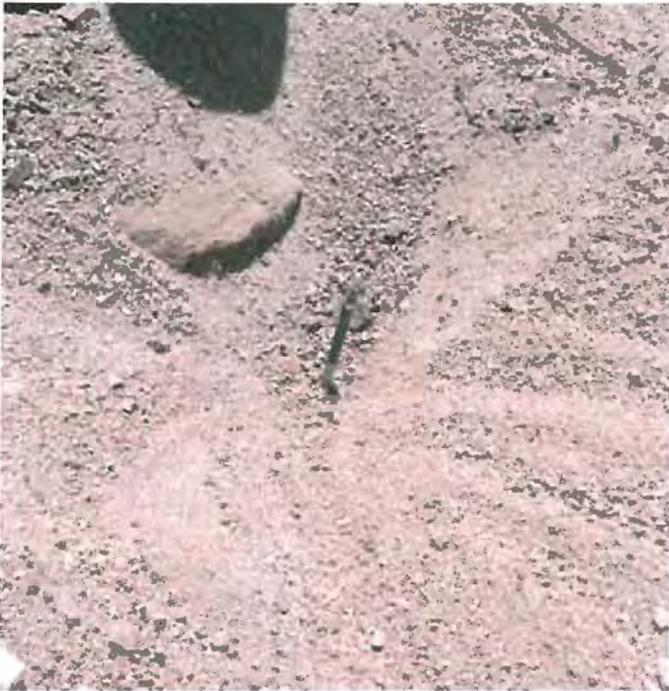
D3-3: Photographic reference for indicator 1.6. Photograph of 7 inch hole excavated in-channel. There is a complete lack of soil structure and moisture. Assessment unit is representative of channel bottom characteristics. Note dry mineral, sand sediments within channel.

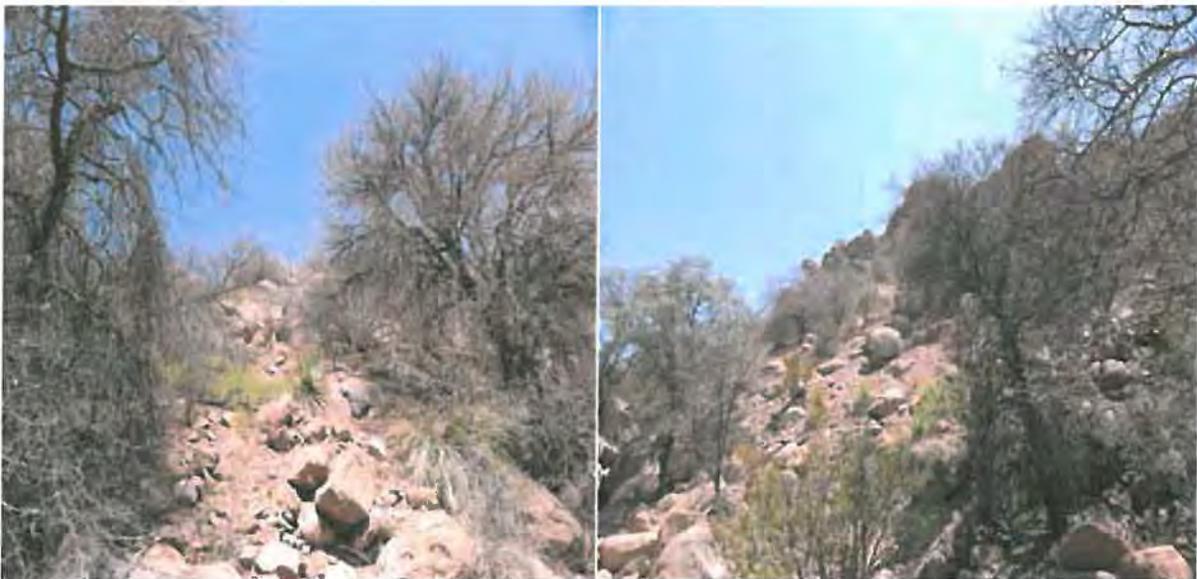
D3-4: Photographic reference for indicator 1.5. Photographs of stream bank and upland vegetation. Indicator 1.5 scored as 0. No vegetative compositional or density differences observed between the banks and the upland area.

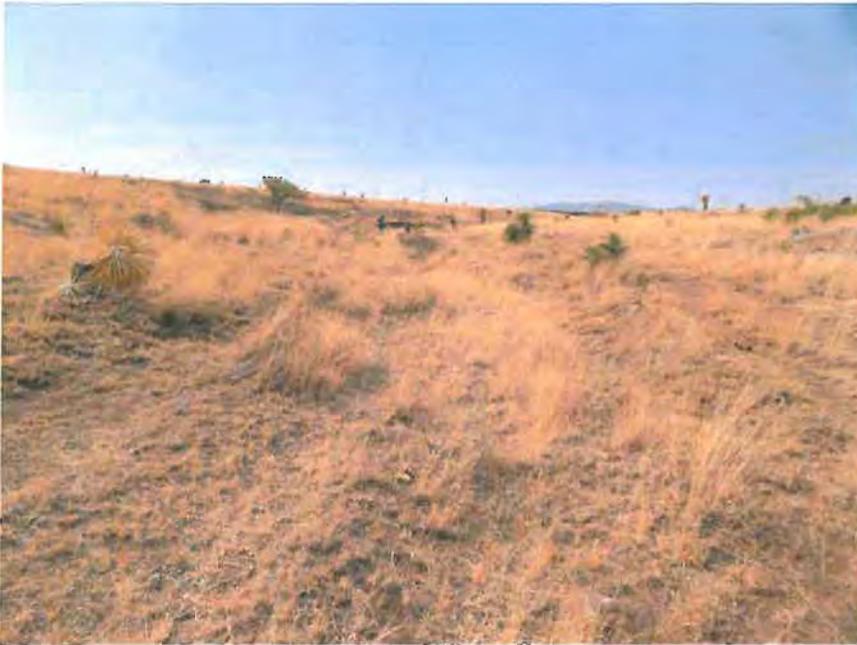
E1-1: Photographic reference of representative channel bottom and vegetation characteristics.

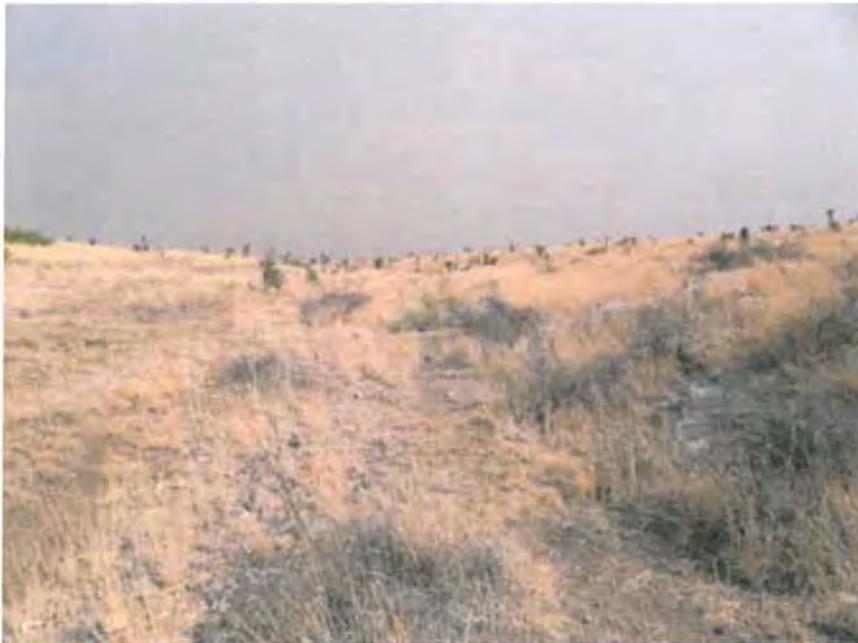
E1-2: Photographic reference for indicators 1.1 through 1.6. Photograph of stream bed. Indicator 1.6 scored as 0 - vegetation in stream bed is prevalent and consistent with bank and upslope areas. No water or biotic indicators of water observed along survey reach.

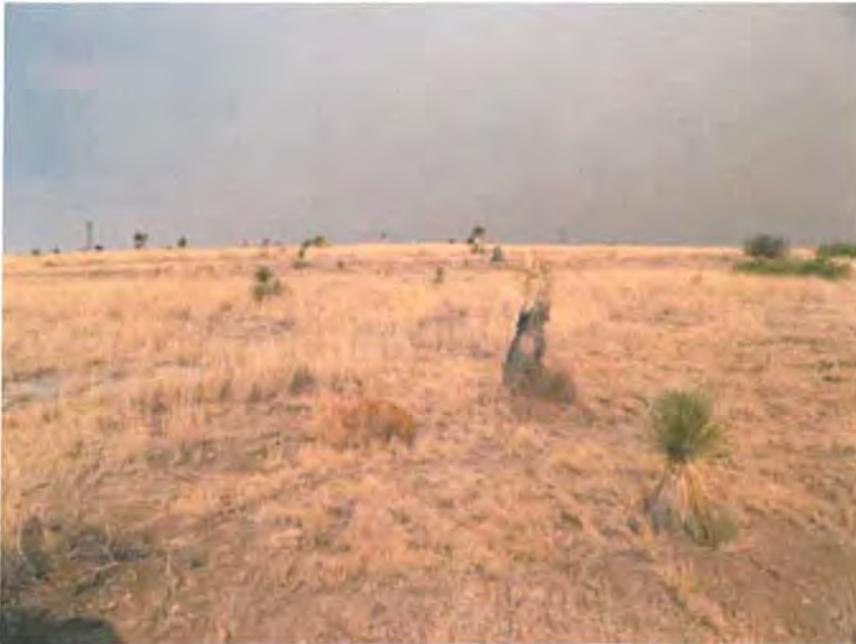
E1-3: Photographic reference for indicator 1.5. Photograph of the stream bank and upland areas. Indicator 1.5 scored as 0 - no vegetative compositional or density differences observed between the banks and the upland area.

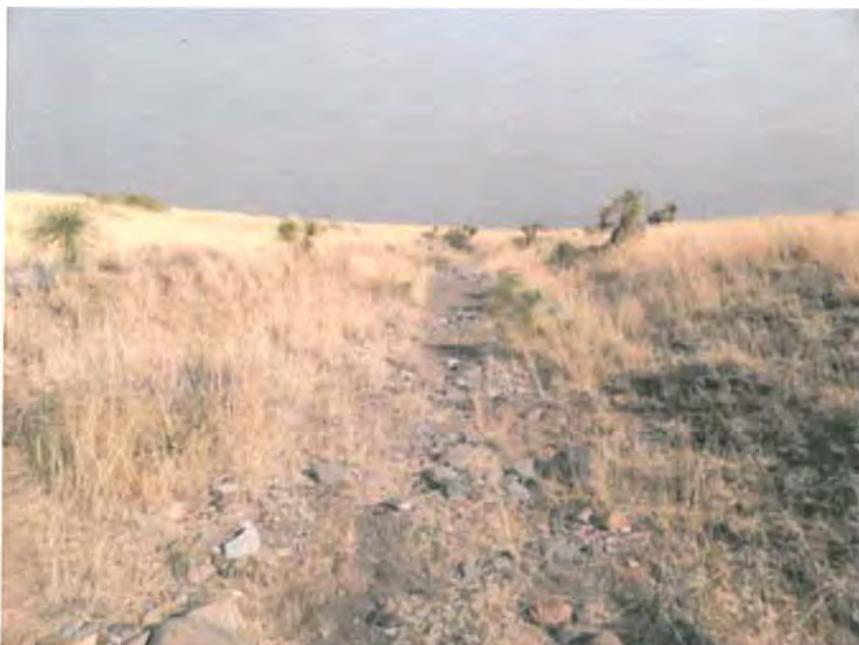
E2-1: Photographic reference for indicator 1.1 through 1.6. Photograph of the stream channel and the bank and upland areas. Indicator 1.5 scored as 0 - no vegetative compositional or density differences observed between the banks and the upland area. No water or biotic indicators of water observed along survey reach.

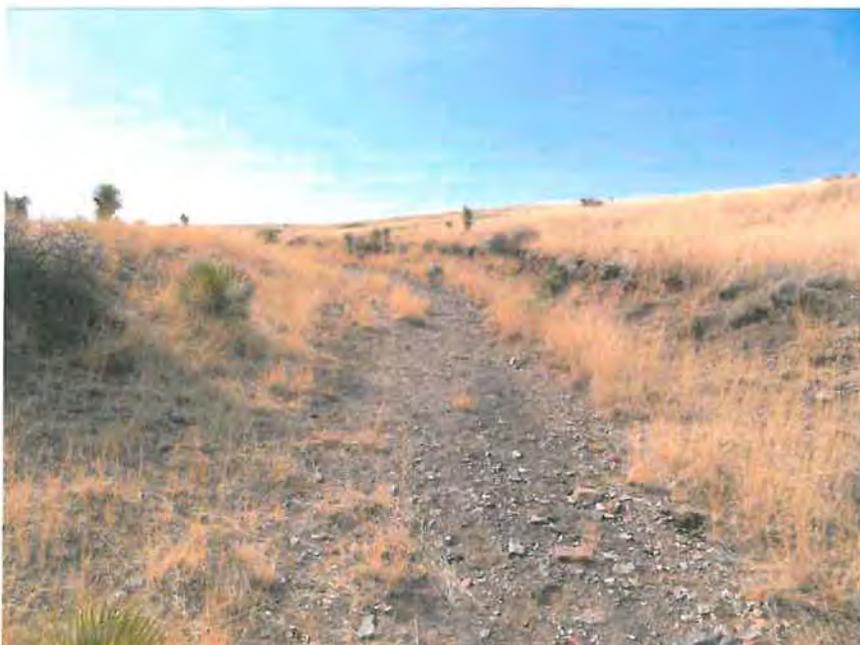
E2-2: Photographic reference of channel bed and bank.

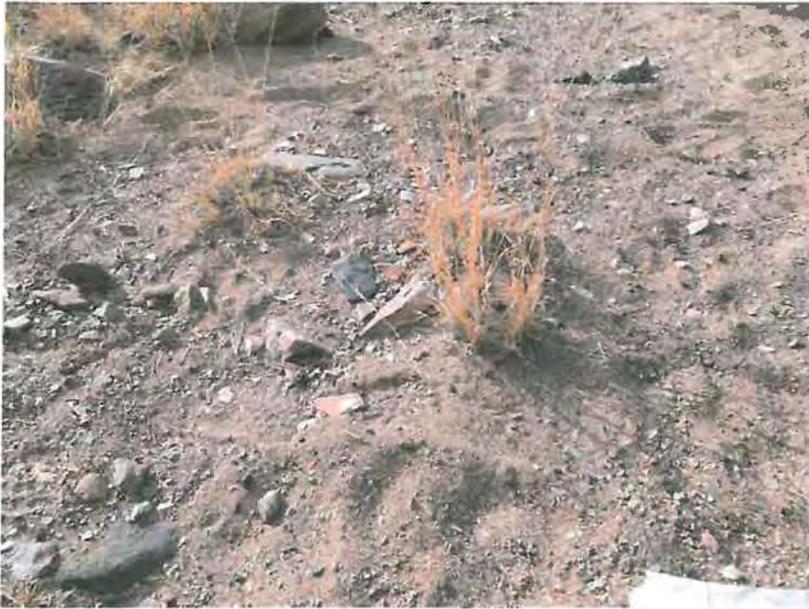
E2-3: Photographic reference of in-channel vegetation.

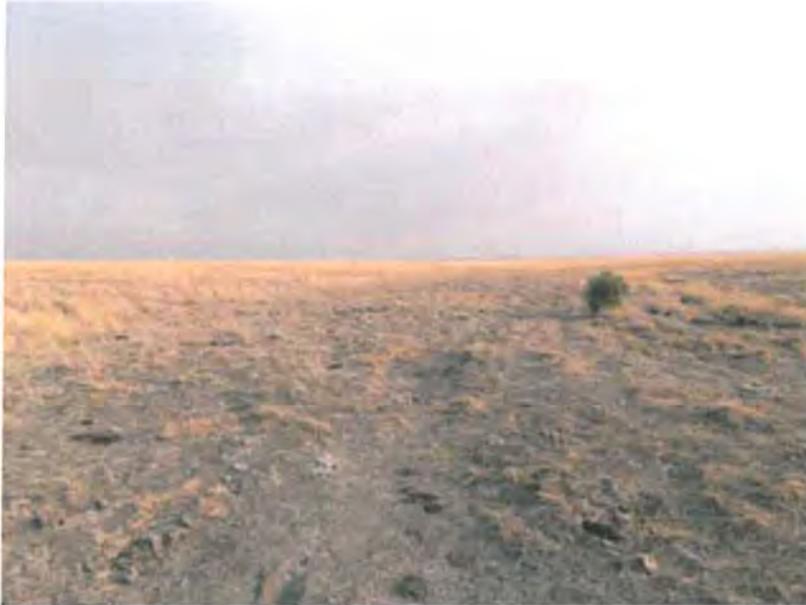
E3-1: Photographic reference for indicator 1.1 through 1.6. Photograph of the stream channel/lowland area and the bank and upland areas. Indicator 1.5 scored as 0 - no vegetative compositional or density differences observed between the banks and the upland area. No water or biotic indicators of water observed along survey reach.

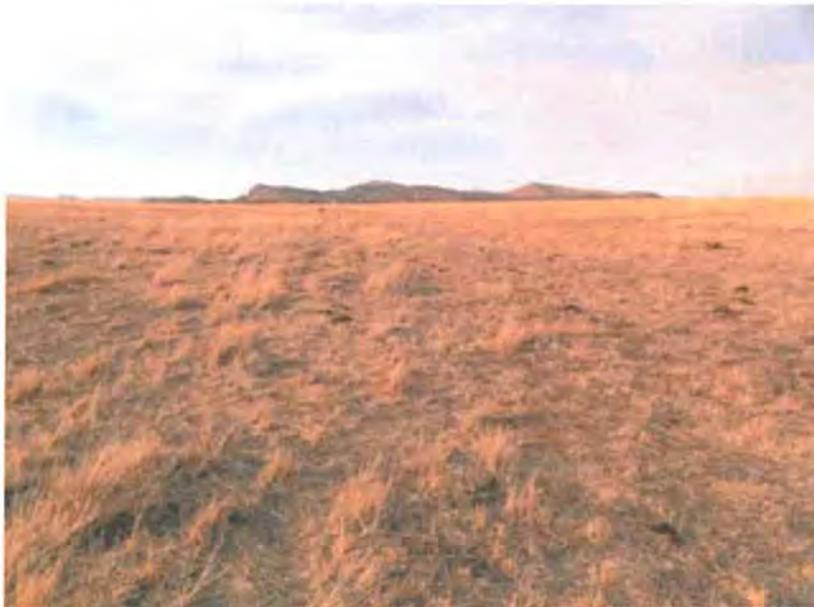
E3-2: Photographic reference for indicator 1.5. Photograph of the stream bank and upland area. Indicator 1.6 scored as 0 - vegetation in stream bed is prevalent and consistent with bank and upslope areas.

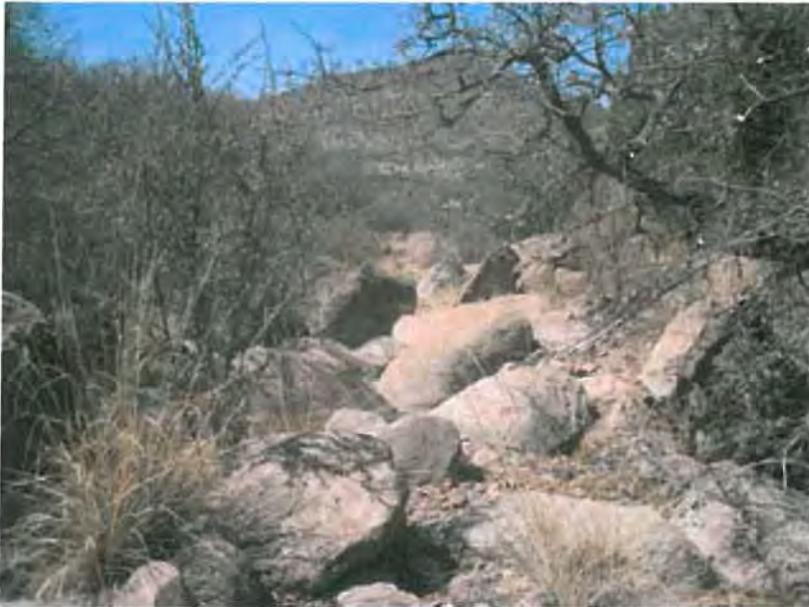
MC11-1: Photographic reference for indicators 1.1 through 1.6. Indicator 1.6 scored as 1. Vegetation in the channel bed is consistently dispersed throughout the streambed between the boulders and where deposition of finer grained material has occurred. No water or biotic indicators of water observed along survey reach.

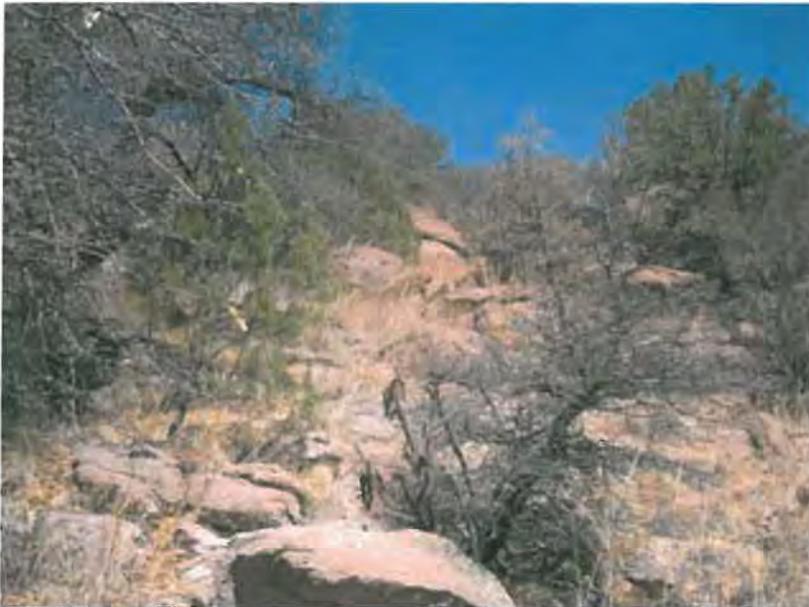
MC11-2: Photographic reference for indicator 1.5. Photograph of the bank and upland area. Indicator 1.5 scored as 1. Vegetation is similar in composition with some slight variation in density between the bank and the upland area.

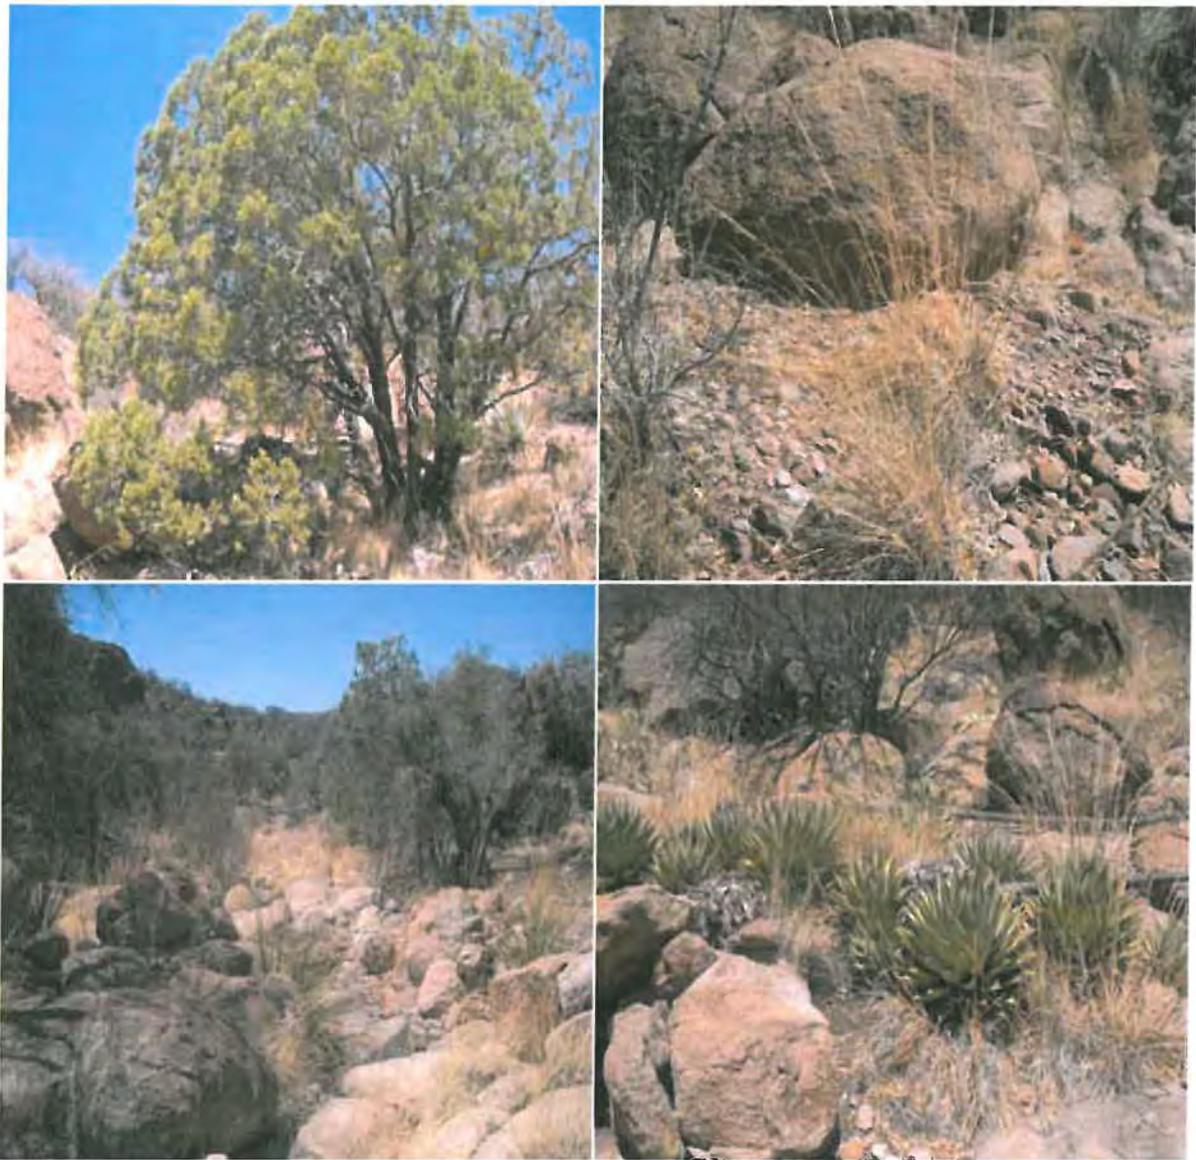
MC11-3: Photographic reference for indicators 1.5 and 1.6. Photographs of the bank/upland area and rooted in channel vegetation. Vegetation is similar in composition between the bank and the upland area. Vegetation is consistently dispersed throughout the channel.

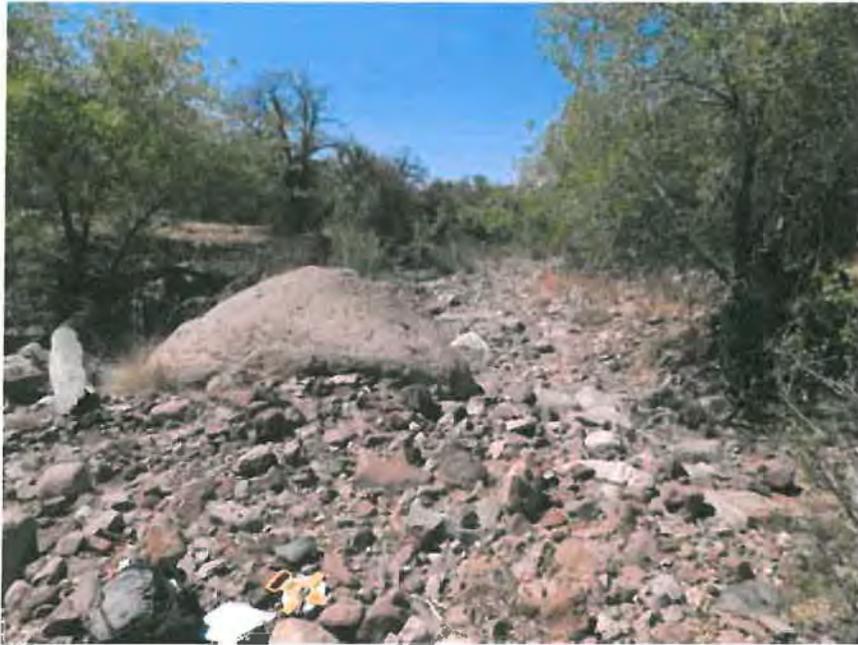
MC12-1: Photographic reference for indicators 1.1 through 1.6. No water or biotic indicators of water observed along survey reach. Channel bed material is predominantly boulders and sand and gravel.

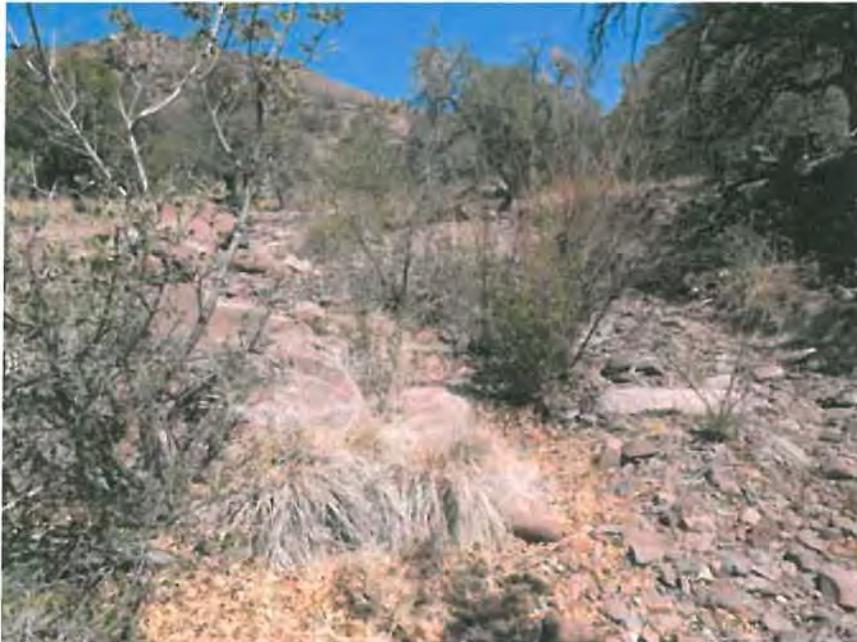
MC12-2: Photographic reference for indicator 1.6. Instream and bank vegetation shown. Indicator 1.6 scored as 1. Vegetation in channel is predominantly grasses and shrub species and are consistently dispersed throughout the channel.

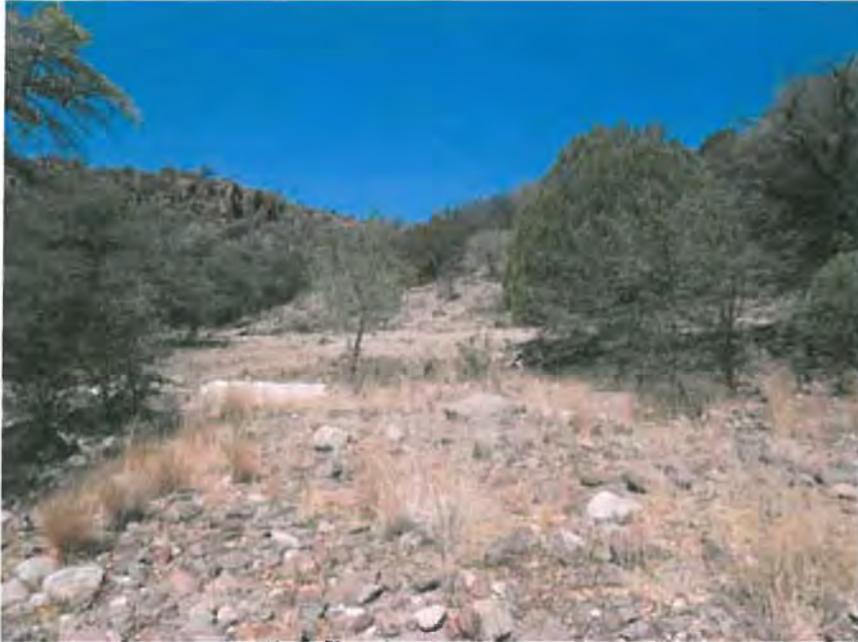
MC12-3: Photographic reference for indicator 1.5. Indicator 1.5 scored as 1. Upland vegetation is similar to what is observable along the banks and within the streambed (previous photograph). Density decrease slightly with distance from the stream but composition is similar.

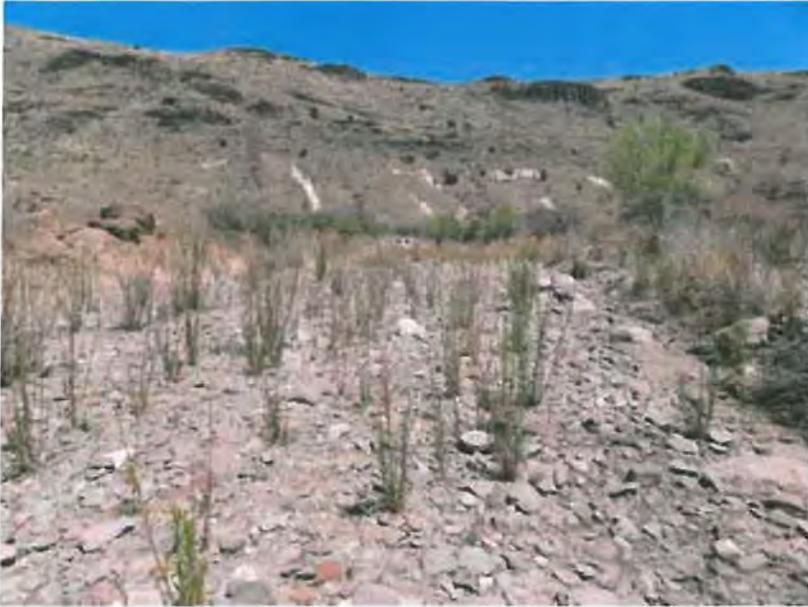
MC13-1: Photographic reference for indicator 1.1 through 1.6. Indicator 1.6 scored as 1. Rooted vegetation within the channel consists of grasses which are dispersed throughout the streambed. No water or biotic indicators of water observed along survey reach.

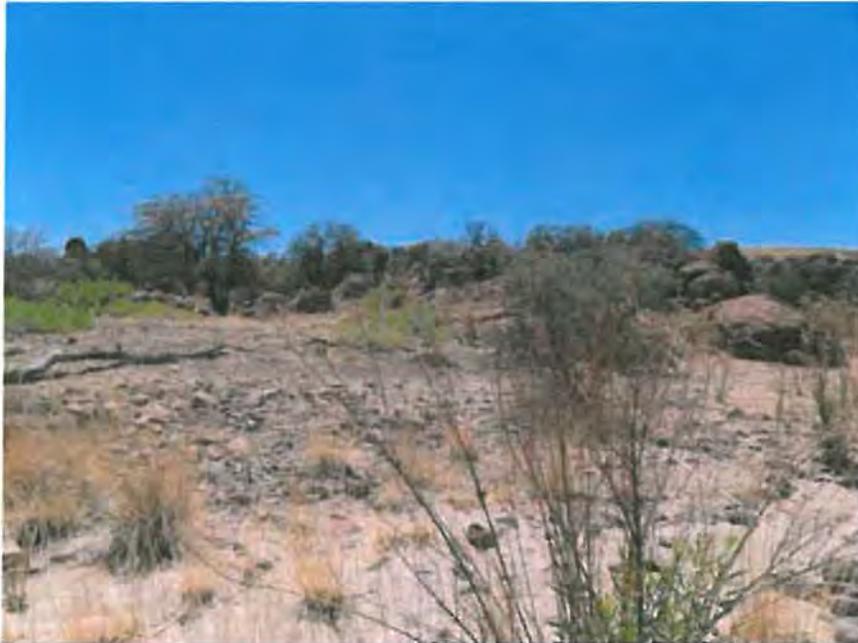
MC13-2: Photographic reference for indicator 1.5. Photograph of the overbank and upslope area. Indicator 1.5 scored as 1. Vegetation in the upslope area is similar to the vegetation along the banks and within the channel observed in the previous photograph. Minimal differences in density are observable. No distinct riparian zone exists.

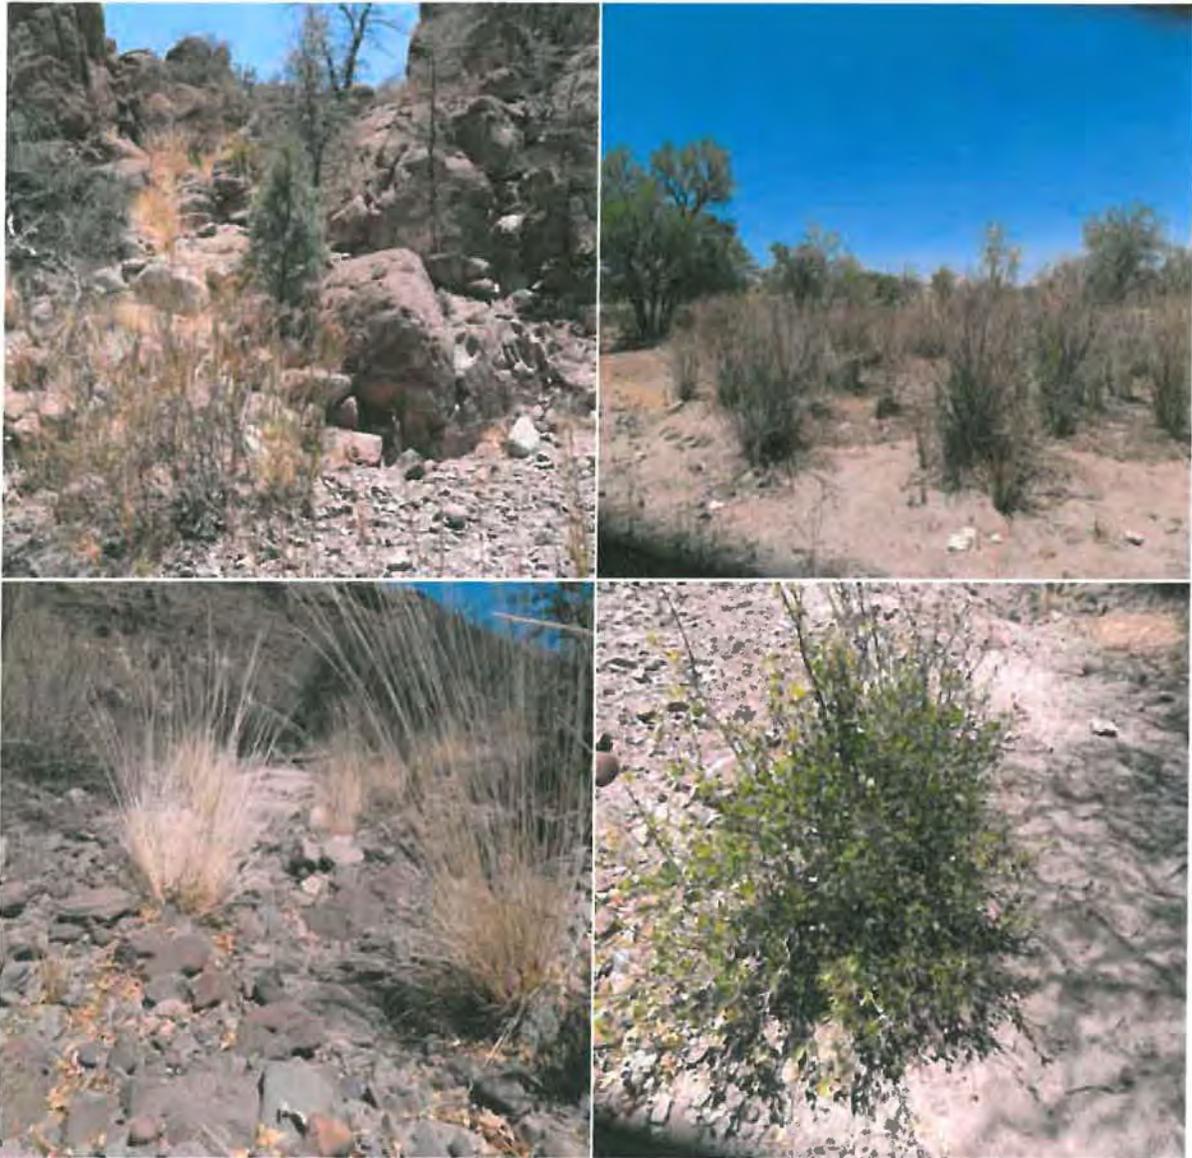
MC13-3: Photographic reference for indicators 1.5 and 1.6. Photographs of the bank/upland area and rooted in channel vegetation. Vegetation is similar in composition between the bank and the upland area. Vegetation is consistently dispersed throughout the channel.

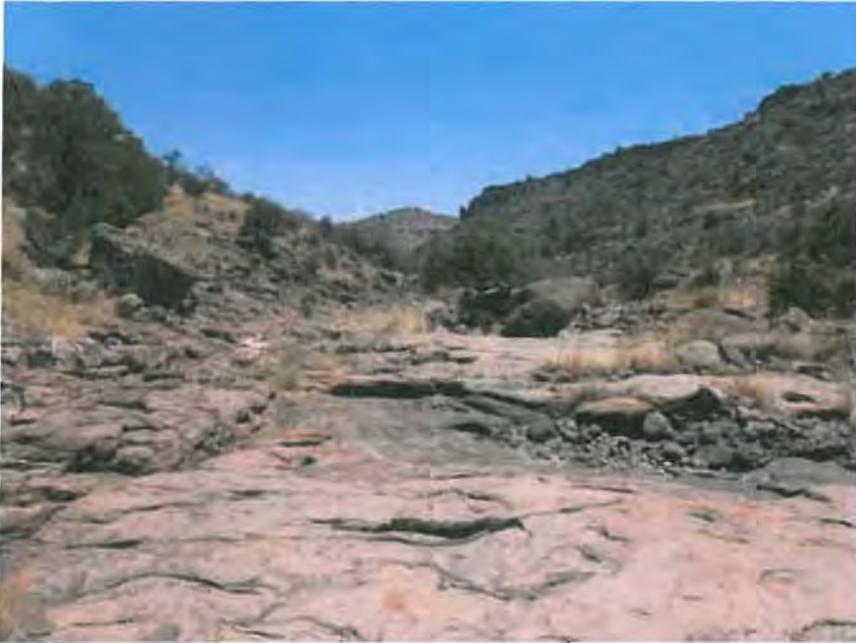
RC14A-1: Photographic reference for indicators 1.1 through 1.6 and 1.9. Water and biotic indicators of water were observed along the reach (see subsequent photos). Channel bed is predominantly bedrock. Note the small dry pool area located in the center right of photograph.

Indicator 1.9 scored as 1 - channel is partially confined with an inactive floodplain.

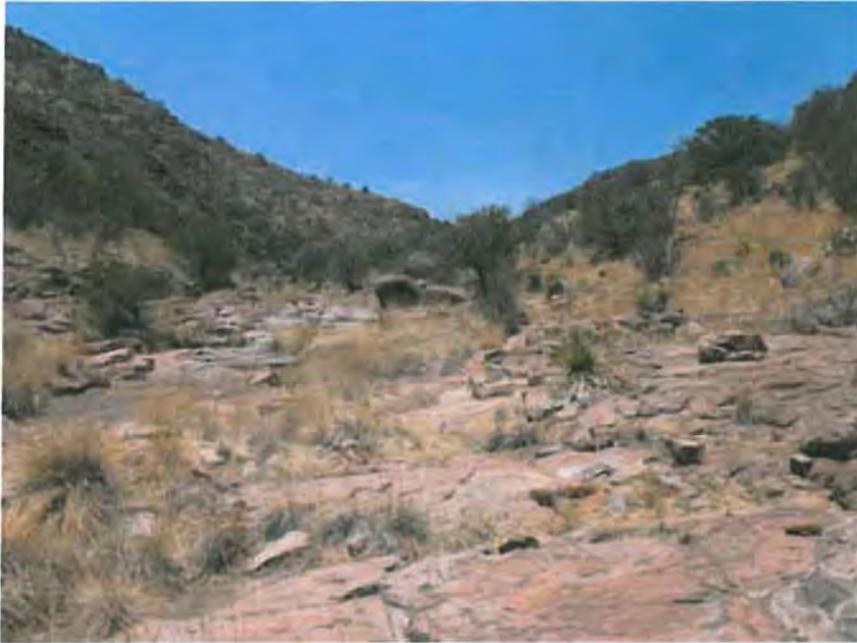
RC14A-2: Photographic reference for indicator 1.5. Indicator 1.5 scored as 1. Vegetation along the reach is compositionally consistent between the bank and the upland area with some differences in density observed. Distinct riparian zone not present.

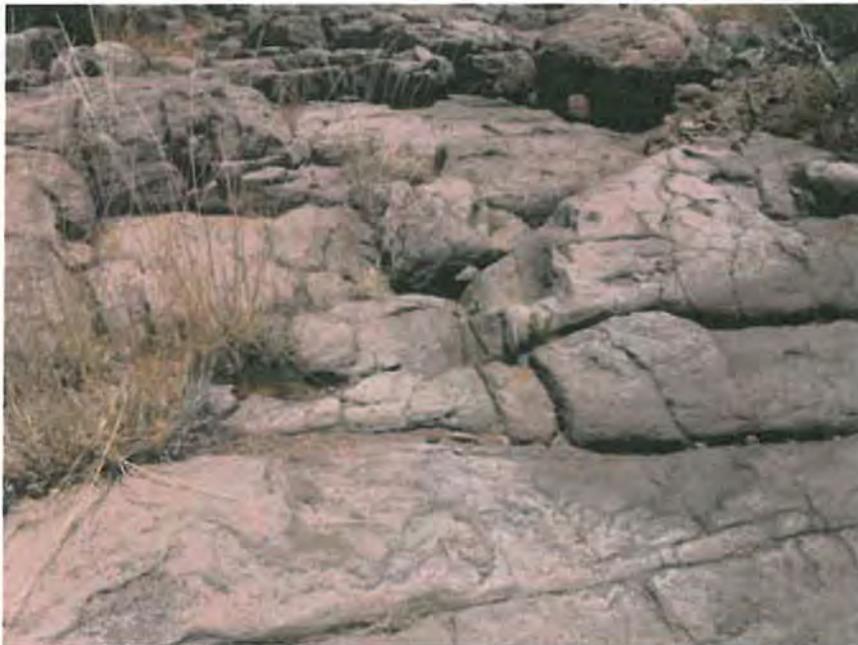
RC14A-3: Photographic reference for indicator 1.6. Indicator 1.6 scored as 2. A few rooted grasses are present in the streambed but are generally not present because of the bedrock present.
