**Application of the Hydrology
Protocol to STSIU Drainages**

Chino Mines, Vanadium, New Mexico

**Application of Hydrology
Protocol to STSIU Drainages**

Date:
November 2012

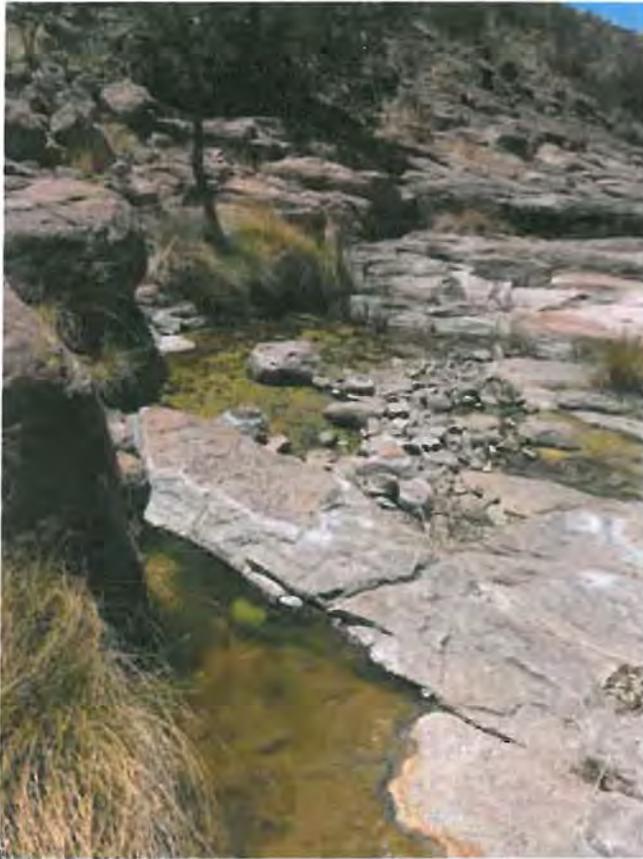
RC14A-4: Channel is primarily dry with small pools and standing water observed along the stream stretch. Indicator 1.1 scored as 2. No fish were present in the pools but benthic macroinvertebrates and filamentous algae/periphyton were observed after extensive searching. Both indicators 1.3 and 1.4 scored as 1. Seeps were observed to feed the pools; however, the pools are isolated.

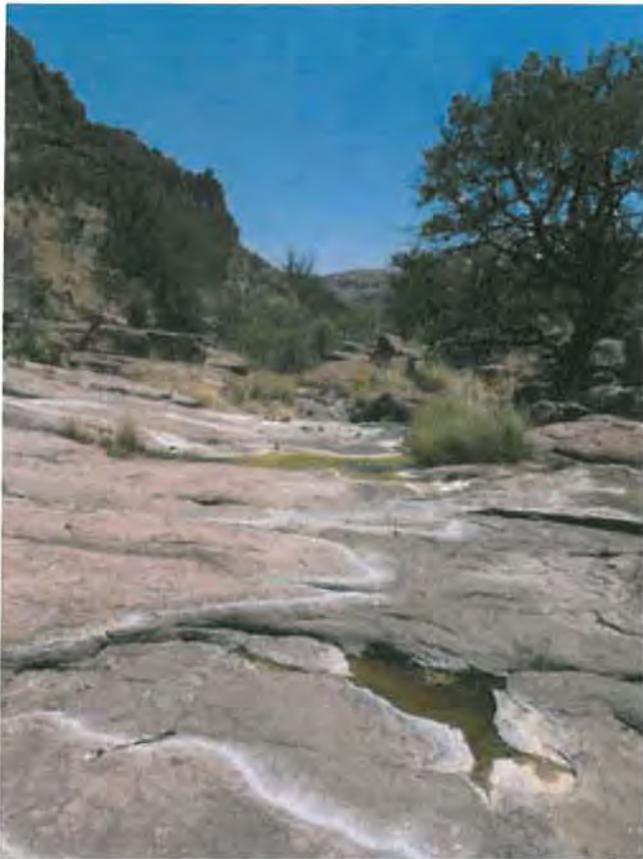
RC14A-5: Channel is primarily dry with small pools and standing water observed along the stream stretch. Filamentous algae/periphyton were observed after extensive searching.

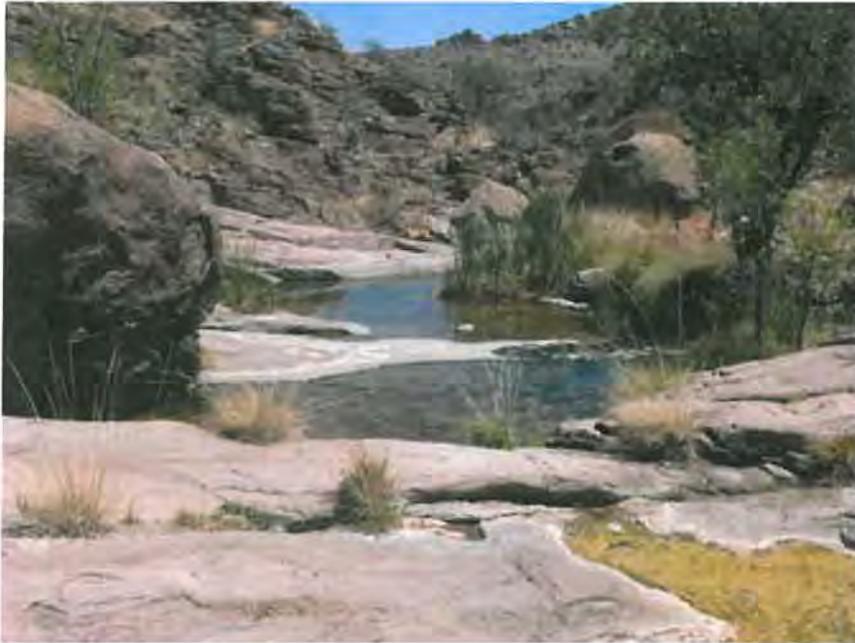
RC14B-1: Photographic reference for indicators 1.1 through 1.6 and 1.9. Biotic indicators of water and water were observed along the reach (see subsequent photos). Multiple isolated pools present along the stretch and springs/seeps observed. Biotic indicators of water found with little difficulty.

Indicator 1.5 scored as 2 - distinct riparian corridor present for parts of the stretch near pools as bank and upland vegetation is noticeably lush.

Indicator 1.9 scored as 1 – pool sequences likely but difficult to discern. Stream morphology is dominated by bedrock features.

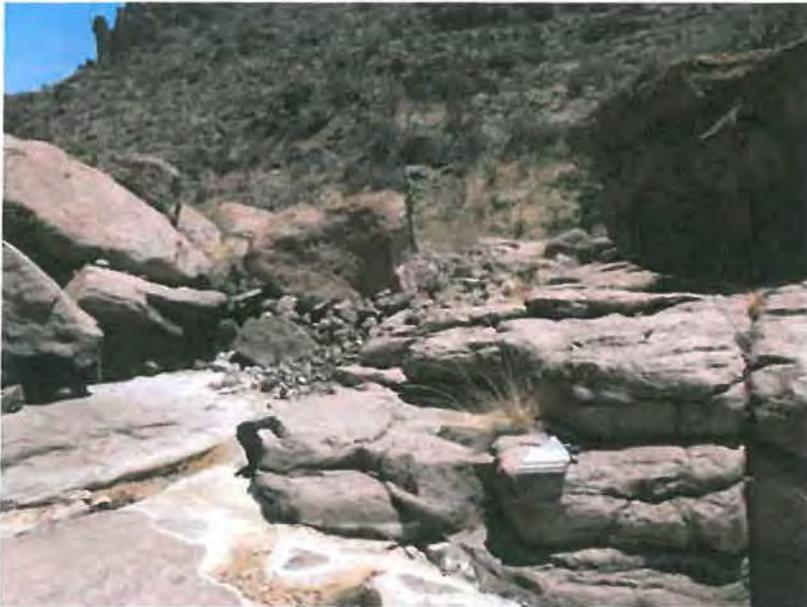
RC14B-2: Photographic reference for indicator 1.5. Photograph is of channel, bank, and upland area. Indicator 1.5 scored as 2 - distinct riparian zone not evident along portions of stream where pools are not present. Area shown in photograph is noticeably lacking riparian vegetation. Indicates that water is only persistent in areas where pools are maintained by bedrock springs.

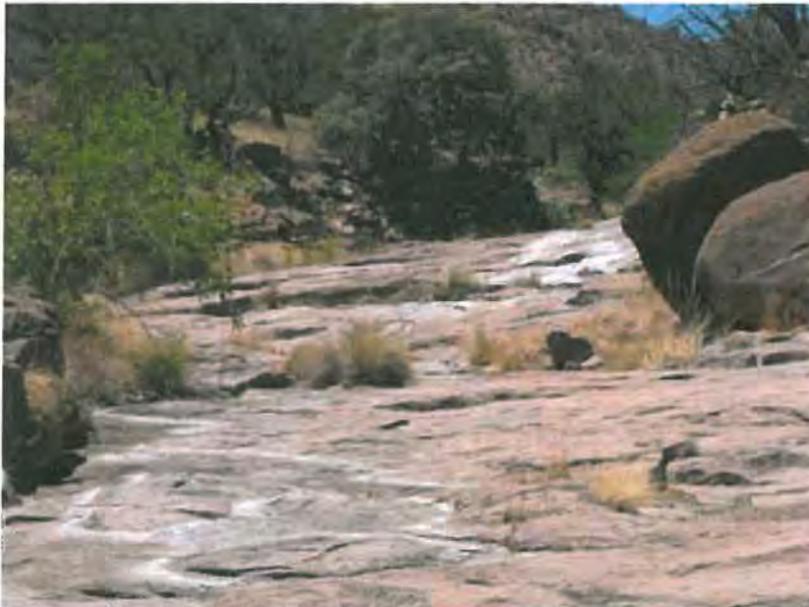
RC14B-3: Photographic reference for indicator 1.6. Indicator 1.6 scored as 2. Rooted vegetation present in the streambed, but limited by bedrock rather than persistence of flow.

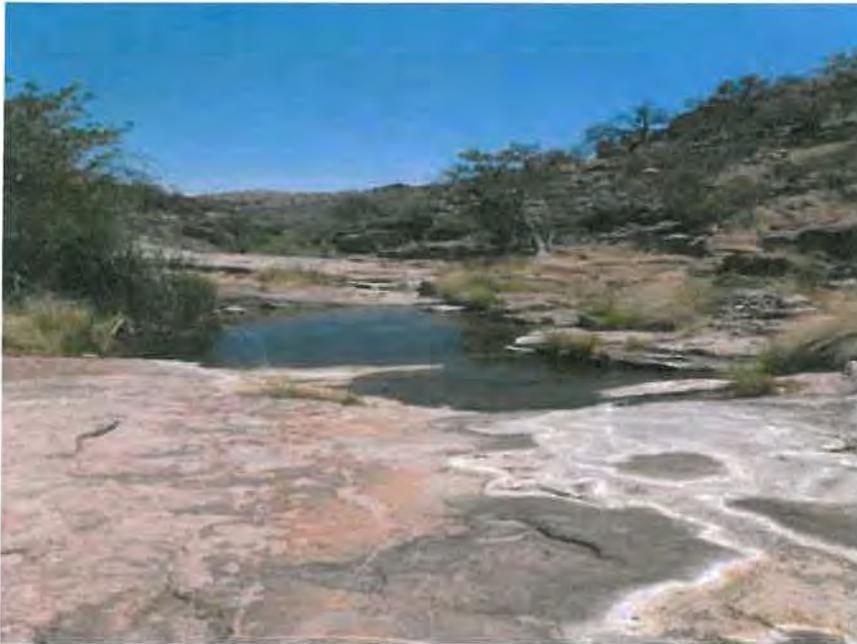
RC14B-4: Photographic reference of representative channel bottom characteristics.

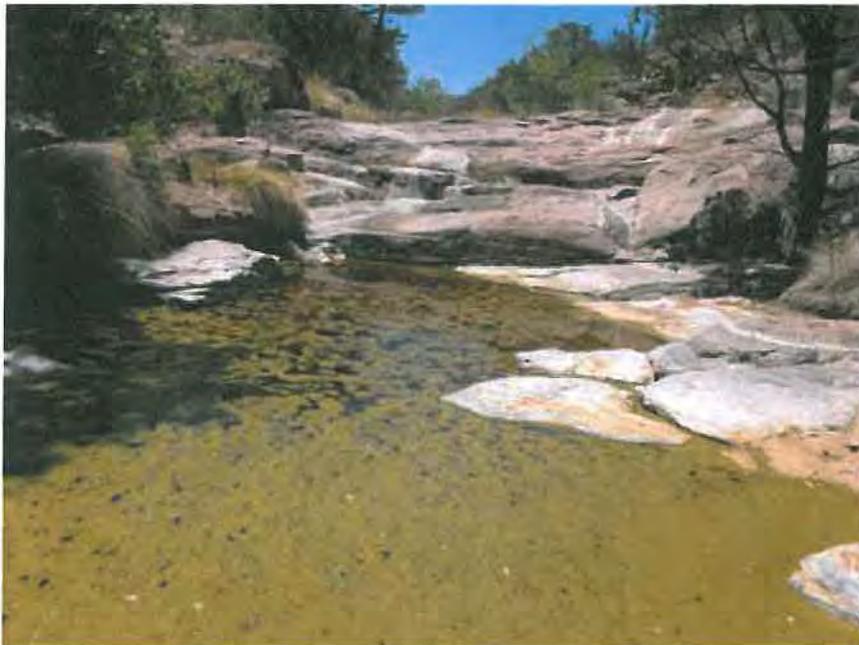
RC14B-5: Photographic reference of algae and benthic macro-invertebrates located near standing water.

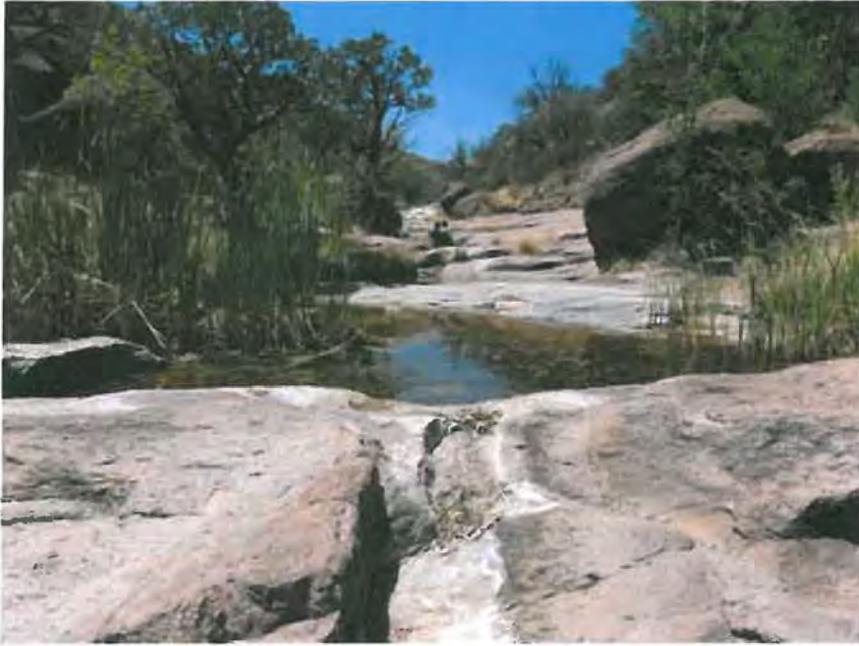
RC14B-6: Photographic reference for indicators 1.1 through 1.6. Filamentous algae/periphyton was observed along the reach. Multiple isolated pools present along the stretch. Biotic indicators of water found with little difficulty.

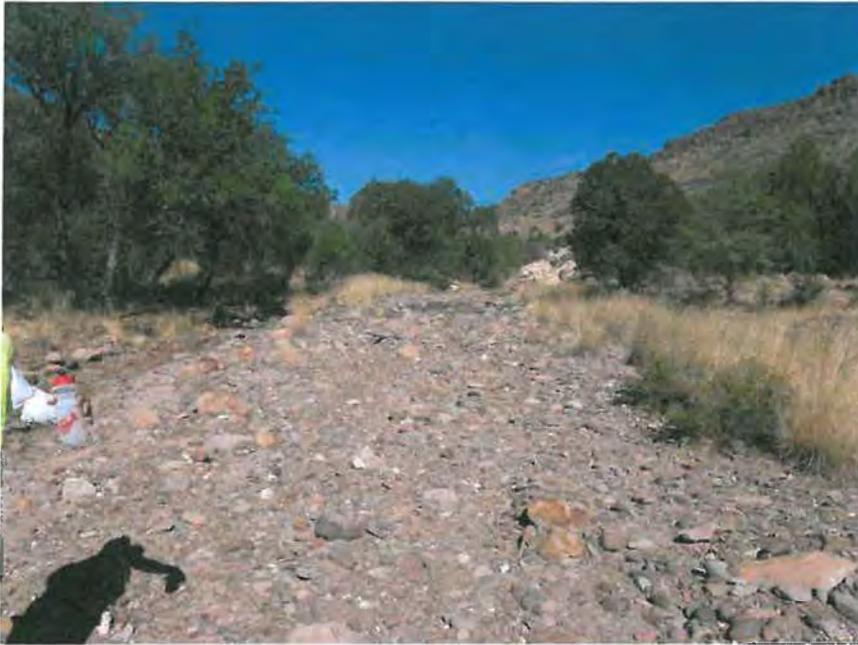
RC15-1: Photographic reference of representative channel bottom characteristics.

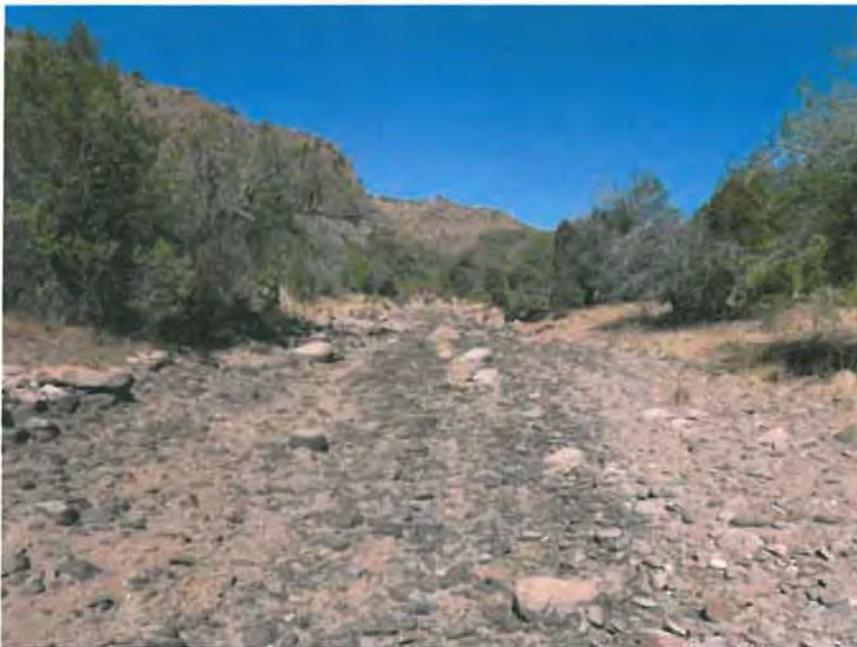
RC15-2: Photographic reference for indicators 1.1 through 1.6. No water observed over survey reach. Indicator 1.6 scored as 2 - few rooted plants along streambed. Vegetation limited by streambed material which is primarily coarse grain material and boulders.

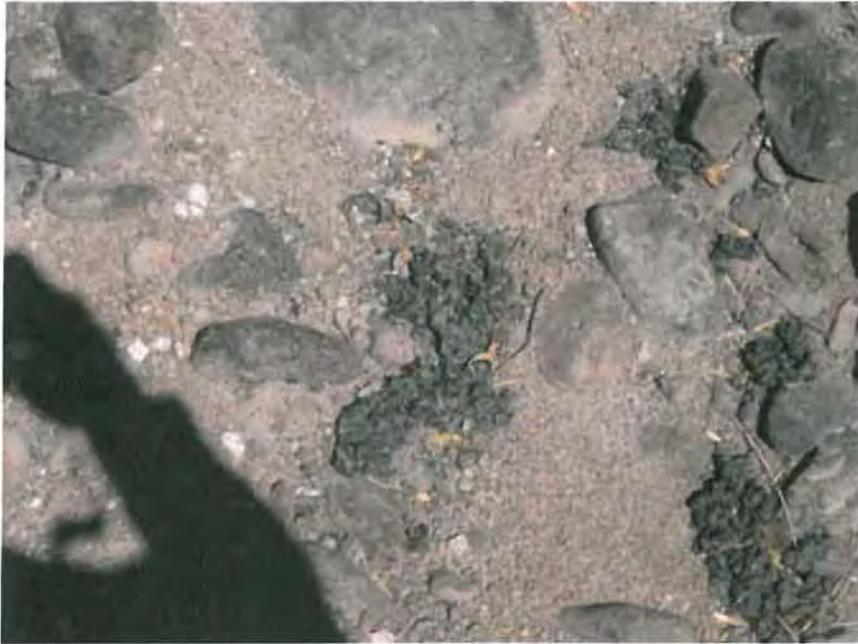
RC15-3: Photographic reference for indicator 1.4. Indicator 1.4 scored as 1. Algae is present in stream but is very isolated.

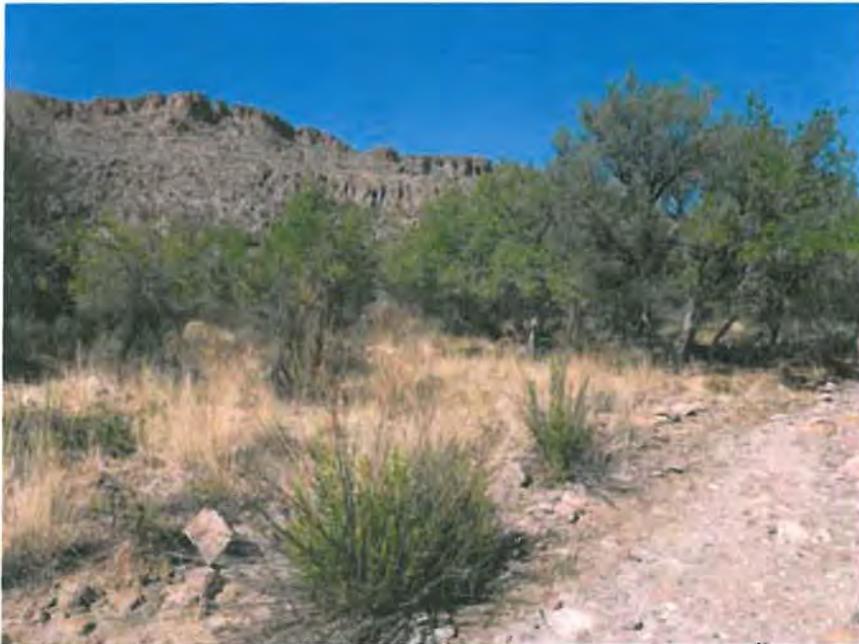
RC15-4: Photographic reference for indicator 1.5. Photograph of stream bank and upland area. Indicator 1.5 scored as 2. Distinct riparian corridor exists over portions of the reach but are not consistent over the entirety of the reach.

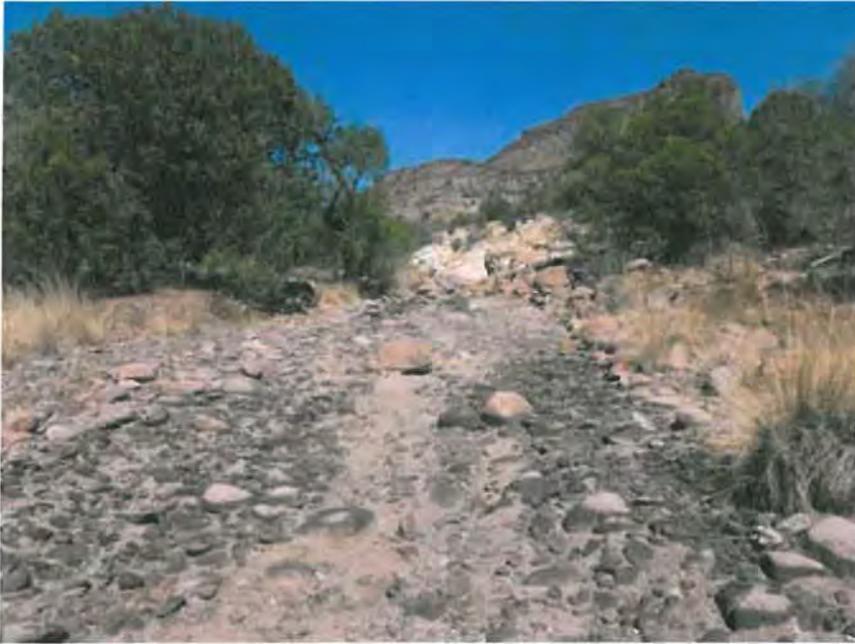
RC15-5: Photographic reference for indicator 1.8. Photograph of the general proximity of the stream cross-section transect. Indicator 1.8 scored as 1.5. Stream is moderately confined with an inactive flood plain based on vegetative growth.

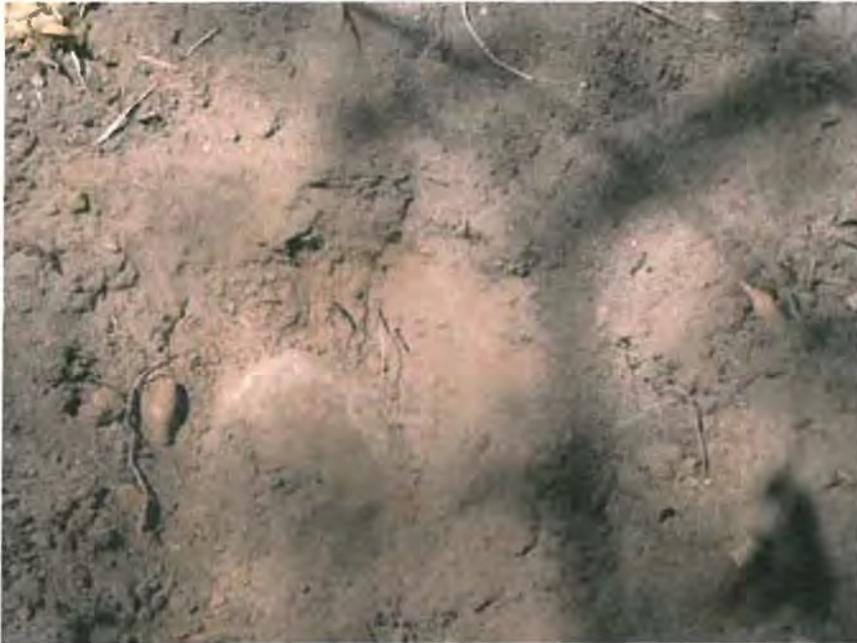
RC15-7: Photographic reference for indicator 1.10. Photograph is example of soil in the floodplain. Indicator 1.10 scored as 3. Distinct differences observed between soil outside of the streambed and the soil within the streambed. Streambed distribution of substrate material evident where finer material drops in pools and areas of lower velocity flow, while other portions of the stream bed are coarser materials.

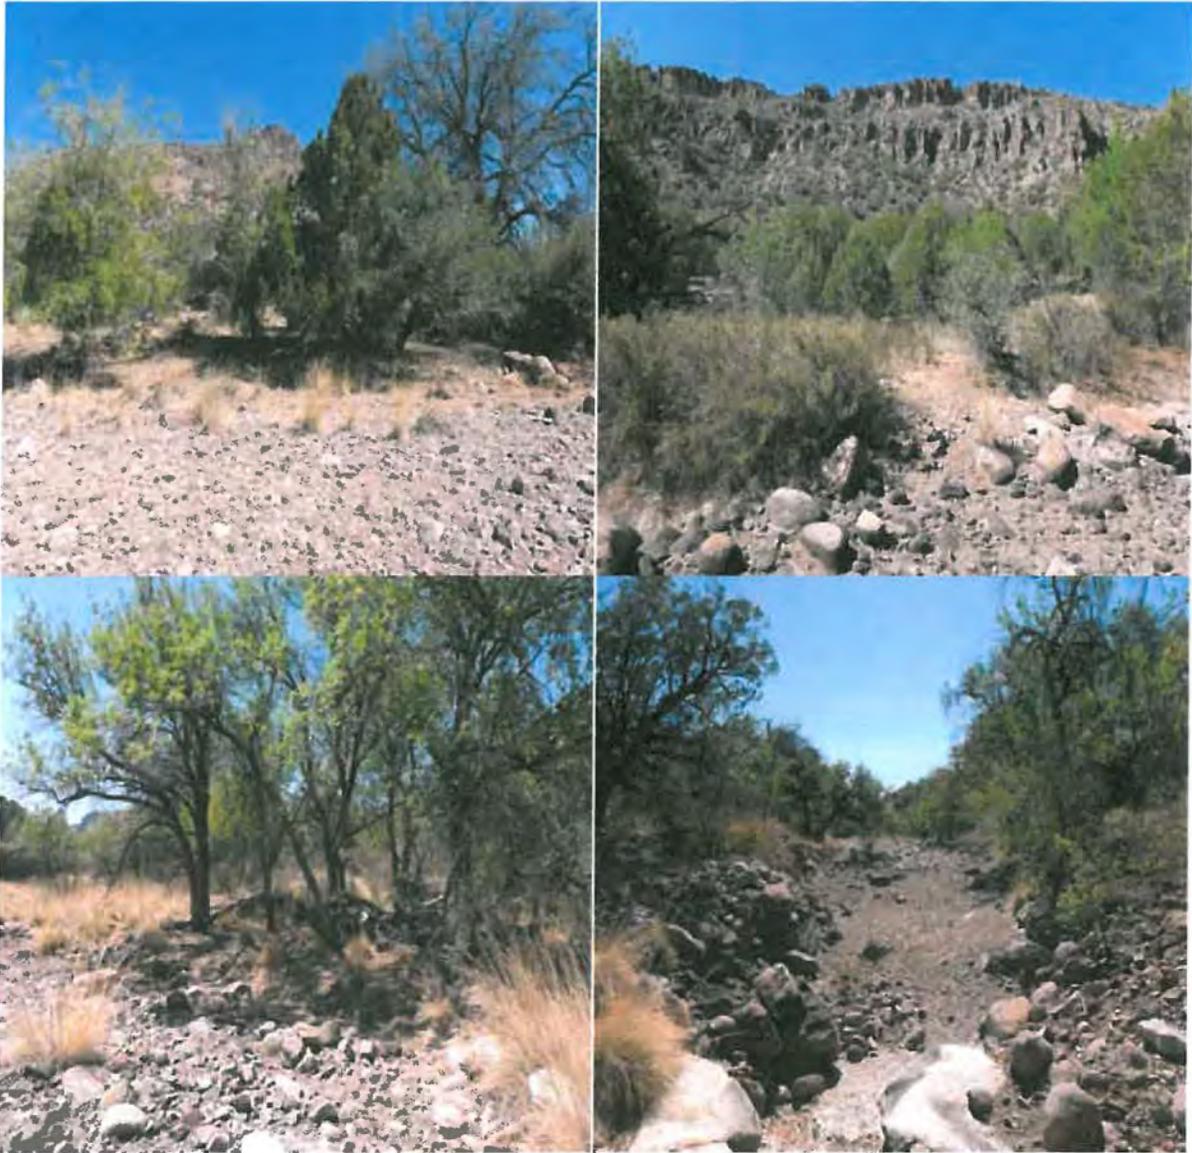
RC15-8: Photographic reference for indicators 1.5 and 1.6. Photographs of the bank/upland area and rooted in channel vegetation. Distinct riparian corridor exists over portions of the reach. Vegetation is inconsistently dispersed throughout the channel.

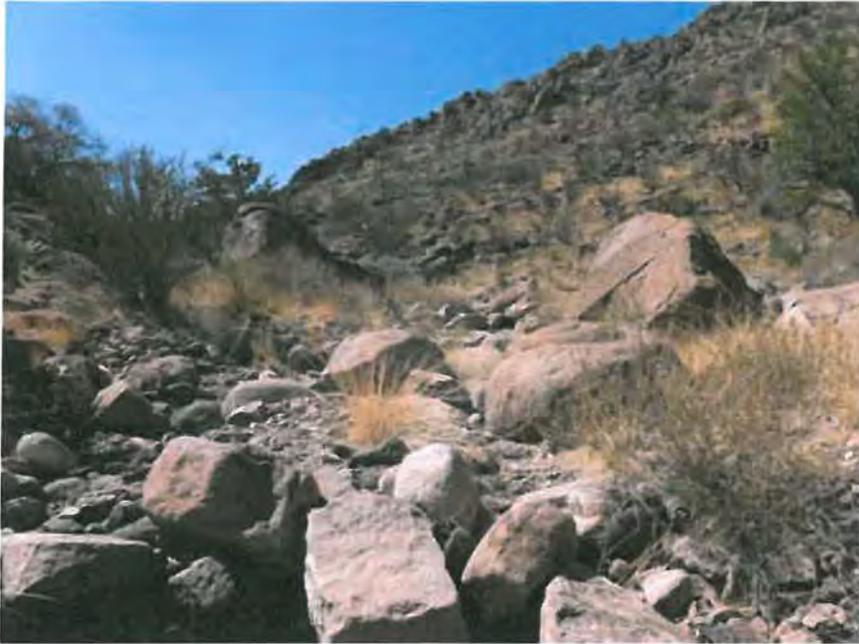
RC2-22-1: Photographic reference for indicators 1.1 through 1.6. Indicator 1.6 scored as 1 – rooted upland plants consistently dispersed throughout streambed. Channel bed is primarily gravel and boulders. No water or biotic indicators of water observed along survey reach.

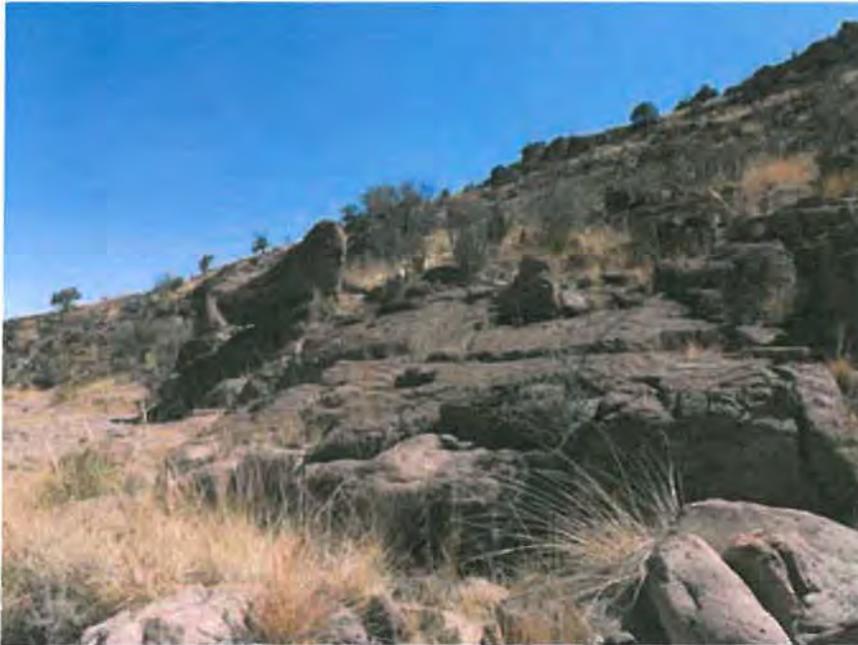
RC2-22-2: Photographic reference for indicator 1.5. Indicator 1.5 scored as 1. Vegetation along banks of the reach is similar in composition as vegetation in the upland areas. Some density differences were evident.

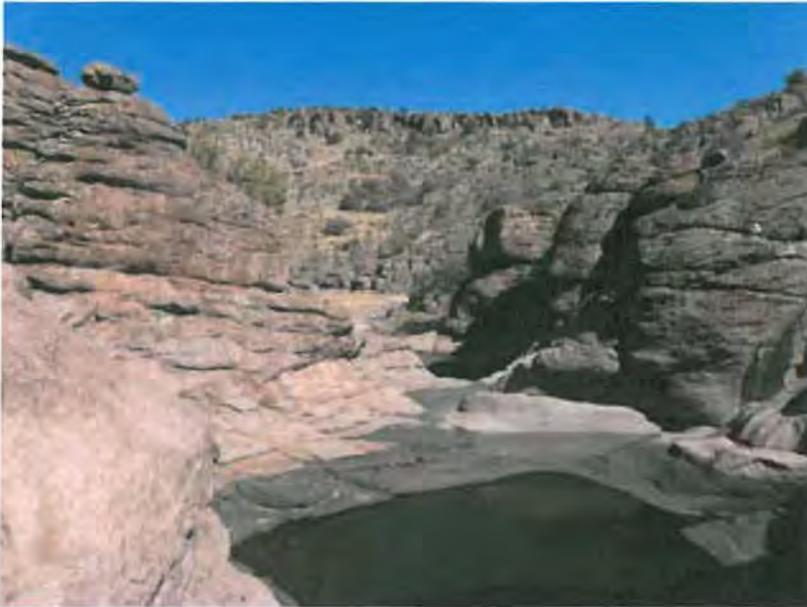
RC2-22B-1: Photographic reference for indicator 1.1 through 1.5. Small isolated pools are located along the sample reach. Seeps or springs were not observed along the reach. Biotic indicators of persistent water located with little effort but are not consistent throughout the reach. Indicators 1.1, 1.3, and 1.4 scored as 2.

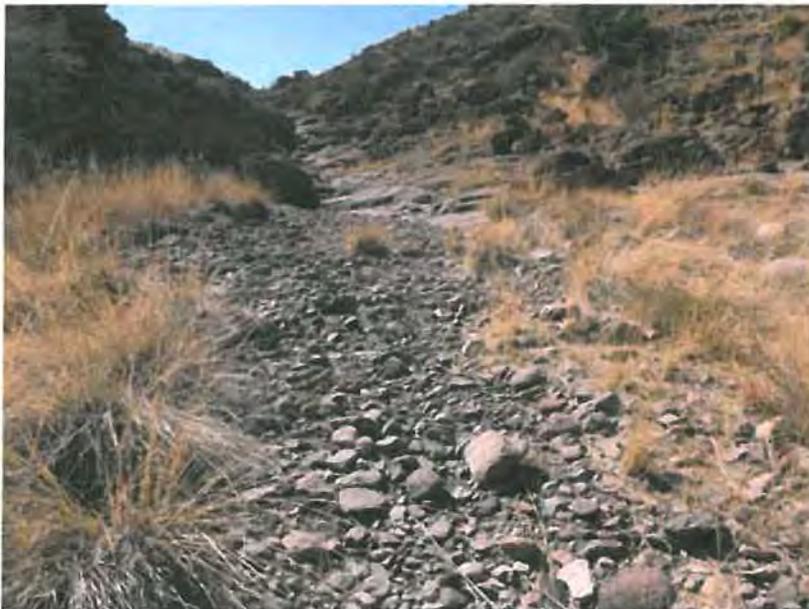
RC2-22B-2: Photographic reference for indicator 1.6. Streambed and geomorphology is dominated by bedrock. Indicator 1.6 scored as 2. Rooted vegetation is present along some portions of the stream reach, but is inconsistent.

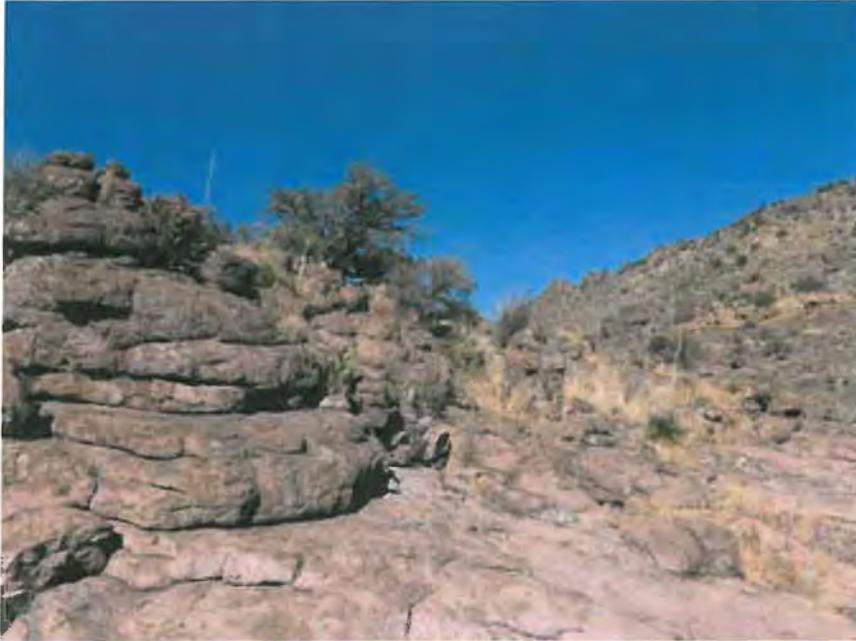
RC2-22B-3: Photographic reference for indicator 1.5. Indicator 1.5 scored as 0 - compositional and density differences in vegetation between stream bank and upland area not evident. No distinct riparian zone present.

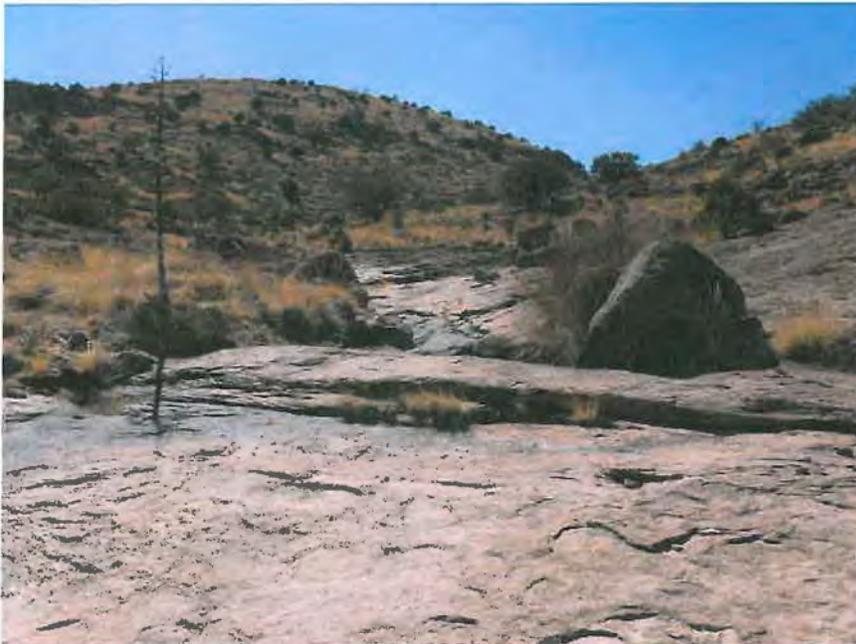
RC2-22B-4: Photographic reference of bedrock controlled channel.

Both assessment units within West Branch Rustler Canyon (RC-22 and RC-22B) represent bedrock controlled stream channels (Photos RC2-22-3 and RC2-22B-4, respectively); however, the location of the downstream assessment unit (RC-22B) was selected to include a number of large standing pools of water (Photos RC2-22B-5 and RC2-22B-6). Based on the presence of standing water and the observed benthic macro-invertebrates within the downstream assessment unit (RC-22B) (Photo RC2-22B-7) the West Branch Rustler Canyon hydrologic classification is indeterminate, assumed to be intermittent until further study indicates ephemeral.

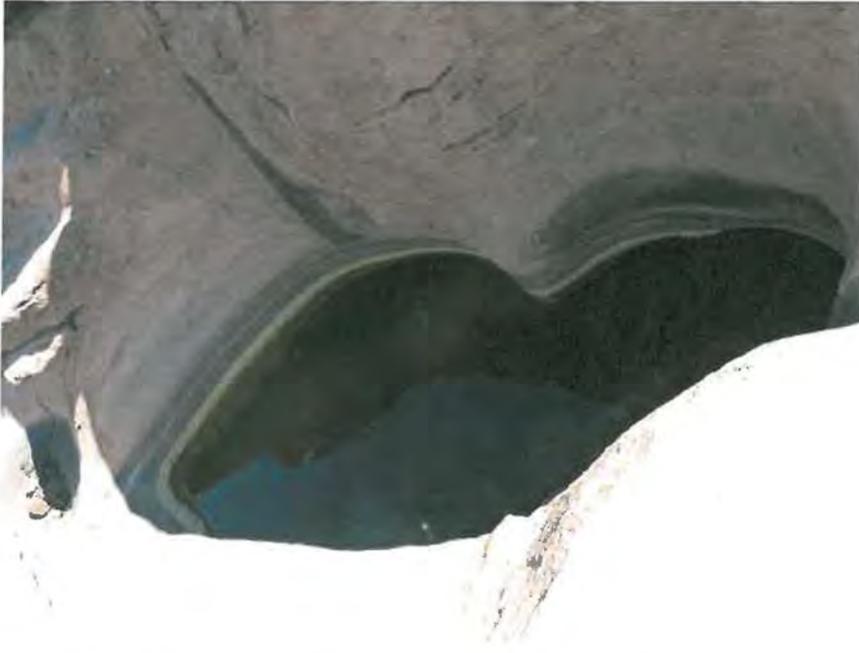
RC2-22B-5: Photographic reference of standing pool within downstream West Branch Rustler Canyon assessment unit.

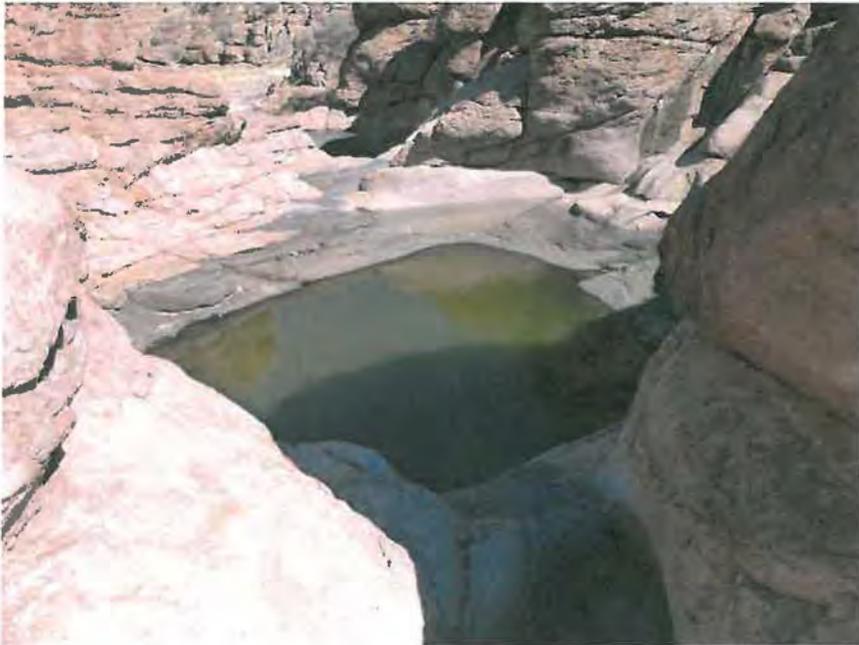
RC2-22B-6: Photographic reference of standing pool within downstream West Branch Rustler Canyon assessment unit.

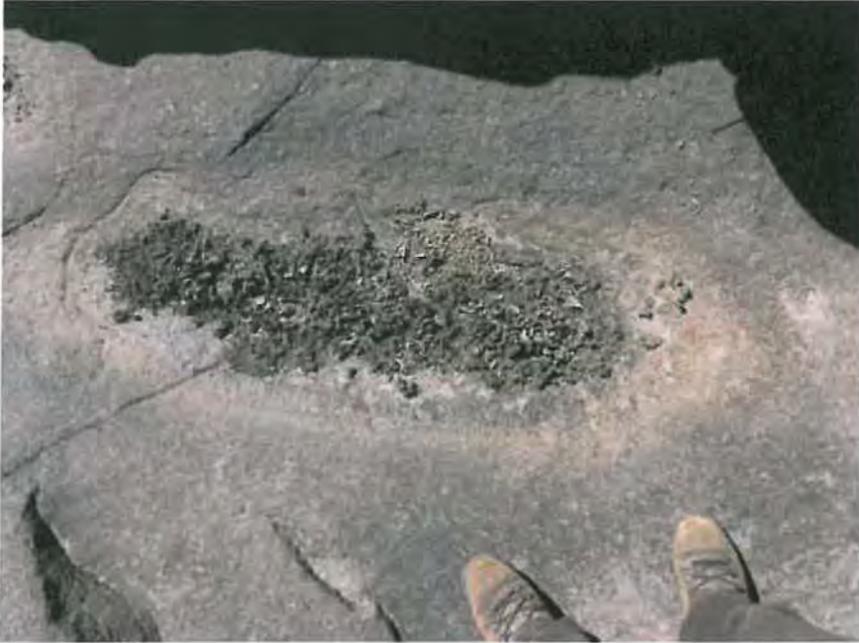
RC2-22B-7: Photographic reference of algae and benthic macro-invertebrates within downstream West Branch Rustler Canyon assessment unit.

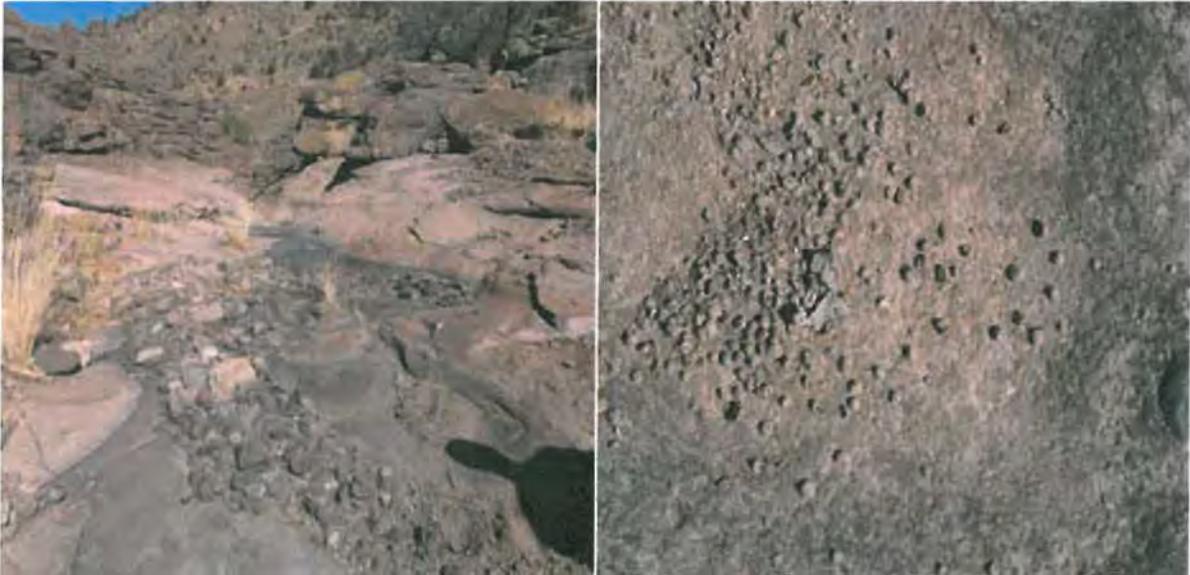
RC2-22B-8: Photographic reference for indicators 1.1 through 1.6. Filamentous algae/periphyton was observed along the reach. Multiple isolated pools present along the stretch. Biotic indicators of water found with little difficulty. Vegetation is inconsistently dispersed throughout the channel.
