CANYON CREEK SUBWATERSHED (MIDDLE FORK GILA RIVER TO HEADWATERS)

TMDL parameter exceeded: Plant nutrients

TMDL parameter exceeded: Turbidity

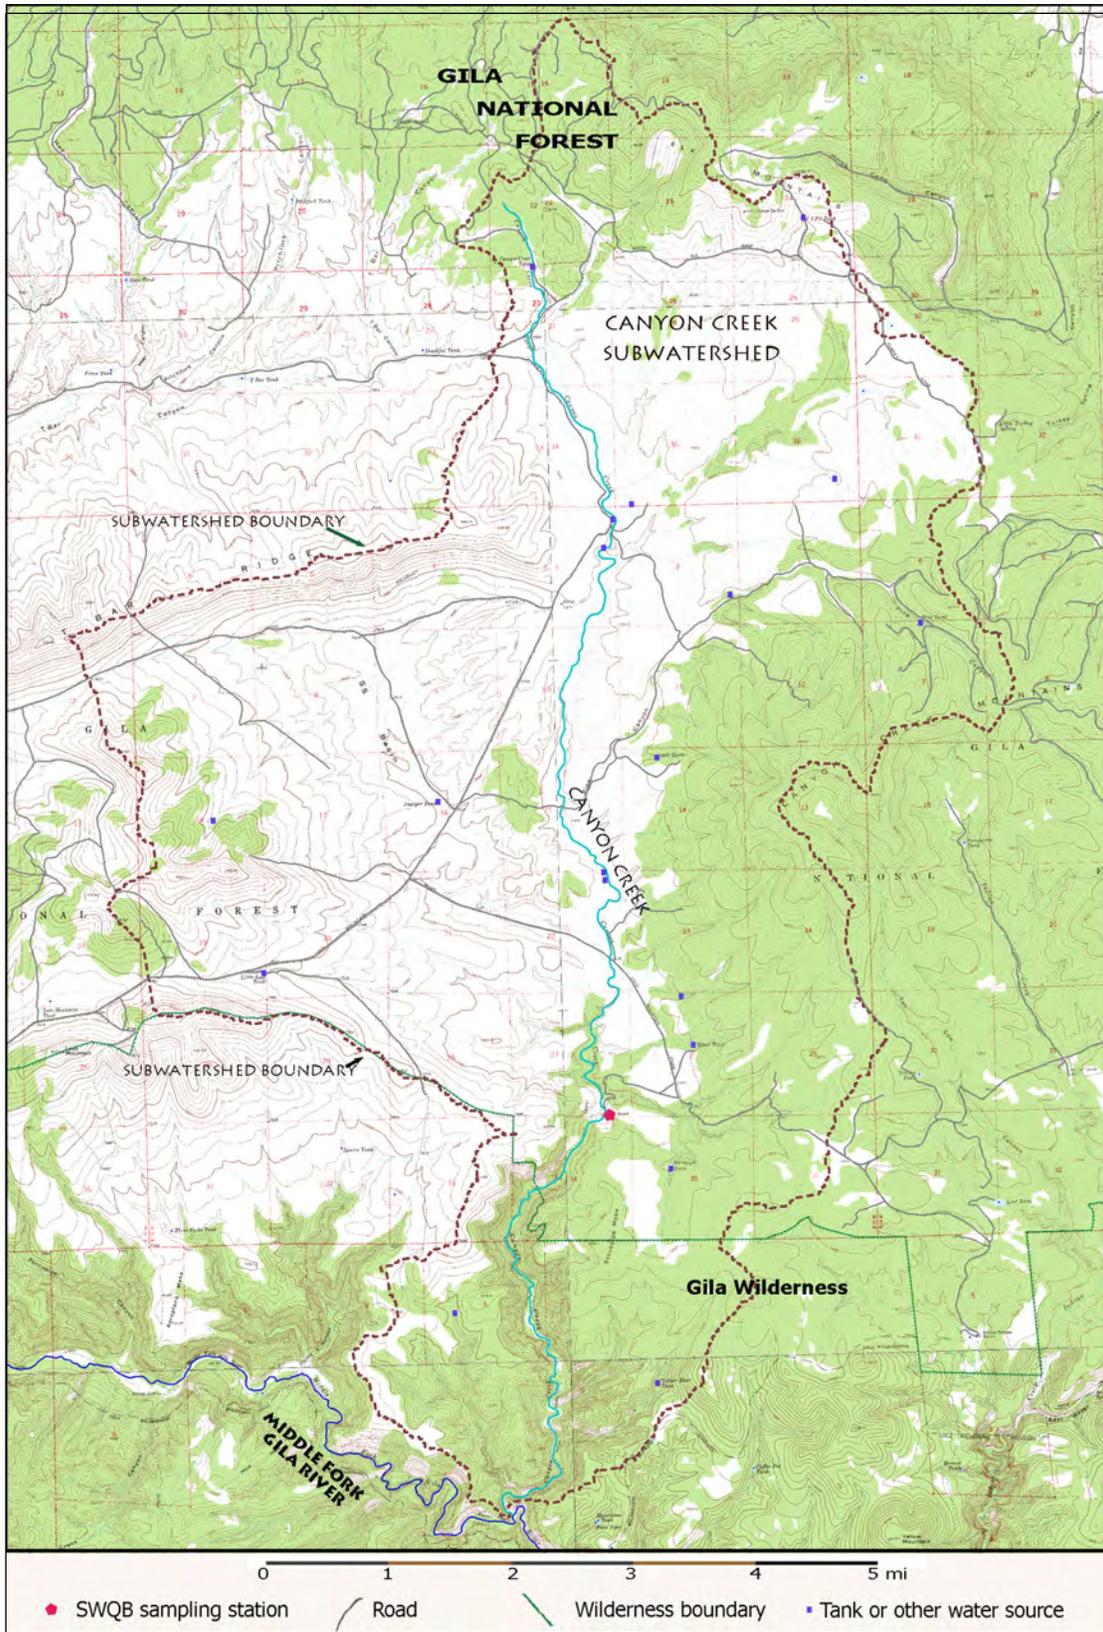
Map TMDL-05. Topographic map, Canyon Creek subwatershed. Base image from USGS 1:24000 quads. All data from USGS, NMED, and USFS Gila National Forest .

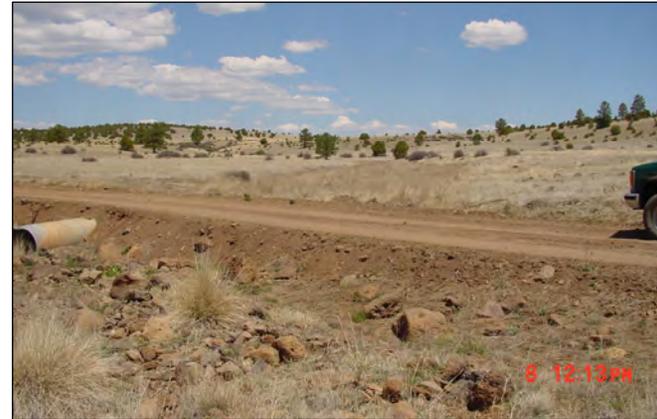
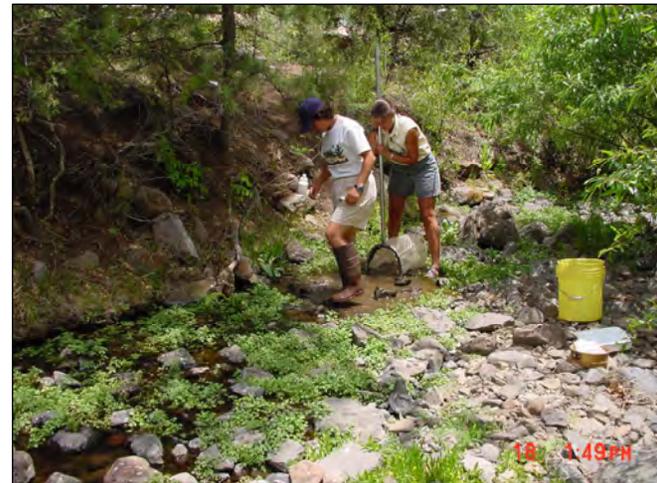
Canyon Creek photos. Clockwise from left: Downstream past NMED sampling site, May 2001; FR 142 and culvert near sampling location, May 2001; NMED/SWQB staff in dense aquatic vegetation at sampling site, June 2001. All photos courtesy NMED, Silver City.
