**SAPILLO CREEK SUBWATERSHED BELOW LAKE ROBERTS**

**TMDL parameter exceeded:** Turbidity

**Current exceedance:** Turbidity (as total suspended solids) exceeds standard by 625 lbs/day (31%)

**SAPILLO CREEK SUBWATERSHED (LAKE ROBERTS TO GILA RIVER)—continued**

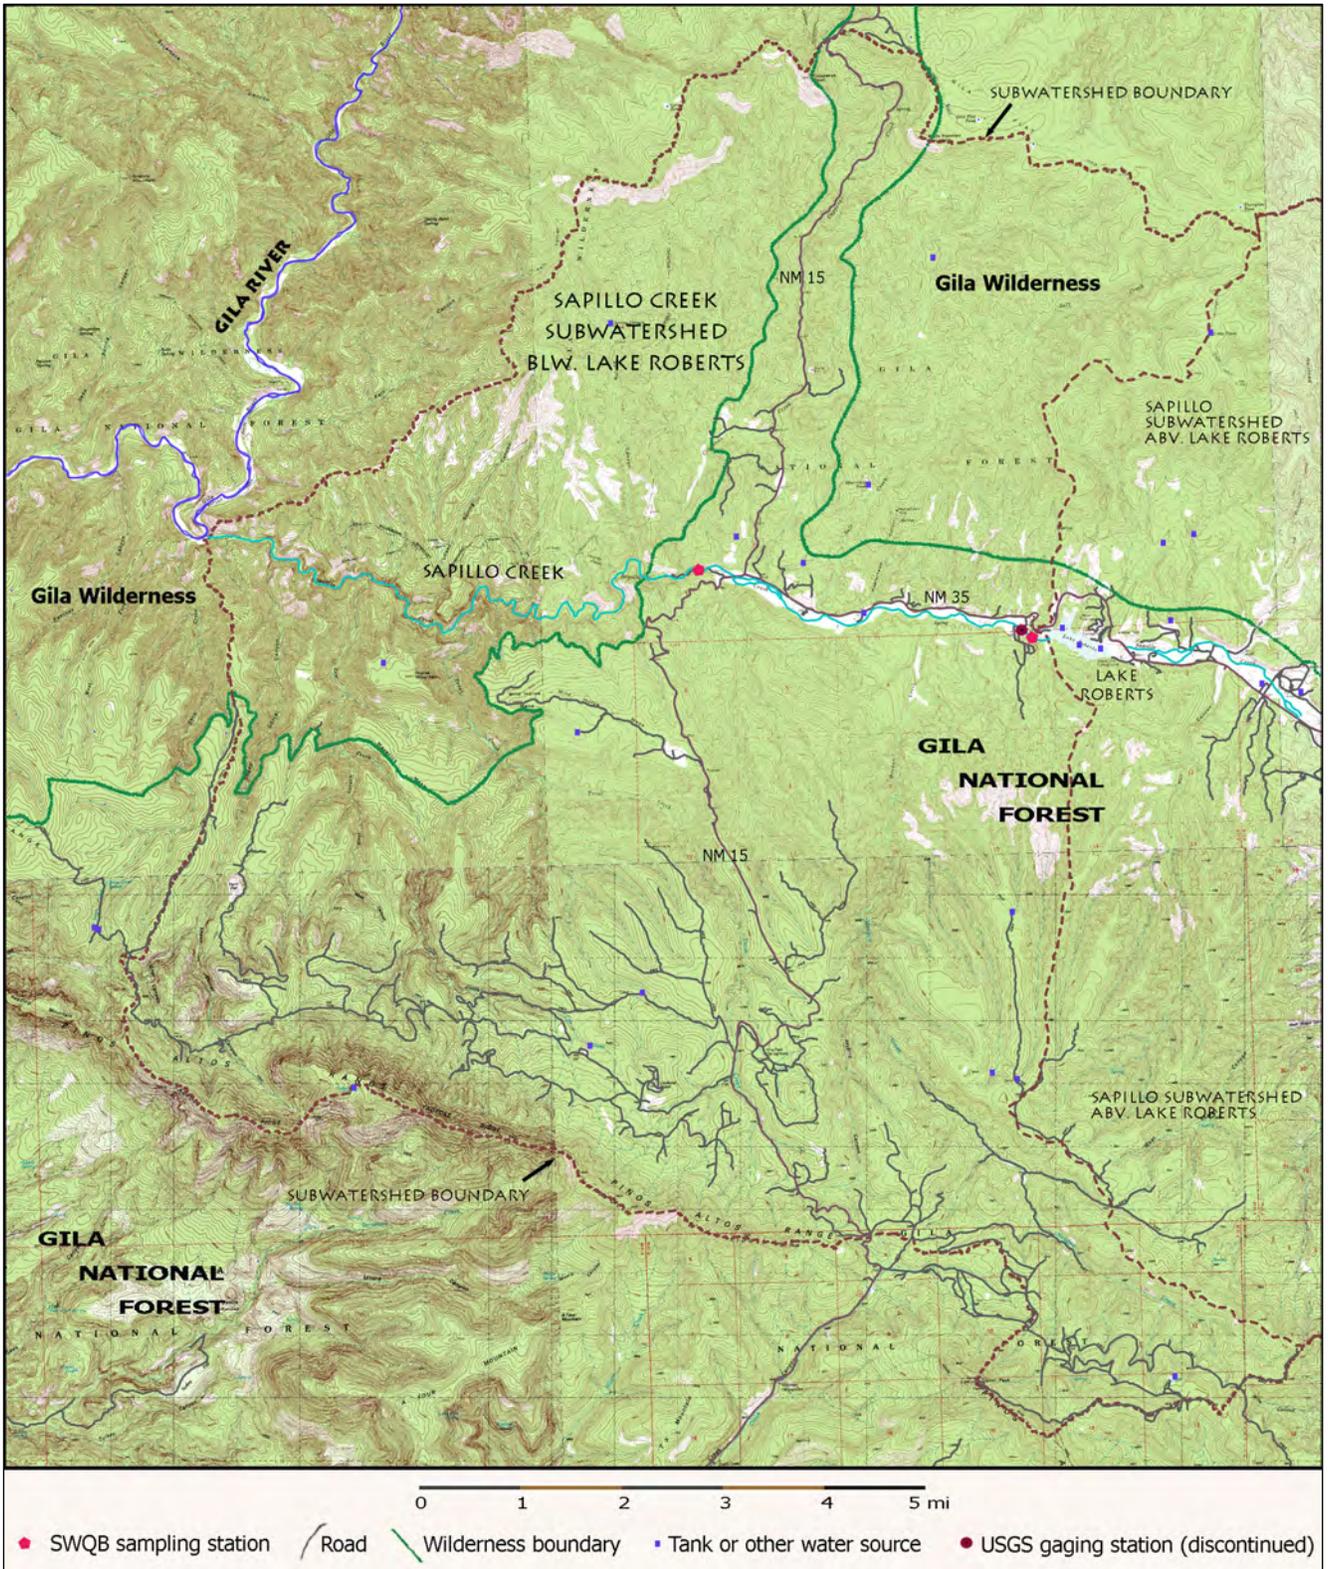
Map TMDL-17. Topographic map of the Sapillo Creek subwatershed downstream of Lake Roberts. Base image: USGS 1:24000 quads. All data from NMED, USGS, and USFS Gila National Forest.

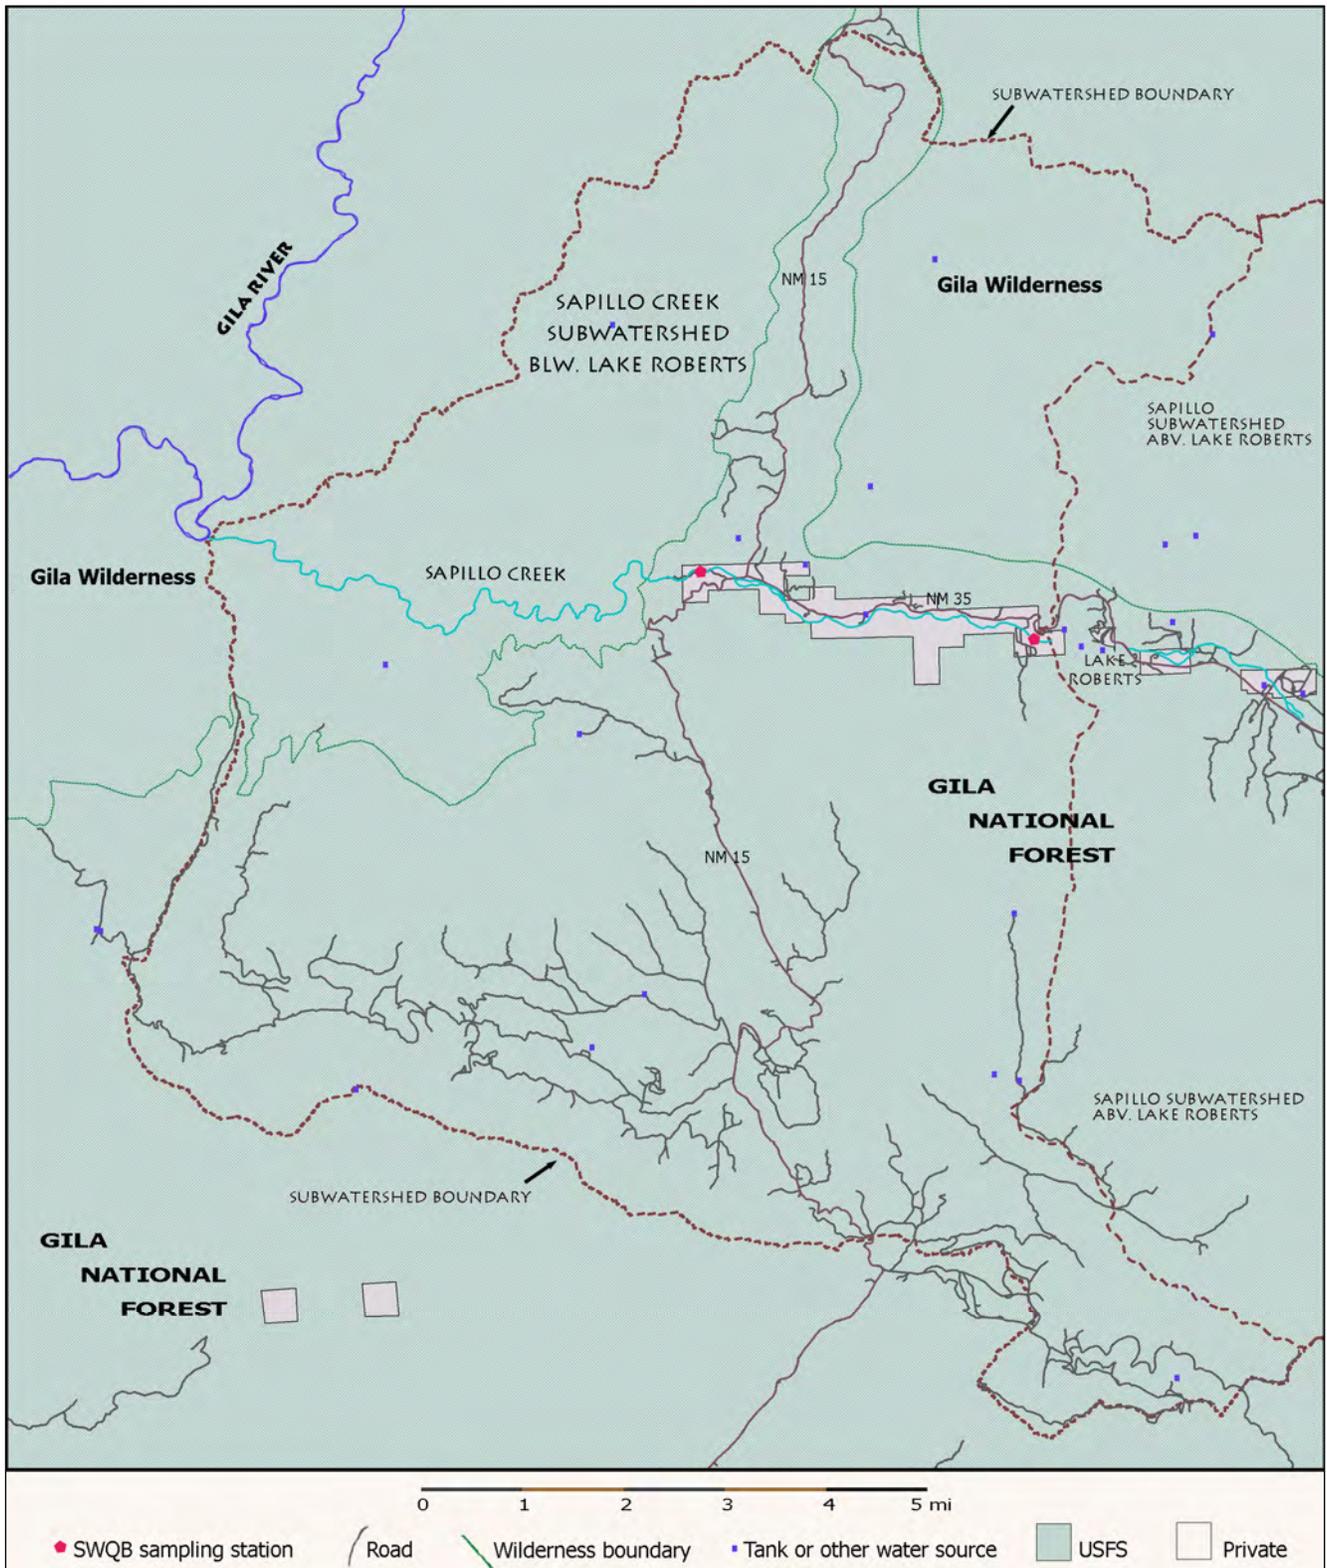
Map TMDL-18. Land management status map, Sapillo Creek subwatershed downstream of Lake Roberts. All data from NMED, USGS and USFS Gila National Forest.

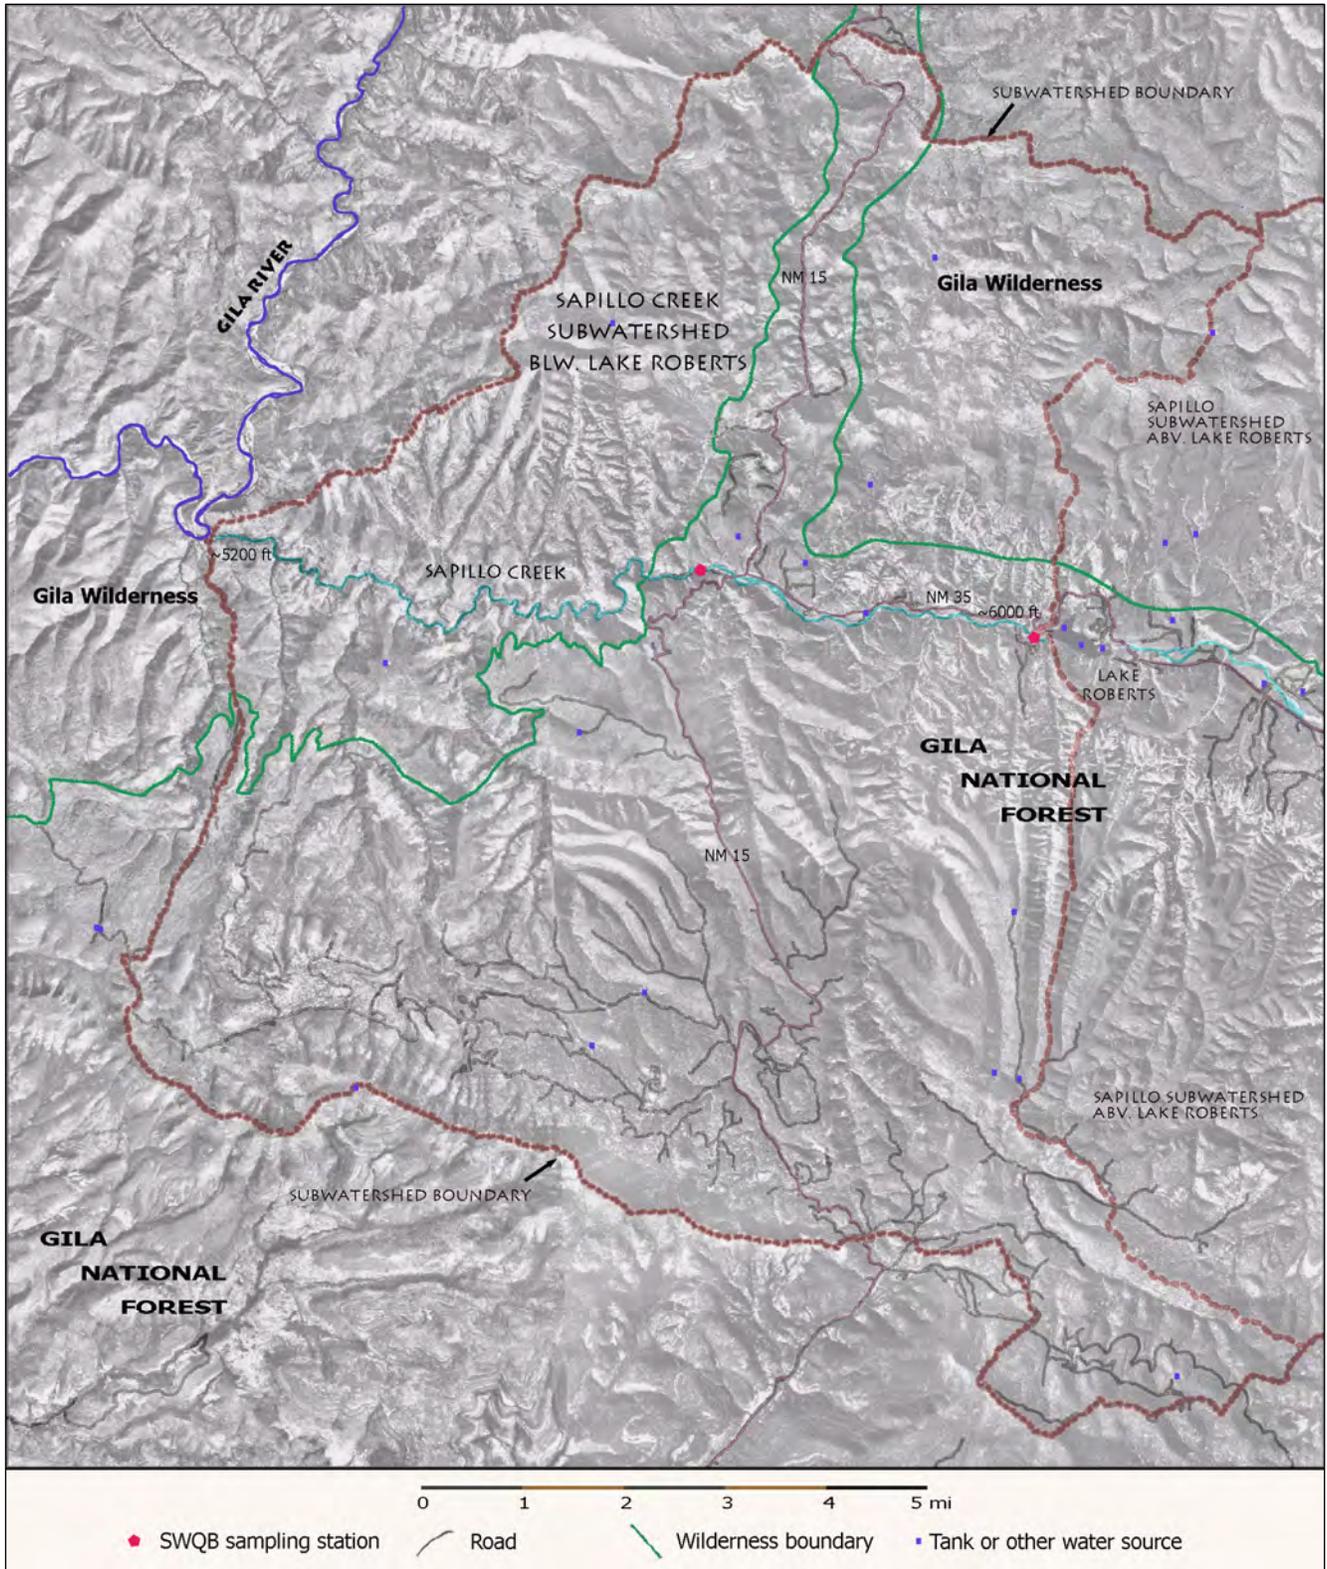
Map TMDL-19. Aerial photography relief map, Sapillo Creek subwatershed downstream of Lake Roberts. Base image: 1996-2002 USGS digital orthophotoquads. All data from USGS, NMED, and USFS Gila National Forest.

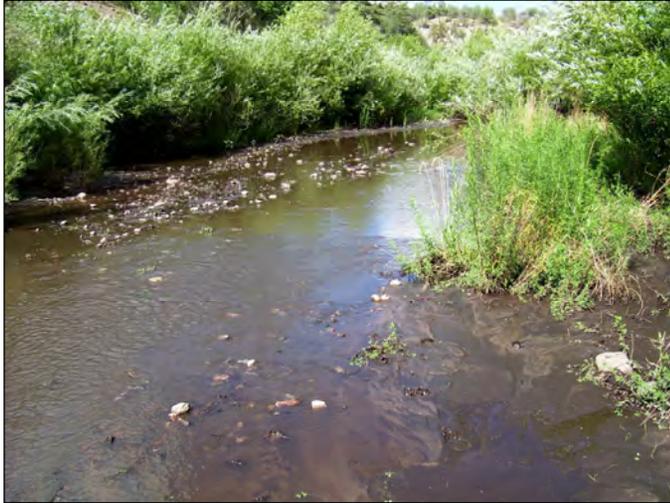
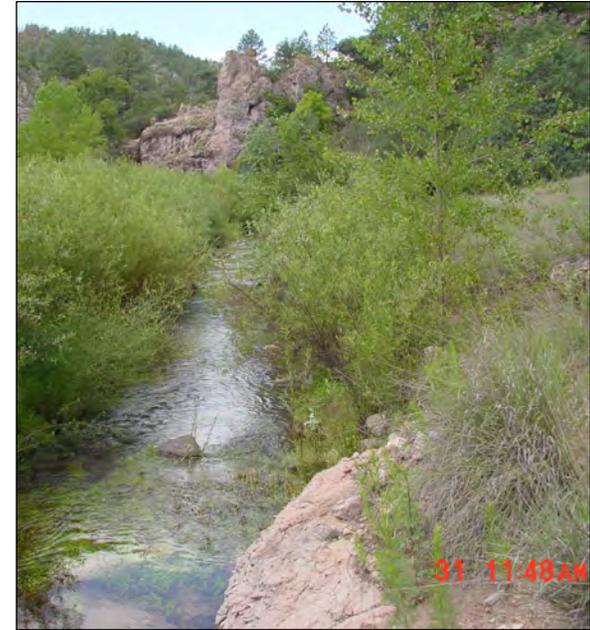
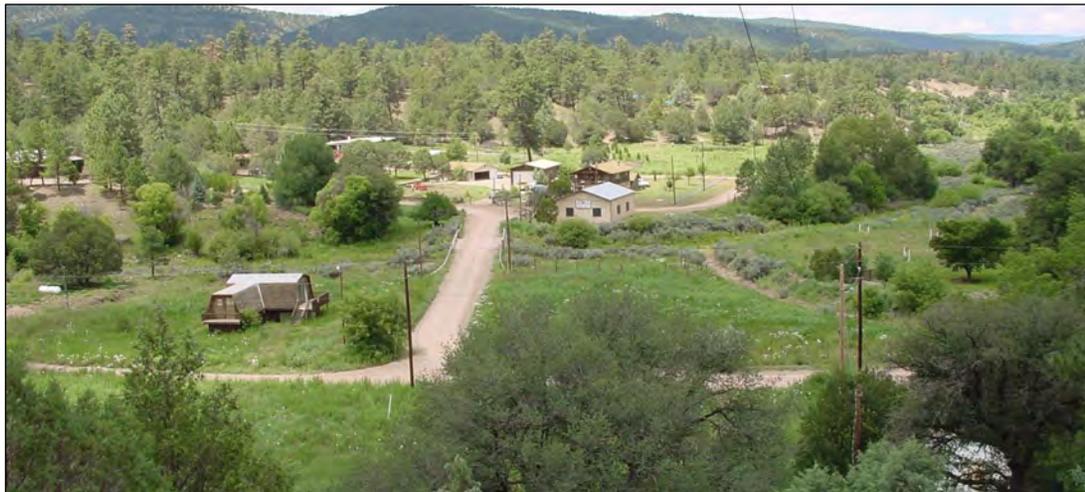
**Sapillo Creek photos. Clockwise from upper left: ash from the June 2006 Skates fire transported downstream and deposited on banks below FR 15, July 2006; SWQB sampling site just upstream of Wilderness boundary, July 2001; Lake Roberts community ~1/2 mile downstream of Lake Roberts (Sapillo Creek flows across the center of the photograph), July 2001. Photos from 2001 courtesy NMED, Silver City.**
