TAYLOR CREEK SUBWATERSHED BELOW WALL LAKE

TAYLOR CREEK SUBWATERSHED (WALL LAKE TO BEAVER CREEK)—continued

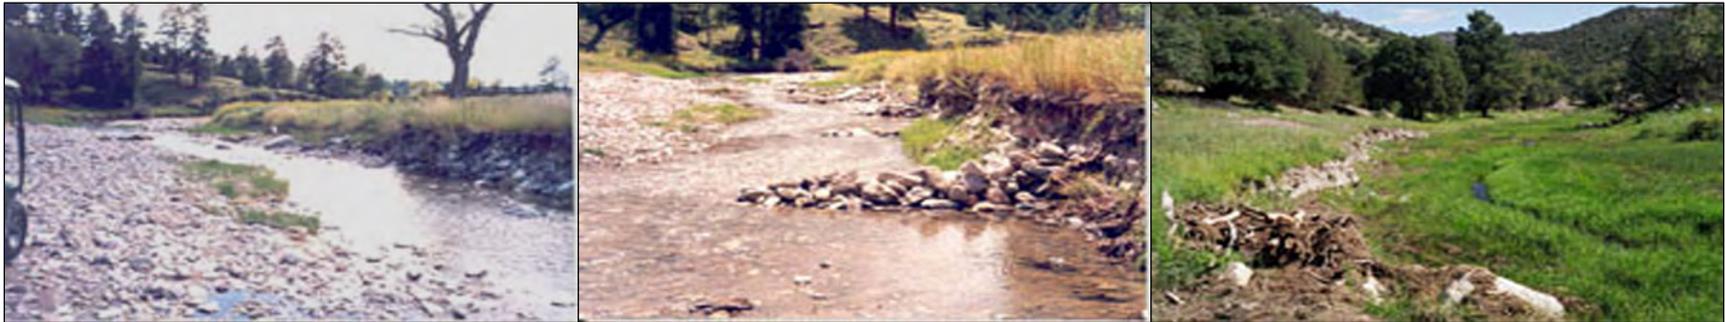
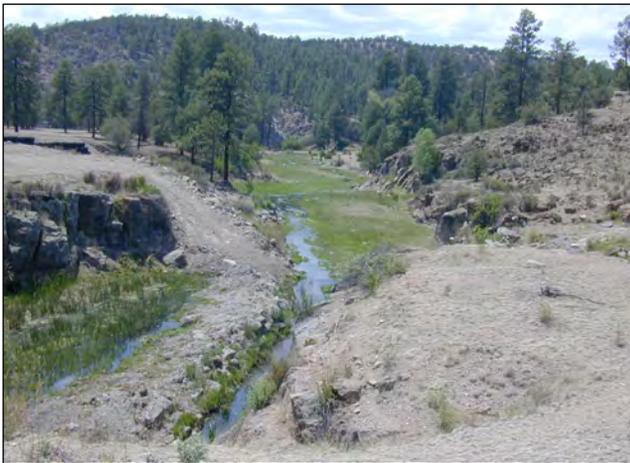
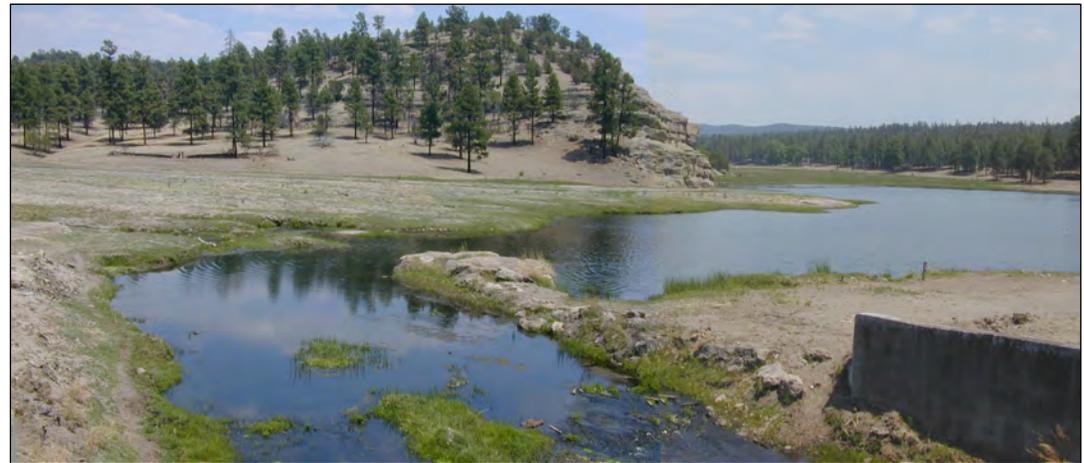
Taylor Creek photos: Top row, left to right: Taylor Creek before (left) and after (center) installation of stream barbs, September 1999; deposition of fines and stream bank vegetation recovery at barb site after floods in August 2004 (right). Bottom left: Taylor Creek immediately downstream of Wall Lake spillway at FR 150, June 2006. Bottom right: Wall Lake at FR 150, June 2006. Top row photos courtesy NRCS (2005).
