SAN FRANCISCO WATERSHED

(HUC 15040004)

CENTERFIRE CREEK SUBWATERSHED (SAN FRANCISCO RIVER TO HEADWATERS)

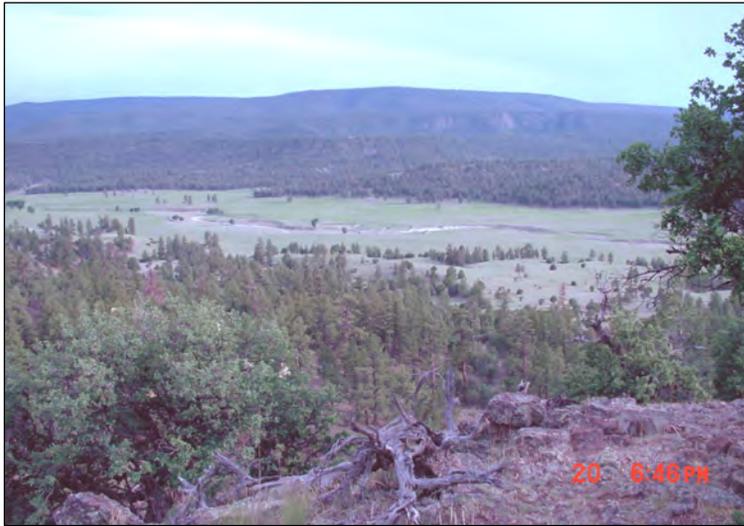
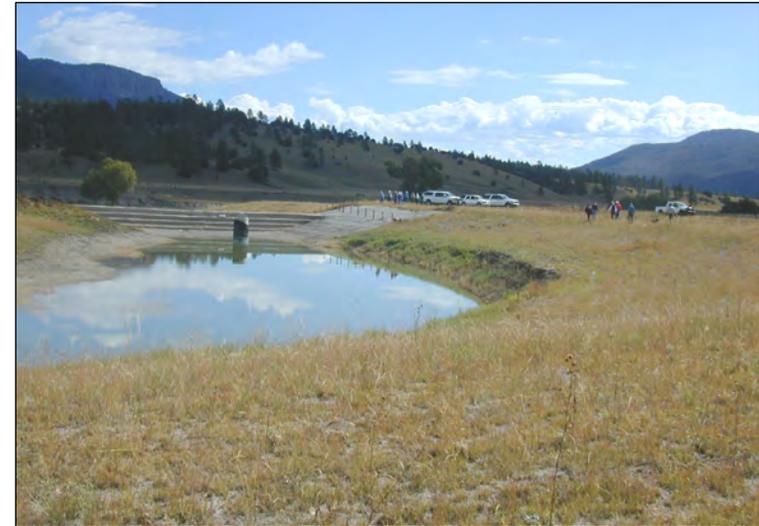
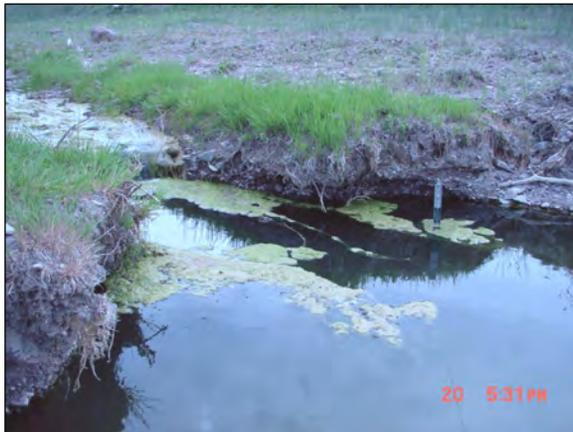
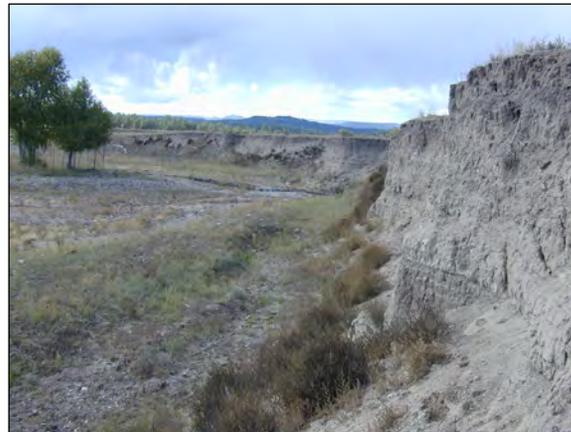
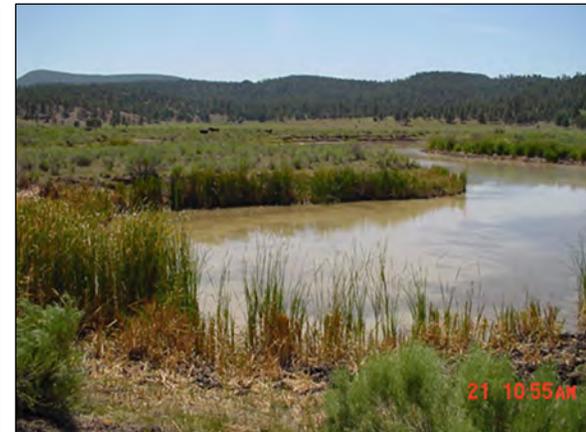
Centerfire photos, clockwise from top left: View south across Centerfire Creek valley approx. 3 mi. upstream of San Francisco River confluence, June 2001; tour of Centerfire Creek §319 project by landowner, October 2005; Gila N. F. wetlands project on Arroyo Grande, a significant, ephemeral Centerfire Creek tributary, June 2001; typical cutbank on creek, October 2005; sampling station at project site, March 2001. All 2001 photos courtesy NMED, Silver City.
