# Rio Nutrias Watershed Based Plan

5/20/2015

A Plan to Determine the Best Management Practices to Improve Water Quality on the Rio Nutrias

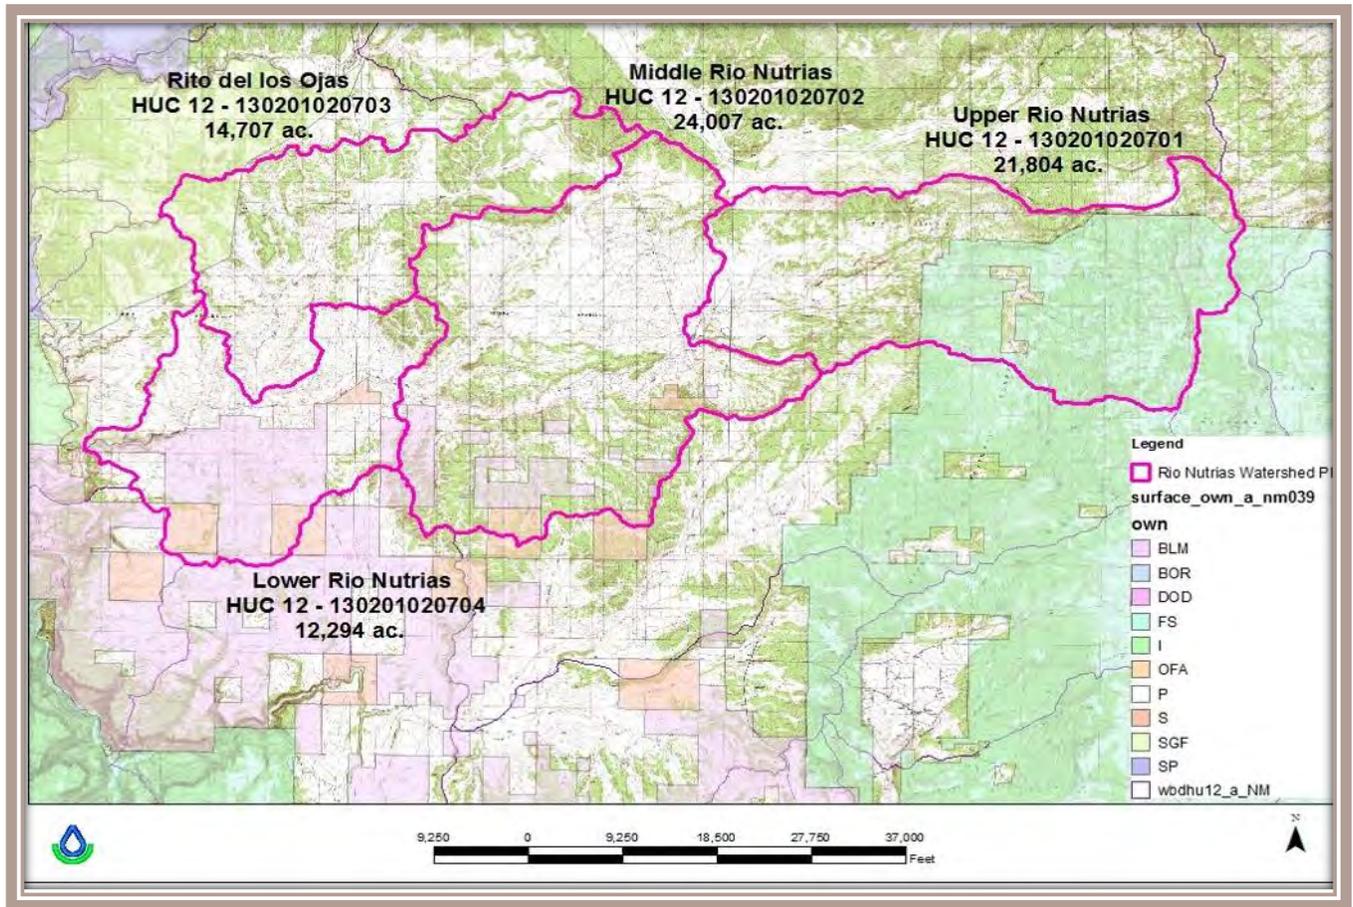
FIGURE 1. TOPGRAPHICAL MAP RIO NUTRIAS WATERSHED

The Rio Nutrias is located within the greater Rio Chama watershed (USGS Hydrologic Code 13020102), Rio Arriba County, New Mexico. The Rio Nutrias is part of the Cebolla/Nutrias watershed planning area. This watershed based planning approach is specific to the Rio Nutrias (Rio Chama to headwaters) (NM-2116.A\_060). The size of the Rio Nutrias watershed is 106 square miles and the miles of impaired stream reach is 34.63 miles. The Rio Nutrias watershed has four smaller watersheds including the Upper, Middle and Lower Rio Nutrias, and the Rito de los Ojas.

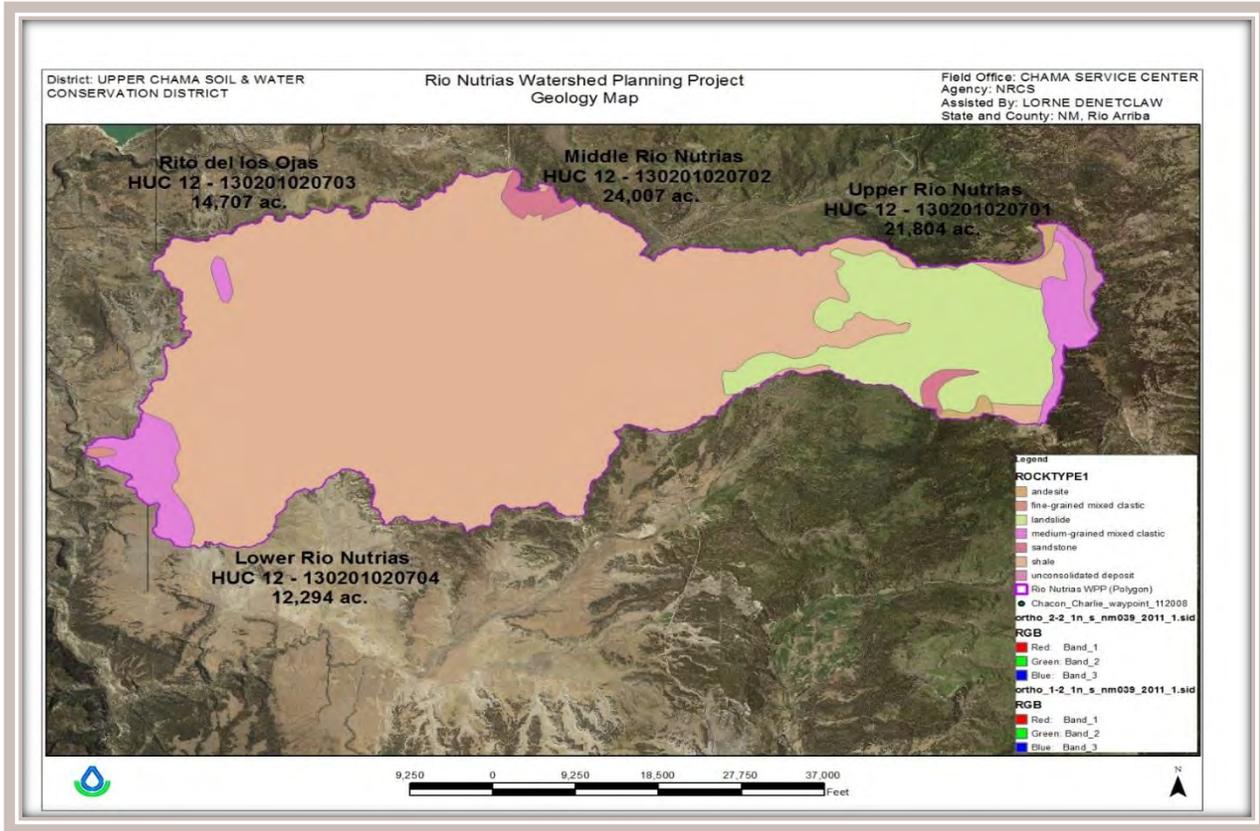
FIGURE 2 GEOLOGY MAP RIO NUTRIAS WATERSHED

The geology of the watershed consists of predominately shale rock formations. Watershed land ownership is 74% private, 12% US Forest Service, 10% Bureau of Land Management, 2% State of New Mexico and 2% State of New Mexico Game and Fish. Several small streams including the Terrero Creek, flow west into the Rio Nutrias, which eventually empties through deep canyons into the Rio Chama.

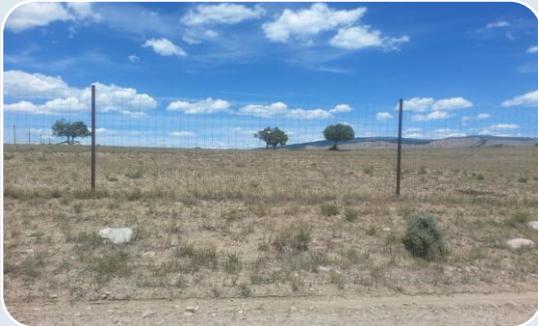
**Drought** -New Mexico has been in a drought for the last five years. The drought has had an effect on the amount of vegetation in the watershed

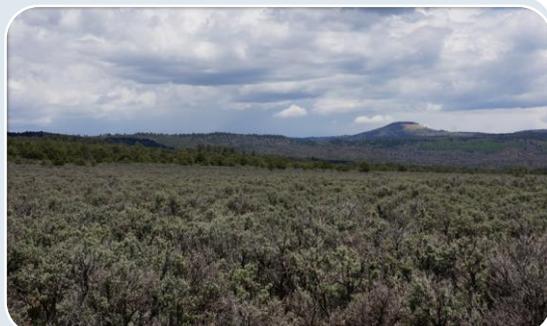
**Brush/Shrub Encroachment**-The watershed had massive brush removal in the 1950's. Some of the brush has returned, there has been an ongoing effort to return the area to grasslands.

The areas within the watershed that have had sagebrush eradication have significantly more grasses and groundcover. Removing the invasive brush creates better habitat conditions and inhibits sheet and rill erosion. We estimate that there are approximately 15,000 acres of invasive brush in the watershed that could be treated. Treatment could be mechanical using a brush hog or other equipment to manually remove the brush or could be a chemical application such as aerial spraying of an herbicide. Practice method would depend on size of treatment area and preference of the landowner. Some landowners who have previously completed a mechanical treatment were discouraged by how fast the brush has reoccurred. Treatment with an herbicide does not create the same soil disturbance and the skeletons of the dead brush stay intact for several years as they decompose, holding the soil structure in place and also providing a beneficial microclimate for the grasses as they grow back.

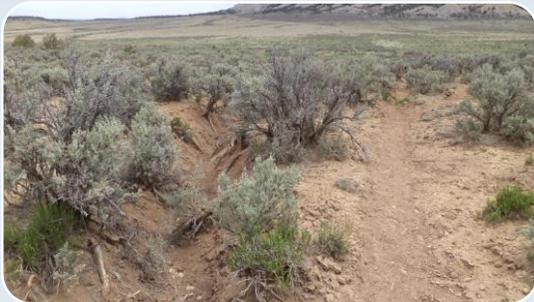
**Arroyos and Gullies**-There are a few gullies actively eroding in the watershed.

There have been several actively eroding gullies, arroyos and headcuts identified. Many degraded arroyos have been remediated previously with some becoming a drainage to a trick tank. We estimate that there are approximately 10 arroyos or headcuts of various size and depths. Prescriptions include regrading the gully and installing rock check dams to encourage water and sediment retention, this will promote revegetation of the disturbed area. Some of the larger headcuts will require a more extensive engineering design to correct the erosion problem.

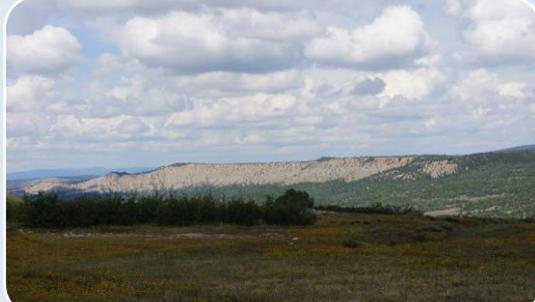
**Geology/Natural Sources**- The underlying geology and soils found in the watershed are inherently erosive.

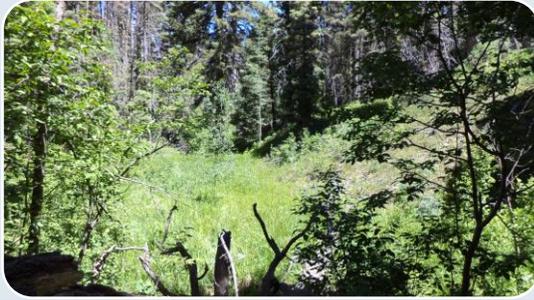
Forest Conditions -The forests in the upper watershed are overgrown. The dense stand of trees prevent grasses from growing.

Forest stands have become very overgrown in parts of the watershed and have created a closed canopy condition where the groundcover cannot grow underneath the trees. This has created sheet and rill erosion, degraded habitat conditions and poses a fire hazard. Prescriptions include thinning trees to a desired density using tools, mastication and controlled burns where necessary to return forest structure and composition to a desired condition.

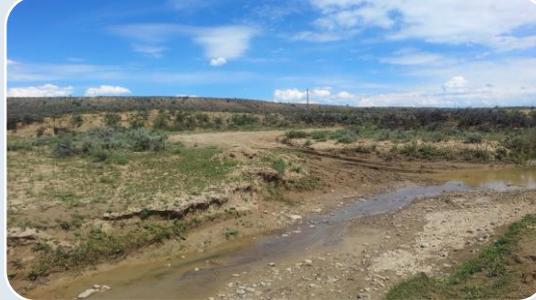
Water Crossings- Culverts and unstabilized streamcrossings can exelerate erosion in a streamchannel.

We have identified two river crossings that could be repaired. Both are located on Rio Arriba County roads. The first is currently an oversized culvert that appears to be creating erosion due to hydro modifications, we suggest replacing it with a bridge so the river can travel underneath the road crossing without impediment.

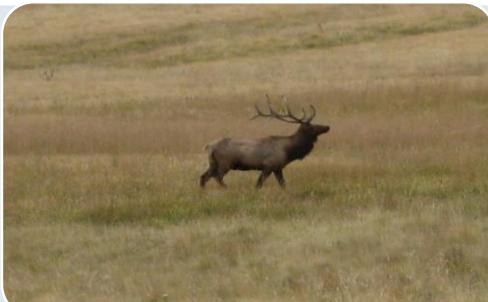
Rangeland Grazing including Wildlife -Massive herds of wildlife are coming to the lower elevations to feed on the areas of previous restoration where grass communities are healthy and water is avaiable via drinkers, trick tanks and the river.

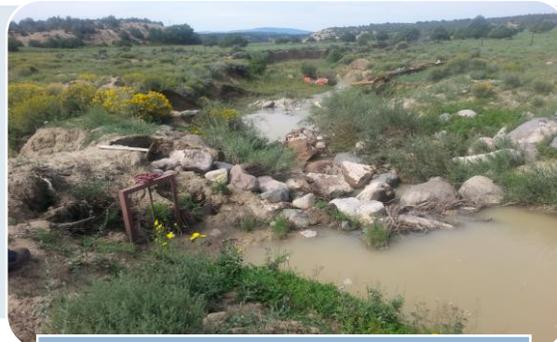
Streambank Destabilization/ Hydro modifications-Much of the watershed is experiencing some level of streambank destabilization including channel downcutting and actively eroding banks.

Streambank bioengineering would be prescribed for a moderately degraded streambanks that are unstable and are showing signs of actively eroding streambanks. Streambank bioengineering includes reshaping the streambanks and utilizing plant materials such as root wads, logs branches and brush mats as structural components, may also include terracing and revetment.

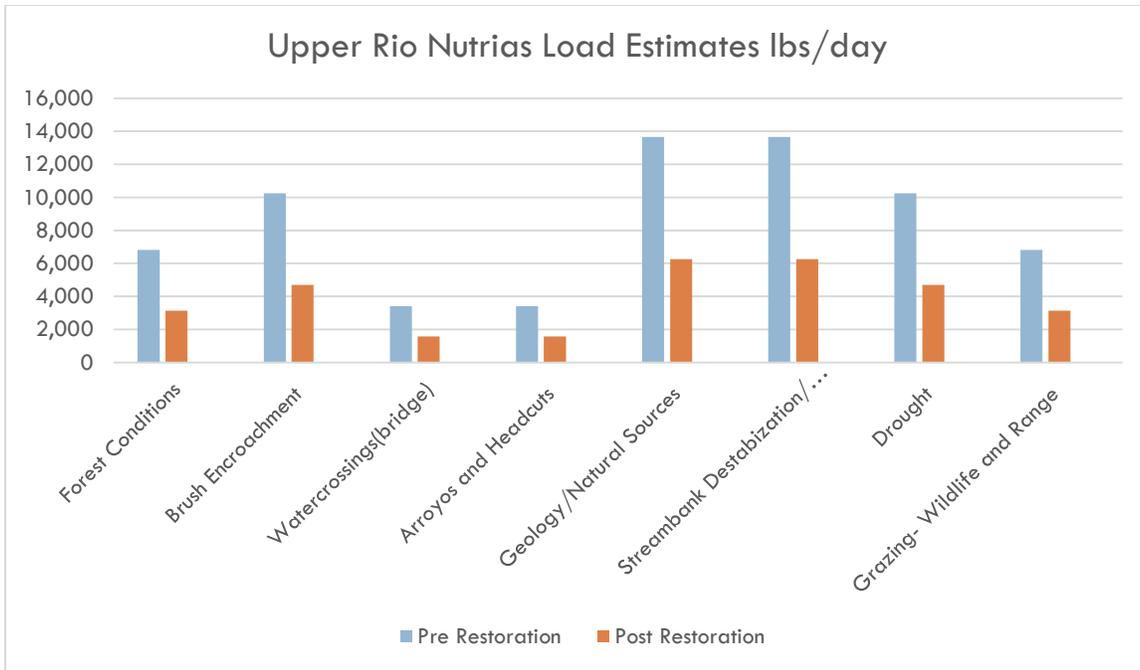
**FIGURE 8 LOAD ESTIMATES UPPER RIO NUTRIAS**

The Rio Nutrias watershed area was broken down into the smaller HUC- 12 sub watersheds to allow for more localized measurements. The PSIAC model was applied to each sub watershed to estimate current pollutant loading. The model was also used to estimate pollutant loading after Best Management Practices are implemented. The total result for each sub watershed was then broken down by the estimated contribution of each pollutant source. The results from the PSIAC modeling in ac ft. /year were converted to lbs. /day. The results from the modeling are found in the graphs below. Model data can be found in the appendices.

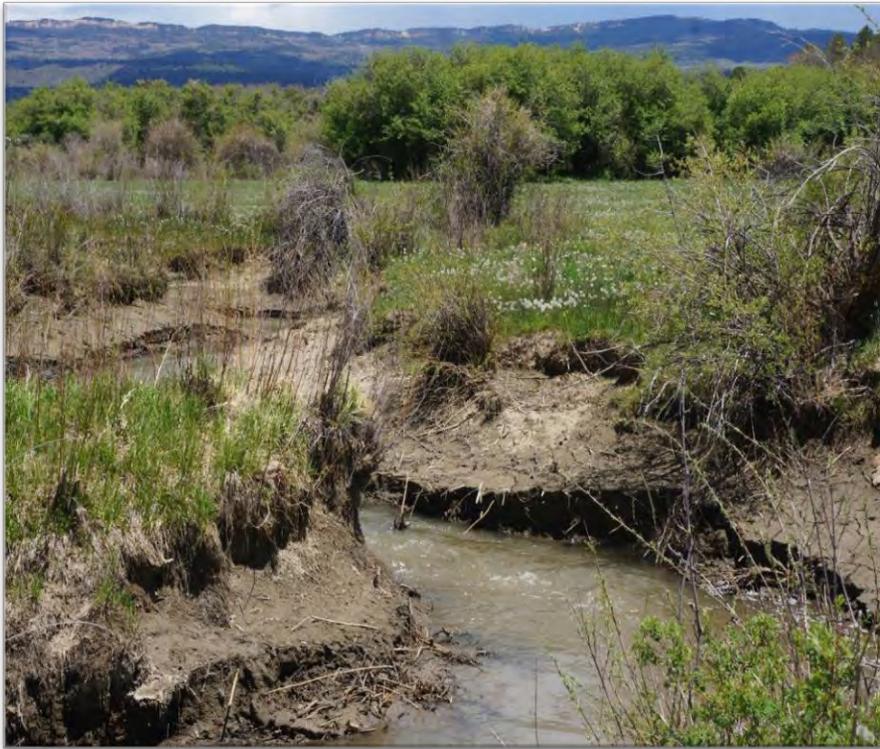
FIGURE 12 RIO NUTRIAS UNSTABLE STREAMBANKS

Vegetative management prescription would be indicated if the river has marginally degraded streambanks that are unstable and are showing signs of actively eroding streambanks.

Vegetative management includes shaping the streambanks, using an erosion control fabric, if appropriate and planting the critical vegetation area. The purpose is to stabilize and protect against bank scour and erosion.

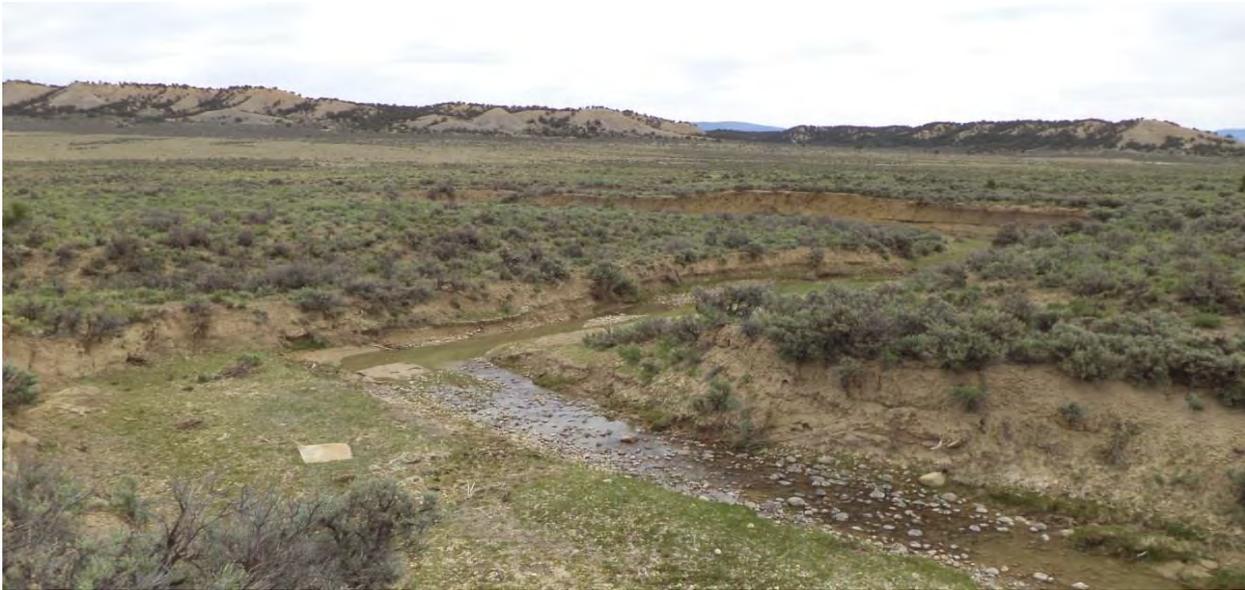
**FIGURE 13 RIO NUTRIAS CHANNEL DOWNCUTTING**

We estimate that approximately 2 miles of streambank engineering and approximately 5 miles of vegetative management prescriptions will be needed to be implemented to restore the river channel to a more stable state. It is not likely that any streambank stabilization project will be an entire mile in length, but rather smaller sections in the most severely eroded areas and where a willing landowner would like to participate. It is important to improve the upland conditions before engaging in a large scale streambank stabilization effort, as the stream channel is affected by the greater conditions within the watershed.

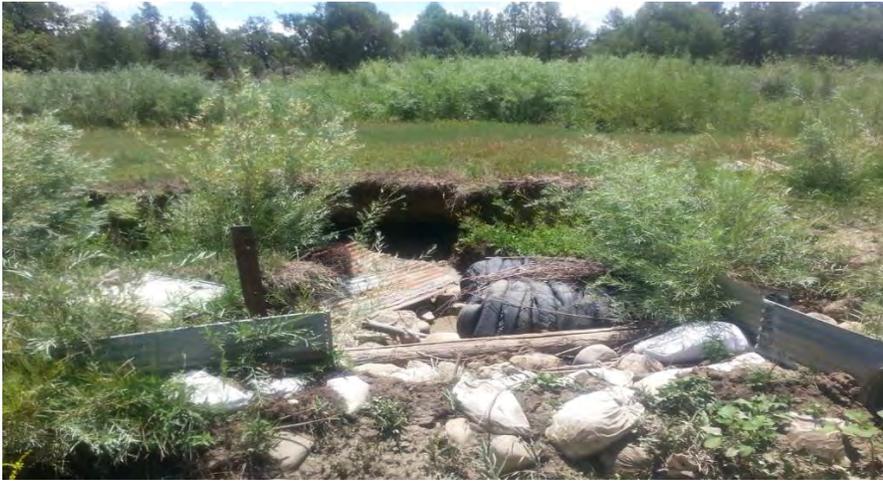
**FIGURE 14 RIO NUTRIAS HEADGATE**

Prescriptions include headgate repair or replacement with the addition of rock check dams or other erosion control practices to create a surface water profile and to stabilize surrounding streambanks. The failure of the headgates in the watershed are all related to land erosion created by degraded streambanks or hydro modification from the diversion structure. Some headgate structural components may be reusable, some may need to be upgraded or resized. All headgates will need some amount of erosion control work to keep the structure stable over time, suggestions would be rock check dams, streambank bioengineering and vegetation management. We approximate 10-15 headgates will need to be repaired or replaced.

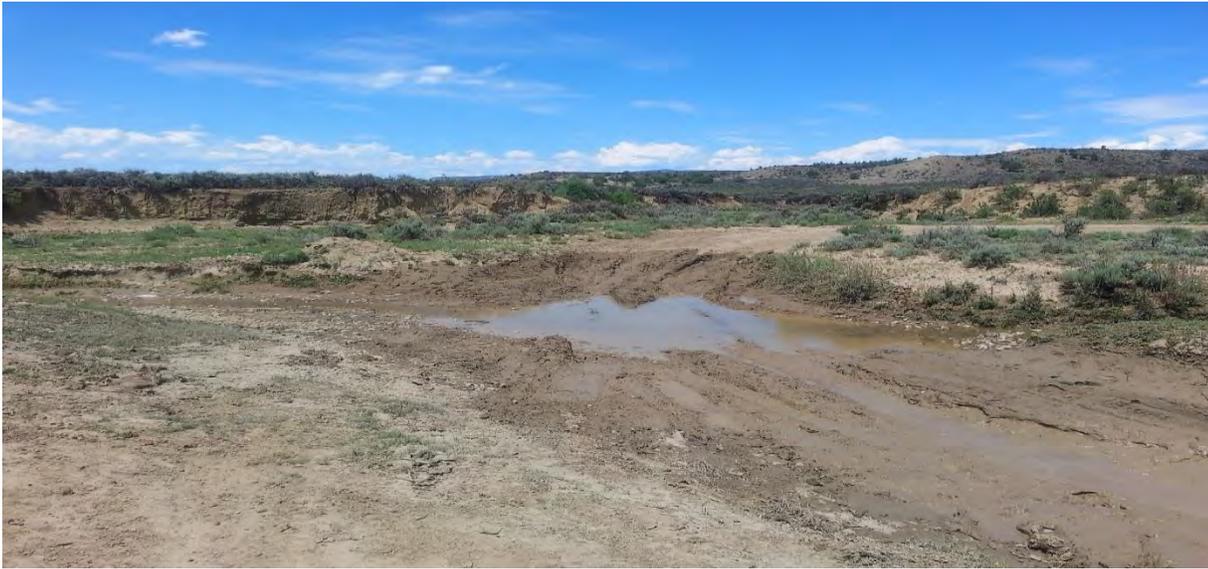
**FIGURE 15 RIO NUTRIAS RIVER CROSSING**

The second is a road crossing the stream, we suggest upgrading to an armored low river crossing, this would include installing a stable surface at the river bottom and approaches. This could be accomplished using paver or blocks, this will reduce potential erosion from vehicular traffic.

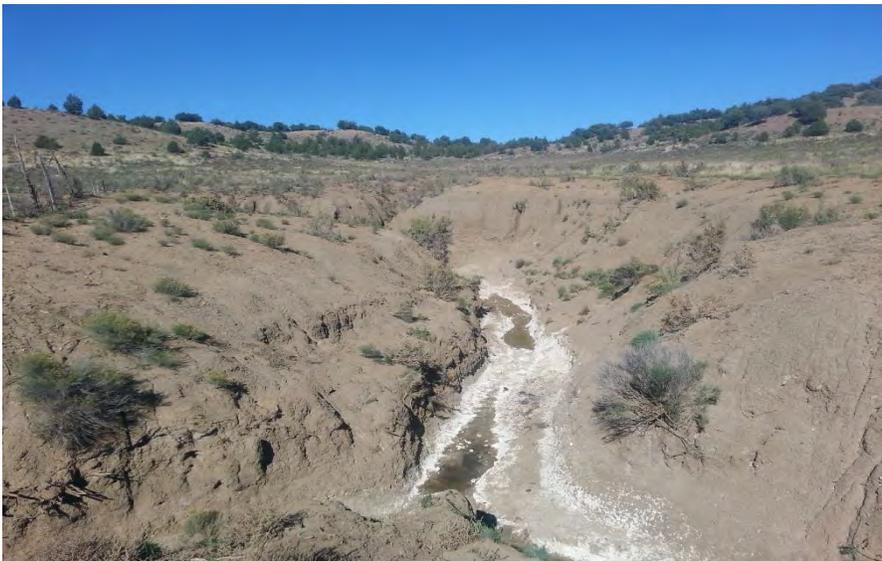
**FIGURE 16 RIO NUTRIAS GULLY**

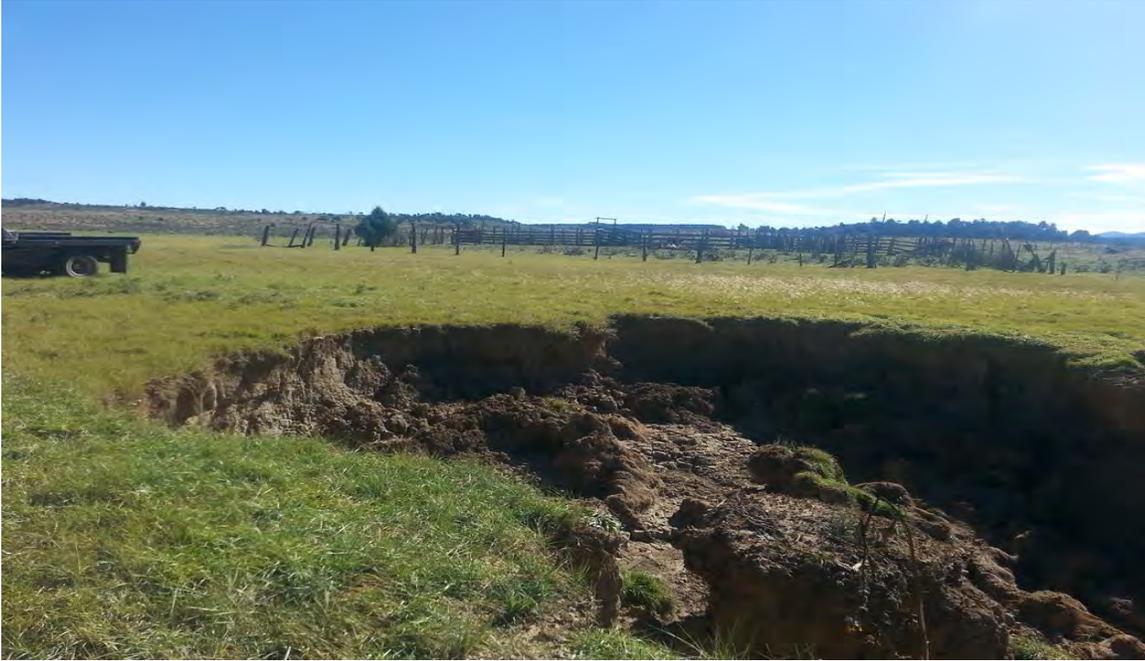
FIGURE 17 RIO NUTRIAS HEADCUT

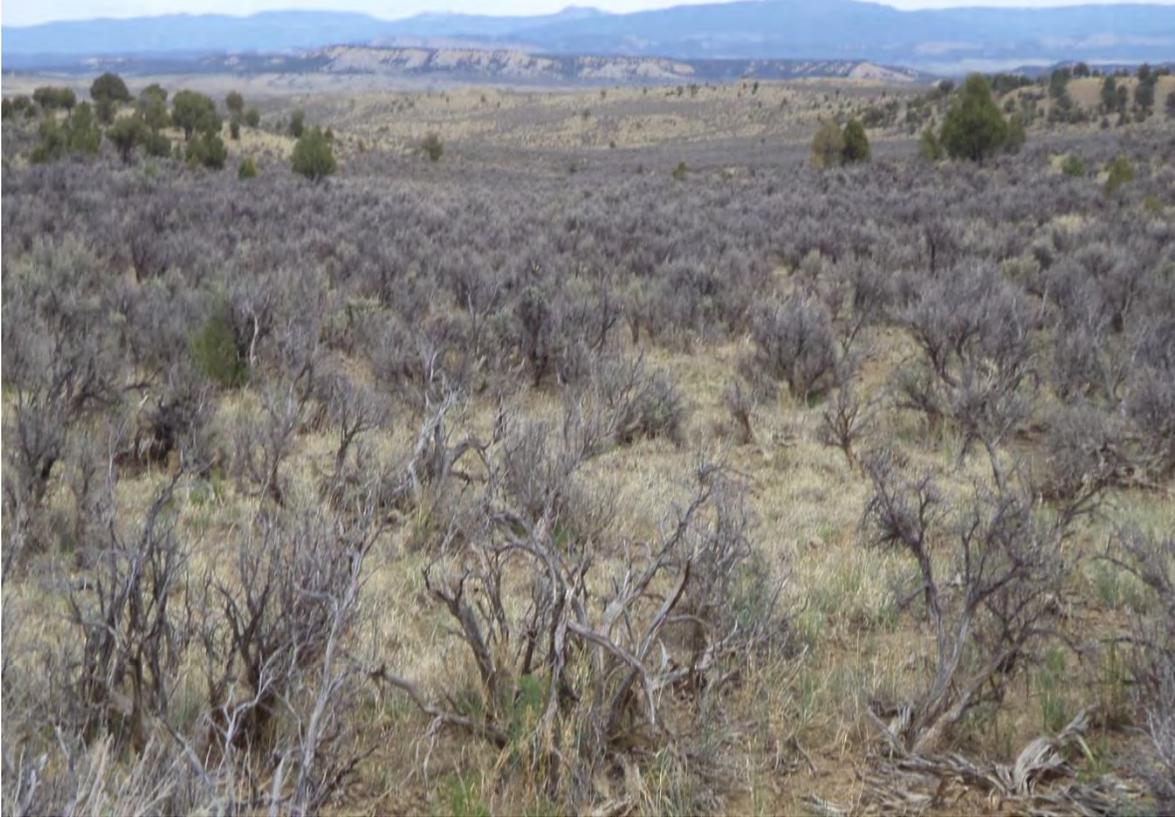
**FIGURE 18 RIO NUTRIAS PREVIOUSLY TREATED SAGEBRUSH**

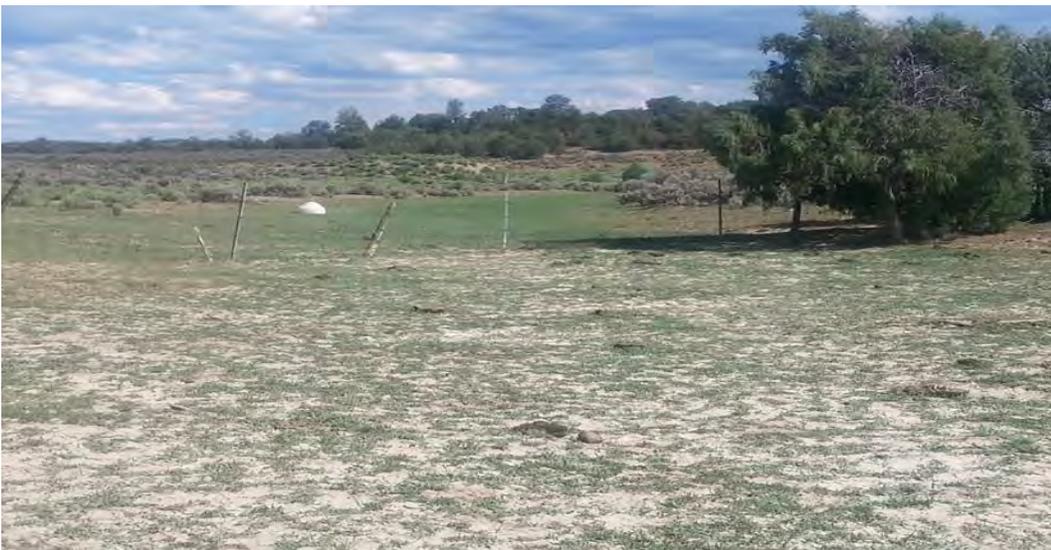
Prescriptions include range reseeding to improve forage conditions, wildlife habitat and erosion concerns, and pasture reseeding to improve forage condition and reduce erosion concerns. Many landowners have indicated that they would like to reseed with native grasses that may be more tolerant of the drought conditions that we have been experiencing. Reseeding range and pasture lands will improve ground cover and eliminate erosion conditions. We estimate that there are 2,000 acres of range and 200 acres of pasture that could be reseeded.

**FIGURE 19 RIO NUTRIAS AREA TO BE RESEDED**

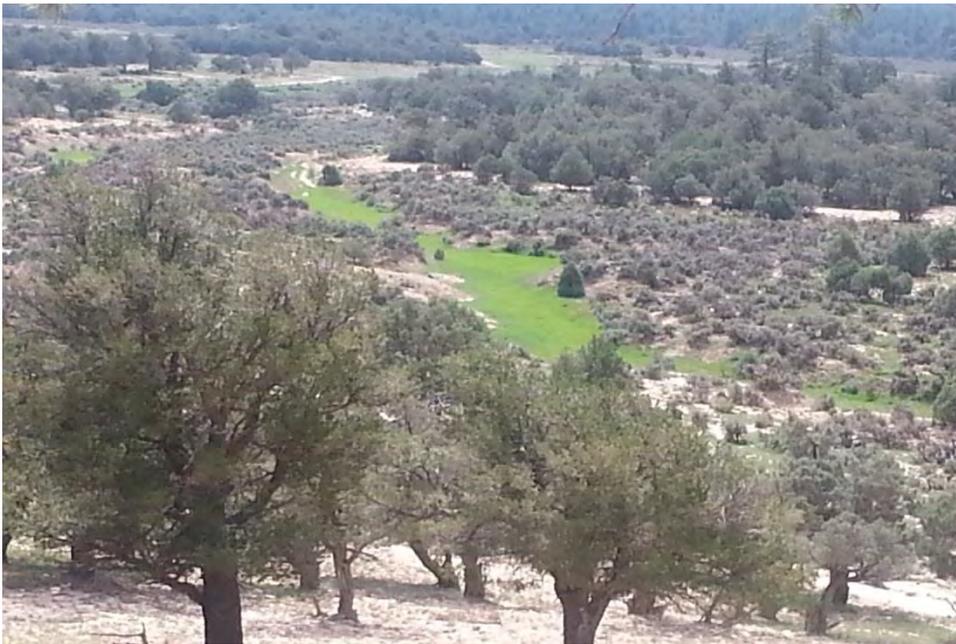
**FIGURE 20 RIO NUECES EXAMPLE OF OVERGROWN FORESTS**

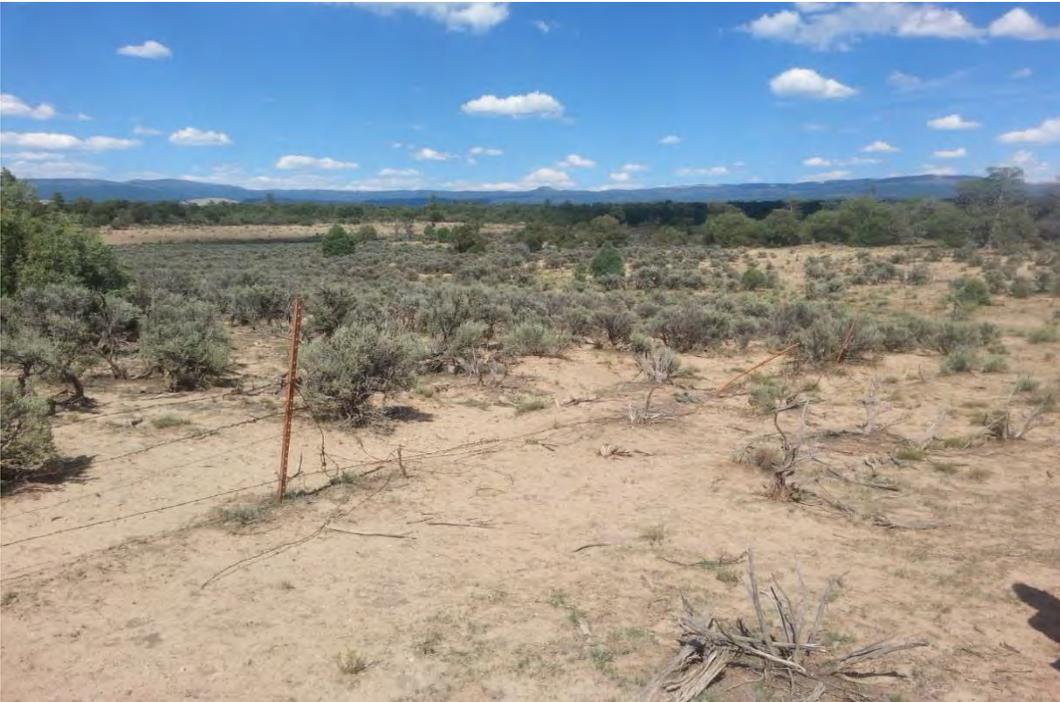
Fencing is a best management practice to disburse grazing and could be helpful in establishing better groundcover conditions that will reduce soil erosion. Many of the fences in the watershed have been damaged by elk. We estimate the need for approximately 10 miles of fencing to be installed in the watershed.

**FIGURE 21 RIO NUTRIAS FENCING DAMAGED BY ELK**

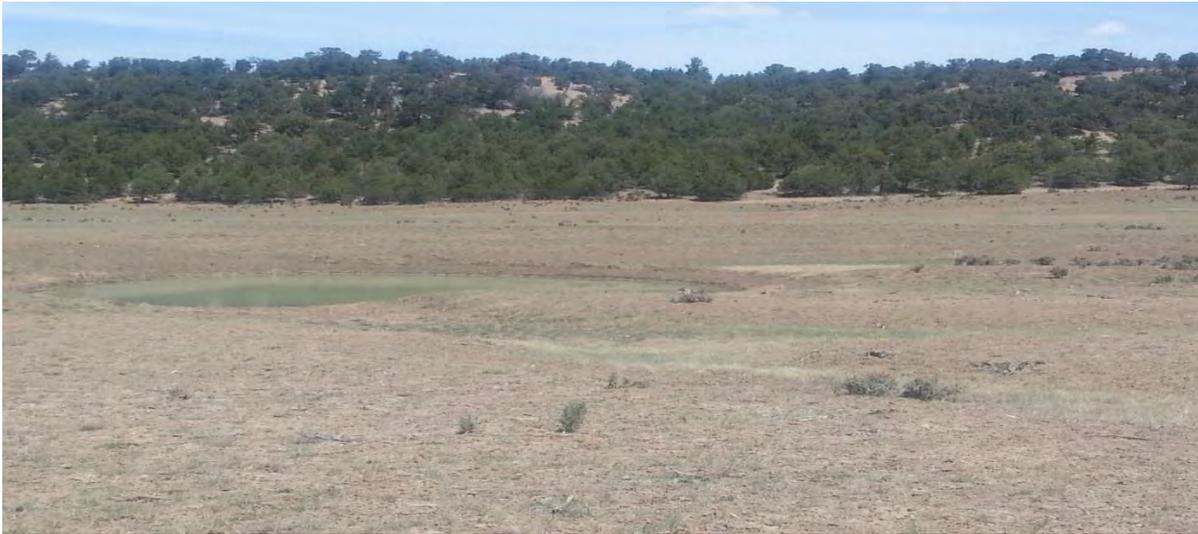
**FIGURE 22 RIO NUTRIAS DIRT TANK**

Water development is a range and wildlife management technique that can disburse the animals on the landscape, can also relieve the pressure on the river and riparian area. Many of the landowners rely on dirt tanks for providing water for their livestock. Most of the tanks have been installed at the end of an already existing gully or arroyo. These tanks have effectively served as sediment traps and most tanks have a vegetated and healed arroyo upstream from it. These tanks also provide a valuable habitat for wildlife and birds. Because they have been filled with sediments over the years many of the tanks need to be cleaned. Several landowners would like to install new dirt tanks and there is a lot of interest in wells, pipelines and drinkers because our most recent drought has made water collection undependable at best. We estimate that 7 wells with infrastructure and 10 Ponds could be installed or upgraded.

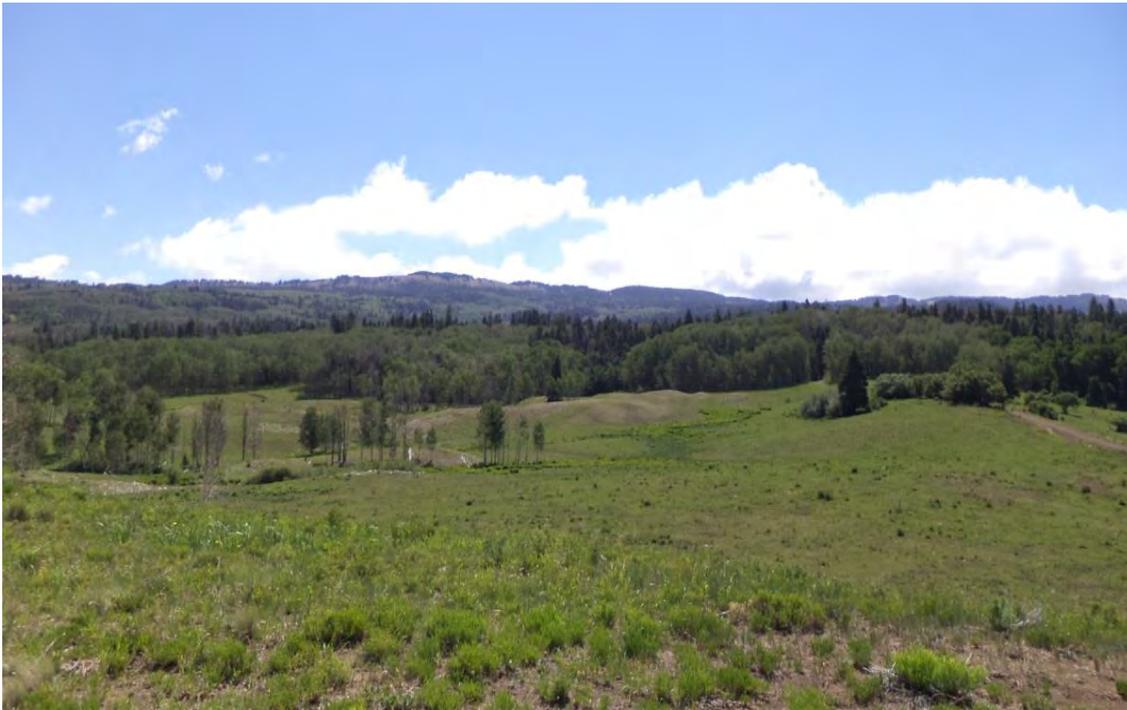
*The Upper Rio Nutrias*

To apply this model we visited the field and found a vantage point to assess the different factors in the model. For the upper section of the watershed we visited USFS lands and found a bluff to look out upon the watershed, for the middle section we visited a vista above irrigated fields, and for the lower section of the watershed we visited a site looking over the Rio Nutrias valley on BLM lands. We also included our experiences in the many site visits we have done in the Rio Nutrias watershed in our ratings
