KAFB Fuel Spill History

- **1951-53** – Kirtland Air Force Base (KAFB) Bulk Fuels Facility (BFF) constructed
- **1975** – Handling of aviation gasoline containing the additive ethylene dibromide (EDB) discontinued
- **1999** – KAFB notified NMED of soil contamination from underground piping leak, and ceased use of piping
- **2001** – KAFB notified NMED of groundwater contamination with dissolved fuel constituents
- **2003** – Soil vapor extraction (SVE) begins to vacuum contaminants from soil
- **2007** – Fuel (light non-aqueous phase liquid, LNAPL) discovered floating on groundwater
- **2009** – Water level rise begins to submerge LNAPL within aquifer
- **2014-15** – Inter-agency partnership, additional interim measures
- **2015** – Dissolved EDB groundwater cleanup begins

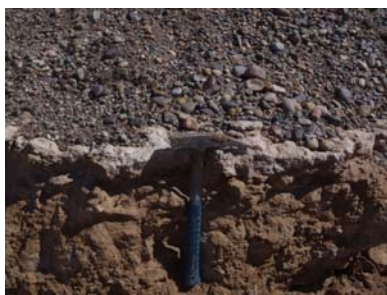
Outcrop of sediment similar to what is at fuel spill site

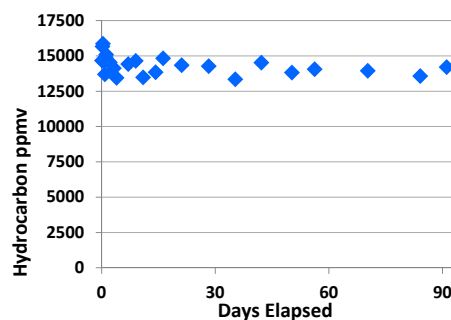
SVMW-03 at
300 ft below ground surface

Hydrocarbon concentrations
remained stable
