Animas River Mine Water Spill Briefing Report

For the Water and Natural Resources Committee August 31, 2015

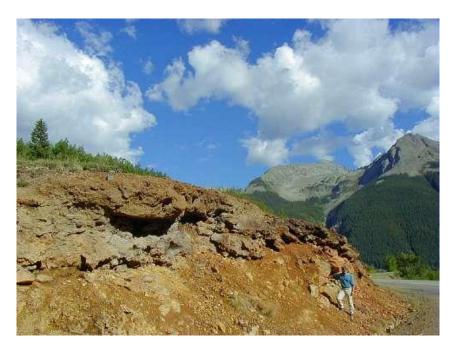
Ferricrete

Iron and other metals in ARD can precipitate and cement near-surface sediments into ferricrete. Geologic deposits of ferricrete in Cement Creek demonstrate that ARD has been occurring in this mineralized area long before mining began in the late 19th century.

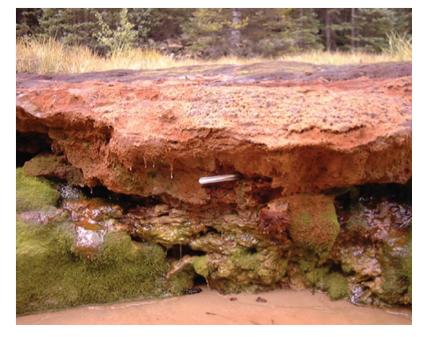
Mining, Milling and Smelting

- Hundreds of miles of mine tunnels in the Silverton area provide even greater opportunity for oxidation of sulfide minerals and release of sulfuric acid and metals. ARD has been seeping out of mine workings and into Cement Creek for more than a century.
- A number of mills and smelters in the Silverton area also discharged waste into the Animas watershed.
- Significant flood/spill events occurred on October 5, 1911, in June 1975 (tailings pond breach and fish kill in the Animas River), and on June 6, 1978 (Lake Emma drained through mine workings and carried contaminants into Cement Creek and the Animas River).

- Bulkheads installed to plug up ARD caused the impoundment of mine water in abandoned workings, and a 1,000 foot rise in the water table.
- Gold King Mine Adit #7 (mine tunnel entry) had collapsed and impounded water inside the mine.
- An EPA work crew digging into Gold King Adit #7 triggered the blowout and spill.

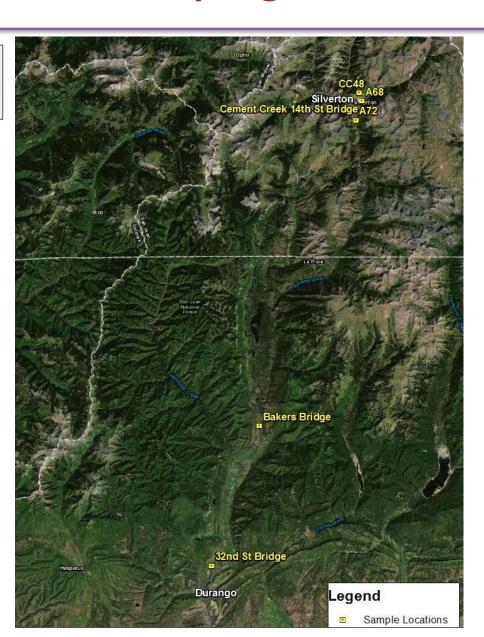
Locations of EPA Sampling Stations in Colorado

Cement Creek: CC

Animas River: A

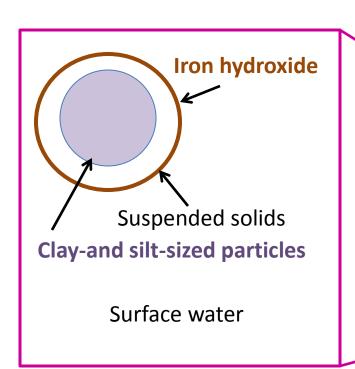
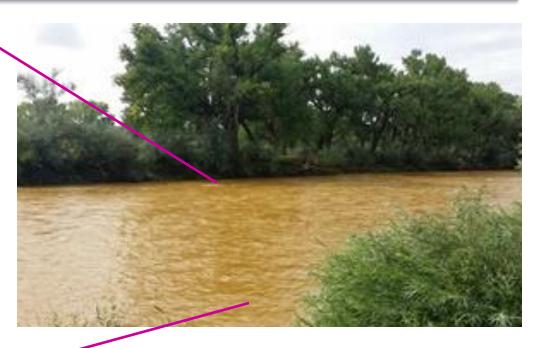
Conceptual Model of Contaminants Released from the Gold King Mine and Their Transport Along the Animas River in Colorado and New Mexico

The very high abundance of suspended particles containing iron hydroxide give the Animas River a brown color.

Contaminants also dissolve in surface water at lower concentrations compared to suspended particles.

Suspended particles of clay- and siltsized solids

Iron solids (iron hydroxide) containing arsenic, lead, zinc and other metals coat clay- and silt-sized particles

- Heavy metal concentrations in river water were generally much higher in the suspended solids (mud), not in the dissolved phase.
- High contaminant levels near the spill area decreased downstream.
- Discoloration of river water did not necessarily mean that heavy metals were present at concentrations exceeding public health standards.
