**FACT SHEET/STATEMENT OF BASIS**

**Notice of Intent to Approve a Class 3 Permit Modification to Grant  
Corrective Action Complete Status for Five Solid Waste Management  
Units Listed in the RCRA Hazardous Waste Permit**

**United States Department of Army  
White Sands Missile Range  
RCRA Permit Number NM2750211235**

**April 2021**

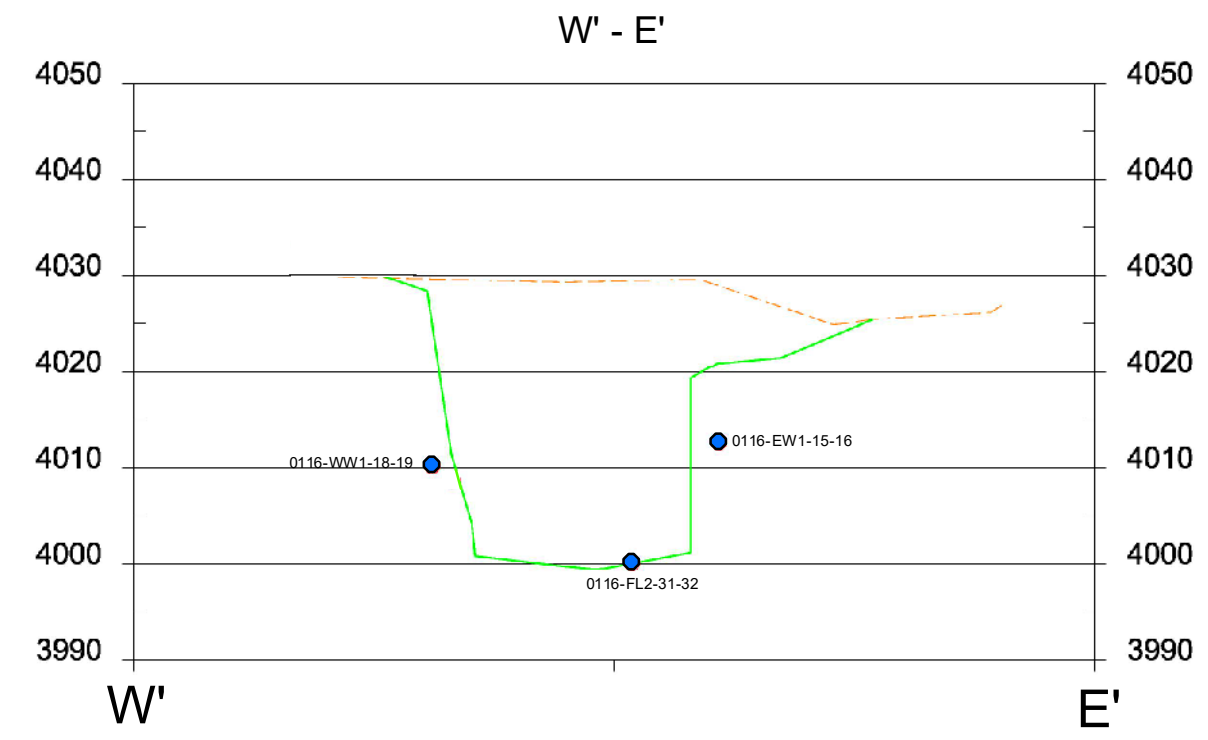
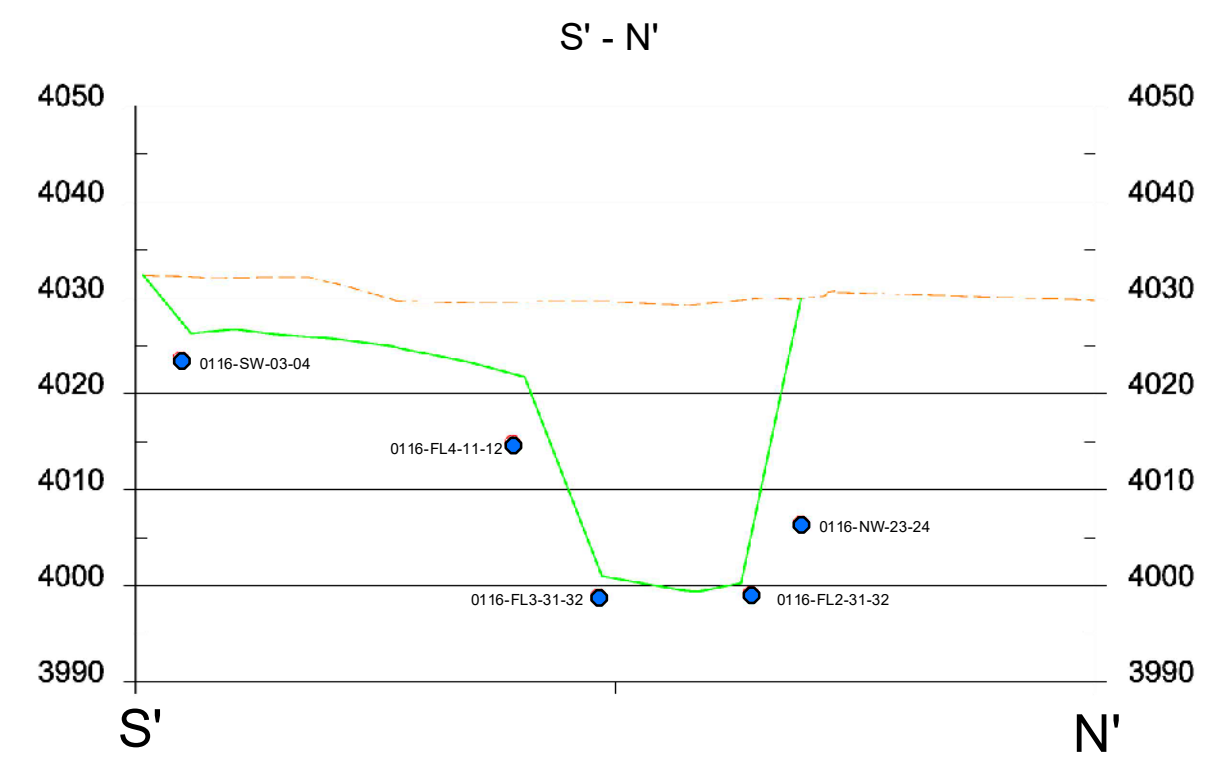
**FIGURE 6**  
**CROSS-SECTIONS OF EXCAVATION**  
 CORRECTIVE ACTION COMPLETE WITHOUT CONTROLS PETITION  
 SWMU 116, RHODES SUBGRADE ASPHALT TANKS  
 WHITE SANDS MISSILE RANGE, NEW MEXICO

Note(s):  
 1. Imagery Source: ESRI Street Map online mapping service.  
 2. Site features presented are based on available information from the WSMR geodatabase.  
 3. Cross-sections not to scale, elevations are shown in feet above mean sea level.

Soil removal began at the northeastern edge of the SWMU near boring 116-BH12 and continued south. Visibly stained soil was removed and placed in staged roll-off bins. Soil excavation was guided by visible staining, odors, PID headspace readings, and PetroFlag sample results. Excavation continued at the site until PetroFlag sampling results showed TPH-DRO concentrations along the sidewalls and floor of the excavation were less than 500 parts per million (equivalent to 500 mg/kg). The final extent of the excavation was 73 feet long by 24 feet wide; the excavation depth ranged from 4 feet bgs at the south end of the excavation to 30.5 feet at the north end. Confirmation soil samples were collected along the floor and sidewalls of the excavation for analytical testing. Sampling confirmed that the TPH-DRO, TPH-

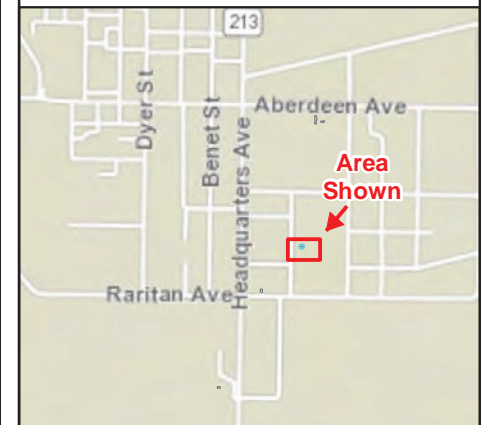
SWMU 137  
PREVIOUS INVESTIGATION  
SAMPLING LOCATIONS

1. Adapted from Figure 2-3 of the Subsurface Soil Investigation Report, SWMU 137, Paint Shop Sump (April 2014).

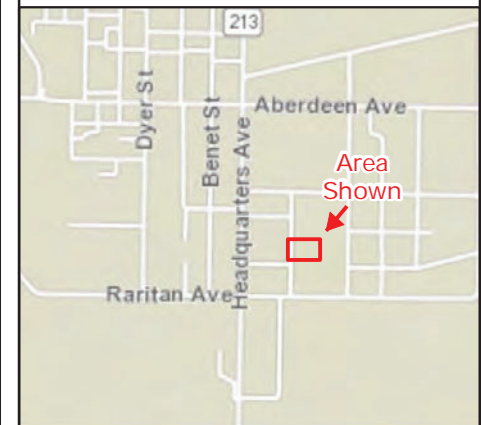
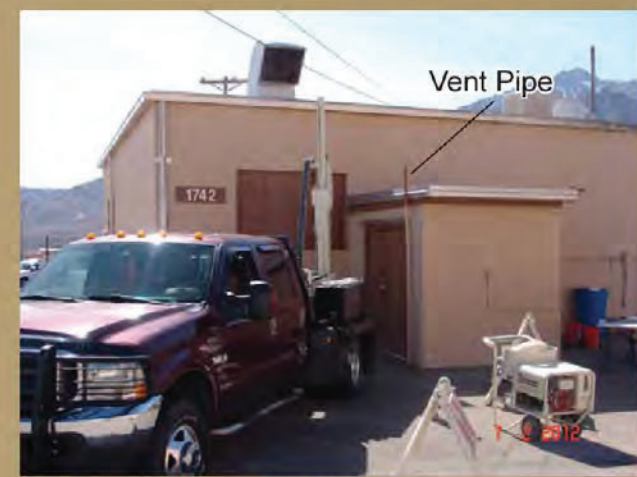
SWMU 137  
SCHEMATIC OF SUBSURFACE  
AND BOREHOLE LOCATIONS

1. Adapted from Figure 3-1 of the Subsurface Soil Investigation Report, SWMU 137, Paint Shop Sump (April 2014).

Additional investigation activities were directed in June 2013 Disapproval letter for the *Final Subsurface Soil Investigation Report* (NMED, 2013) which included the investigation and abandonment of the sump drain line, installation of two additional soil borings along the main sewer line, and removal of the sump. No evidence of leaks or soil staining was observed, and no odors or field screening evidence of volatile organic compound (VOCs) were detected in the soils immediately beneath the sump drain line. One waste characterization sample was collected from the sump demolition debris and analyzed for TCLP VOCs, SVOCs, and metals. Five confirmation soil samples (137-CS01 through 137-CS05) were collected from the soils adjacent to the former sump, one from each sidewall and one from the floor. Two soil borings, 137-BH07 and 137-BH-08, were installed immediately adjacent to the main wastewater line. All samples were analyzed for TAL metals, VOCs, SVOCs, TPH-GRO, TPH-DRO, and PCBs. Detected contaminant concentrations did not exceed the NMED SSLs (NMED, 2012a). The sump excavation was subsequently filled with concrete and all investigation derived waste was managed in accordance with Permit requirements.

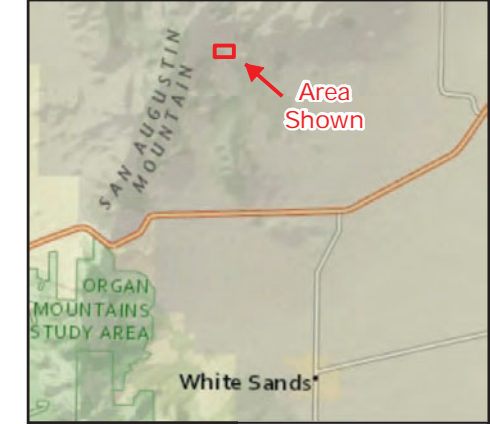
SWMU 153  
MONITORING WELL LOCATIONS  
FORMER VANDAL BURIAL SITE

1. Adapted from Figure 3-1 of the RCRA Facility Investigation Report, SWMU 153, Former Vandal Burial Site (January 2015).
  2. NMED Residential SSLs:  
Lead = 400 mg/kg  
Antimony = 31.3 mg/kg
- HTA = Hazardous Test Area  
RCRA = Resource Conservation and Recovery Act  
RFI = RCRA Facilities Investigation  
SWMU = Solid Waste Management Unit  
WSMR = White Sands Missile Range

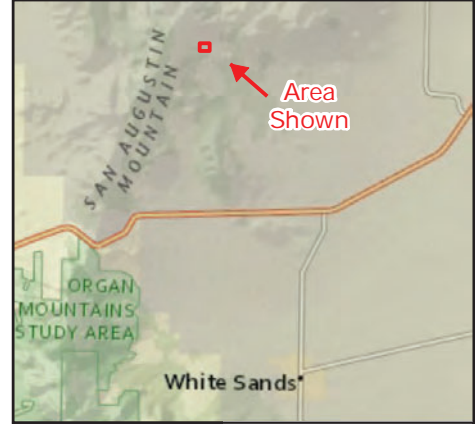
SWMU 153  
SOIL ANALYTICAL RESULTS  
EXCEEDING NMED RESIDENTIAL SSLs  
FORMER VANDAL BURIAL SITE

- Adapted from Figure 6-1 of the RCRA Facility Investigation Report, SWMU 153, Former Vandal Burial Site (January 2015).  
 AMSL = Above Mean Sea Level  
 HTA = Hazardous Test Area  
 LTM = Long Term Monitoring  
 ND = Non Detect  
 OB/OD = Open Burn/Open Detonation  
 RCRA = Resource Conservation and Recovery Act  
 RFI = RCRA Facility Investigation  
 SWMU = Solid Waste Management Unit  
 WSMR = White Sands Missile Range  
 µg/L = Micrograms per liter  
 RCRA Permit Standard = 4.0 µ/L

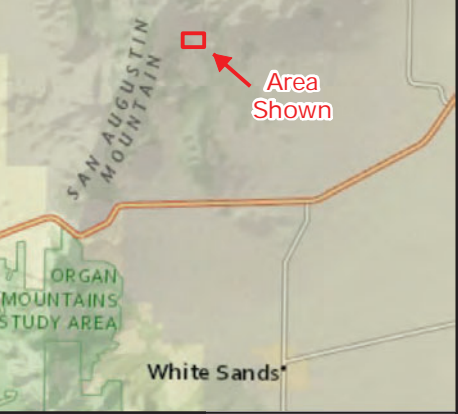
SWMU 153  
PERCHLORATE IN GROUNDWATER  
FORMER VANDAL BURIAL SITE

- Adapted from Figure 6-2 of the RCRA Facility Investigation Report, SWMU 153, Former Vandal Burial Site (January 2015).  
 AMSL = Above Mean Sea Level  
 HTA = Hazardous Test Area  
 LTM = Long Term Monitoring  
 ND = Non Detect  
 OB/OD = Open Burn/Open Detonation  
 RCRA = Resource Conservation and Recovery Act  
 RFI = RCRA Facility Investigation  
 SWMU = Solid Waste Management Unit  
 WSMR = White Sands Missile Range  
 µg/L = Micrograms per liter  
 RCRA Permit Standard = 4.0 µ/L

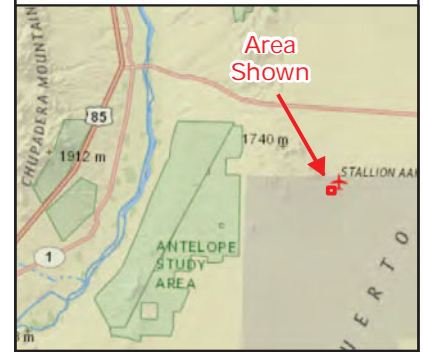
SOIL BORING LOCATIONS  
FOR STALLION  
RANGE CENTER FORMER FFTA  
SWMU 162

- Adapted from Figure 6 of the Revised RCRA Facility Investigation Report for the Stallion Range Center Former Firefighter Training Area (June 2011).
- Base map provided by Zia, and rectified to December 2008 satellite image.
- The screening criteria for DRO is taken from the October 2006 NMED TPH screening guidelines.
- Yellow highlight indicates the reported result exceeds the published SSL.
- Brackets indicate that the result shown is from a duplicate field sample.

The initial investigation of the FFTA was conducted in January 2010 to characterize subsurface conditions and evaluate whether historical operations resulted in impacts to soil and/or groundwater beneath the site (ARCADIS, 2011). The initial field activities included collecting soil samples from eight borings (SB-001 through SB-008) within the FFTA and three background soil borings (BG-001 through BG-003) located outside the FFTA. Soil samples were collected at four depth intervals (i.e., 0.5 to 1-foot bgs, 4 to 5 feet bgs, 9 to 10 feet bgs, 14 to 15 feet bgs) from each of the borings. The investigation soil samples were analyzed for TPH-GRO, TPH-DRO, VOCs, polynuclear aromatic hydrocarbon (PAHs), and RCRA metals (arsenic, barium, cadmium, chromium, lead, mercury, selenium, and silver). Background soil samples were analyzed for metals only. Additional soil samples were subsequently collected from two additional soil borings (SB-009 and SB-010) in April 2010 to delineate TPH-DRO detected during the initial investigation.

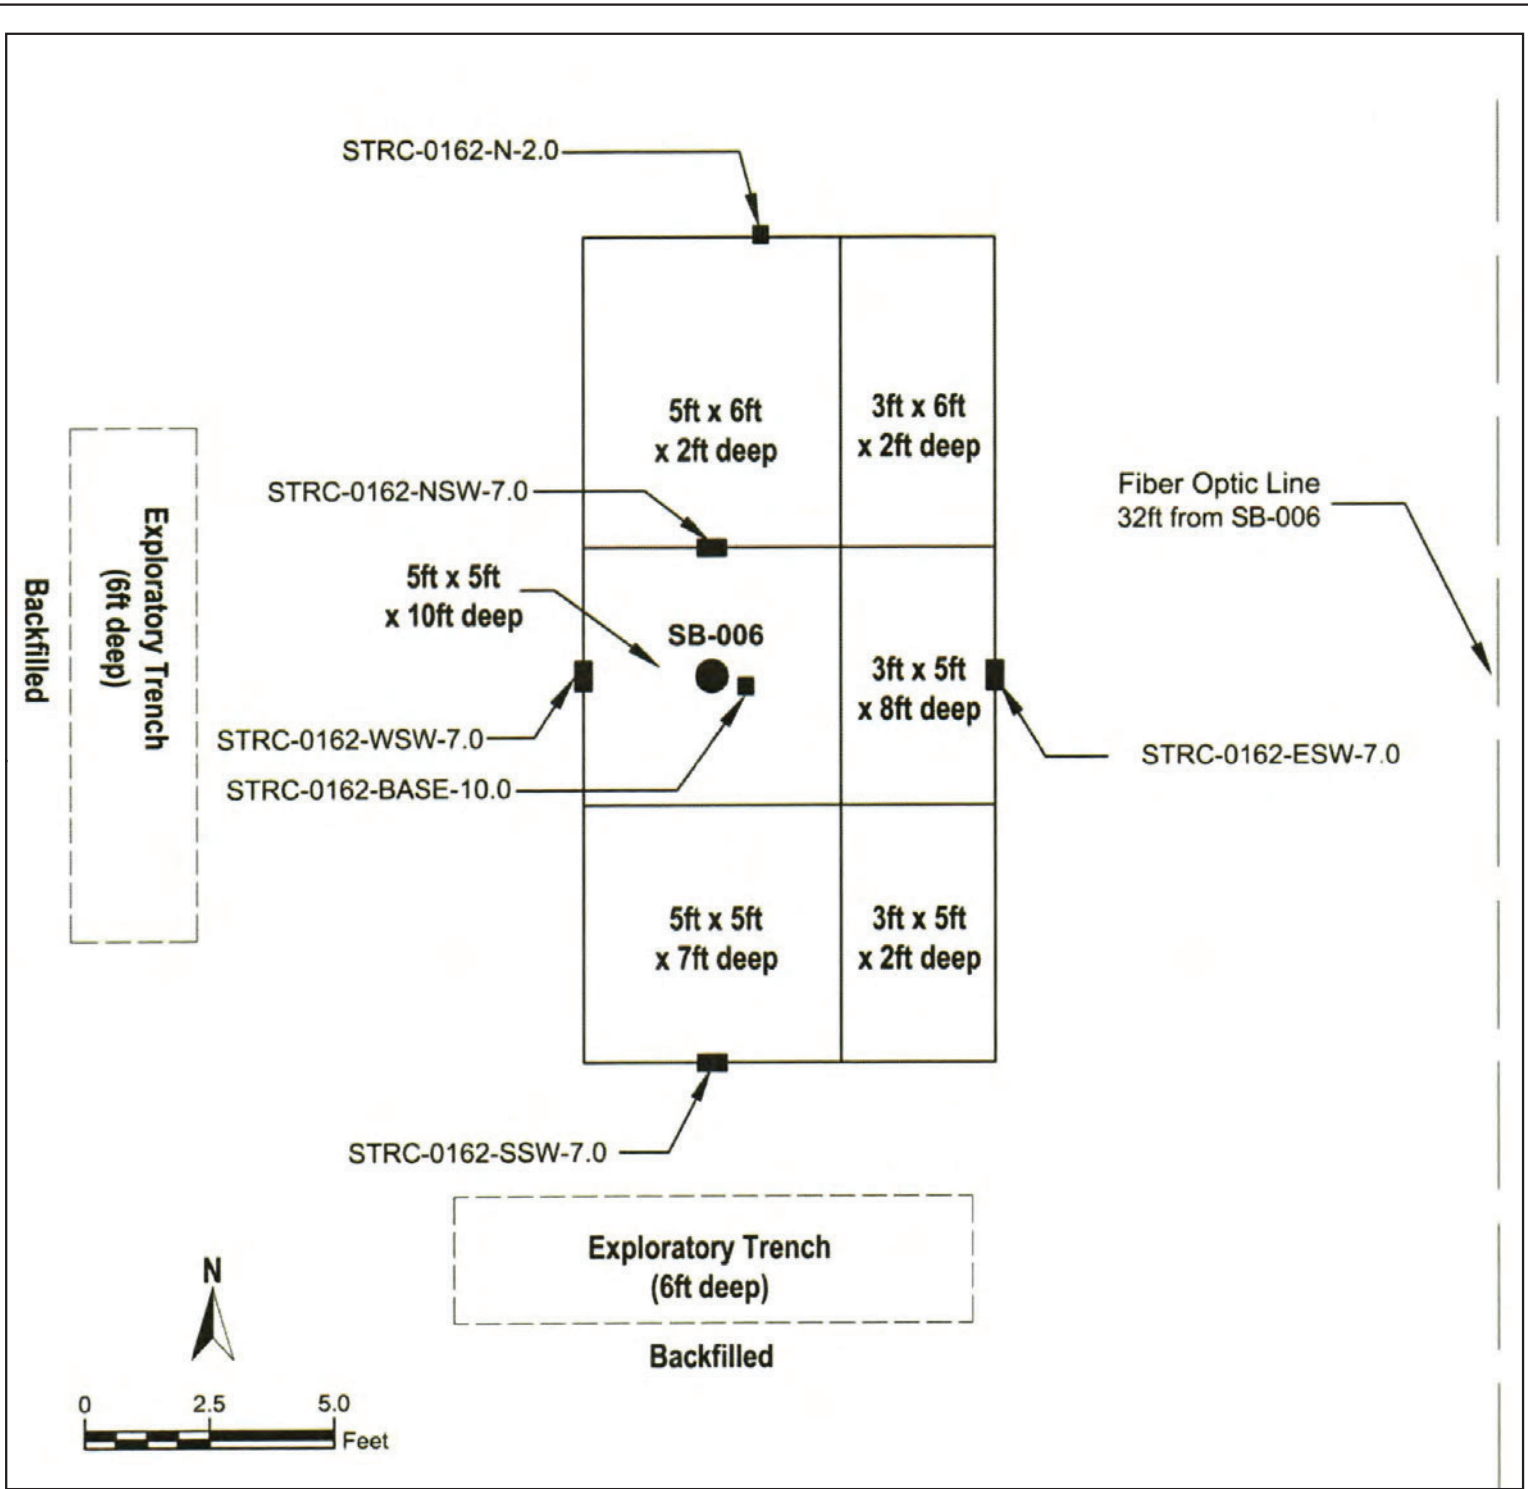
FIGURE: 4-3 | DATE: 11/5/2018

EXTENT OF EXCAVATION AT  
LOCATION SB-006, STALLION  
RANGE CENTER FORMER FFTA  
SWMU 162

Exploratory trenching was performed around sample location SB-006 based on NMED's January 2011 Disapproval comments for the RFI Work Plan (NMED, 2011). Samples from SB-006 reported DRO and arsenic concentrations exceeding the SSLs and debris in the subsurface was identified by ground penetrating radar (GPR) used for utility clearance. Three exploratory trenches were excavated surrounding SB-006 with a final dimension of 16 feet by 8 feet and varying from 2 feet to 10 feet in depth. Trench boundaries were expanded based on field observations of staining, odors, or encountering debris such as plastic trash, a section of pipe, cardboard and an oil filter. Grout from the 2010 soil sampling activities was encountered between 0.5 to 1-foot bgs. Trenches that did not contain debris were backfilled and not sampled. Approximately 60 cubic yards of impacted soil and debris were removed from the exploratory trench at SB-006 and shipped off-site for disposal. Confirmation samples collected from the floor and side walls of the excavation indicated that the extent of the excavation had adequately removed all impacted soils from the area and concentrations of constituents of concern were less than the SSLs; therefore, a risk assessment was not warranted for the site.

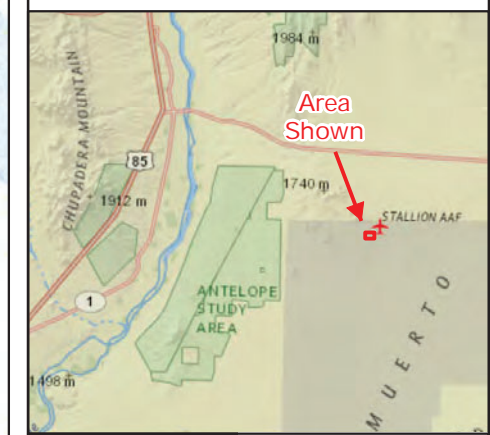
FIGURE: 4-5      DATE: 11/5/2018

- NOTES:**
- Adapted from Figure 7 of the Revised RCRA Facility Investigation Report for the Stallion Range Center Former Firefighter Training Area (June 2011).
  - Base map provided by Zia, and rectified to December 2008 satellite image.
  - The screening criteria includes the residential SSL and the DAF20 SSL. The residential SSL is the lower of the NMED SSL (Dec 2009) or the USEPA RSL (2009).
  - Yellow highlight indicates the reported result exceeds the published SSLs.
  - Italics indicates the reported result exceeds the NMED DAF 20 screening value.
  - Brackets indicate that the result shown is from a duplicate field sample.
  - Only those PAH compounds reported at concentrations above the reporting limit in at least one sample are shown. All other PAH compounds were below the reporting limit in all samples.

PAH CONCENTRATIONS IN SOILS  
 STALLION RANGE CENTER  
 FORMER FFTA  
 SWMU 162

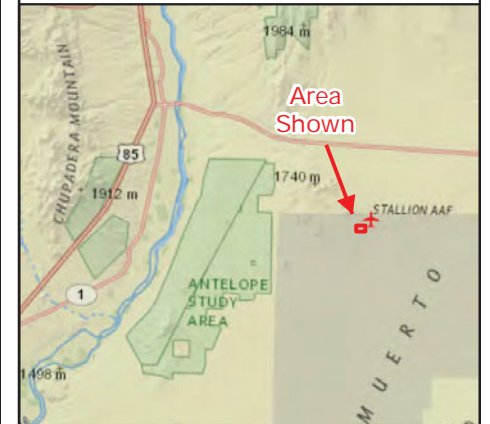
- NOTES:**
1. Adapted from Figure 8 of the Revised RCRA Facility Investigation Report for the Stallion Range Center Former Firefighter Training Area (June 2011).
  2. Base map provided by Zia, and rectified to Dec 2008 satellite image.
  3. The screening criteria includes the residential SSL and the DAF20 SSL. The residential SSL is the lower of the NMED SSL (Dec 2009) or the USEPA RSL (2009).
  4. Yellow highlight indicates the reported result exceeds the published SSLs.
  5. Italics indicates the reported result exceeds the NMED DAF 20 screening value.
  6. Brackets indicate that the result shown is from a duplicate field sample.

METALS CONCENTRATIONS IN SOILS  
STALLION RANGE CENTER  
FORMER FFTA  
SWMU 162

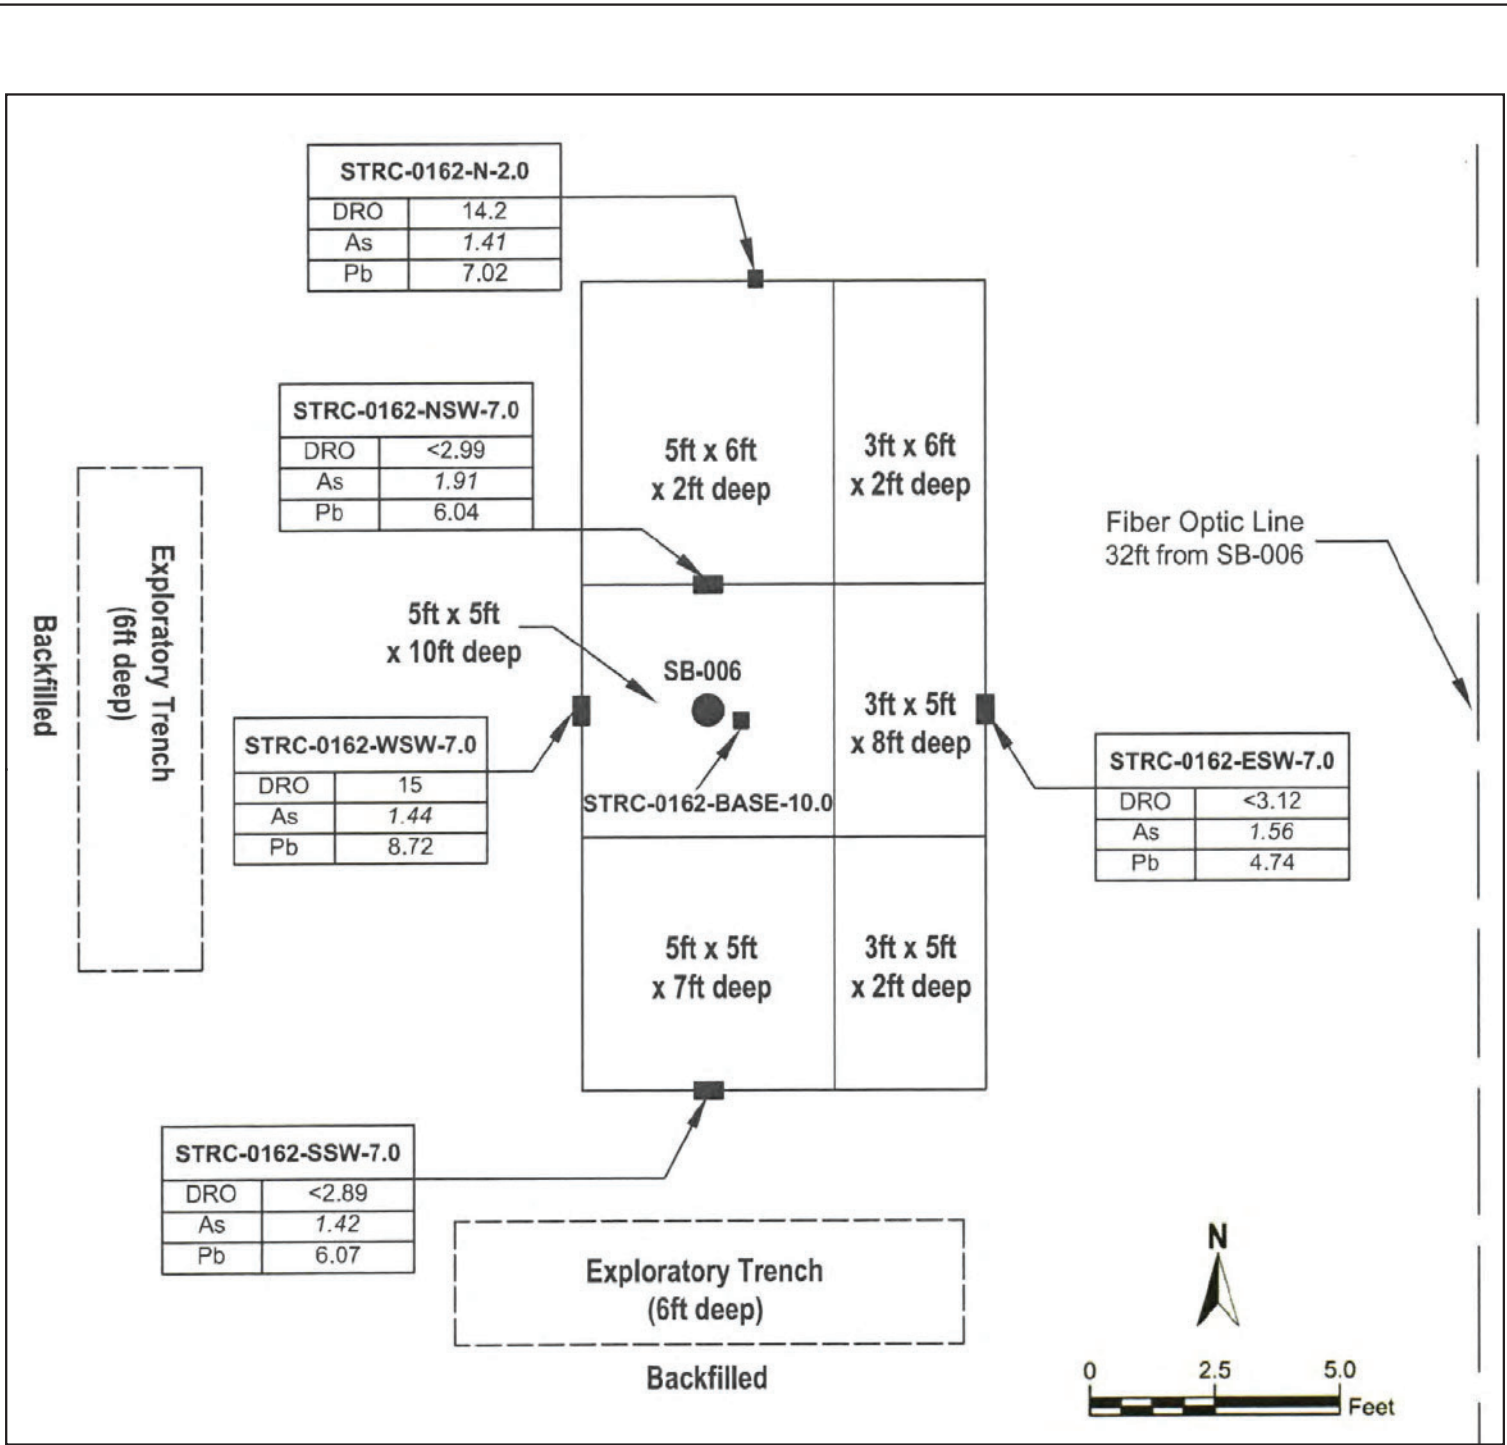
RESULTS OF SOIL CONFIRMATION  
 SAMPLES, STALLION RANGE  
 CENTER FORMER FFTA  
 SWMU 162
