DEPARTMENT OF THE AIR FORCE
HEADQUARTERS 377TH AIR BASE WING (AFMC)

SUBJECT: Failure of Jet Fuel Offloading Pipeline

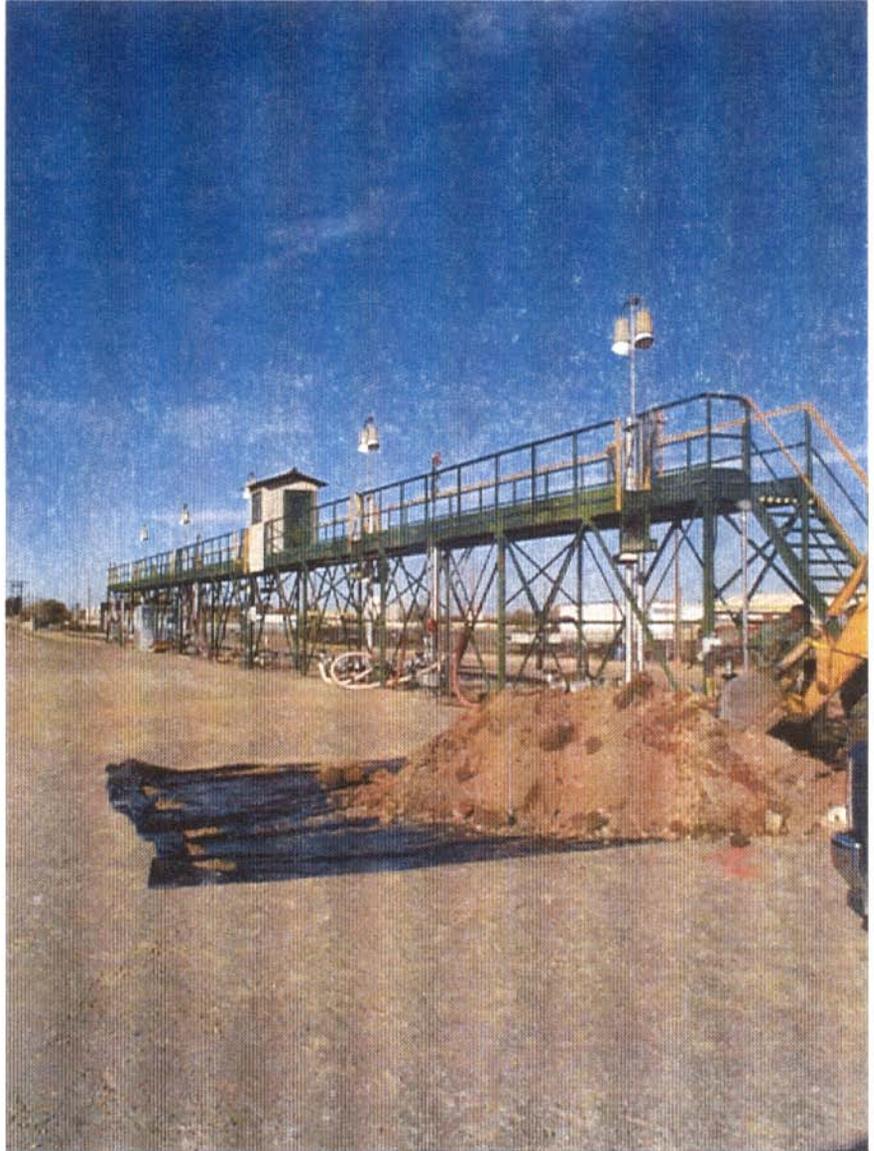
During the testing of the tank 23 pipeline, a cam-lock coupling failed resulting in a fuel spill of approximately 300 gallons. During the testing of the Tank 23 pipeline, a cam-lock coupling failed resulting in a fuel spill of approximately 300 gallons. During the retest of the Tank 23 line, product visibly bubbled from the ground. We uncovered portions of the pipeline and found the 48 year old lines failed because of corrosion (see attached photos).

Pipeline failures located under old stands

4. Request the necessary coordination, programming and approval to allow the immediate replacement of the failed lines and associated equipment. Our recommended corrective action will provide four off loading headers each equipped with two off loading pantographs. An additional single point connection will be provided for R-11 truck returns. The expedient approval of this emergency design-build project will allow us to meet our mission requirements. Please address your questions or concerns on this issue to CMSgt Joel Reinhard, Chief, Utility Infrastructure at DSN 246-2454.

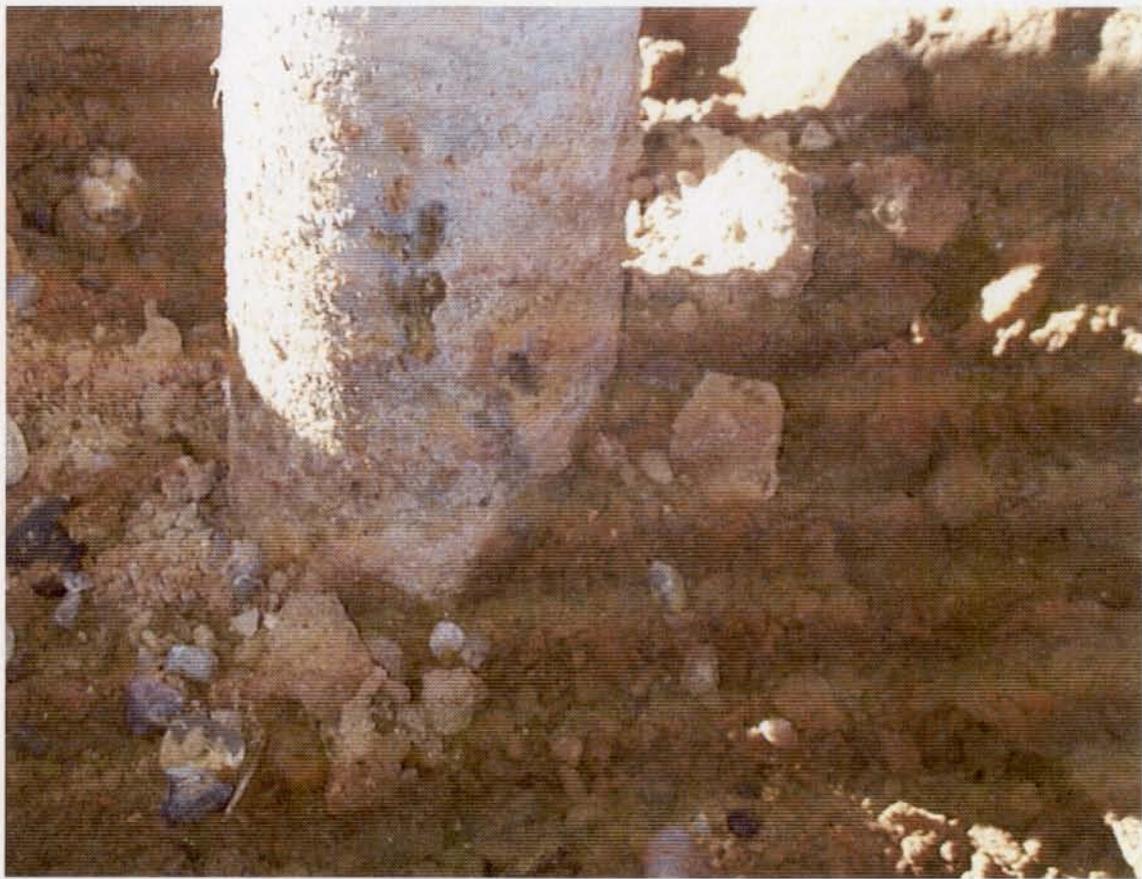
Rusted risers and buried couplings

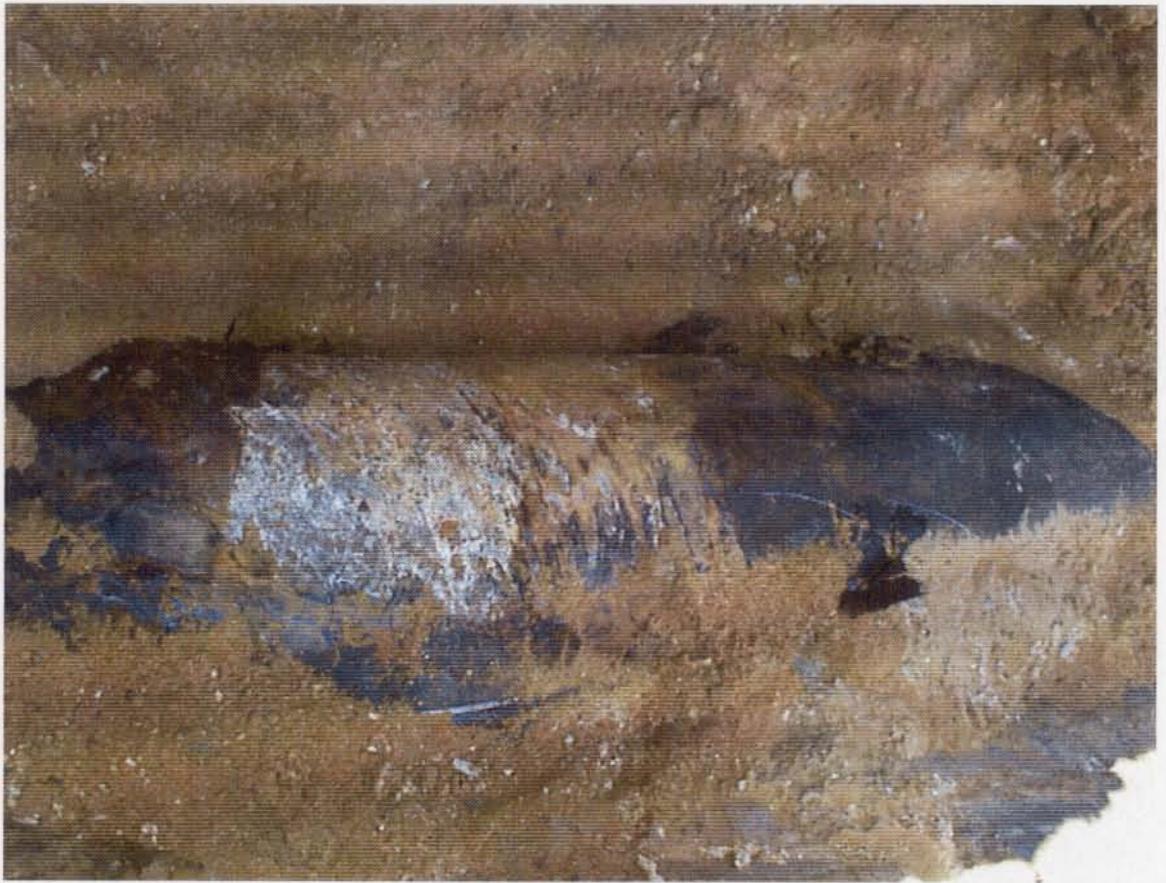
Failed pipe coating and pipeline rust

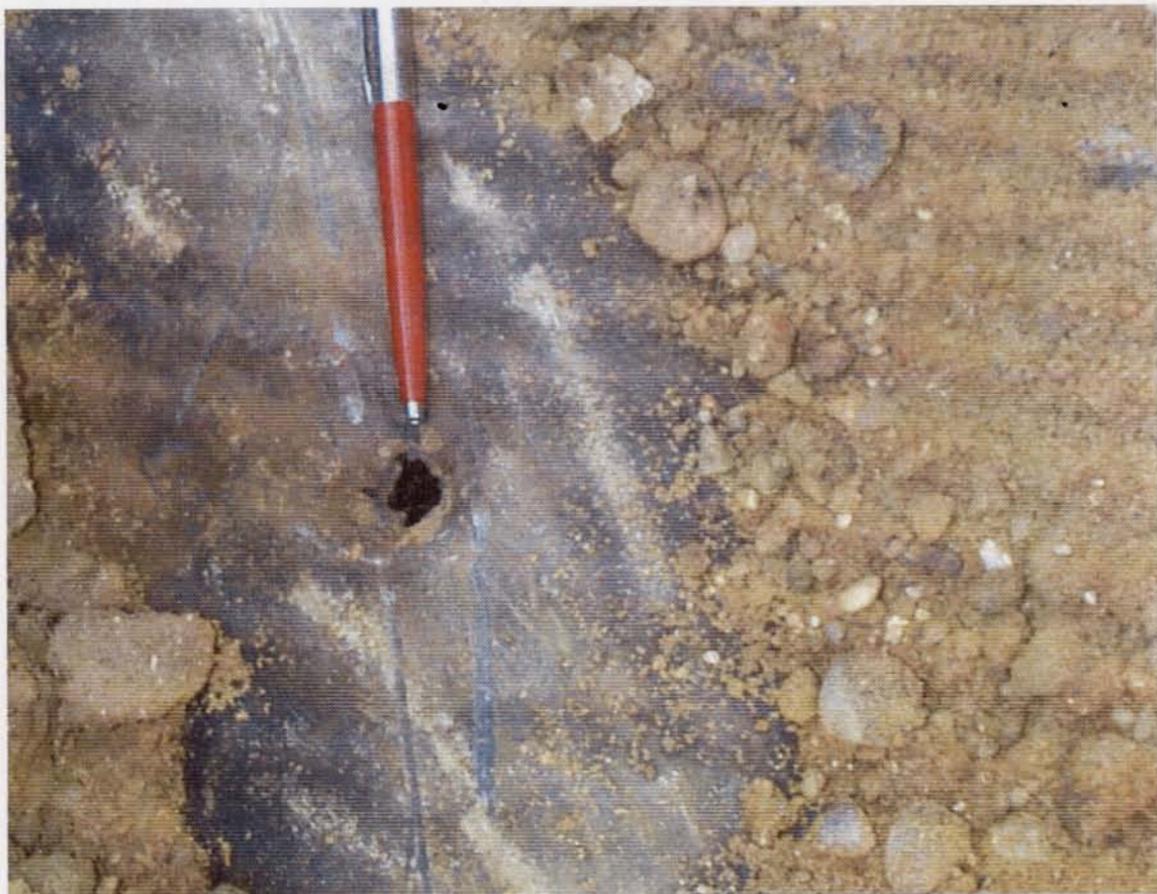
One of the rust through spots

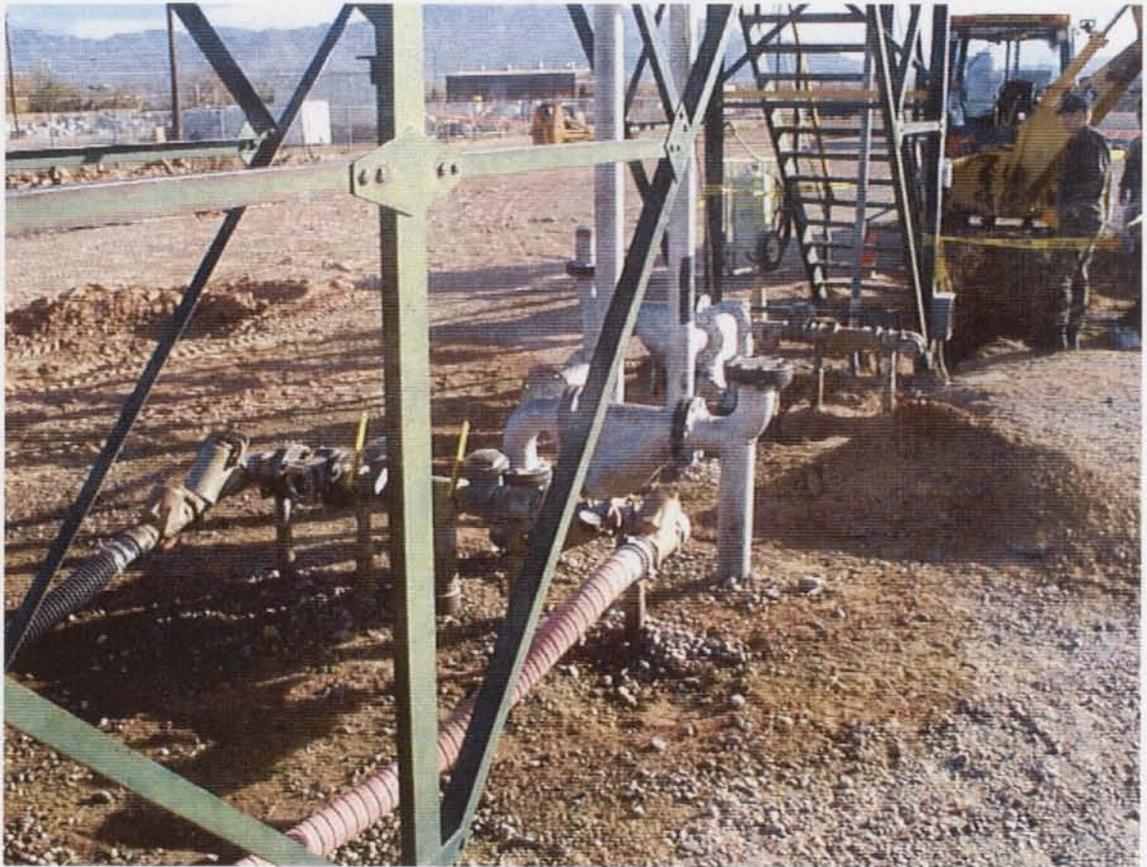
Obsolete RR tank car Headers used for truck offloading
