Rubberized Asphalt Concrete Pavements in New Mexico

Market Feasibility and Performance Assessment

**Prepared for the New Mexico Environmental Department and
the South Central Solid Waste Authority**

June 2011

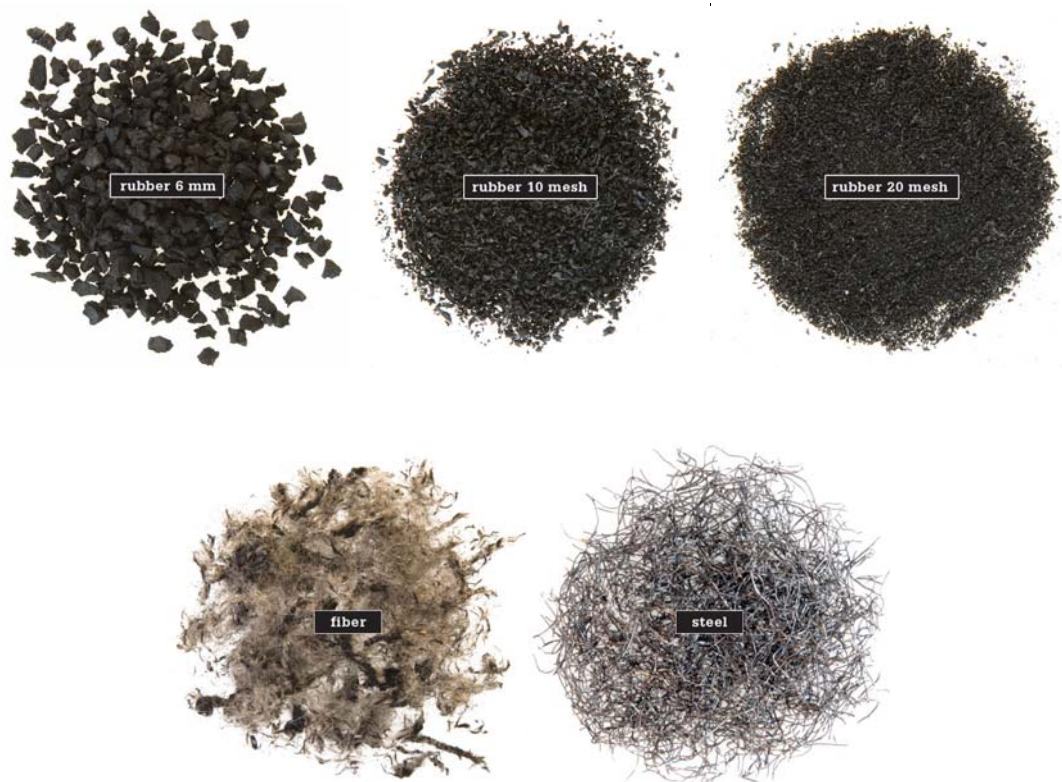
Figure 1. Crumb rubber, steel and fibers samples from recycled scrap tires [Source: reRubber (2011)]

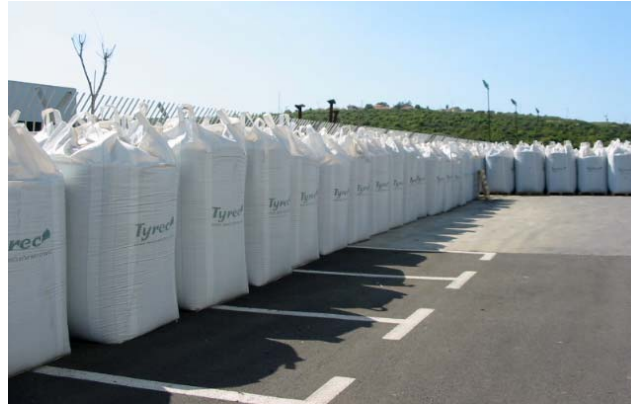
Figure 2. One-ton bulk bags of crumb rubber (Photo by Shuki, Wikimedia Commons)

The dry process can be implemented in batch or drum-dryer plants. The granulated or crumb rubber is usually packed and stored in sacks at the plant (Figure 2). Good control of the feeding of rubber and temperature are critical because the rubber content and temperature affect the performance of the resulting asphalt mixture and pavement. For both batch and drum-dryer HMA plants, the addition of rubber normally requires adjusting the mixing time and temperature. Batch plants require a dry mix cycle to ensure that the heated aggregate is mixed with the crumb rubber before applying the asphalt cement (MEEF, 2011).

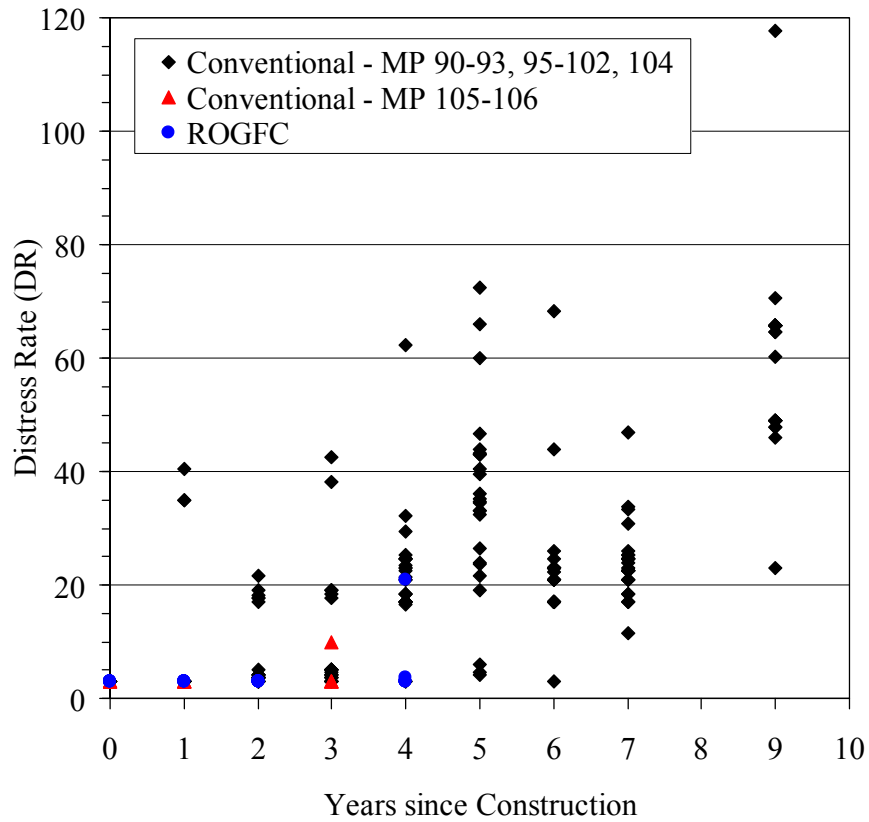
Figure 4. Distress rate for the sample units on US 62/NM 180

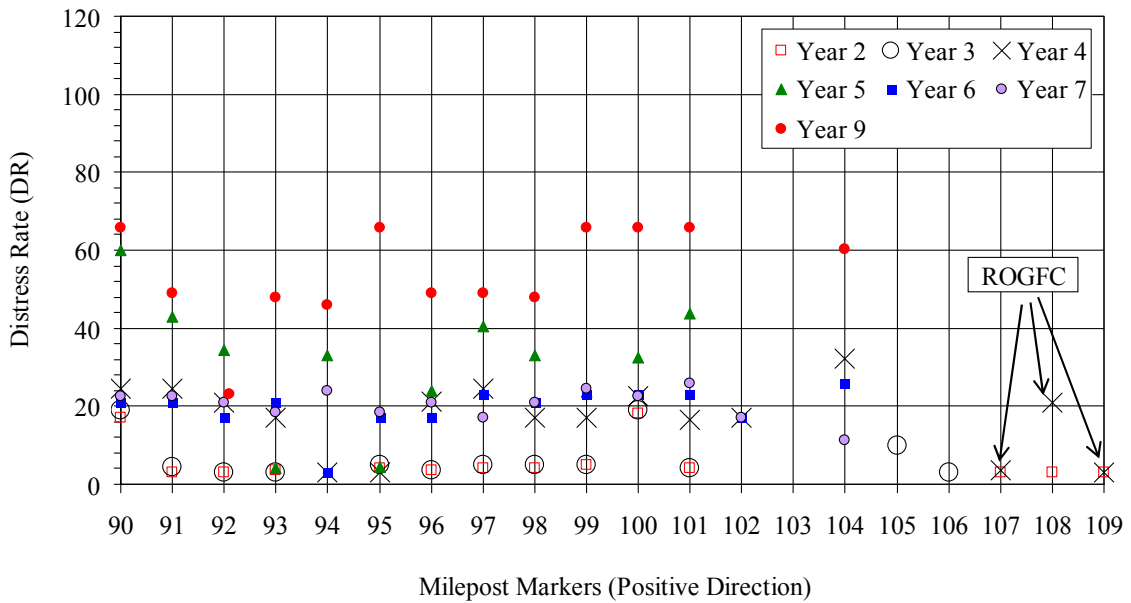
Figure 5. Distress rate values for sample units on US 62/NM 180 (Positive direction)

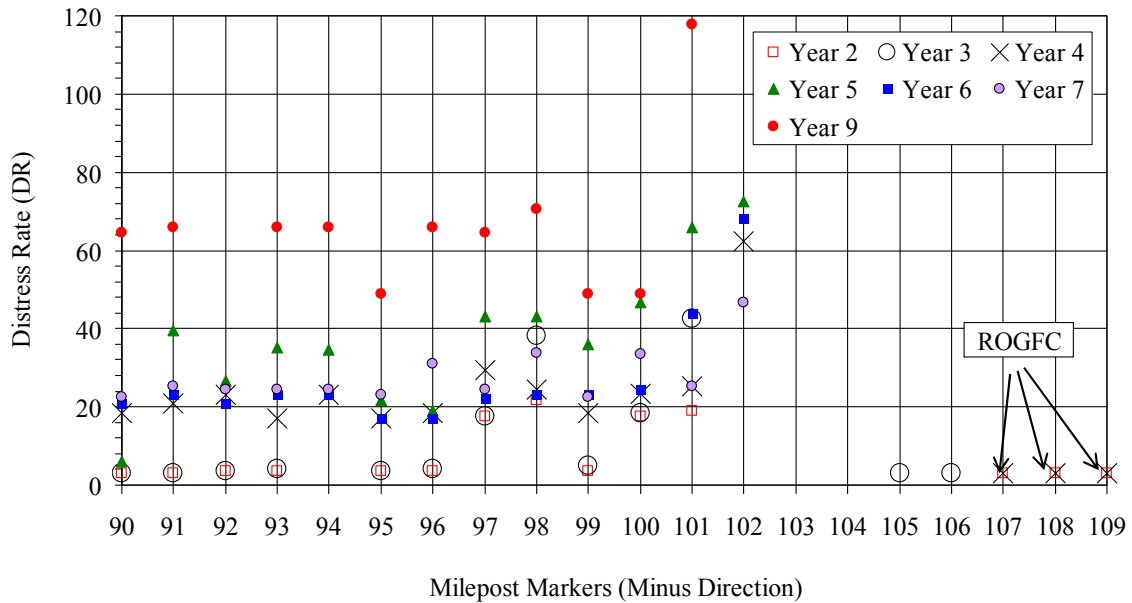
Figure 6. Distress rate values for sample units on US 62/NM 180 (Minus direction)

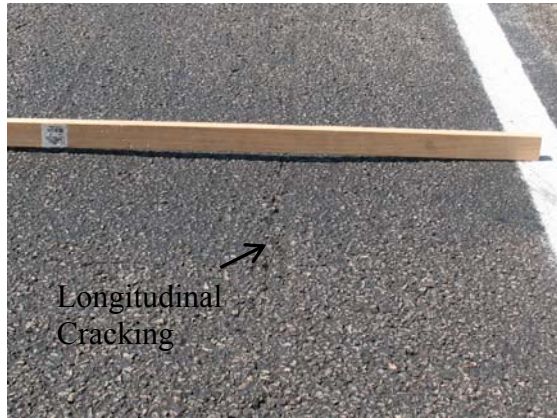
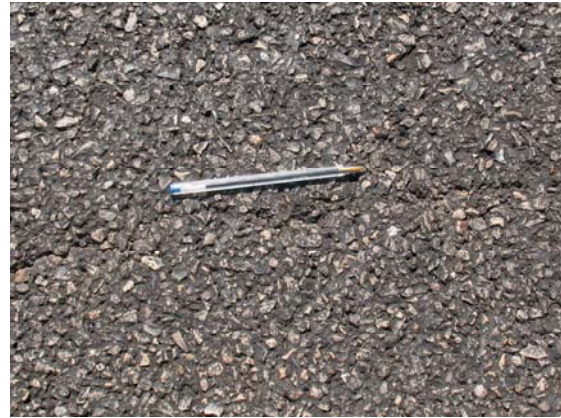
Figure 7. Pavement surface in MP 3 (Minus direction) on US 54: a) medium severity rutting and low severity longitudinal cracking, and b) detail of a longitudinal crack (2011)

after 9 years. Figures 7, 8 and 9 show rutting (estimated using a 4-ft rut bar) and edge or longitudinal cracking in three ROGFC sample units in Year 9 (2011).

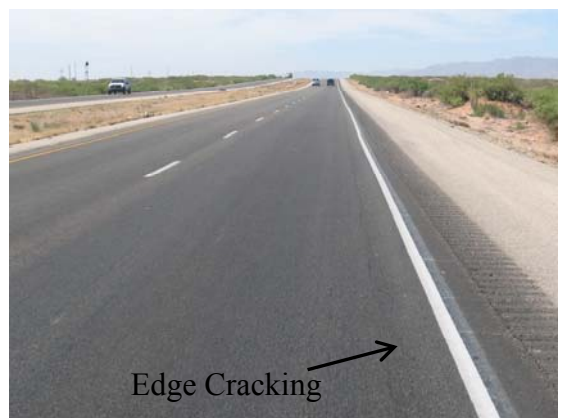
Figure 8. Pavement surface in MP 4 (Minus direction) on US 54: a) medium severity rutting and low severity edge cracking, and b) view of the ROGFC sample unit

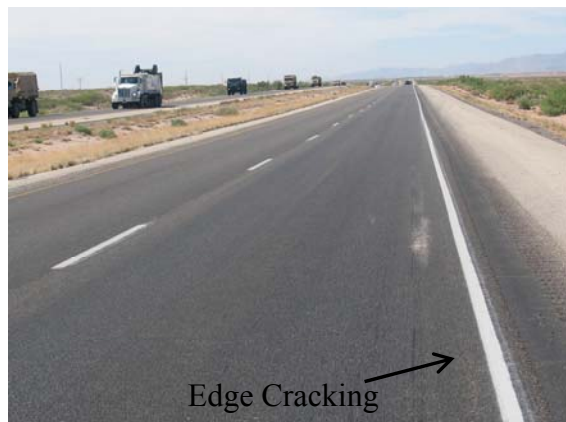
Figure 9. Pavement surface in MP 5 (Minus direction) on US 54: a) low severity rutting and edge cracking, and b) view of the ROGFC sample unit (2011)

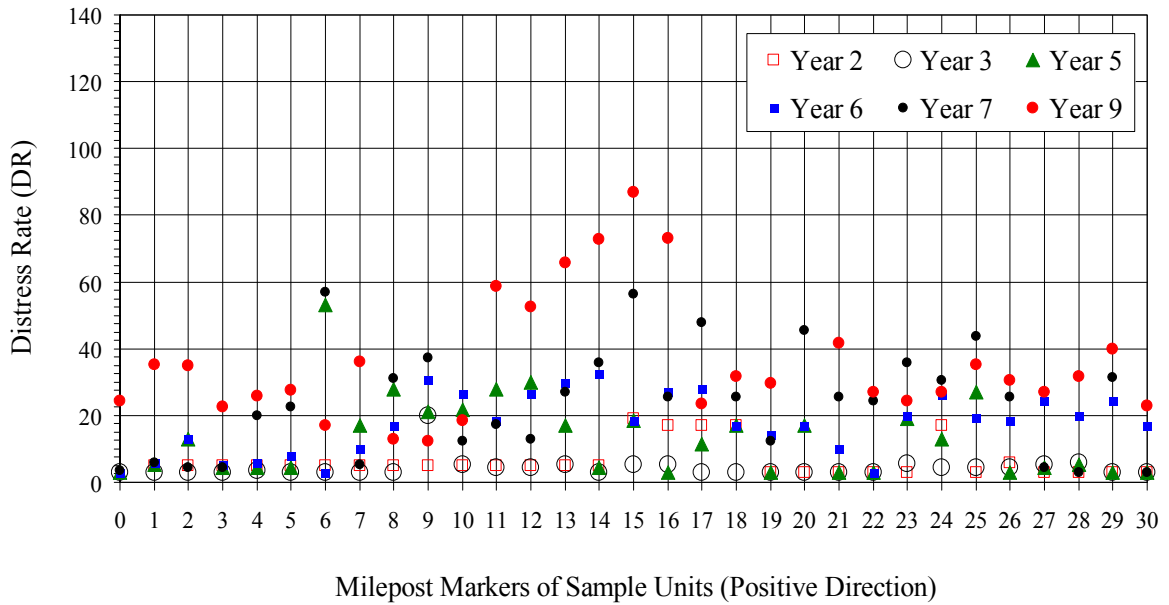
Figure 10. Distress rate for ROGFC sample units on US 54 from MP 0 to MP 30 (Positive direction)

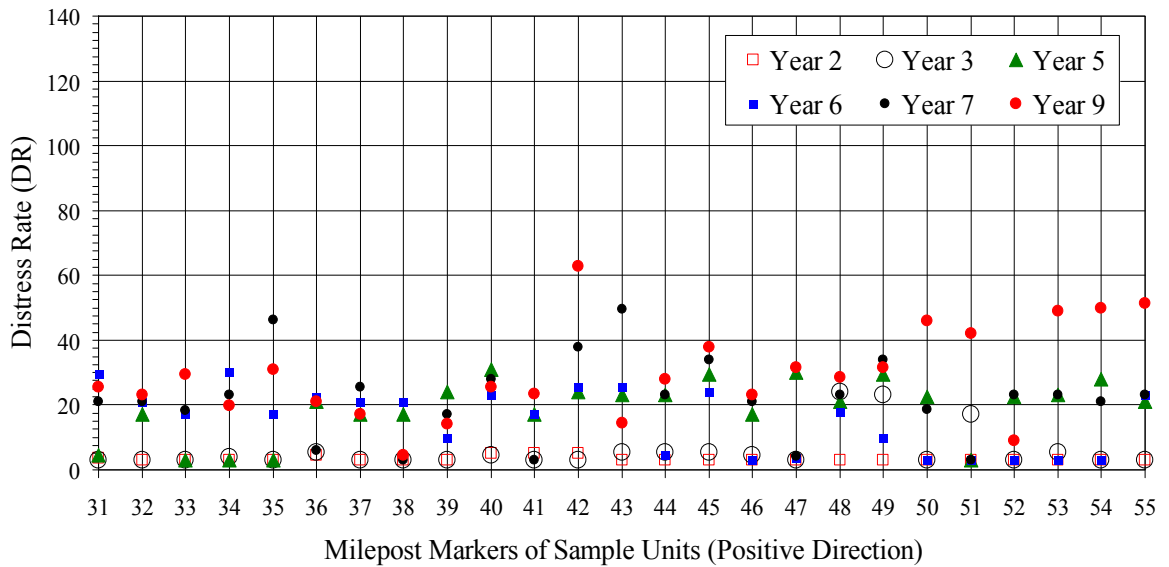
Figure 11. Distress rate for ROGFC sample units on US 54 from MP 31 to MP 55 (Positive direction)

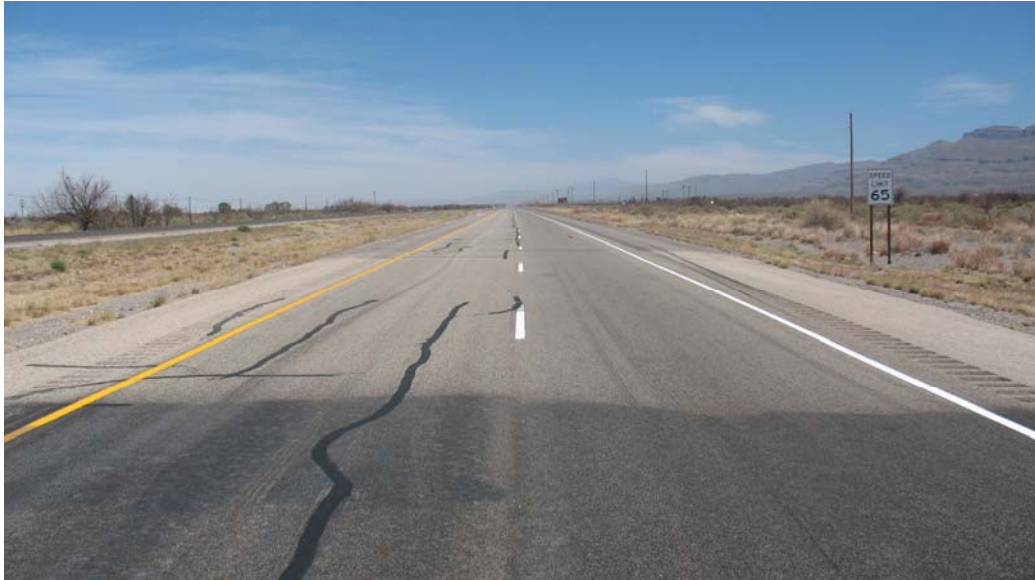
Figure 14. End of ROGFC pavement (lighter) and beginning of OGFC pavement (darker) on US 54 at MP 55 sample unit (Positive direction): a) view of the pavement, and b) sealed longitudinal crack (OGFC: left-hand side; ROGFC: right-hand side)

Figure 14 shows the end of the ROGFC pavement and beginning of the OGFC pavement at MP 55 sample unit. Close inspection of this ROGFC pavement surface shows considerably more binder on top of and among the aggregates compared to the OGFC pavement surface (Figure 14b). In Year 9 (2011), the OGFC sample units from MP 56 to MP 62 are affected mainly by medium severity longitudinal and edge cracking. As mentioned earlier, most of the ROGFC sample units have developed longitudinal, transverse and edge cracking of low and/or medium severity after 9 years of service.

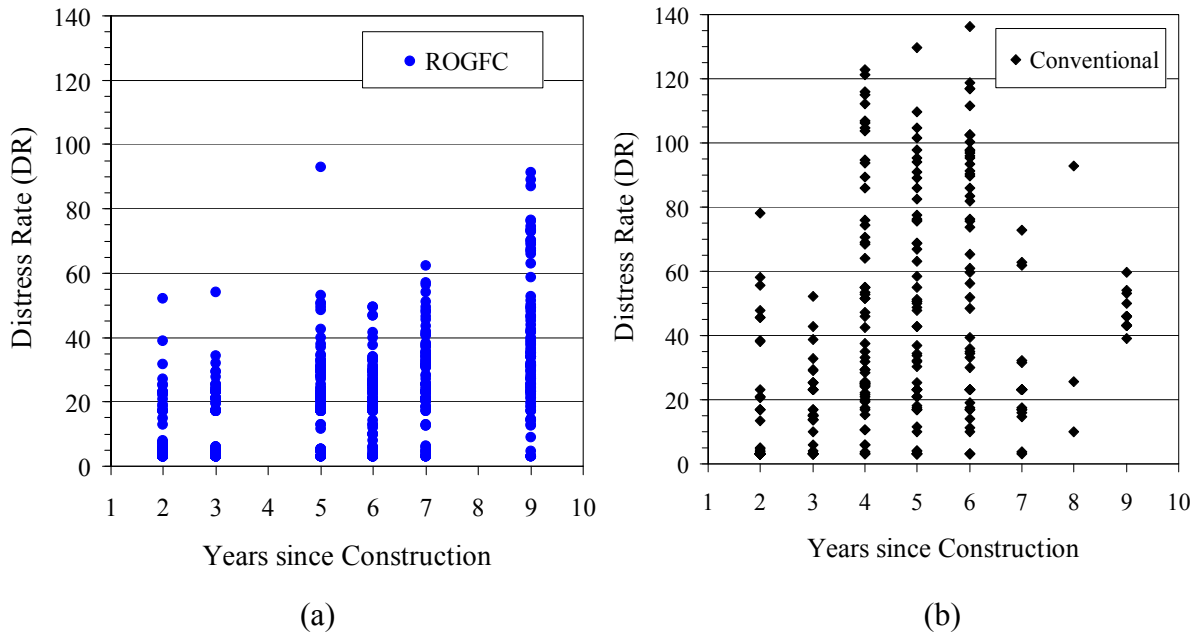
Figure 15. Distress rate values for sample units on US 54: a) ROGFC and b) conventional (non-ROGFC) pavements

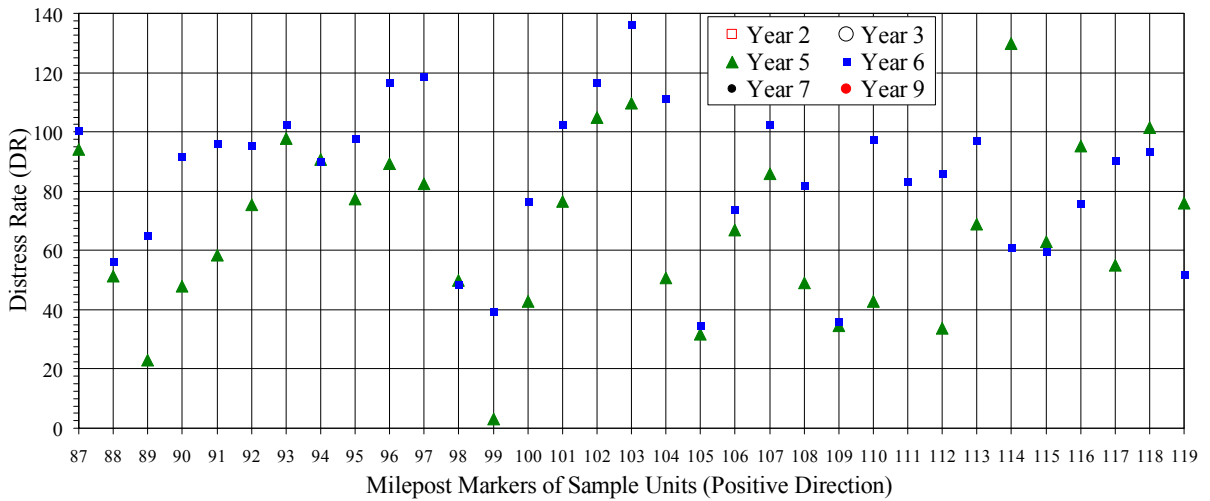
Figure 17. Distress rate for conventional (non-ROGFC) sample units on US 54 from MP 87 to MP 119 (Positive direction)

The distress rate values for the non-ROGFC sample units on US 54 are shown in Figures 16 through 18. There is indication that the set of ROGFC sample units on US 54 built in 2002 has performed better than conventional sample units in terms of the distress rate in the short and long terms. In particular, the majority of the sample units from MP 87 to MP 119 (Positive direction) have shown significantly higher DR in the long term compared to the rest of the data set. None of these pavements was part of an experimental program and there are several factors affecting the performance of these pavements that could not be accounted for in this comparison.

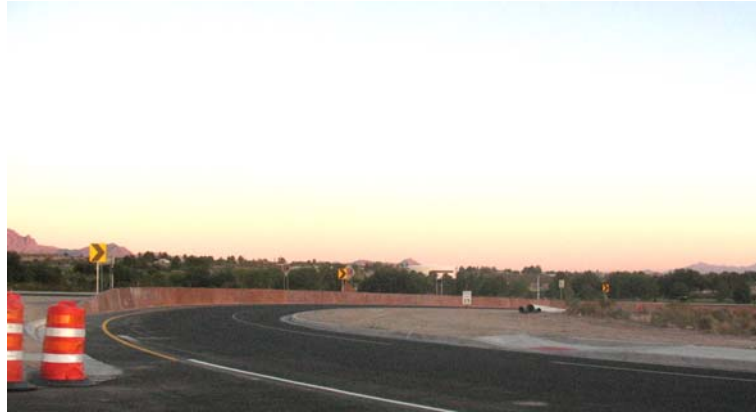
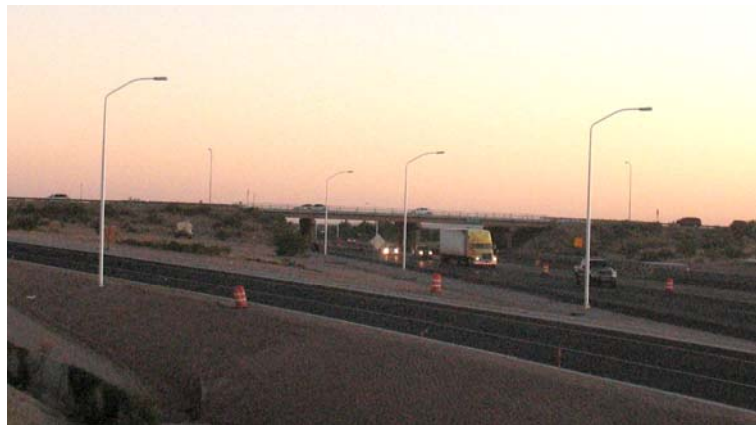
Figure 19. Construction of ramps in interstate I-25 and University Ave. Interchange with ROGFC: a) first loop on-ramp of northbound, and b) second on-ramp of northbound

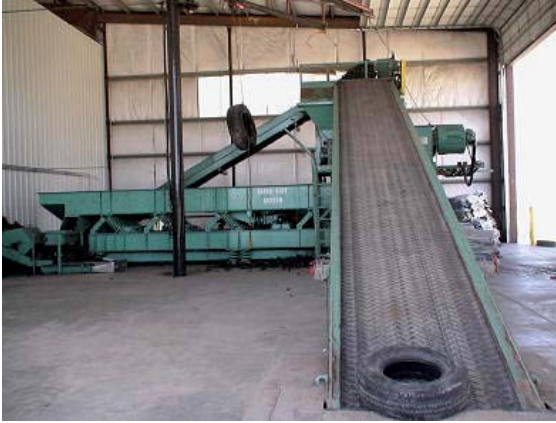
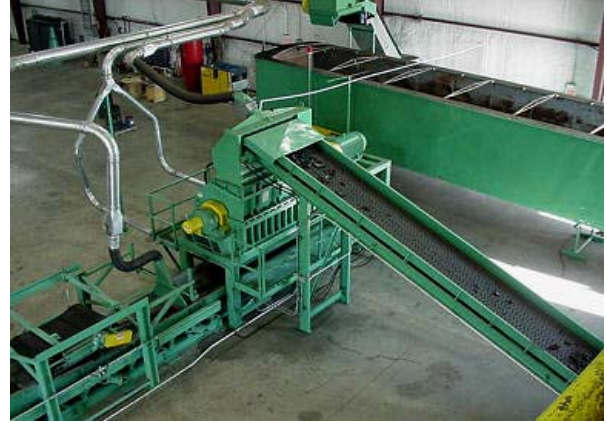
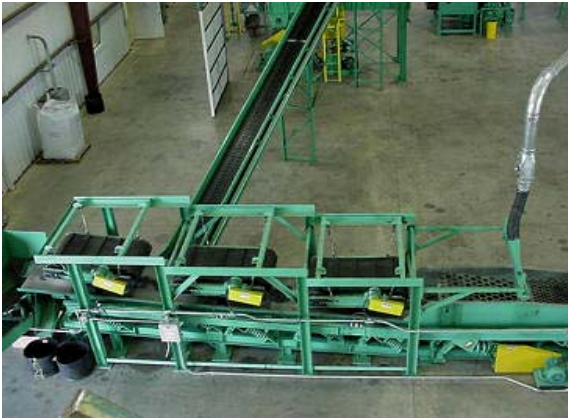
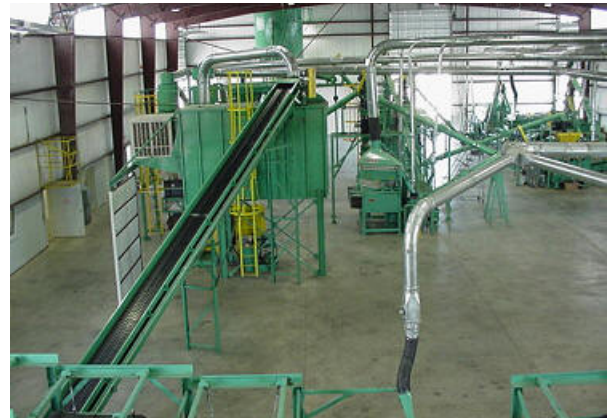
Figure 20. Conveyors to a) primary 3-in. shredder, b) to secondary 3/4-in. shredder, and c) to 1/4-in. granulator, and d) belt magnet system in a crumb rubber plant (Source: State Rubber and Environmental Solutions, L.L.C., 2011)

State Rubber & Environmental Solutions, L.L.C. utilizes domestic shipping containers to ease the loading and unloading of scrap tires. The containers are delivered to customers for loading scrap tires and brought back to the plant for processing. This provides a safe transportation and storage of the material and efficient movement into the processing plant. The containers are moved onto the processing line and are unloaded directly onto the processing equipment. At this particular crumb rubber processing facility, scrap tires are placed on a conveyor system feeding them in to a primary shredder (Figure 20a), which reduces the scrap tires to 3-in. nominal chips. These chips are then fed to another shredder to reduce the particle size to 3/4-in. (Figure 20b). This material can be processed further using a granulator to reduce the particles to a 1/4-in. maximum size (Figure 20c), which can be used in playgrounds and other athletic fields. This part of the process also reduces the fiber by 90%. The 1/4-in. material can then be fed into a refiner mill to reduce it to 200 mesh size (State Rubber & Environmental Solutions, L.L.C., 2011). At this point, 95% of the steel wire in the crumb rubber has been removed, and the remaining 5% steel wire is removed next using a belt magnet system (Figure 20d).

This type of crumb rubber processing plant can produce consistently approximately 4,500 lb (2.25 tons = 2 metric tons) of 30 mesh crumb rubber per hour. The material is stored depending on the final use of the product. Processed material can be either bagged or moved with a pneumatic system to an on-site bulk storage facility where it can be loaded later into trailers for delivery (State Rubber and Environmental Solutions, L.L.C. , 2011).
