Rio Nutrias Watershed Based Plan

A Plan to Determine the Best Management Practices to Improve Water Quality on the Rio Nutrias

A PLAN TO DETERMINE THE BEST MANAGEMENT PRACTICES TO IMPROVE WATER QUALITY ON THE RIO NUTRIAS

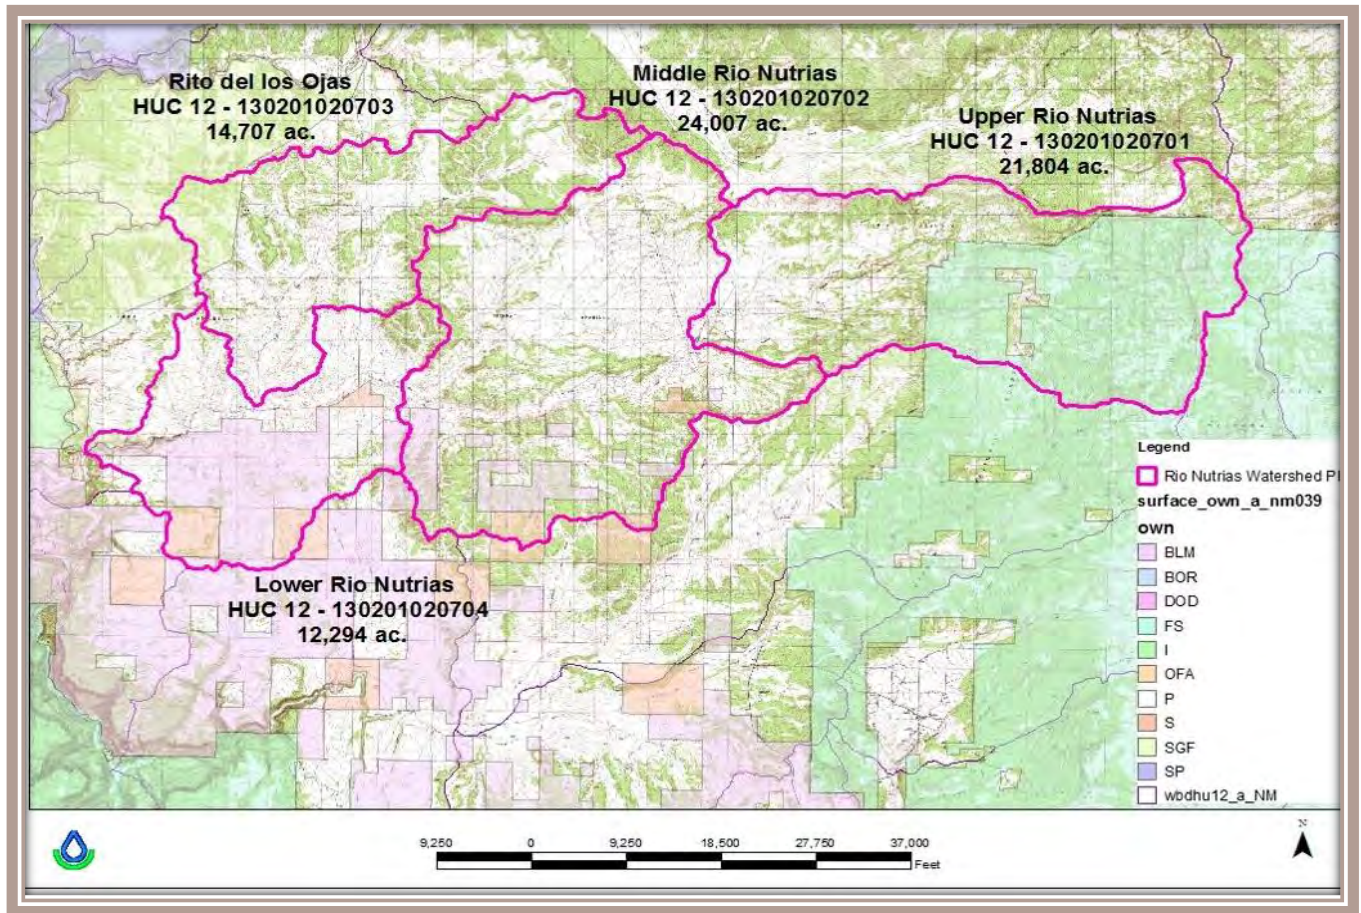
FIGURE 1. TOPGRAPHICAL MAP RIO NUTRIAS WATERSHED

The Rio Nutrias is located within the greater Rio Chama watershed (USGS Hydrologic Code 13020102), Rio Arriba County, New Mexico. The Rio Nutrias is part of the Cebolla/Nutrias watershed planning area. This watershed based planning approach is specific to the Rio Nutrias (Rio Chama to headwaters) (NM-2116.A_060). The size of the Rio Nutrias watershed is 106 square miles and the miles of impaired stream reach is 34.63 miles. The Rio Nutrias watershed has four smaller watersheds including the Upper, Middle and Lower Rio Nutrias, and the Rito de los Ojas.

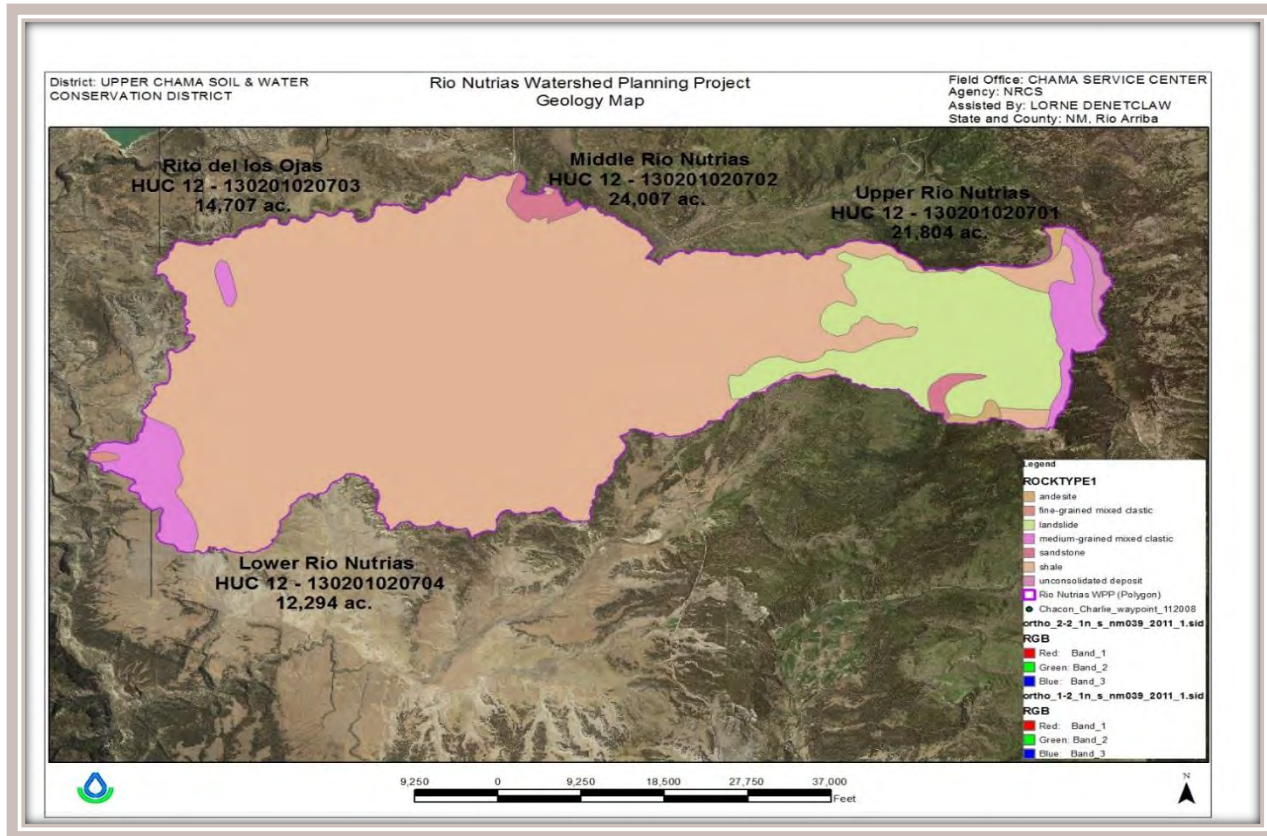
FIGURE 2 GEOLOGY MAP RIO NUTRIAS WATERSHED

The geology of the watershed consists of predominately shale rock formations. Watershed land ownership is 74% private, 12% US Forest Service, 10% Bureau of Land Management, 2% State of New Mexico and 2% State of New Mexico Game and Fish. Several small streams including the Terrero Creek, flow west into the Rio Nutrias, which eventually empties through deep canyons into the Rio Chama.

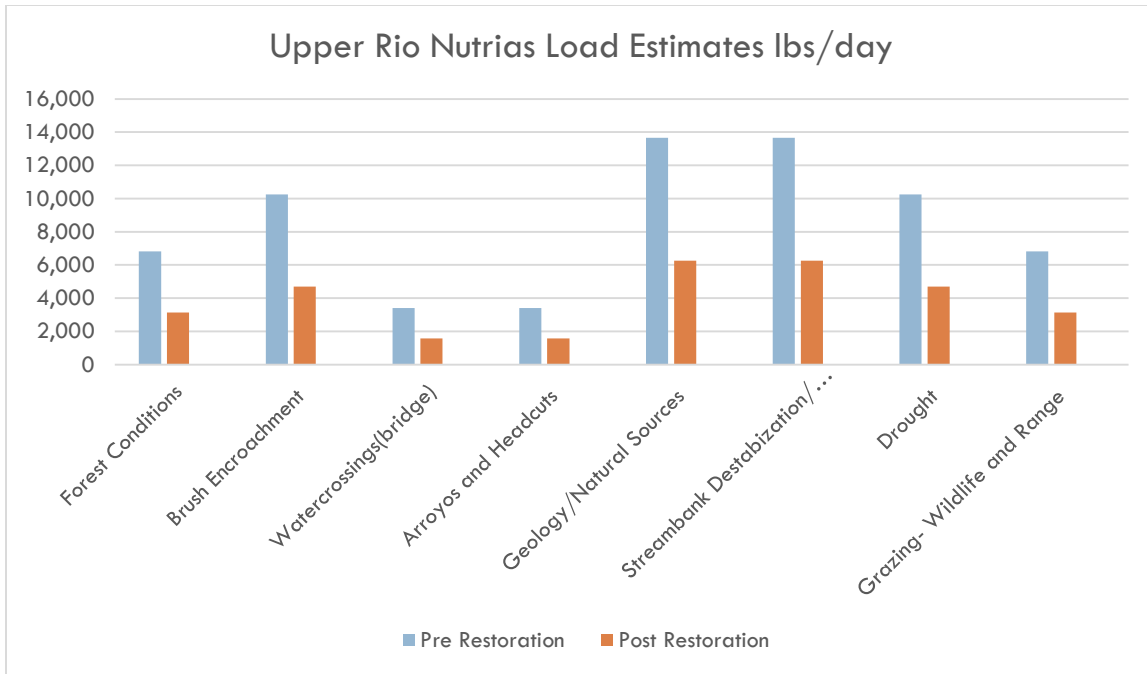
FIGURE 8 LOAD ESTIMATES UPPER RIO NUTRIAS

The Rio Nutrias watershed area was broken down into the smaller HUC- 12 sub watersheds to allow for more localized measurements. The PSIAC model was applied to each sub watershed to estimate current pollutant loading. The model was also used to estimate pollutant loading after Best Management Practices are implemented. The total result for each sub watershed was then broken down by the estimated contribution of each pollutant source. The results from the PSIAC modeling in ac ft. /year were converted to lbs. /day. The results from the modeling are found in the graphs below. Model data can be found in the appendices.

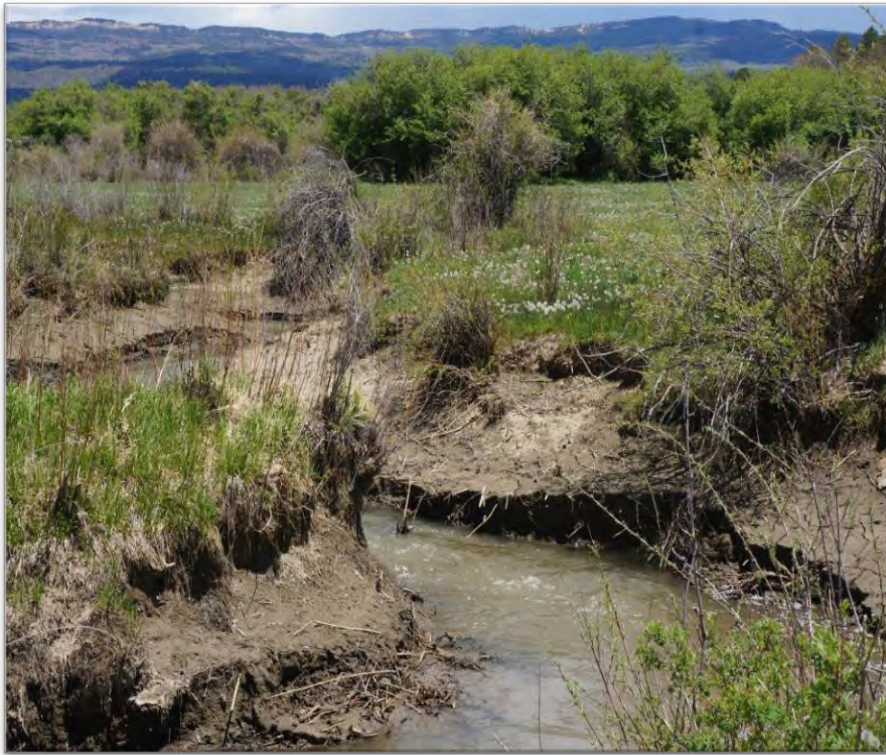
FIGURE 12 RIO NUTRIAS UNSTABLE STREAMBANKS

Vegetative management prescription would be indicated if the river has marginally degraded streambanks that are unstable and are showing signs of actively eroding streambanks.

Vegetative management includes shaping the streambanks, using an erosion control fabric, if appropriate and planting the critical vegetation area. The purpose is to stabilize and protect against bank scour and erosion.

Streambank bioengineering would be prescribed for a moderately degraded streambanks that are unstable and are showing signs of actively eroding streambanks. Streambank bioengineering includes reshaping the streambanks and utilizing plant materials such as root wads, logs branches and brush mats as structural components, may also include terracing and revetment.

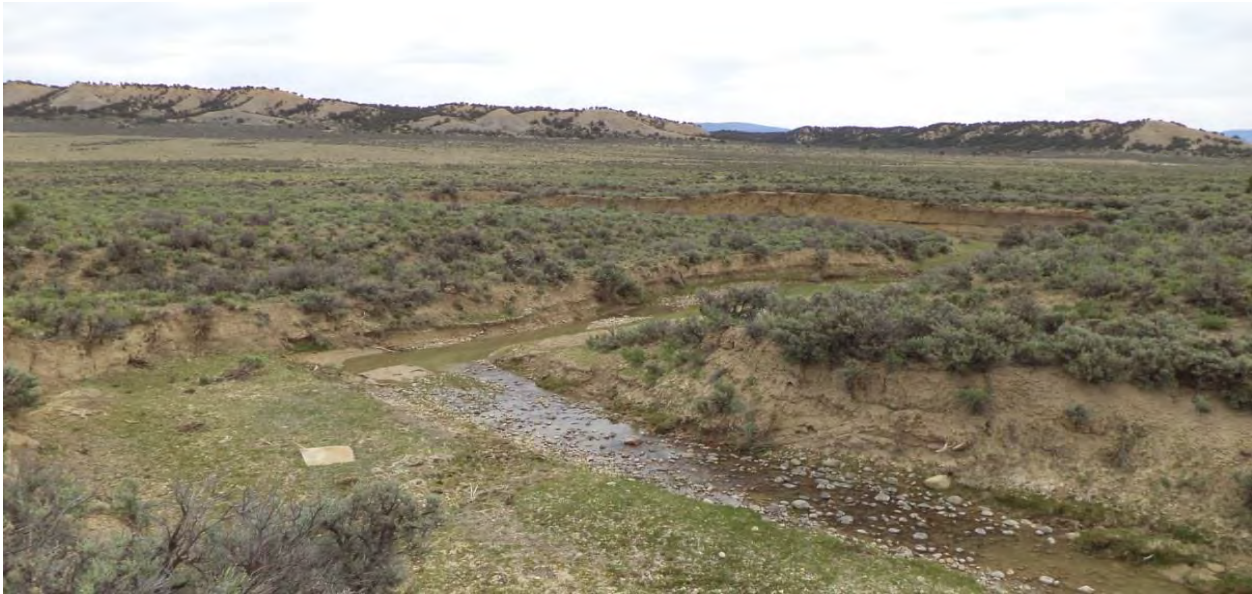
FIGURE 13 RIO NUTRIAS CHANNEL DOWNCUTTING

We estimate that approximately 2 miles of streambank engineering and approximately 5 miles of vegetative management prescriptions will be needed to be implemented to restore the river channel to a more stable state. It is not likely that any streambank stabilization project will be an entire mile in length, but rather smaller sections in the most severely eroded areas and where a willing landowner would like to participate. It is important to improve the upland conditions before engaging in a large scale streambank stabilization effort, as the stream channel is affected by the greater conditions within the watershed.

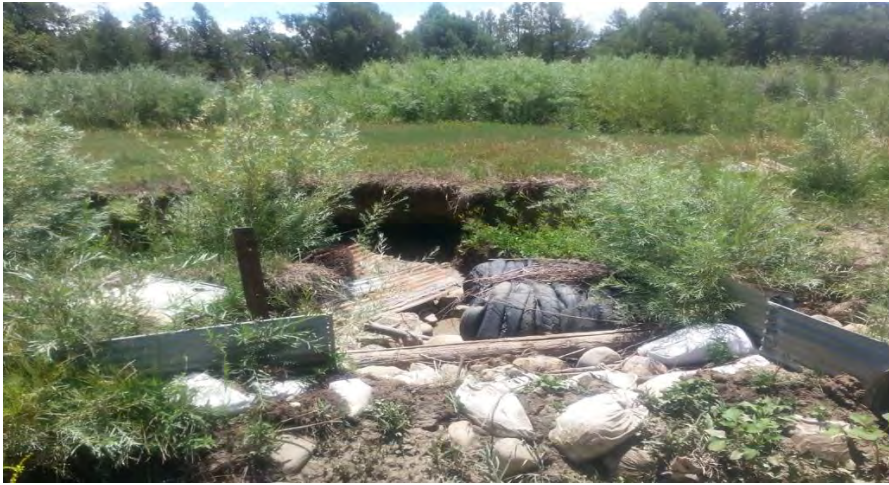
FIGURE 14 RIO NUTRIAS HEADGATE

Prescriptions include headgate repair or replacement with the addition of rock check dams or other erosion control practices to create a surface water profile and to stabilize surrounding streambanks. The failure of the headgates in the watershed are all related to land erosion created by degraded streambanks or hydro modification from the diversion structure. Some headgate structural components may be reusable, some may need to be upgraded or resized. All headgates will need some amount of erosion control work to keep the structure stable over time, suggestions would be rock check dams, streambank bioengineering and vegetation management. We approximate 10-15 headgates will need to be repaired or replaced.

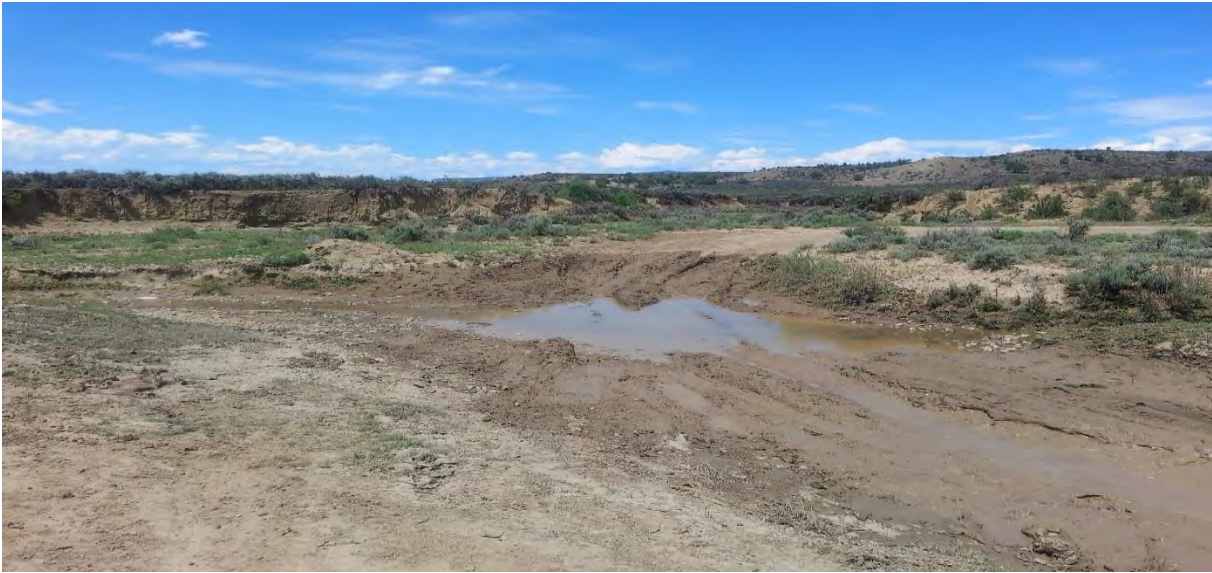
FIGURE 15 RIO NUTRIAS RIVER CROSSING

We have identified two river crossings that could be repaired. Both are located on Rio Arriba County roads. The first is currently an oversized culvert that appears to be creating erosion due to hydro modifications, we suggest replacing it with a bridge so the river can travel underneath the road crossing without impediment.

The second is a road crossing the stream, we suggest upgrading to an armored low river crossing, this would include installing a stable surface at the river bottom and approaches. This could be accomplished using paver or blocks, this will reduce potential erosion from vehicular traffic.

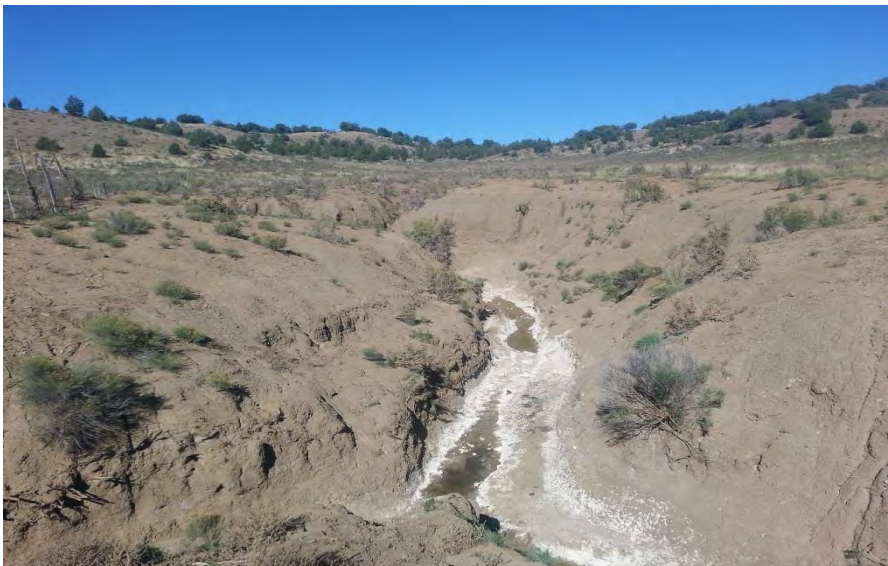
There have been several actively eroding gullies, arroyos and headcuts identified. Many degraded arroyos have been remediated previously with some becoming a drainage to a trick tank. We estimate that there are approximately 10 arroyos or headcuts of various size and depths. Prescriptions include regrading the gully and installing rock check dams to encourage water and sediment retention, this will promote revegetation of the disturbed area. Some of the larger headcuts will require a more extensive engineering design to correct the erosion problem.

FIGURE 16 RIO NUTRIAS GULLY

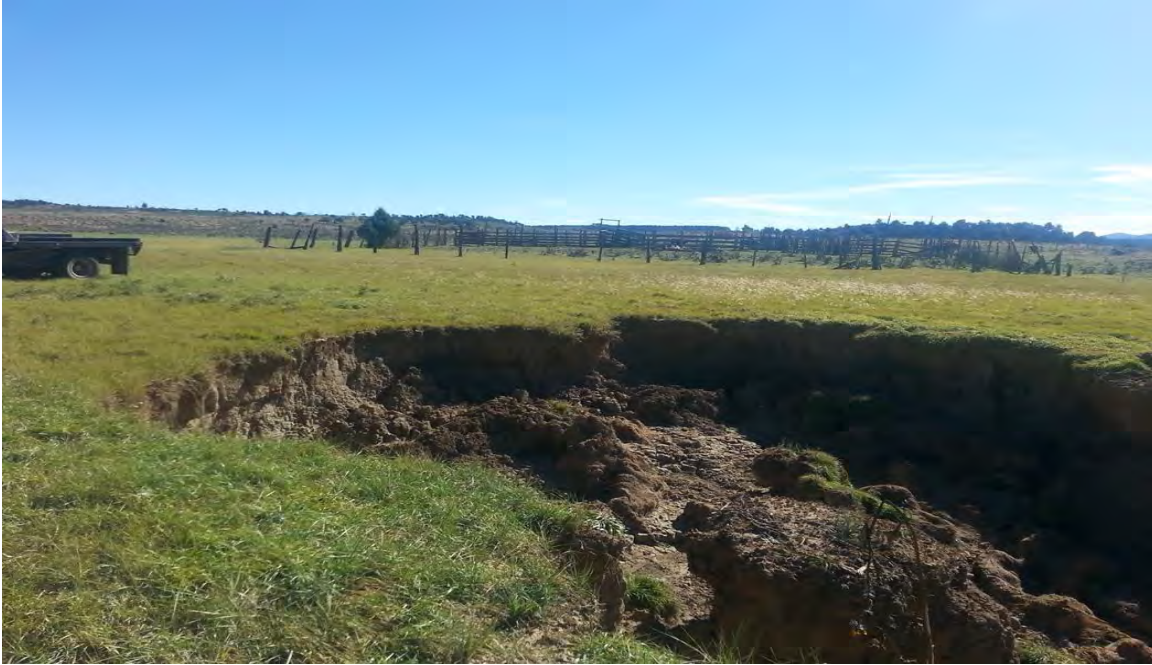
FIGURE 17 RIO NUTRIAS HEADCUT

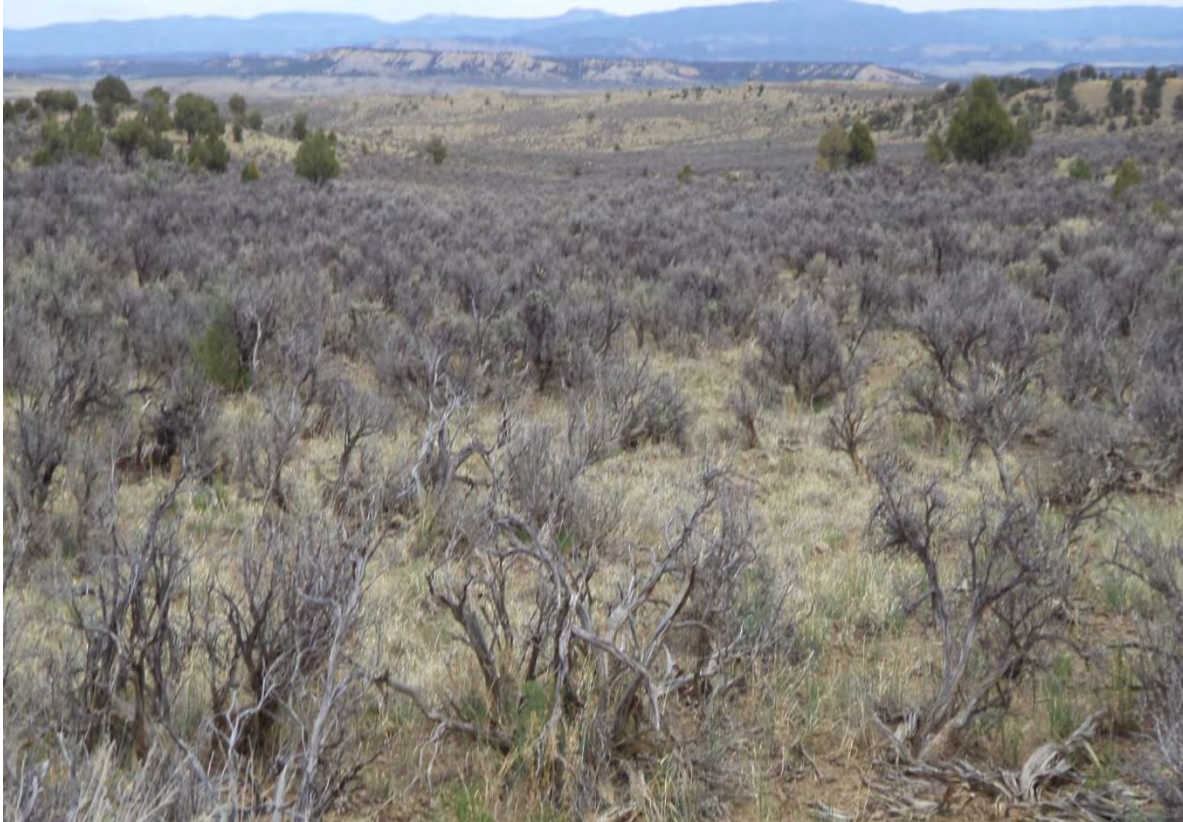
The areas within the watershed that have had sagebrush eradication have significantly more grasses and groundcover. Removing the invasive brush creates better habitat conditions and inhibits sheet and rill erosion. We estimate that there are approximately 15,000 acres of invasive brush in the watershed that could be treated. Treatment could be mechanical using a brush hog or other equipment to manually remove the brush or could be a chemical application such as aerial spraying of an herbicide. Practice method would depend on size of treatment area and preference of the landowner. Some landowners who have previously completed a mechanical treatment were discouraged by how fast the brush has reoccurred. Treatment with an herbicide does not create the same soil disturbance and the skeletons of the dead brush stay intact for several years as they decompose, holding the soil structure in place and also providing a beneficial microclimate for the grasses as they grow back.

FIGURE 18 RIO NUTRIAS PREVIOUSLY TREATED SAGEBRUSH

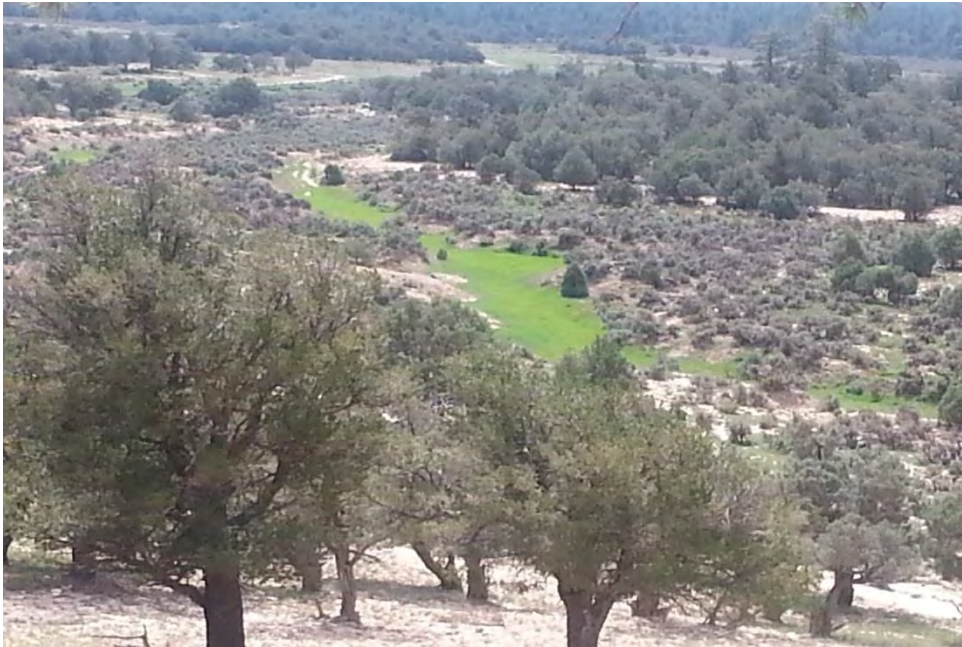
Forest stands have become very overgrown in parts of the watershed and have created a closed canopy condition where the groundcover cannot grow underneath the trees. This has created sheet and rill erosion, degraded habitat conditions and poses a fire hazard. Prescriptions include thinning trees to a desired density using tools, mastication and controlled burns where necessary to return forest structure and composition to a desired condition.

FIGURE 20 RIO NUECES EXAMPLE OF OVERGROWN FORESTS

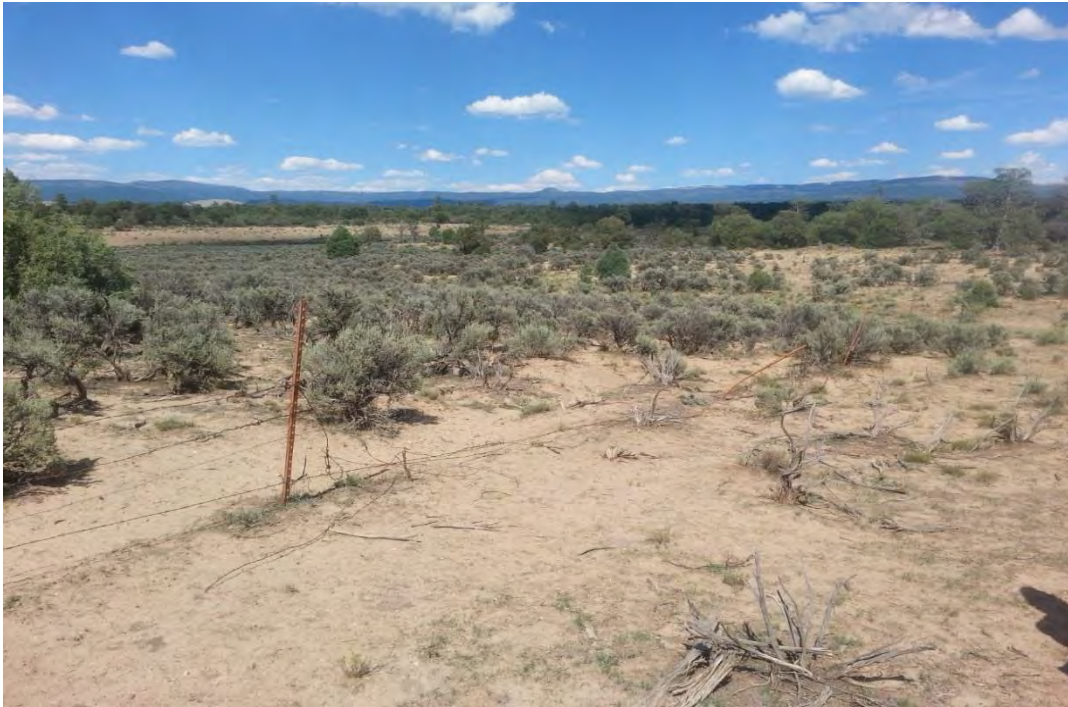
Fencing is a best management practice to disburse grazing and could be helpful in establishing better groundcover conditions that will reduce soil erosion. Many of the fences in the watershed have been damaged by elk. We estimate the need for approximately 10 miles of fencing to be installed in the watershed.

FIGURE 21 RIO NUTRIAS FENCING DAMAGED BY ELK

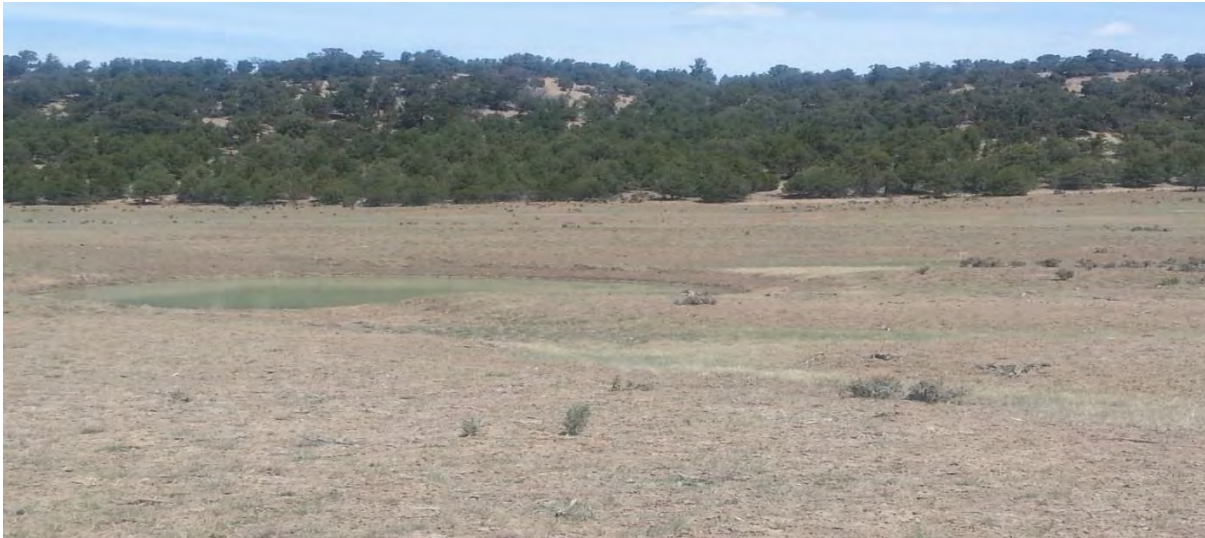
FIGURE 22 RIO NUECES DIRT TANK

Water development is a range and wildlife management technique that can disburse the animals on the landscape, can also relieve the pressure on the river and riparian area. Many of the landowners rely on dirt tanks for providing water for their livestock. Most of the tanks have been installed at the end of an already existing gully or arroyo. These tanks have effectively served as sediment traps and most tanks have a vegetated and healed arroyo upstream from it. These tanks also provide a valuable habitat for wildlife and birds. Because they have been filled with sediments over the years many of the tanks need to be cleaned. Several landowners would like to install new dirt tanks and there is a lot of interest in wells, pipelines and drinkers because our most recent drought has made water collection undependable at best. We estimate that 7 wells with infrastructure and 10 Ponds could be installed or upgraded.
