# Updated Watershed Based Plan for the Upper Gallinas River – National Forest Addendum

## **On-The-Ground Surface Water Quality Improvement Projects: Phase II**

In Partial Fulfillment of Federal Clean Water Act Section 319 (h) Nonpoint Source Grant  
Submitted to the New Mexico Environment Department (NMED)

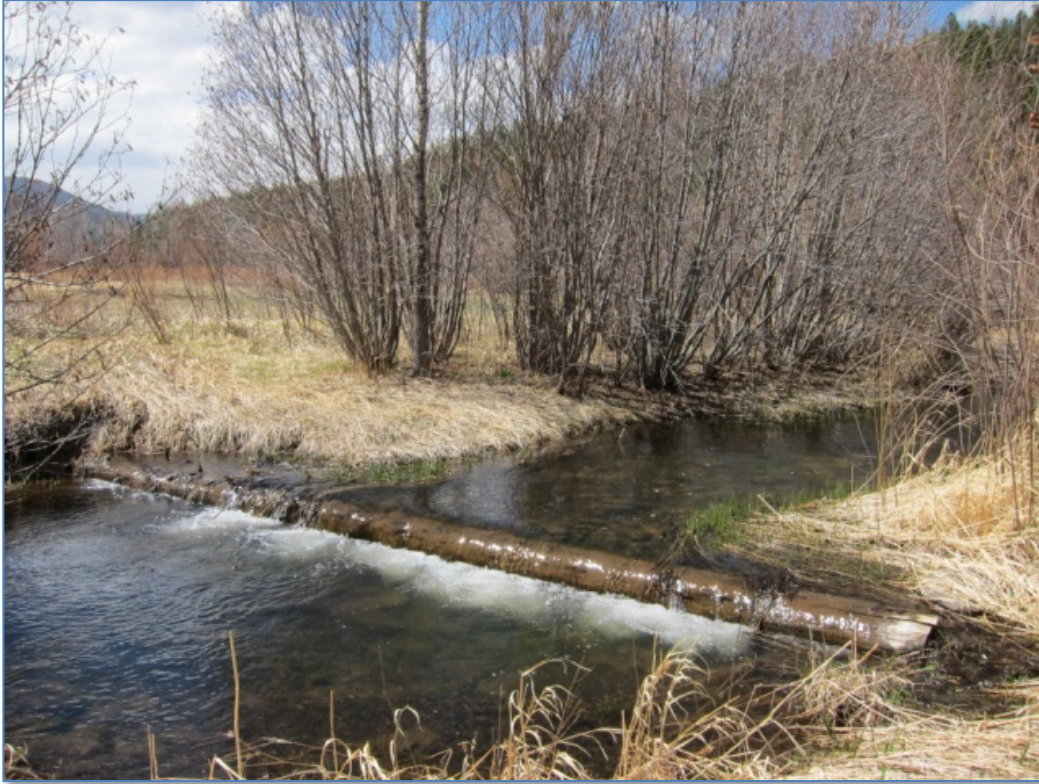
Figure 2 - Channel widening caused by man-made log dam.

During the initial watershed condition assessment (Mahan Saleem, 2017), numerous man-made log dams were found to occur in the Gallinas River/Creek from EV Long Campground to its headwaters including Burro Canyon and along Beaver Creek in meadows near the Lone Pine Trail. These log dams were apparently installed in the 1960's and 1970's and are common to mountain streams throughout northern New Mexico. They were constructed for the purpose of improving fish habitat, long before stream hydrology was well understood. Because they are flat and level, they do not direct water to flow toward the middle of the channel. Consequently, when water encounters a log dam, it is directed laterally against the bank at each end of the log on the upstream side. This frequently causes bank erosion and channel widening (see Figure 2). Sometimes, the water cuts a channel around the ends of the logs or under them. In other cases, channel widening reduces flow energy and causes sediment to fill in the channel on the upstream side.

Thirty one man-made log dams were found and assessed on the Porvenir Creek/ Beaver Creek drainage; all were located in grassy meadow environments. Treatment (repair or removal) was recommended for 11 of those structures and 4 were deemed to be high priority. Those dams with willow roots or large streambank or downstream rocks experienced less end of log erosion compared with dams that have no such anchors. Log dams to be removed may need replacement with one-rock dams to arrest or repair erosion; repairs, such as a notching the log dam, may be sufficient for others. GPS locations and specific recommendations for each log dam assessed are contained in the report *Gallinas Trail and Beaver Creek Trail Assessments* (Tatro, 2017).

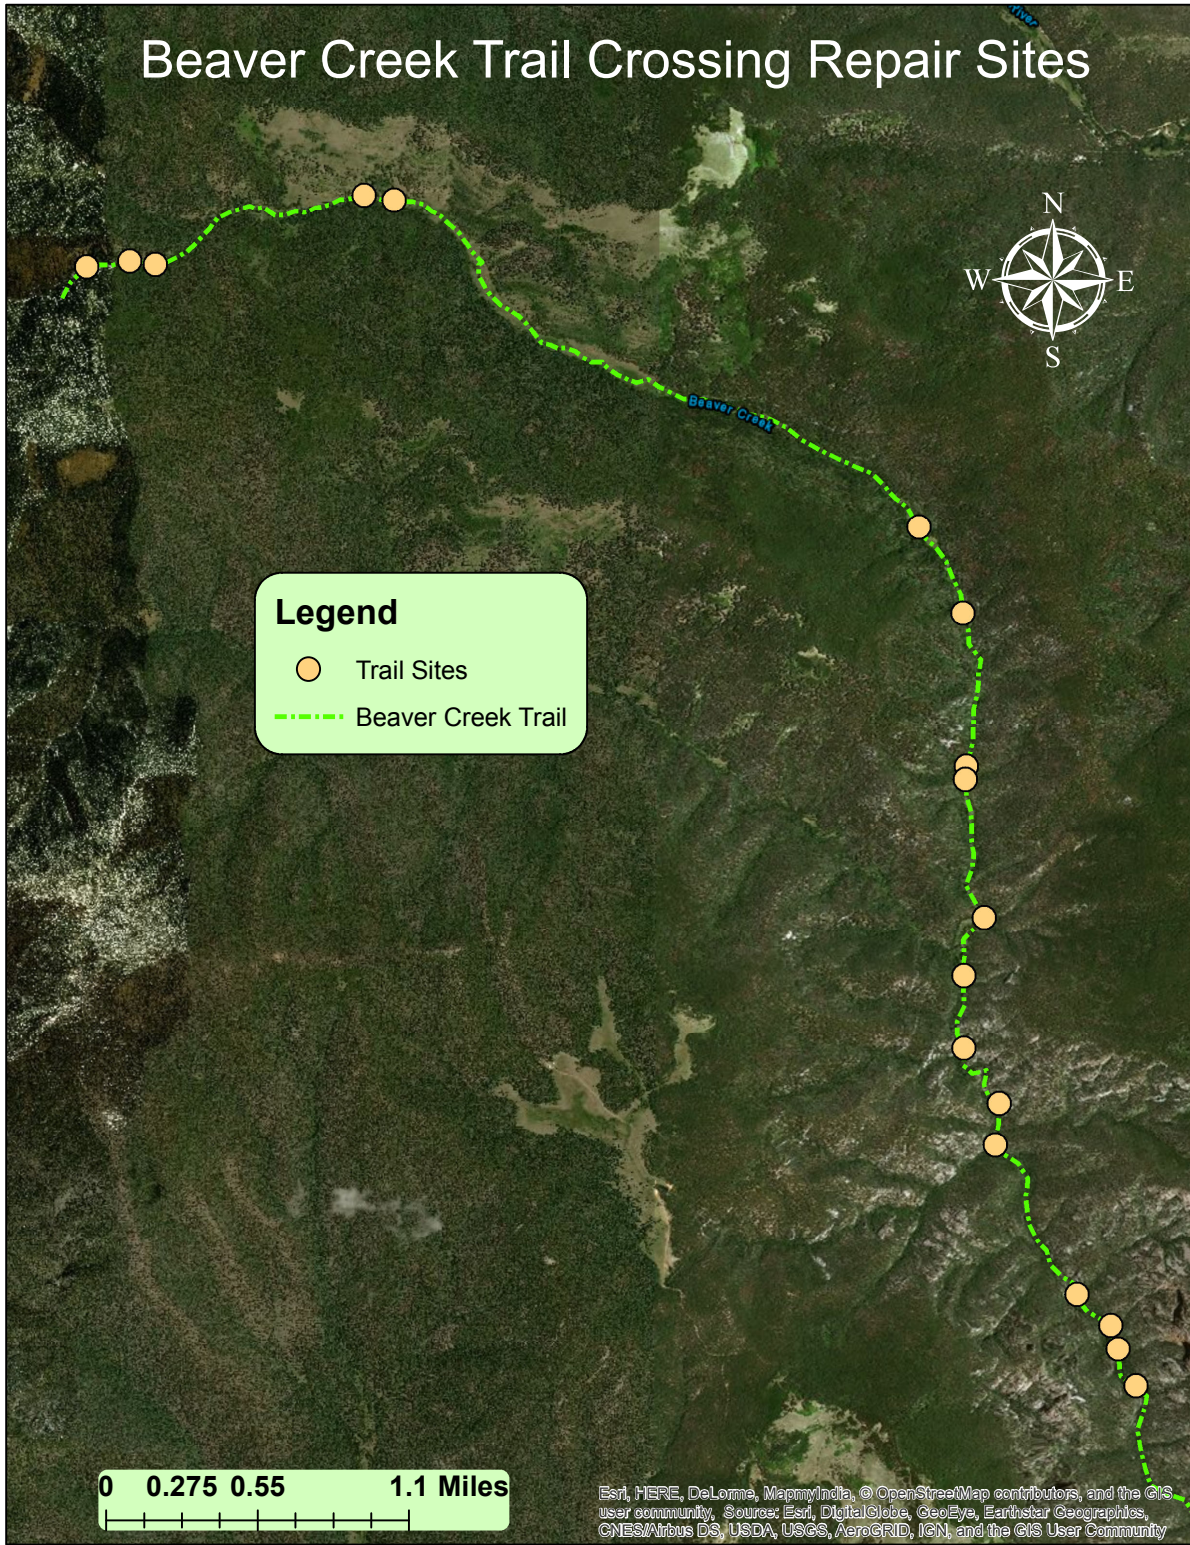
Map 3 - Recommended trail repair sites

While some activities related to trail improvements are considered maintenance and do not require a NEPA review (Map 3), rerouting the trail involves new ground disturbance so does require NEPA (Map 4).
