# Upper Pecos

## Watershed Protection and Restoration Plan

Submitted to the New  
Mexico Environment  
Department

The Upper Pecos  
Watershed  
Association

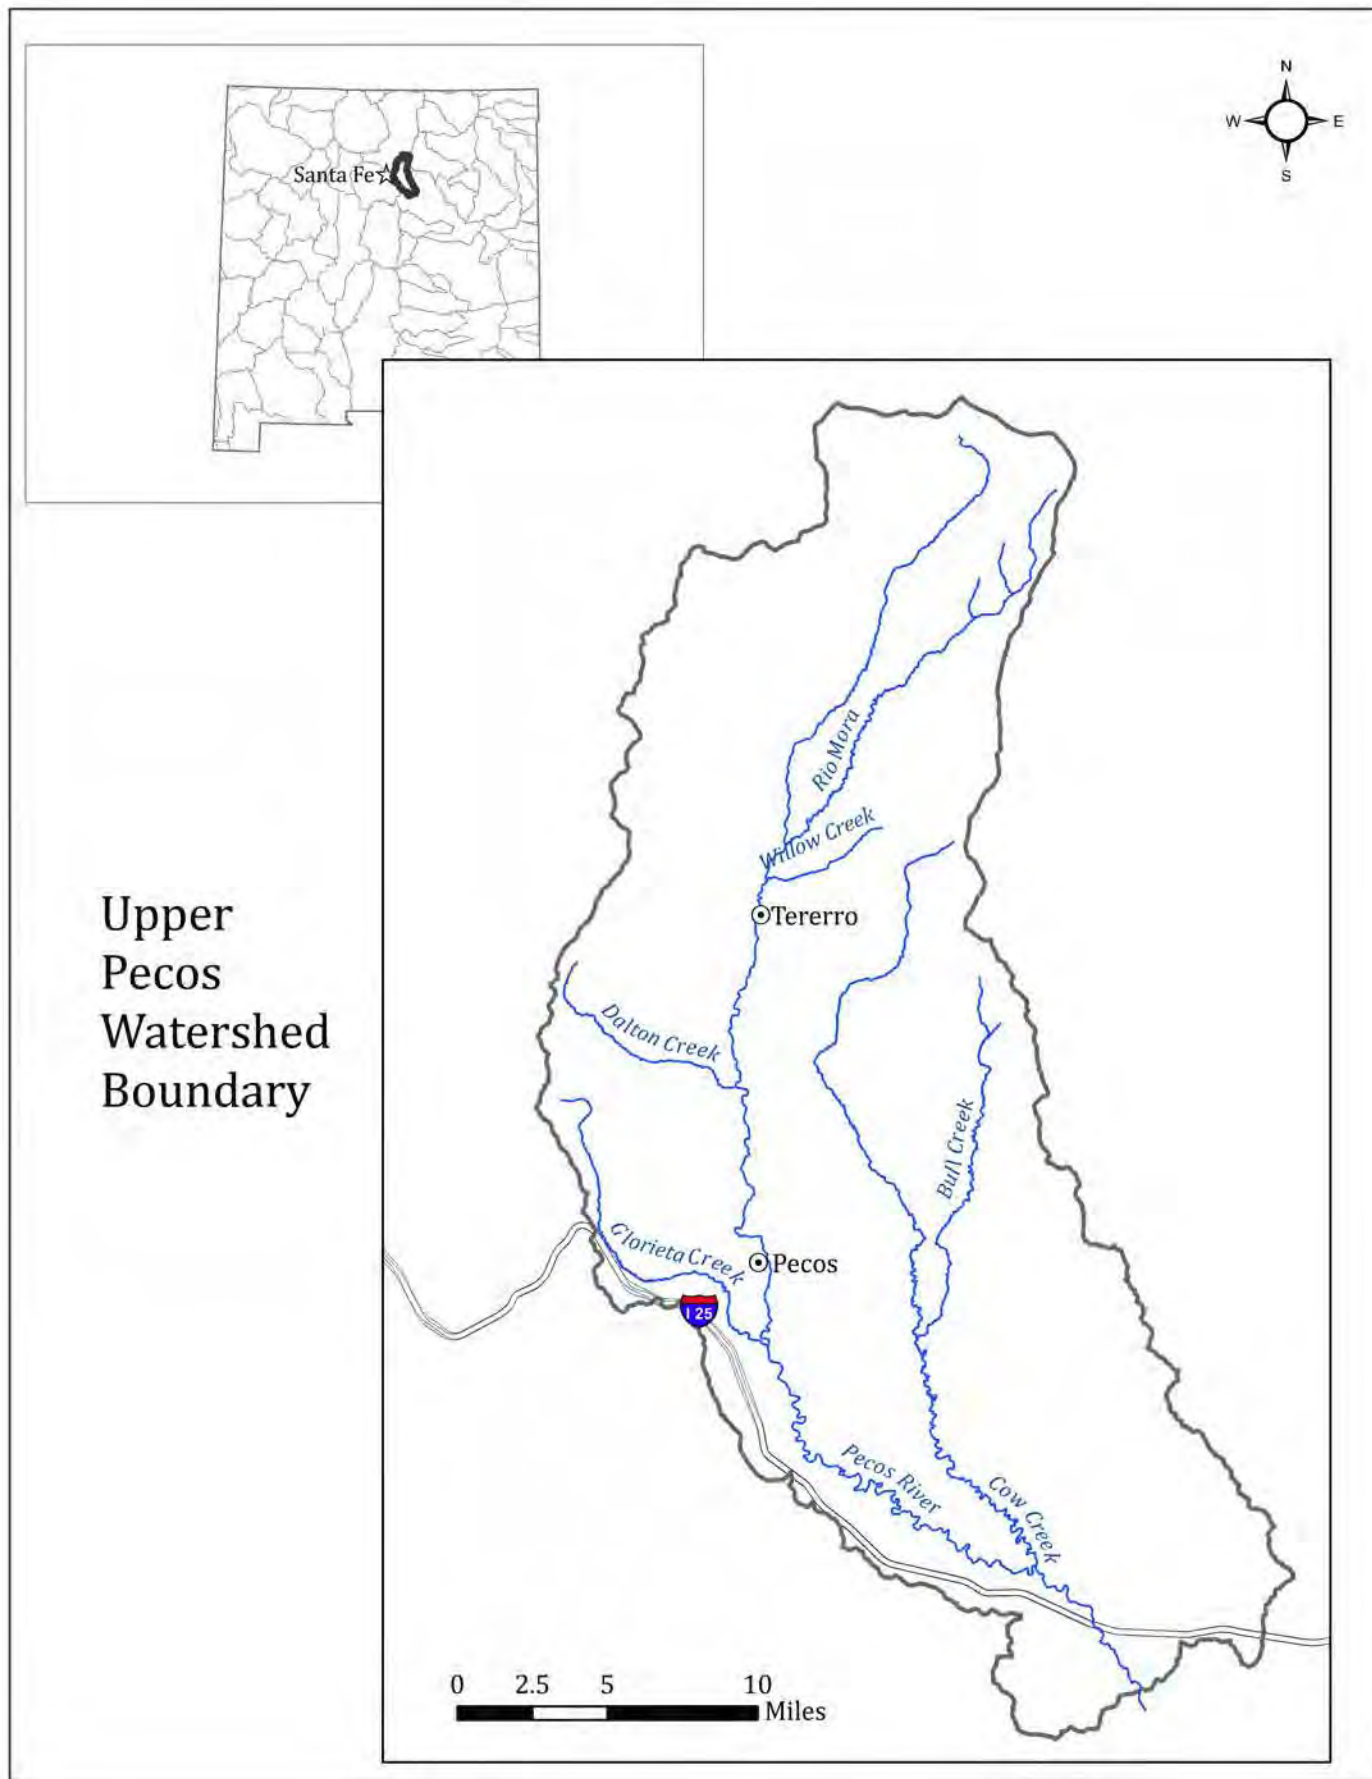
## Pecos Canyon HUC12 Subwatersheds

This Plan does not include the watershed of the Pecos River south of Interstate Highway 25. For purposes of assessing stream condition and planning for restoration, the Upper Pecos watershed can be subdivided into 12 sub-watersheds, as shown below. Although this is not a complete list of all of the named tributaries within the watershed, it does reflect the principal hydrologic units, or reaches of the Pecos River, its tributaries, and their associated watersheds, as mapped by the US Geological Survey in its Watershed Boundary Dataset.

The location of the Upper Pecos watershed within New Mexico can be seen on the map on the following page, and the locations of these sub-watershed hydrologic units within it are shown on page 3.

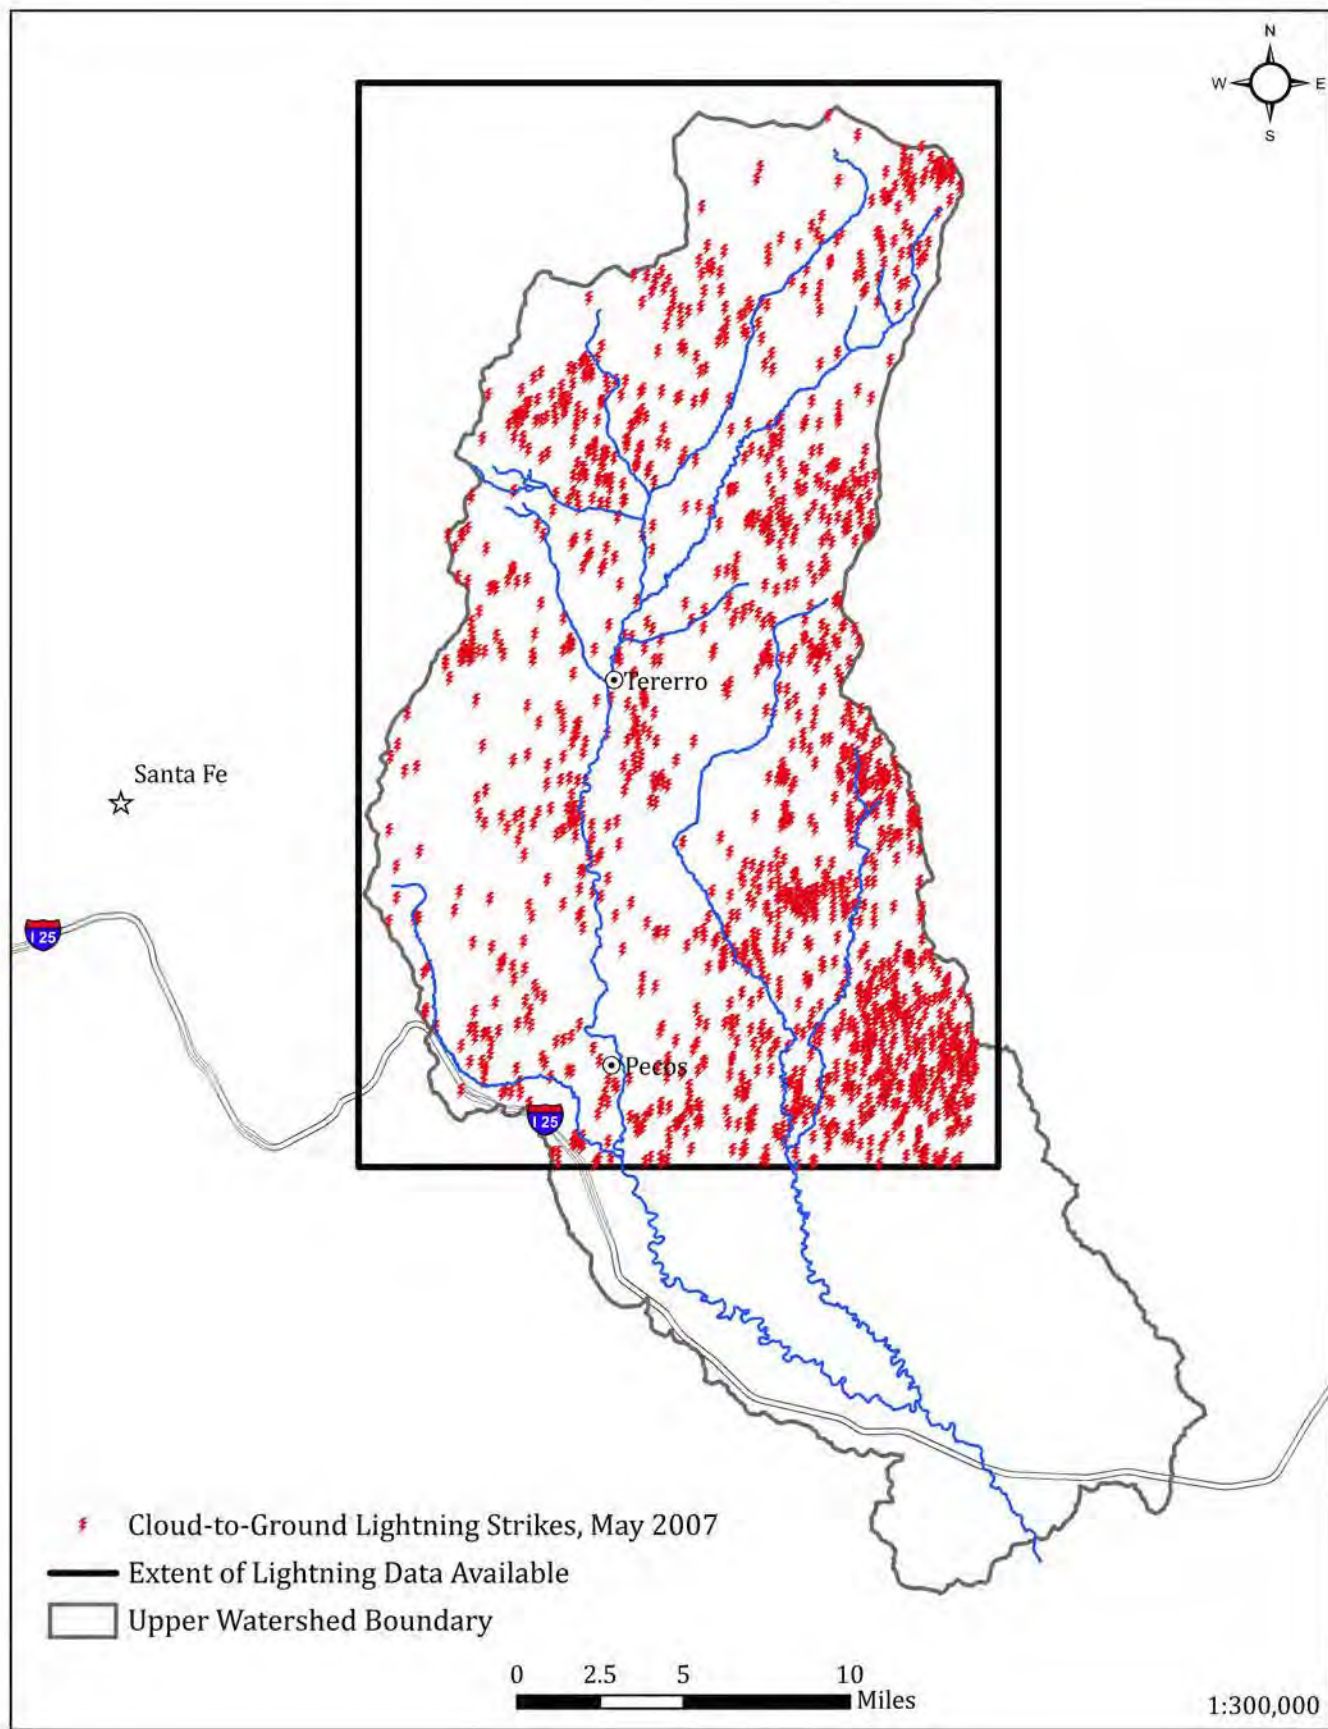
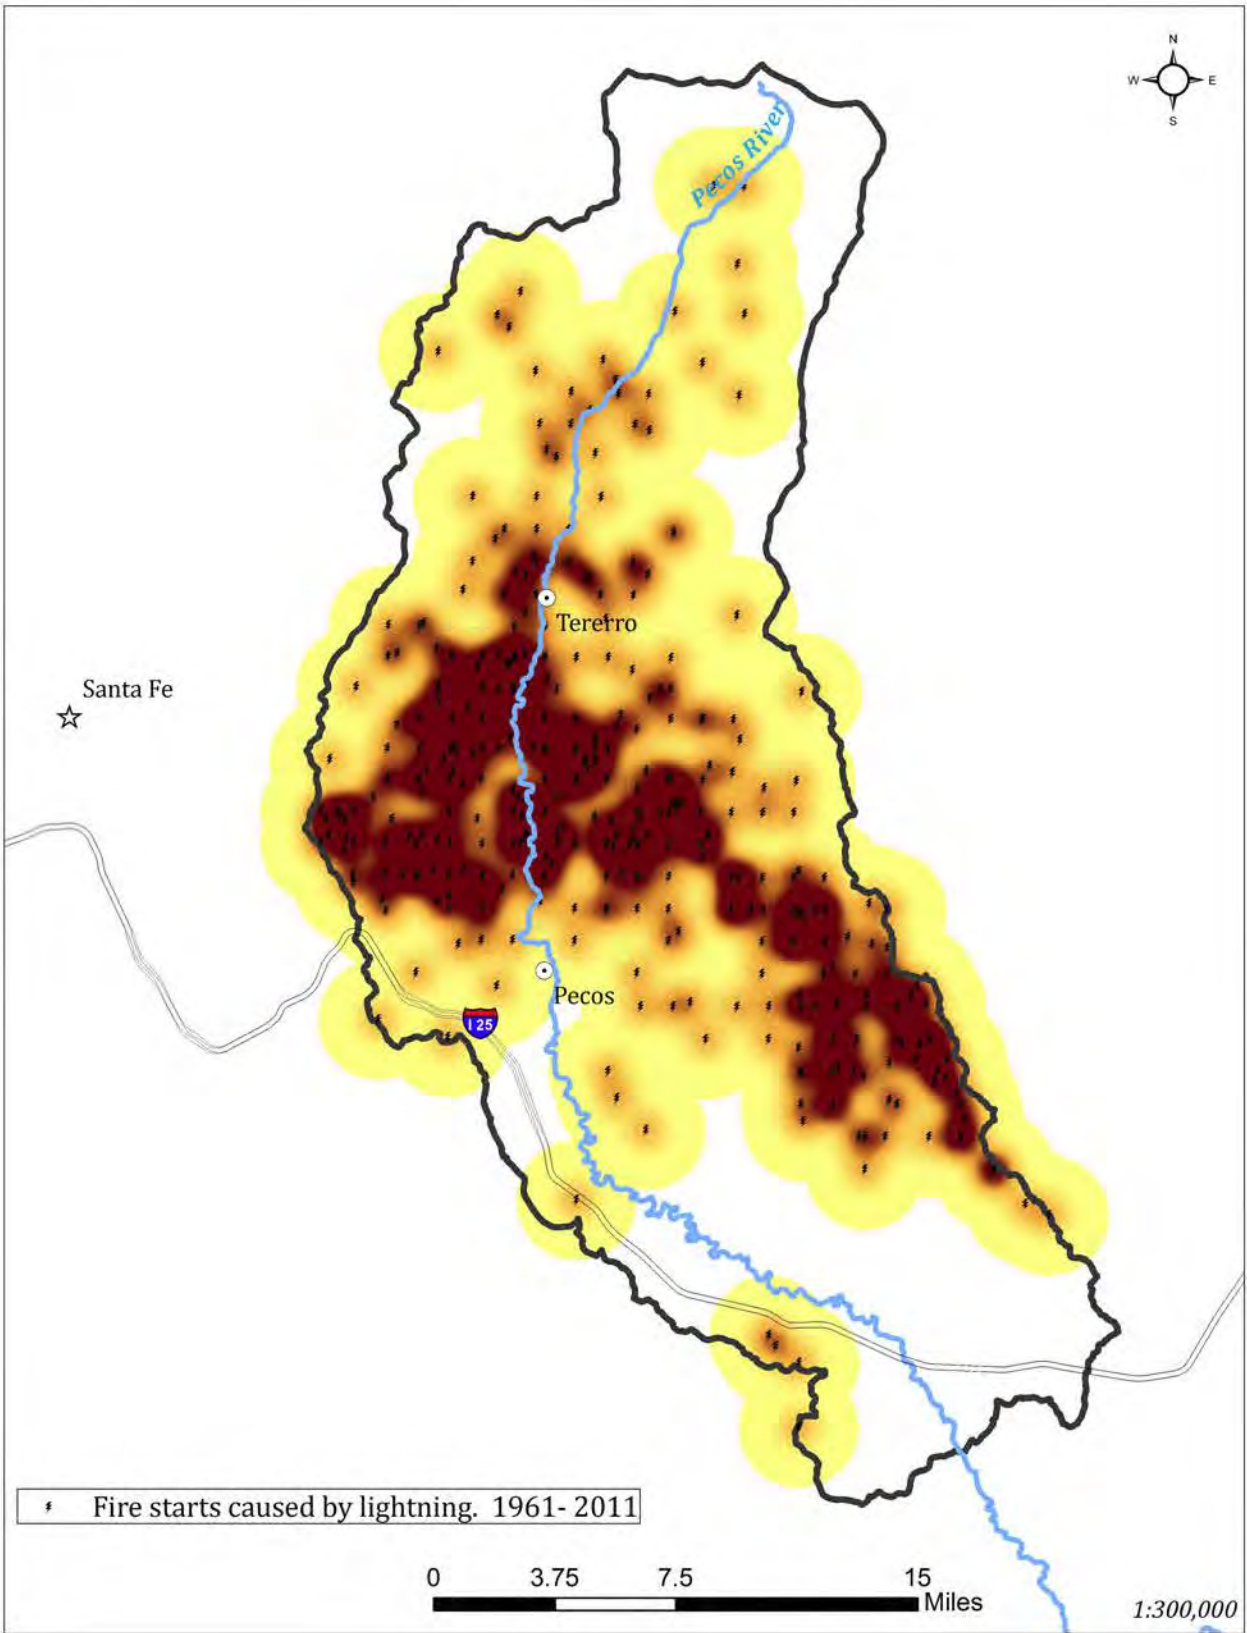
The map on the following page shows the distribution of lightning ground strikes recorded by weather observation satellites during just one month – May of 2007. The next map, on page 13, shows lightning-caused fire starts (as distinct from the far more numerous lightning strikes, most of which do not cause fires) in the Upper Pecos from 1961 through 2000 – concentrated in the ponderosa and lower-elevation mixed conifer forests. The map on page 14 shows the areas that have burned within the watershed since 1971.

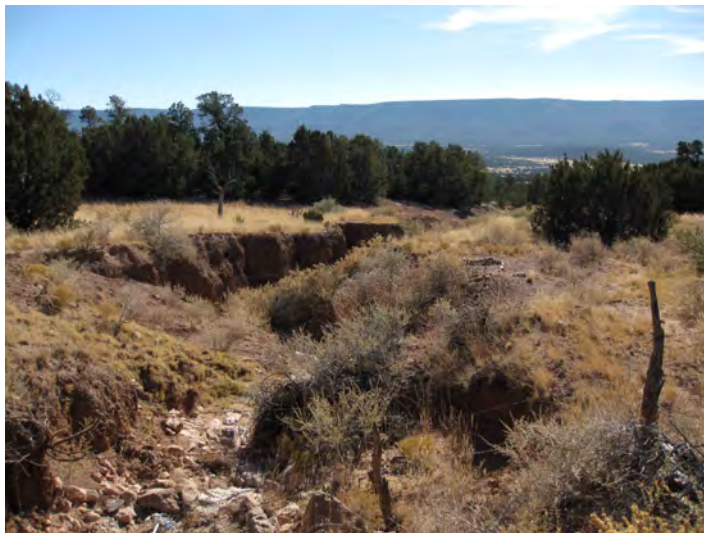
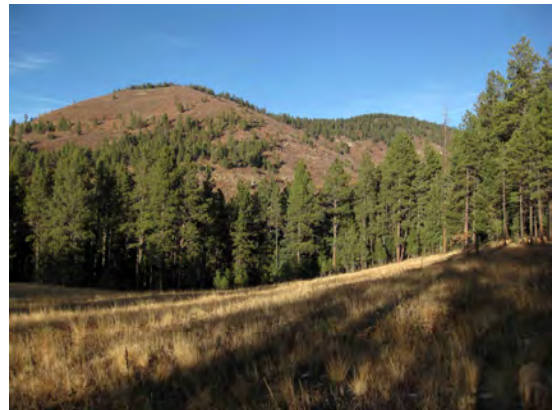
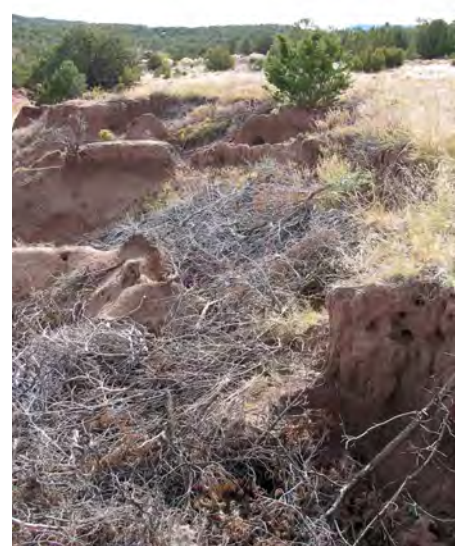
*Typical sediment class landforms in the upper Pecos: Foothills (above), mountain (upper right), and xeric (lower right).*

A 2010 study by Tetra-Tech, Inc. (funded by the New Mexico Environment Department and EPA) analyzed data on both streambed and suspended sediment in a large sample of streams in New Mexico, eastern Arizona, and southern Colorado in relation to both disturbance patterns and geographical location. The focus of the study was to evaluate and suggest potential numerical sediment levels that would be valid indicators of disturbance or lack of it in New Mexico streams. These suggestions of sediment levels (percentages of different size classes of stream bottom sediment) are preliminary and have no regulatory status, but one significant finding of the study is that the percentages of sediment size classes present in relatively undisturbed streams is quite different in different geographical zones, based primarily on altitude and topography (with associated differences in vegetation types). In terms of expected background sediment transport levels in streams, the study found three relevant geographic or land-form types within New Mexico: mountain, foothill, and xeric zones.

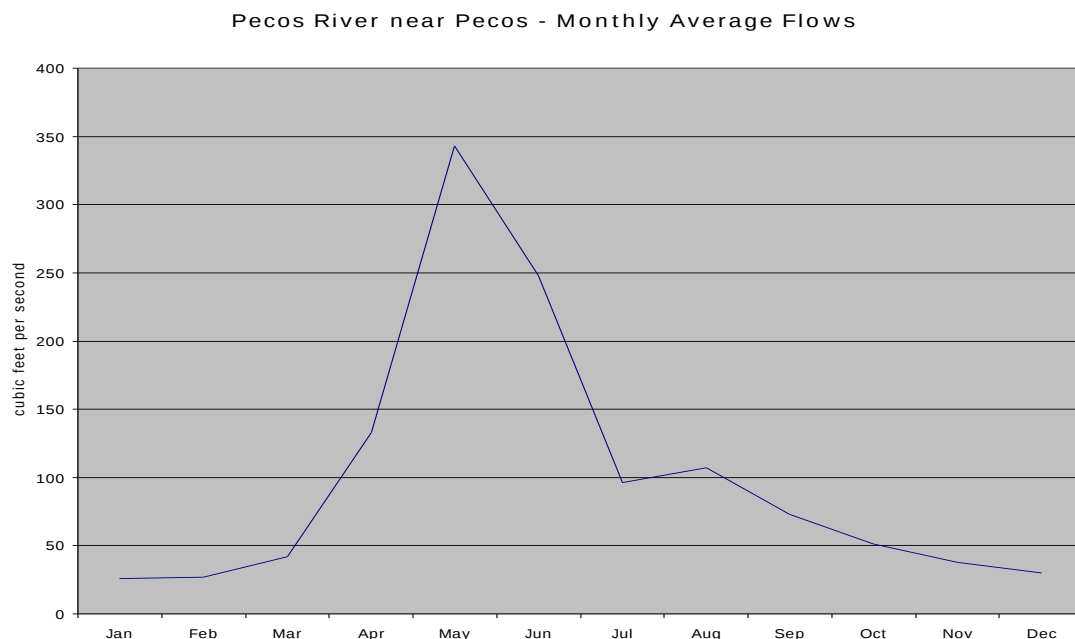
The flow regimes for both stream types are dominated by springtime snowmelt runoff, followed by smaller, more localized, and more unpredictable secondary rises during the summer monsoons. The average flow rates for the Pecos River at the USGS gauging station near the Village of Pecos are shown in the graph below, while the major tributaries and sub-watersheds of the upper Pecos are shown on the map on Page 2 above.

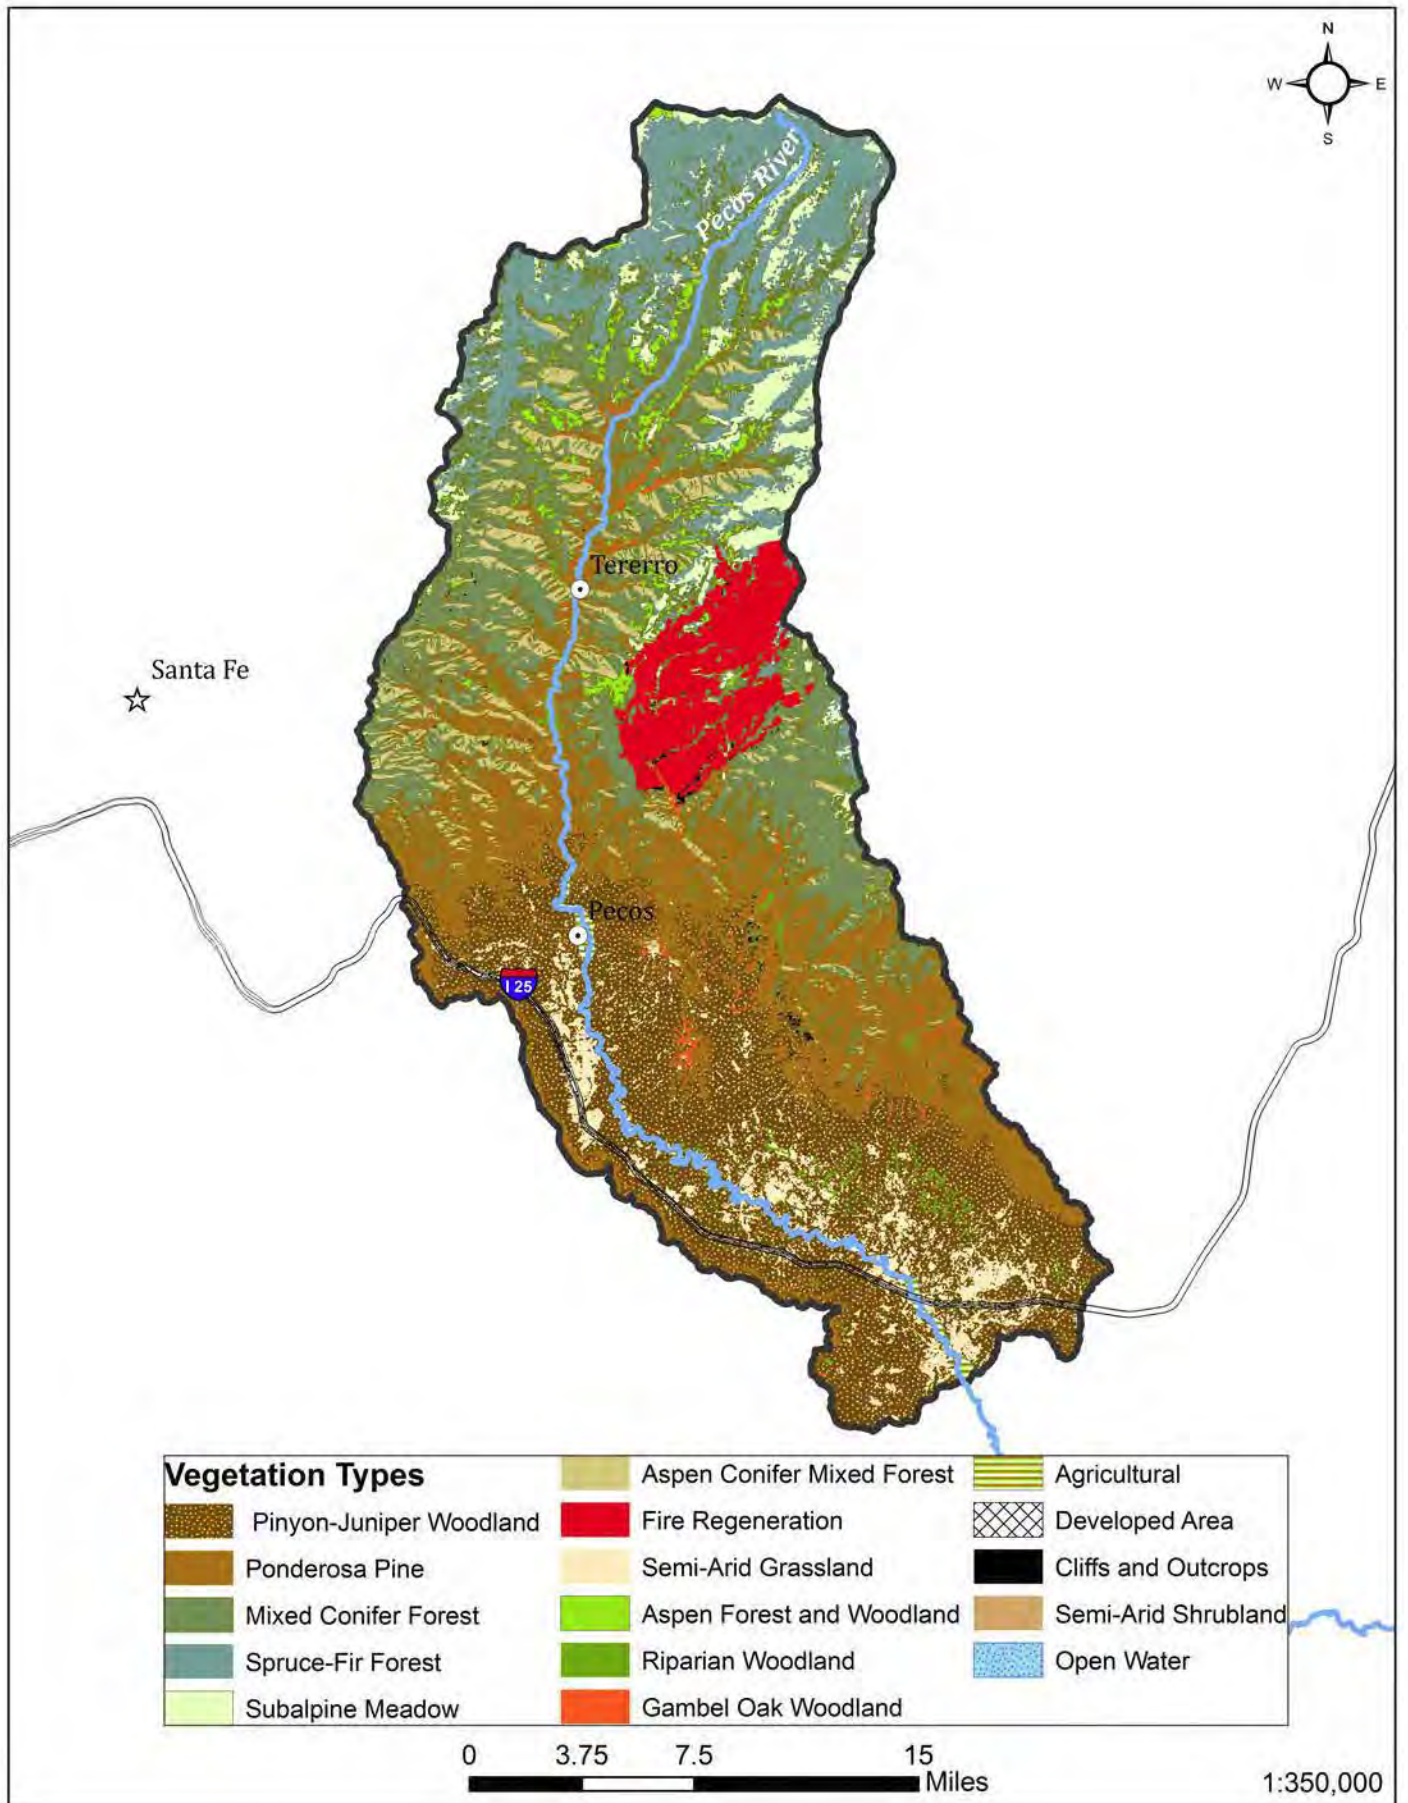
At the higher elevations of the watershed, from approximately 9,000 feet to tree line at 11,000 feet or more, Engelmann spruce is the dominant plant species, forming the primary forest canopy along with white and sub-alpine fir in about 11% of the watershed. Douglas fir and other mixed conifers are typically dominant between about 8,000 and 10,000 feet, covering about 19% of the watershed area; although a similar conifer mix with a significant fraction of aspen present covers another 5% of the watershed. Ponderosa pine dominates almost 20% of the area, at elevations between 7,000 and 9,500 feet, and is found mostly on south and west facing slopes at the higher elevations and north or east facing slopes at the lower elevations. At the lower elevations of the watershed, vegetation is dominated by piñon-juniper and oak woodlands, with some areas of grassland as well as savannahs with more scattered juniper and grass. High-altitude meadows (like Hamilton Mesa) and aspen groves are evident in much of the higher-altitude and more northerly parts of the watershed, but do not make up a large fraction of the total area. The table below shows the principal vegetation types present in the watershed, and the acreages and percentages of land dominated by each. The map on the next page illustrates the location of major vegetation types in the watershed.

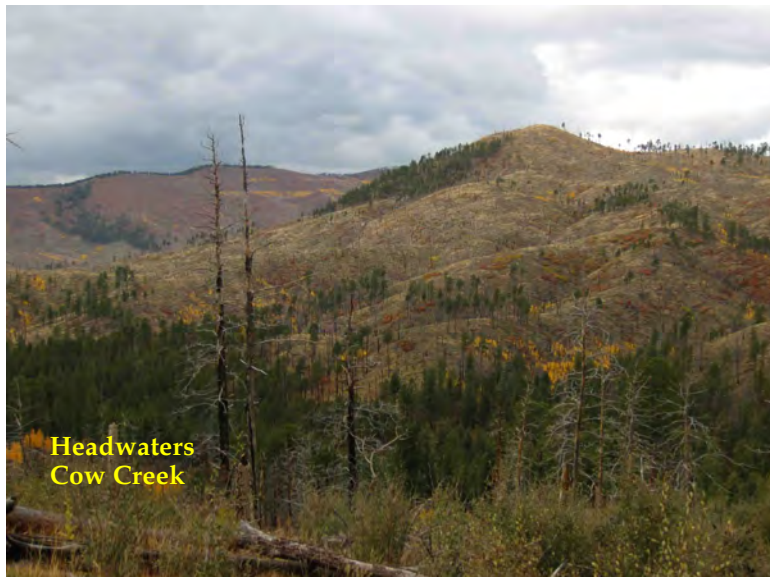
The majority of the Headwaters Cow Creek sub-watershed was affected by the Viveash fire of 2000, and vegetation is classified as "Fire regeneration", which includes primarily early-successional oak, aspen, conifer seedlings, and grasses. Areas not affected by the fire are mainly dominated by high-altitude mixed conifer forest, with some spruce-fir and subalpine meadow at the highest altitudes. Most of the sub-watershed is Forest Service land, but there are appreciable private in-holdings totaling thousands of acres altogether. This entire reach of Cow Creek is listed as non-attaining because of excessive water temperatures, suggesting a need for

additional streamside vegetation for shade, and some scope for correcting excessive stream width in places. There are also opportunities to keep runoff from roads and parking/camping areas from draining directly into Cow Creek and its tributaries, raising water temperature as well as bringing excessive sediment into the streams.

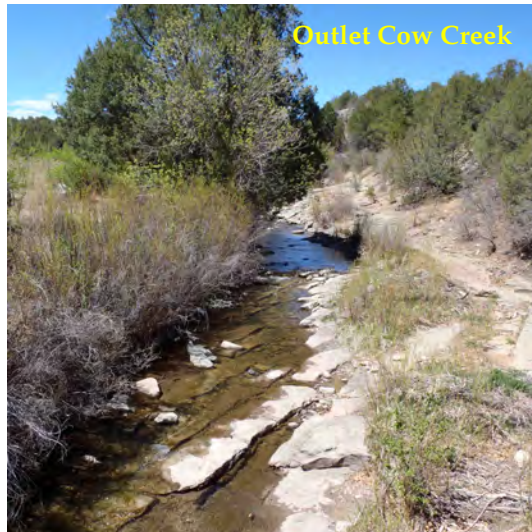
*Very little of this sub-watershed is accessible by road, and the majority is private land, making it very difficult to obtain direct information about watershed conditions. This reach of Cow Creek also fails to attain standards because of high temperatures, and examination of air photos suggests considerable opportunity for additional streamside vegetation, but actual riparian conditions could not be observed in the field for most of the reach. Stream restoration will be crucially dependent on collaboration with private landowners.*

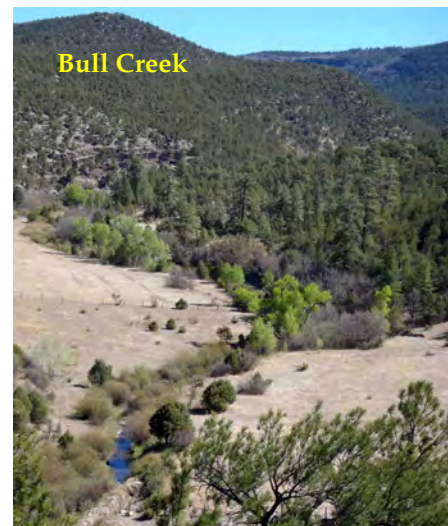
*The upper reaches of Bull Creek are very similar to the un-burned parts of upper Cow Creek – pockets of spruce-fir and aspen among extensive mixed conifer. However, the Bull Creek sub-watershed extends through large areas of ponderosa and includes some piñon-juniper country by the time it reaches Cow Creek halfway along the reach of Cow Creek in the Outlet sub-watershed. Like the headwaters of Cow Creek, the majority of land in the sub-watershed is Forest Service, but there are some large private in-holdings, including land along the Creek. Although Bull Creek attains temperature and other water quality standards at present, there are reaches along at least one meadow where there is a need/opportunity for additional shade along the stream.*

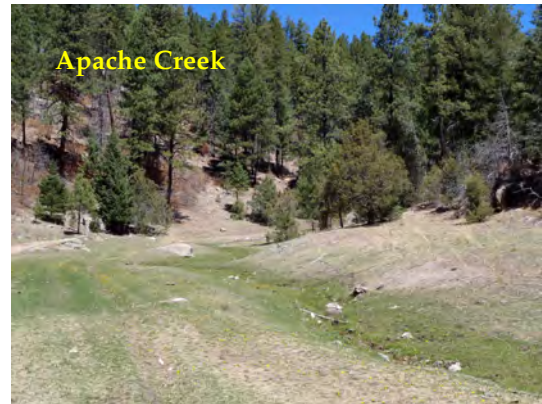
*Apache Creek was not assessed for attainment of water quality standards, and may not be perennial in all years. Its upper reaches were flowing when visited for this study, and there are meadows where cattle grazing appears to have prevented any trees or shrubs at all from becoming established along the stream, and cattle are contributing to damaged streambanks. There are also some road segments in need of culvert replacements and other erosion control.*

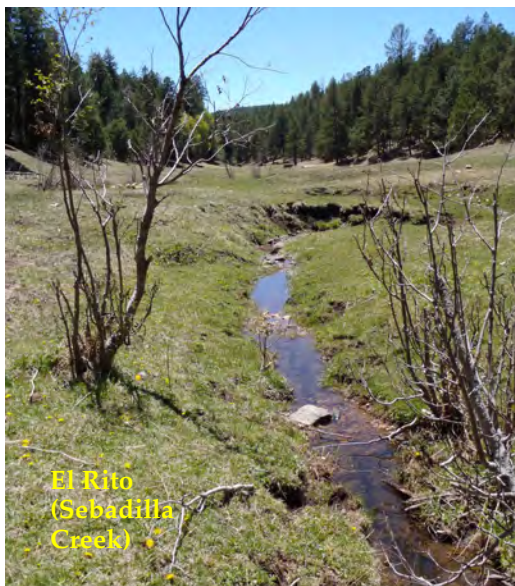
*Like Apache Creek, El Rito was not assessed for attainment of water quality standards, presumably because it also may not be truly perennial. The stream is only called El Rito for its lower few miles, after the confluence of Sebadilla Creek and Commissary Creek. The upper reaches of both were flowing when visited for this study. There are meadows on Sebadilla Creek where cattle grazing appears to have prevented any trees or shrubs at all from becoming established along the stream, and cattle are contributing to damaged streambanks and clear water quality degradation. The Forest Service has done substantial thinning in the ponderosa forest in this sub-watershed.*

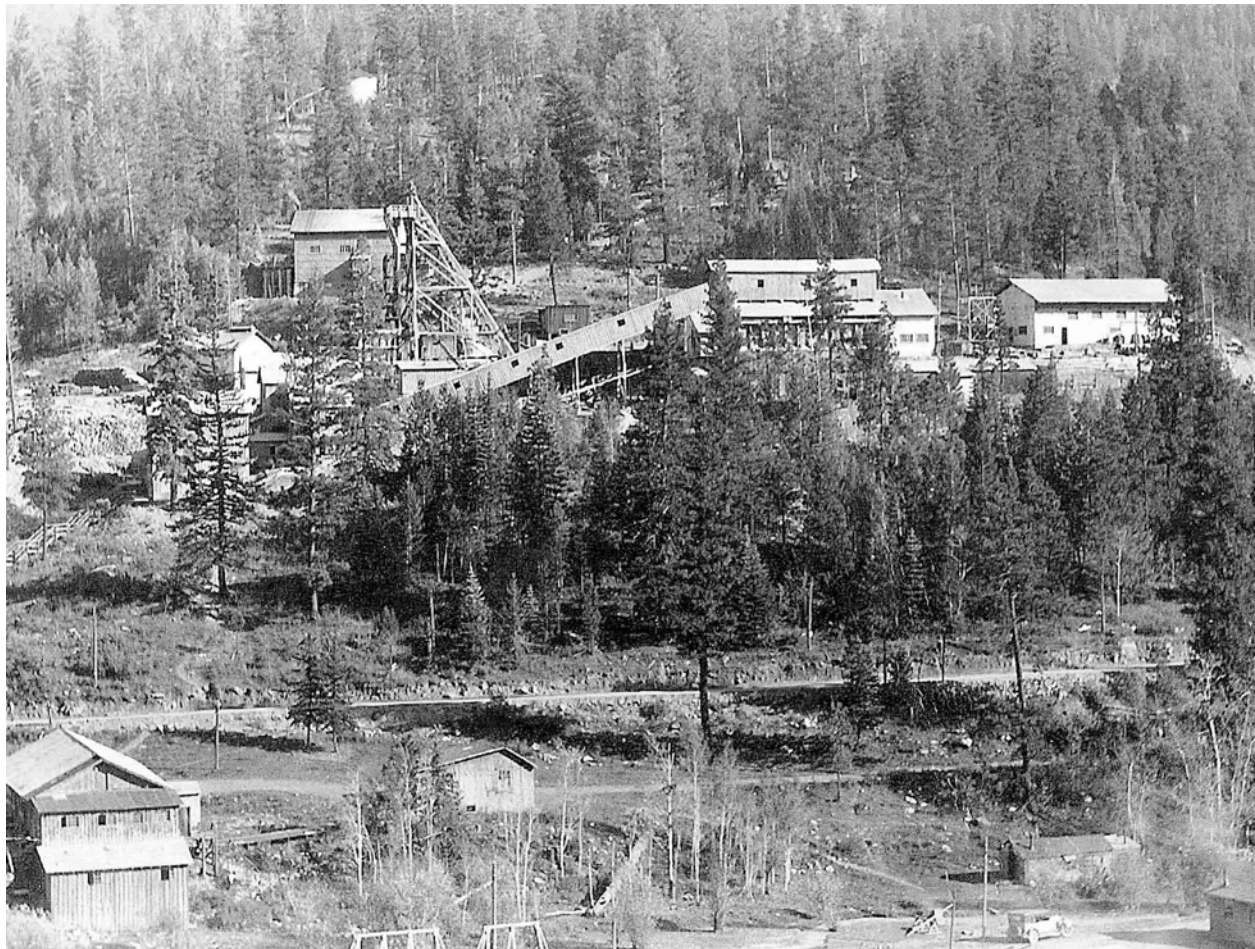
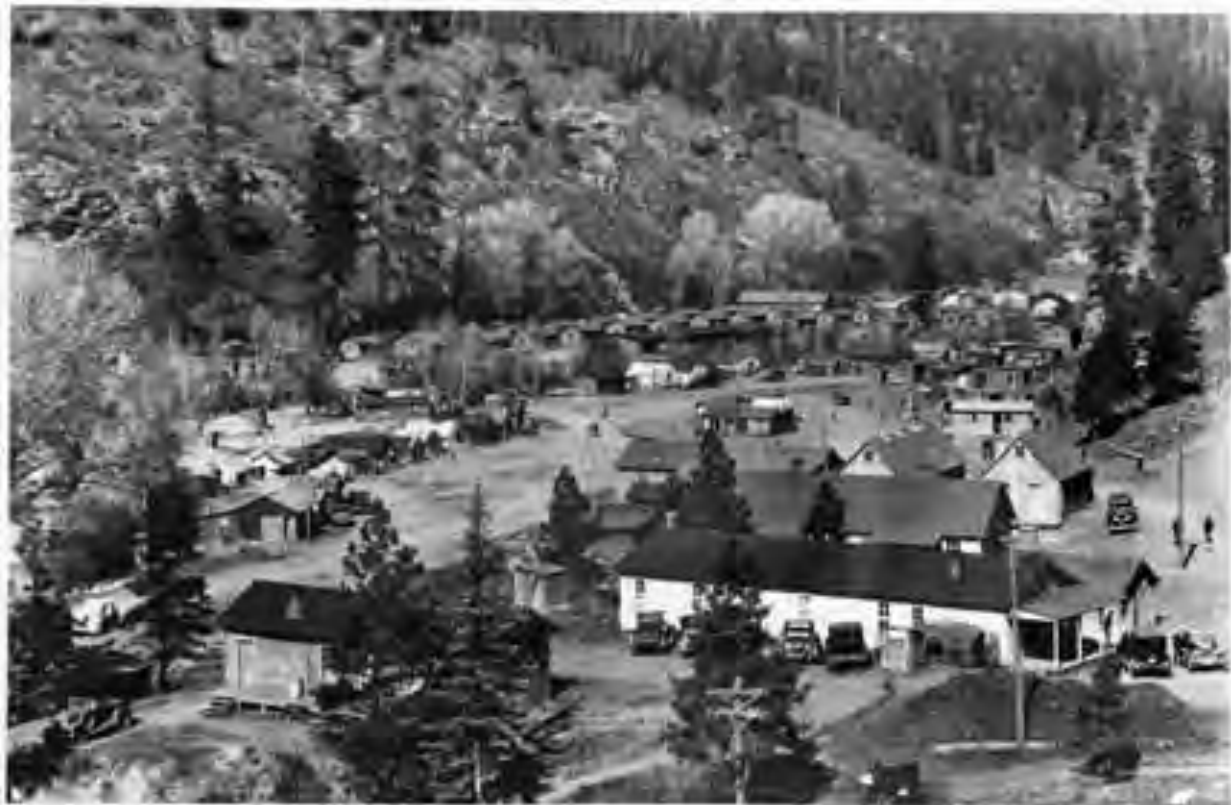
The Tererro mine (“Tererro” means mine dump in Spanish) operated at the confluence of Willow Creek and the Pecos River between 1882 and 1939. Mining activities were relatively small-scale from 1882 until 1925, when the American Metals Company took over the mine and expanded both mining and milling operations dramatically (Figure 3). Between 1926 and 1939, the mine produced approximately 2,200,000 tons of lead and zinc ore (Robinson 1995). Ore was transported aerial tram-cars to the mill in El Molino (near the village of Pecos) for processing. Large amounts of mine tailings were disposed of at three sites, and some tailings at the mine site were dumped into the Pecos River.

In the 1950s, the State of New Mexico obtained the land where the mine and the mill had operated. Mine tailings were used for construction projects between the mine and the Village of Pecos. Additional roads projects, federal and state campgrounds, the Lisboa Springs Fish Hatchery, also utilized mine tailings in their construction. Mine tailings were also used by residents for an unknown number of undocumented construction projects.

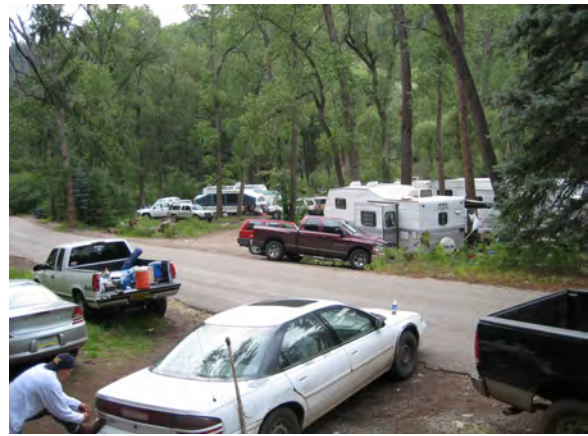
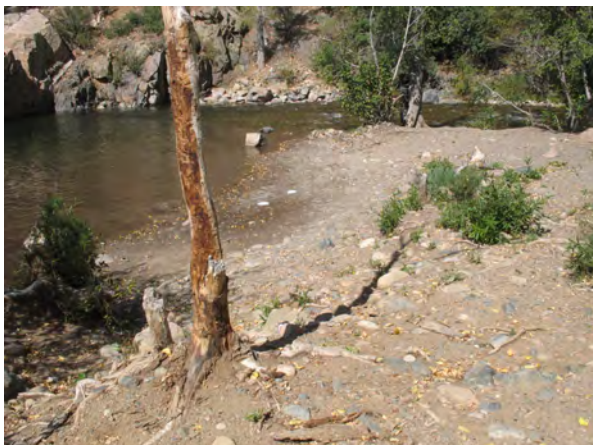
One of the principal effects of recreational overuse is damage to or complete trampling of native vegetation, especially along stream banks and in riparian areas or meadows. Removal of vegetation along with soil compaction and damage to seedlings, prevents vegetative re-growth and leads to increased streamside erosion and sediment transport into the river whenever there is rain or snowmelt. This degrades water quality as well as the recreational experience.

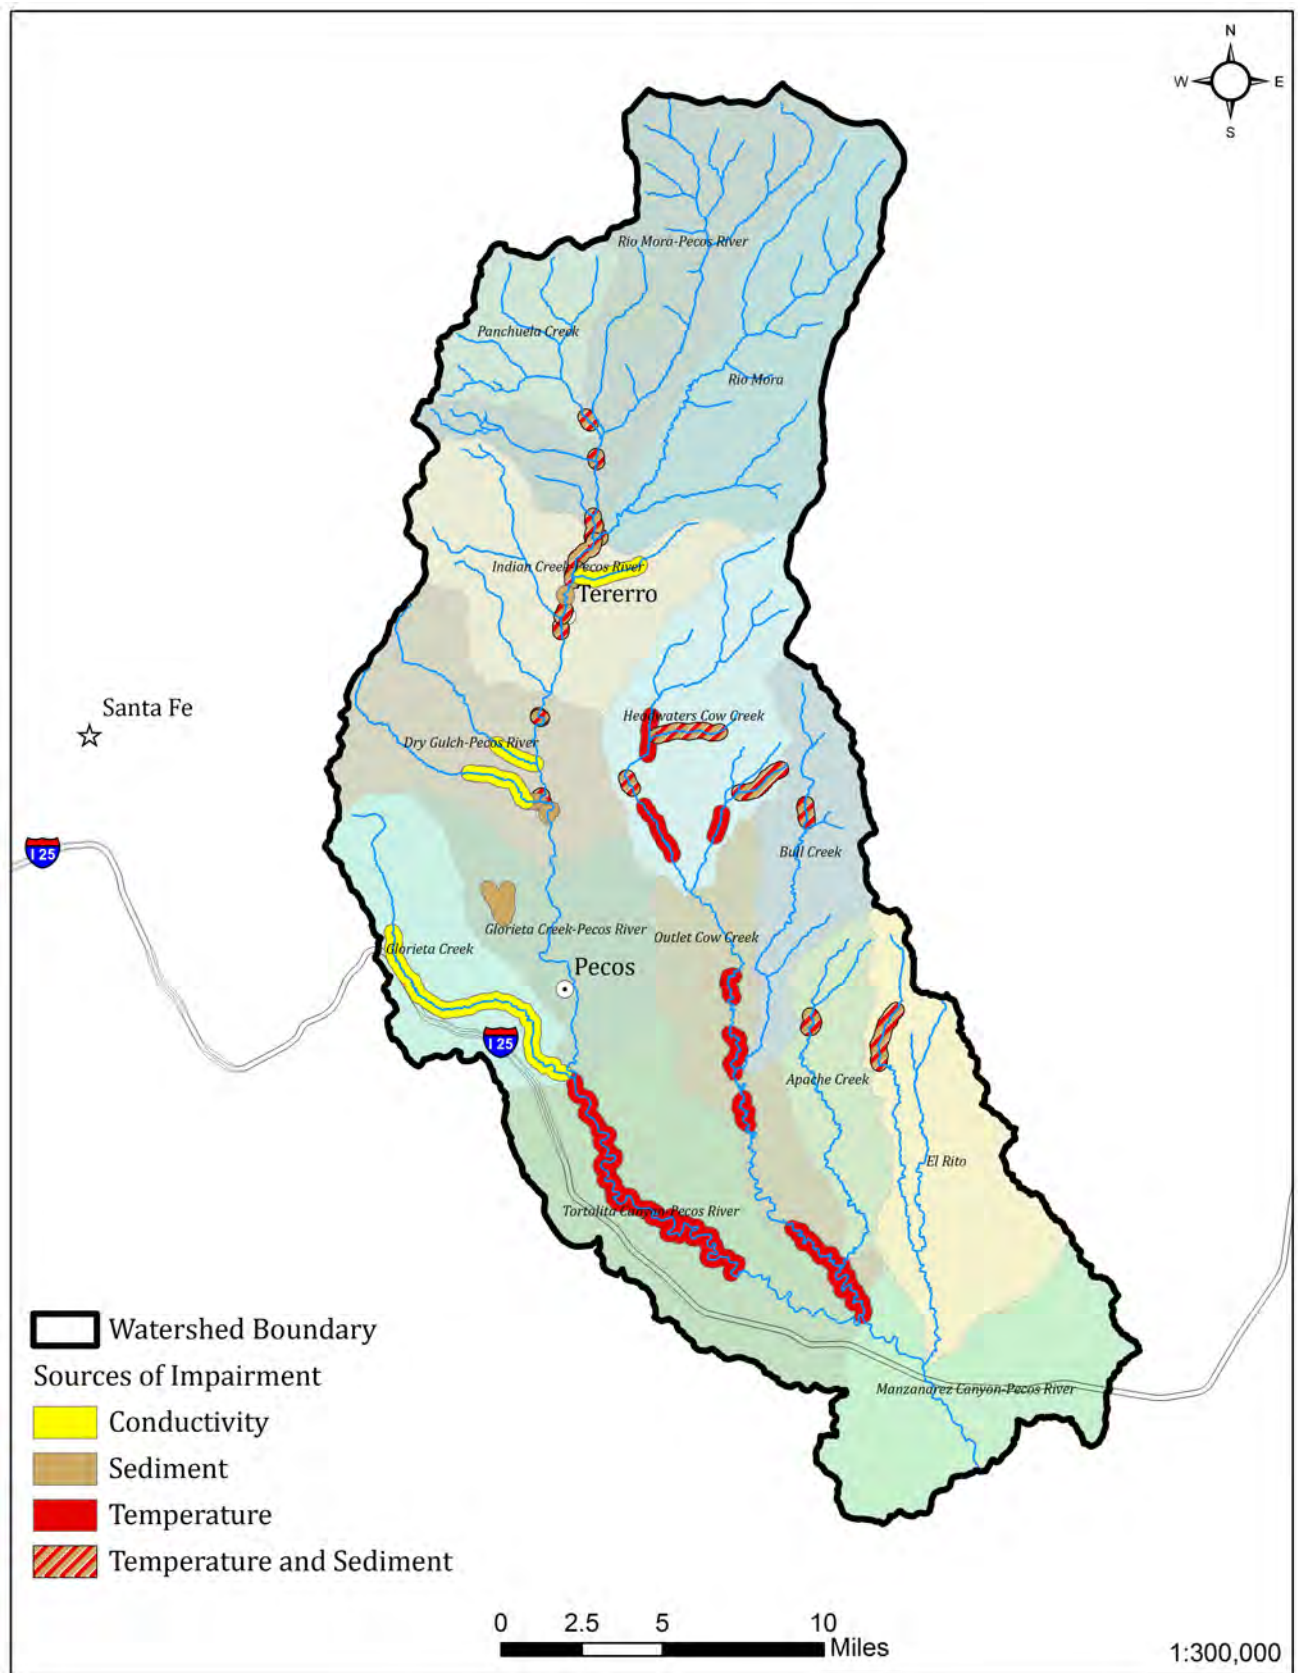
The following chapter on **Management Measures** that begins after the contaminant source map discusses the particular projects and activities needed to accomplish watershed restoration. Chapter 6 on **Pollutant Load Reductions** explains the methodology used to estimate the quantitative levels of pollutants or stress causing water quality impairments, the level of improvements needed, and the anticipated effects of management measures to restore water quality.

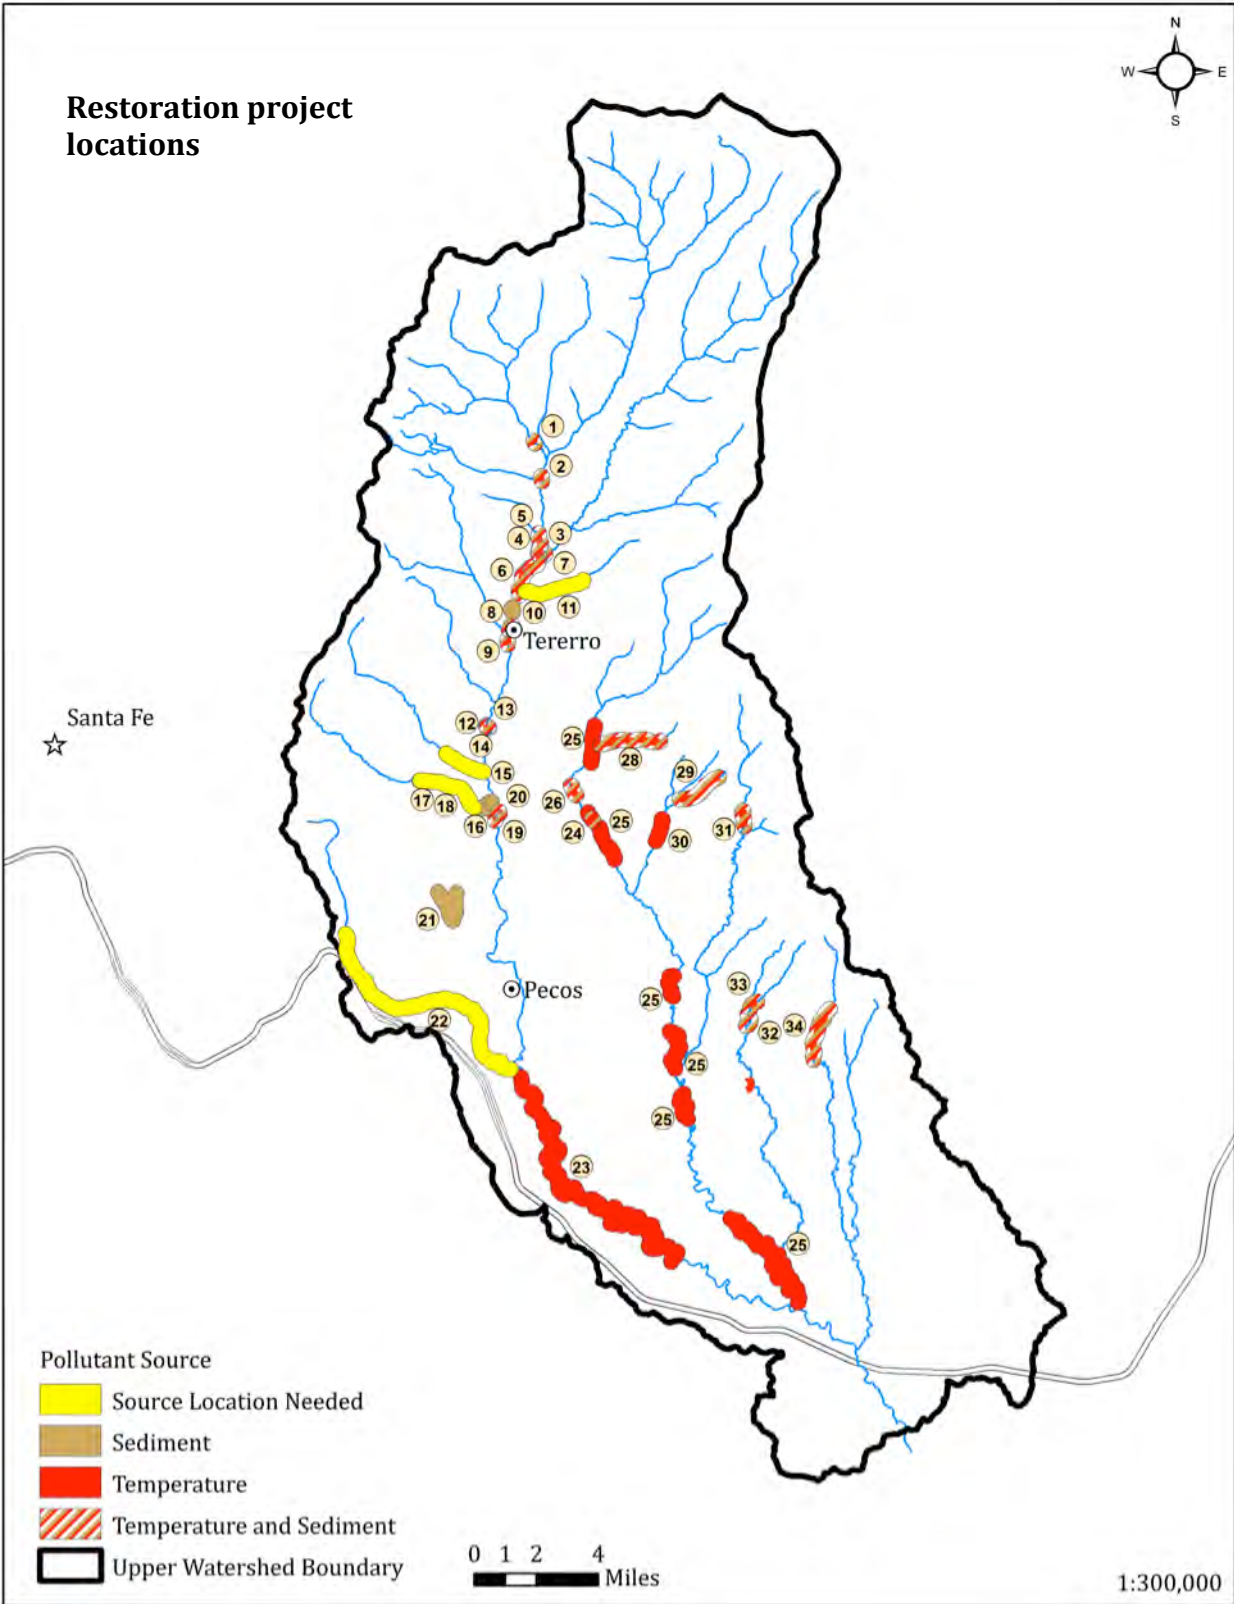
The map on the next page shows the location of all projects that have a specific location, identified by the project number. Projects affecting the entire watershed (like fire damage reduction) or with an uncertain location (like a facility for managing RV waste) are not located on the map.

The projects in the tables below focus on particular pollution sources in specific places, organized by pollution cause. Locations for these projects are mapped by project number on the previous page.
