Moreno Valley Wetland Action Plan

Joanne Hilton, P.G.

the Cimarron Watershed Alliance

New Mexico Environment Department (NMED)

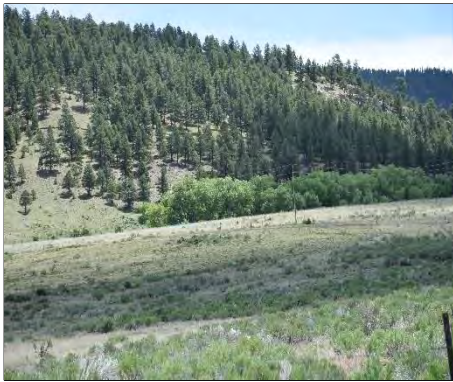
--American Creek with woody riparian vegetation

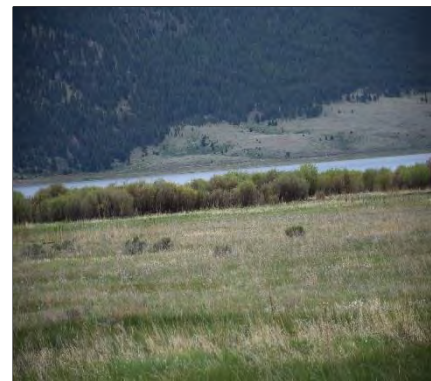
--Woody riparian vegetation along Moreno Creek

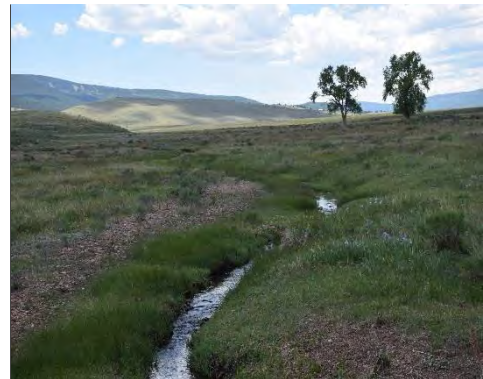
--Riverine wetlands limited to narrow bands where creek is not incised

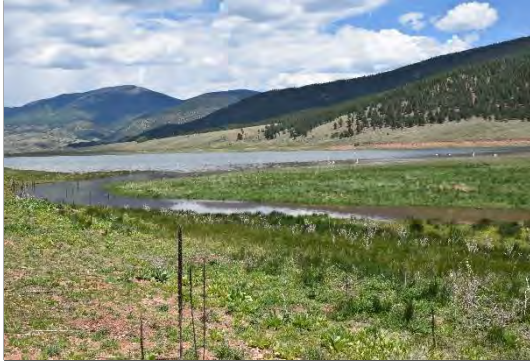
--Lacustrine fringe wetland shown at right where Cieneguilla Creek enters Eagle Nest Lake

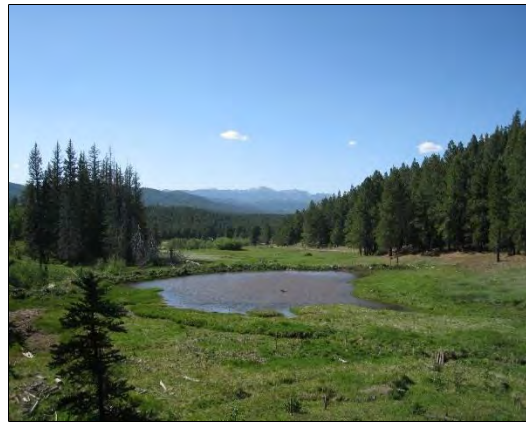
--Depressional wetland (pond)

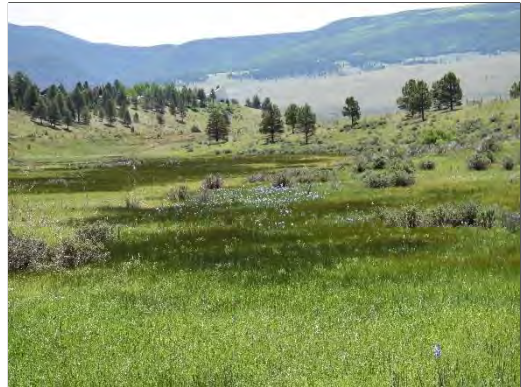
--Slope wetlands upstream of pond

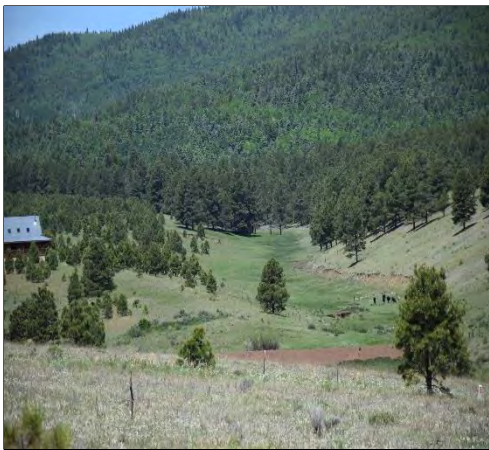
--Slope wetlands with headcut

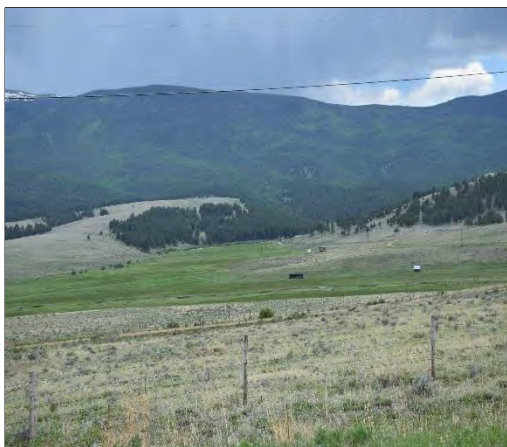
--Slope wetlands along a tributary to Moreno Creek

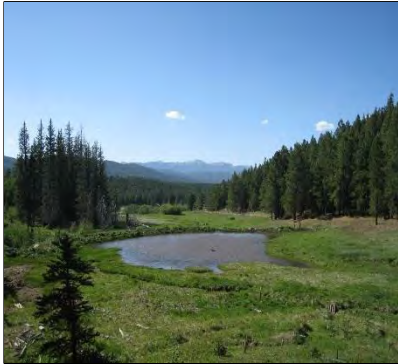
--Palustrine fringe on perimeter of pond

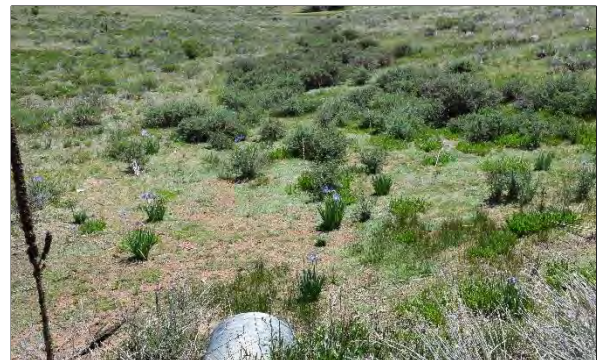
--Slope wetlands dried below road

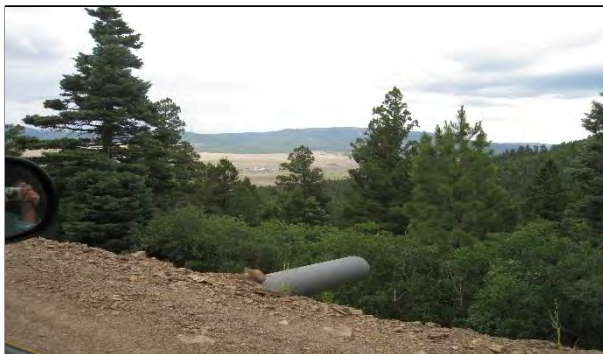
--Poorly placed culverts can accelerate erosion

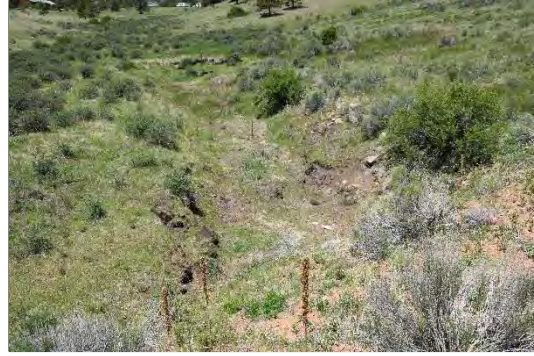
--Presence of shrubby cinquefoil is an indicator of slope wetlands drying below road and culvert

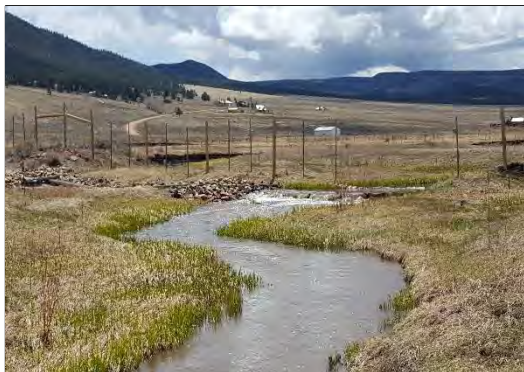
-- Elk enclosure near Eagle Nest Lake

Grazing exclosures may be used to prevent access to important areas for protection. Elk exclosures have been installed on the south side of Eagle Nest Lake. Livestock best management practices, such as rotation and alternate water sources, can be used by ranches in the area to minimize impacts to wetlands. Education and financial assistance may help local ranches to implement grazing best management practices.

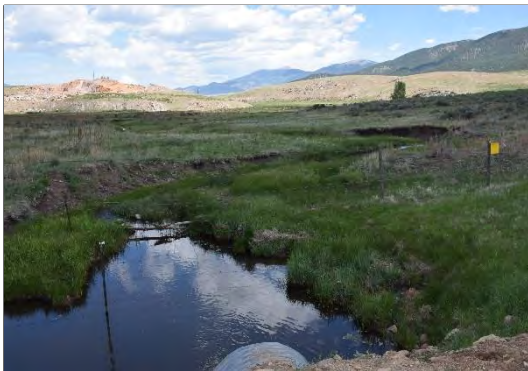
--Riverine wetlands on incised Cieneguilla Creek

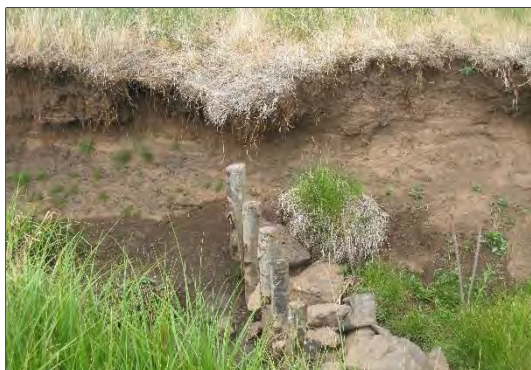
--Post vanes to mitigate bank cutting along Cieneguilla Creek

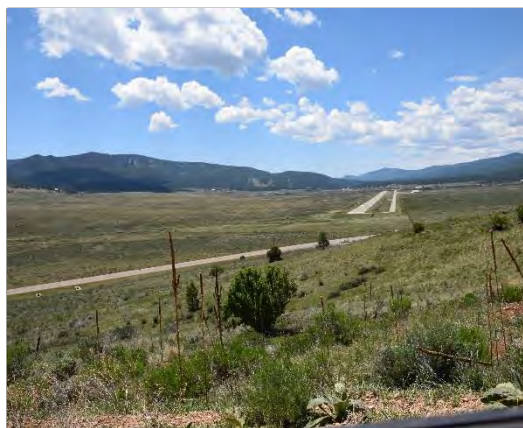
--Angel Fire Airport constructed in Cieneguilla Creek riverine wetland
