# Wetland Action Plan

## Comanche Creek Watershed

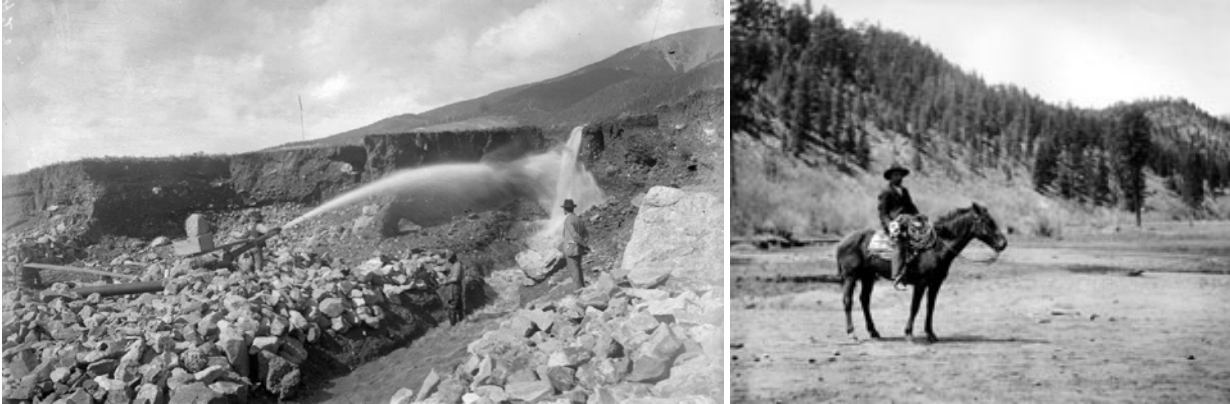
Figure 2a. Placer mining in nearby La Belle, New Mexico between 1890 and 1910 (Denver Public Library, Western History Collection, Aultman, Otis A., 1874-1943. CHS.A646); Figure 2b. Land impacted by livestock grazing in what is now Philmont Scout Ranch (photographers unknown).

of sheep and cattle. Mining was also a common activity in the watershed after gold was discovered in the late 1800s in the Maxwell Land Grant. Figure 2a and Figure 2b show examples of legacy land use impacts in the CCW. Creek names such as Sawmill Creek and Gold Creek give insight into the extent of extractive land use in the watershed.

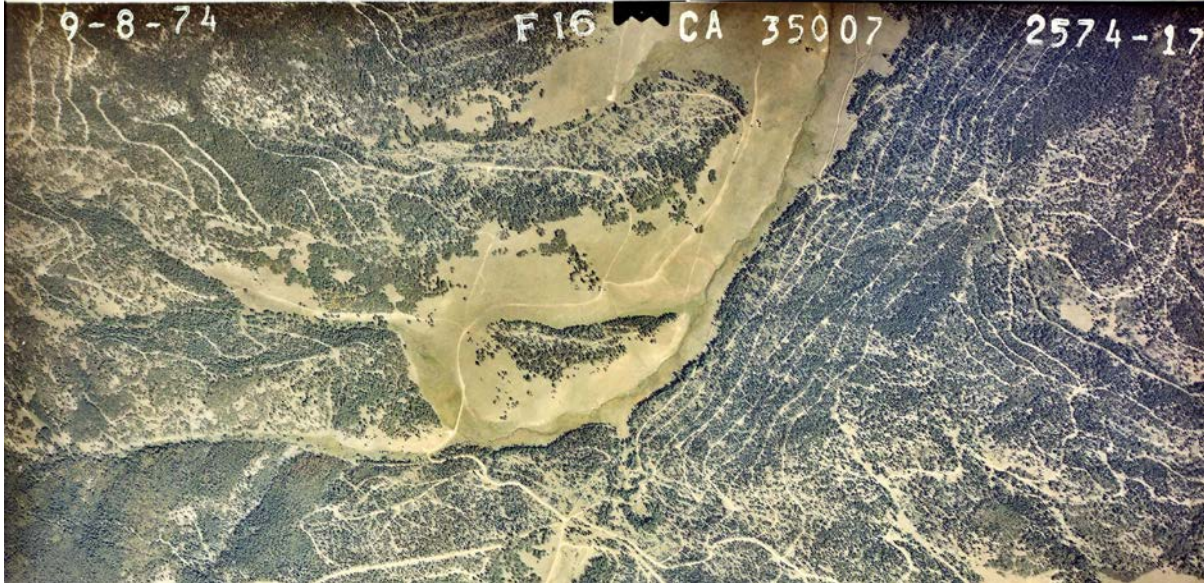
Figure 3. Aerial photograph from September 8, 1974 showing logging roads in the southernmost portion of the watershed

Timber rights were in a third-party ownership and did not belong to Pennzoil to be transferred with the surface ownership. The rights belonged to a logging company with lumber mills in both Amalia and Cimarron. The CCW was logged using the “jammer logging” method, which uses a cable and winch system to drag or skid logs uphill to a collection and loading area (Stokes et al. 1989). Jammer cables have a limited reach of 100 to 300 feet; therefore requiring the construction of closely-spaced roads— in this instance, every 150 feet. Timber harvesting and the subsequent construction of many logging roads further impacted the watersheds of the Valle Vidal. Logging road construction resulted in changed water drainage patterns throughout the watershed. These road networks are clearly visible in aerial photos (Figure 3). More than 700 miles of abandoned logging roads were drained and closed to traffic in the two years following acquisition of the Valle Vidal Unit by the USFS.

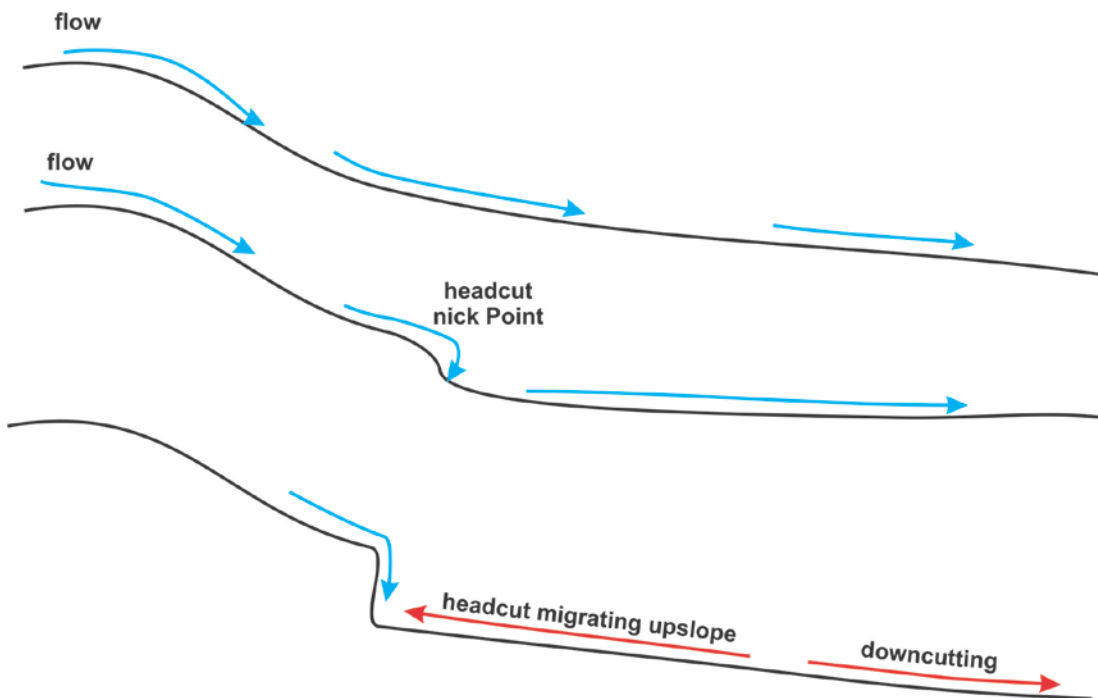
Figure 16. Schematic illustrates the evolution of a headcut through a wetland.

The headcut causes an incision on the wetland surface. This incision concentrates flow and accelerates flow velocity, which increases shear stress and results in the downcutting of the channel bed. The presence of the channel changes the system to one in which channelized flow replaces dispersed flow across the wetland surface. Channelized flow reduces the supply of water available to the surface of the wetland. The water table drops as a result of the downcut channel. Downcut channels move water through the system faster and cause less water to be stored in the banks of the streams and the surrounding wet meadows. These areas become drier and less productive (fewer and less vigorous plants) and store less water in the soil. Less

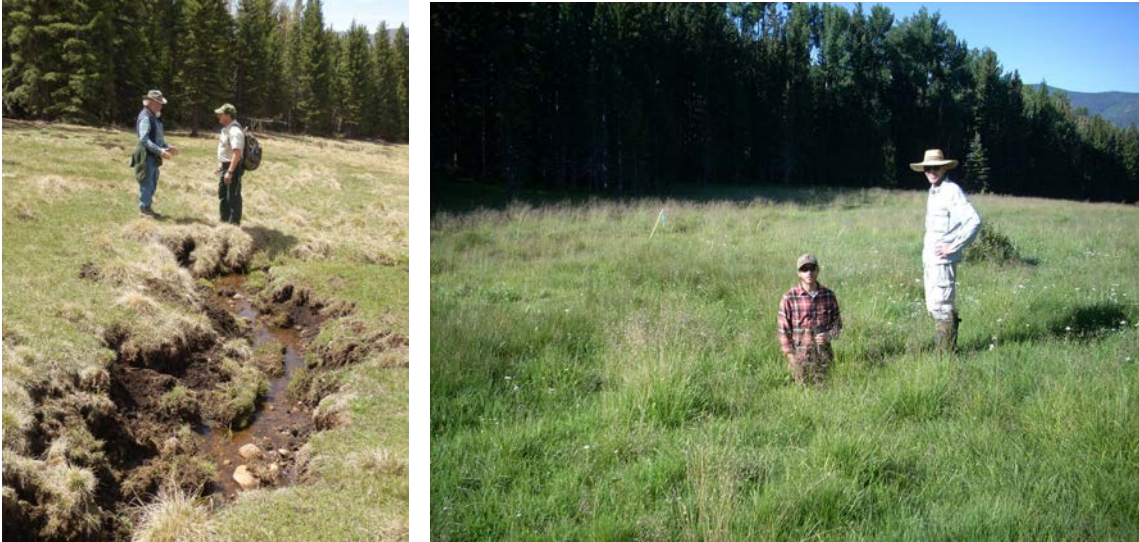
Figure 17a. Headcut in an upper tributary to Comanche Creek Figure 17b. Downcutting channel through a slope wetland in the Springwagon Creek drainage

water stored in the surrounding soil means less wetland vegetation, which means higher erosion and water moving through the system even faster. A river responds to base level decrease with vertical incision (Schumm 2005). This becomes a feedback loop and the system keeps drying (Figures 17a and 17b).

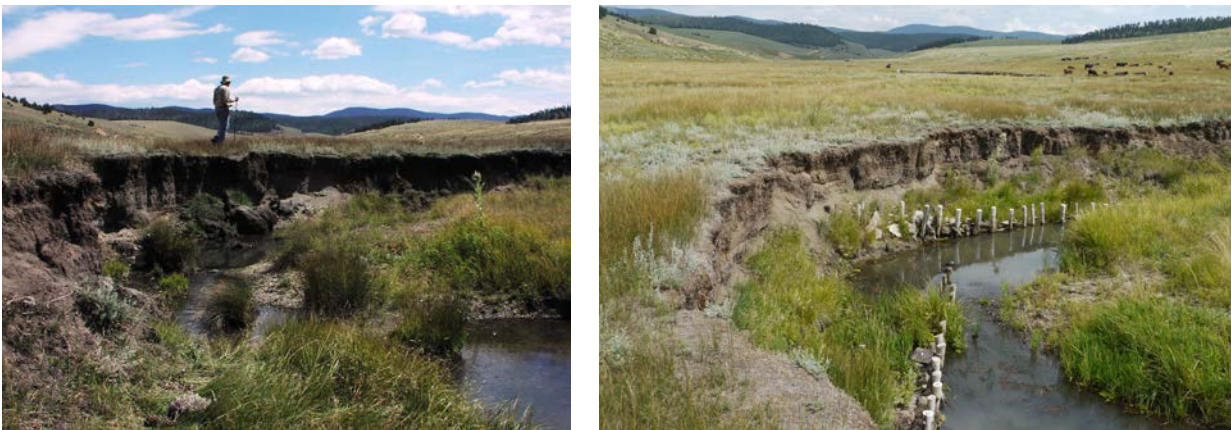
Figure 18a. Erosion and channel incision in the mainstem of Comanche Creek dries the adjacent floodplain and associated riparian wetlands; Figure 18b shows the same area with post vanes installed to stabilize the stream banks.

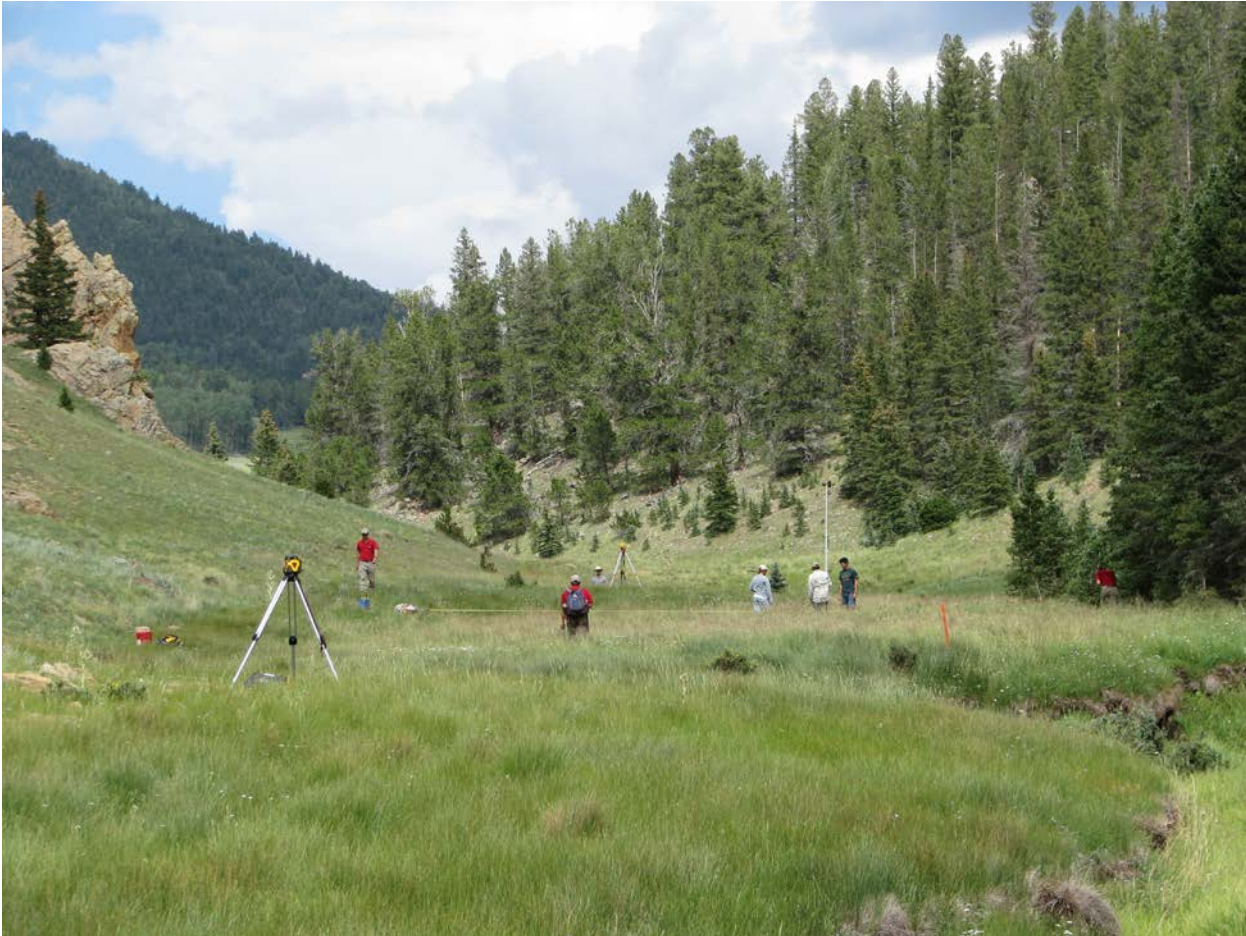
Figure 20. Pre-project monitoring in Lower Grassy Creek at the Quivira Coalition 2012 Volunteer Workshop

In addition to CNF, NMED and NMDGF monitoring of conditions in the watershed, Quivira and volunteers have amassed a large amount of vegetation and geomorphology data since 2001 (Figure 20). The CNF has monitoring data for the upland vegetation communities. NMED has water temperature data loggers installed at many locations in the watershed. Fish population

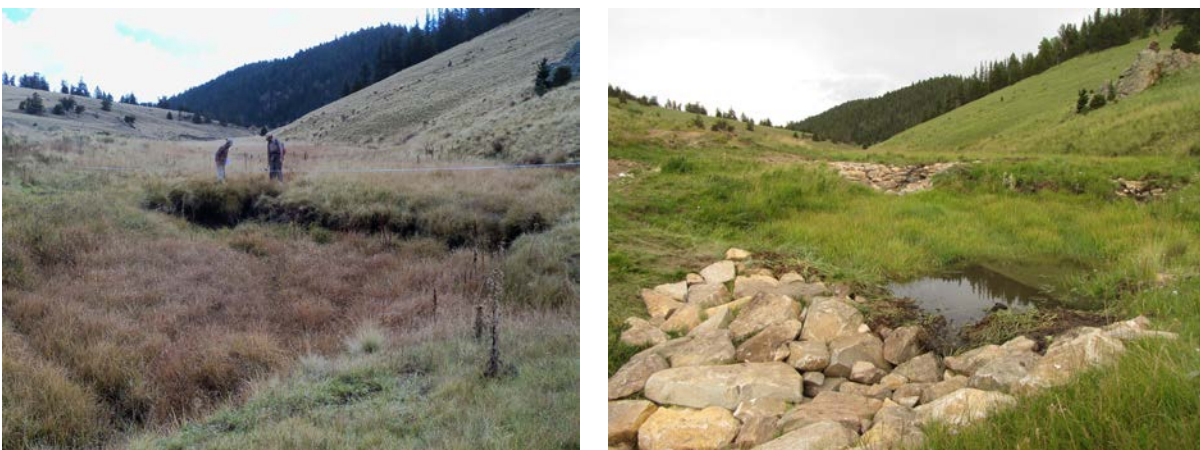
Figure 21a. Cross section measurement of headcut in Grassy Creek; Figure 21b. Zuni bowl remediation of large headcut in 2013.

An example of a treatment found in the guide shows large headcuts treated using boulders to create Zuni Bowls (Zeedyk and Clothier 2009 and Quivira and Zeedyk 2014). Figure 21a and 21b show a large headcut in Grassy Creek that was monitored as a volunteer project in 2011. In 2013, the headcut was remediated using grant funds from the 2011 River Ecosystem Restoration Initiative (RERI) grant (Figure 21b) in the lower portion of Grassy Creek. In the Springwagon Creek wetlands (Figure 22a and 22b), log rundowns and sod are used to stabilize the channel and return dispersed flow to the surrounding wetlands.

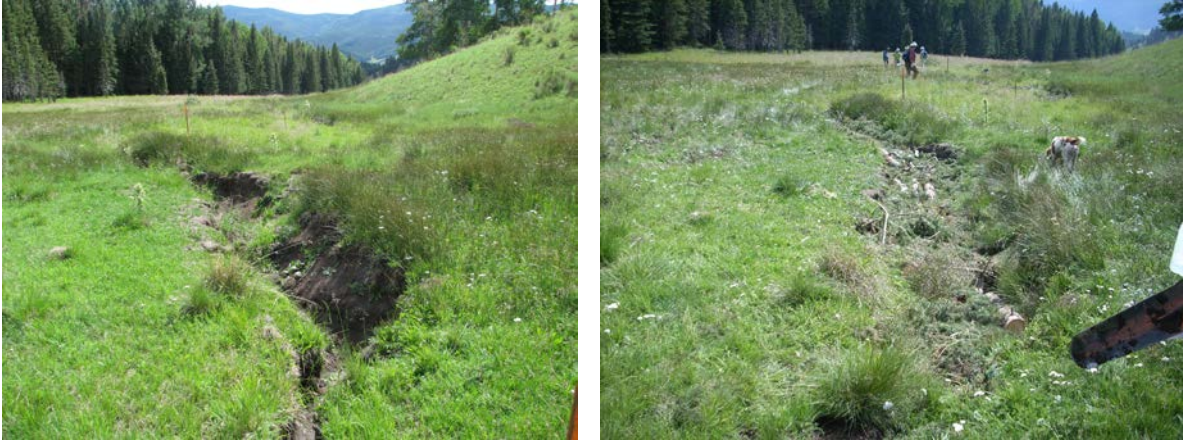
Figure 22a. Smaller headcuts are remediated using logs and sod; Figure 22b shows the headcuts filled with native materials obtained from onsite.

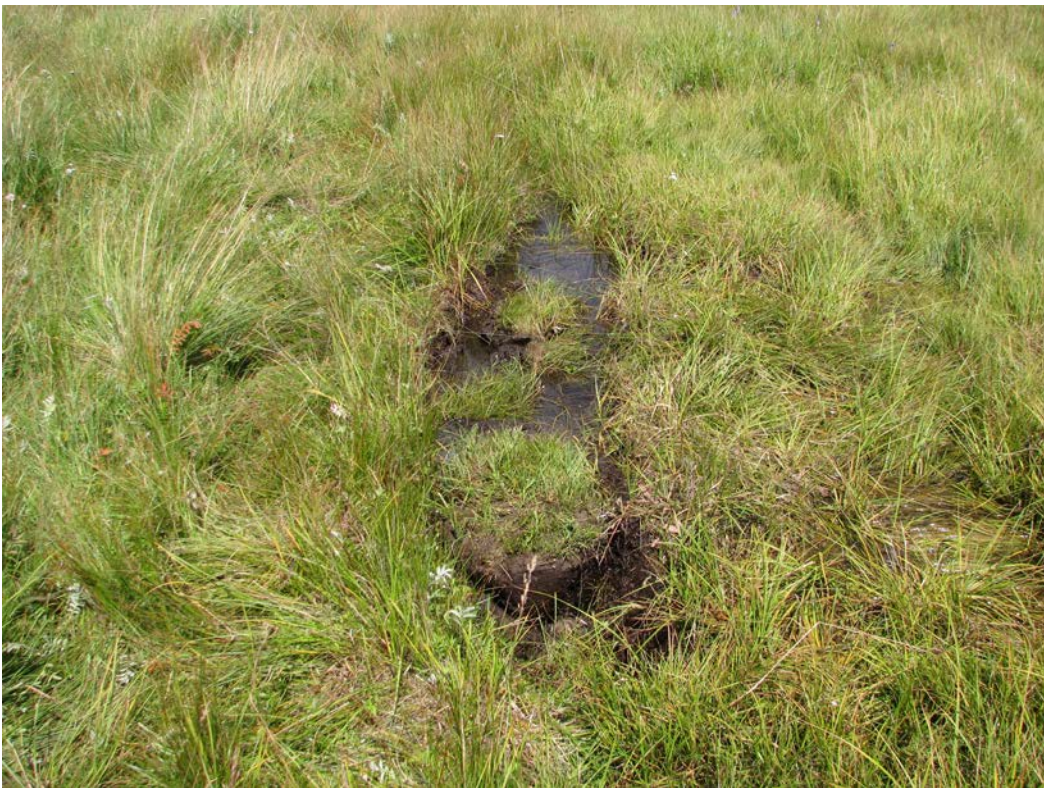
Figure 23. Sod plug blocking incised channel and resaturating wetland

Restoring dispersed flow to the wetland surfaces is critical for the health and functioning of slope wetlands. For detailed descriptions of treatments for stabilizing slope wetlands and restoring dispersed flow over wetland surfaces, see Quivira and Zeedyk 2014. The wetland surface shown in Figure 23 was resaturated by blocking the incised channel, which caused water to back up behind the sod plug and flow onto the wetland surface.

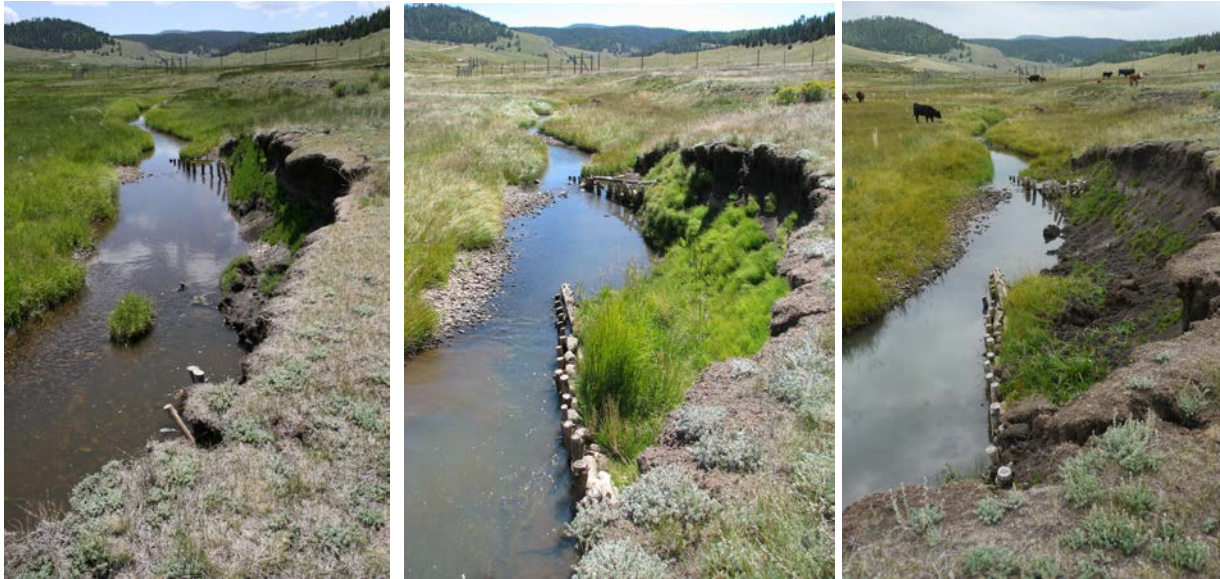
July 2008

September 2010

Figure 24. Bank stabilization using post vanes in the Comanche Creek mainstem

Eroding banks of stream channels accelerate water flow through the system and contribute to the subsequent drying of the associated riparian wetland. Stabilizing banks allows vegetation to anchor the system and slow the movement of water (Figure 24).

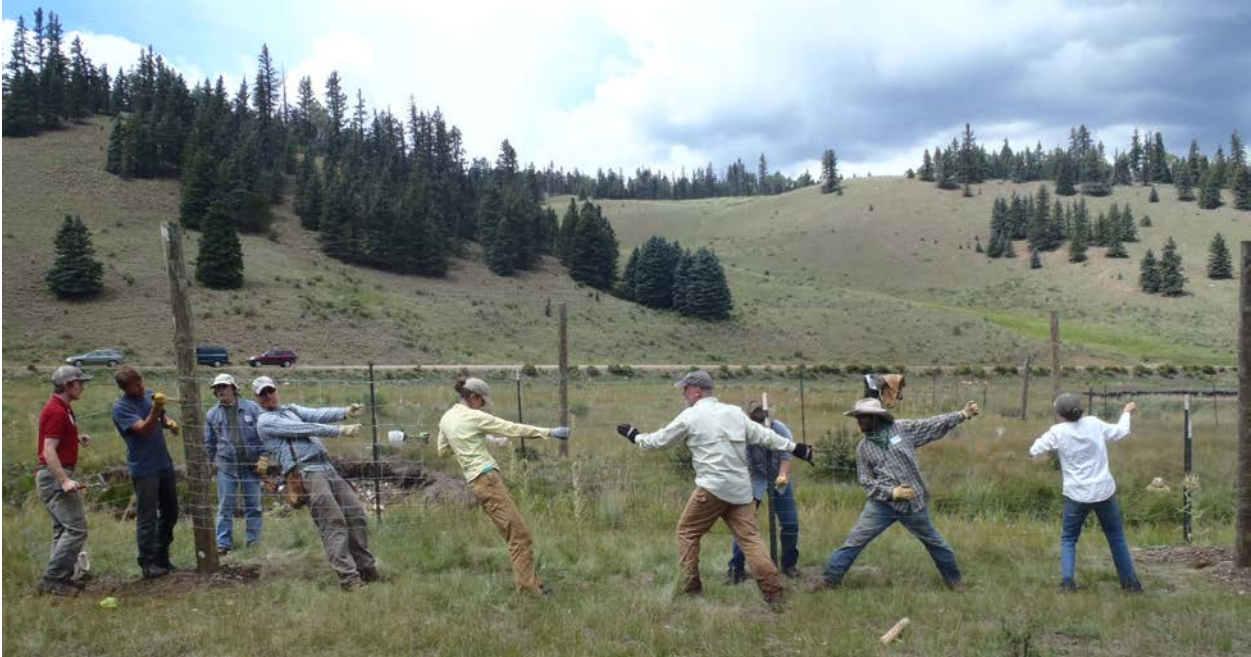
Figure 25. Volunteers repairing elk enclosures to protect willows along Comanche Creek

Elk range across the CCW throughout calving season and the summer months but spend most winters on the eastern side of the mountains depending upon snow depths (Michael Catanach, NMGF 2003). Elk grazing, browsing, and trailing in riparian vegetation along Comanche Creek, in addition to that by cattle, may contribute to TMDL exceedances of temperature and geomorphological instability. Some success lowering the water temperature along the mainstem of Comanche Creek may be due to the installation of elk and cattle exclosures to allow willow, alder, and cottonwood regrowth on the banks of the creek (Figure 25 and 26) as well as protecting fens, springs and other vulnerable locations that are important to the functioning of healthy wetlands.

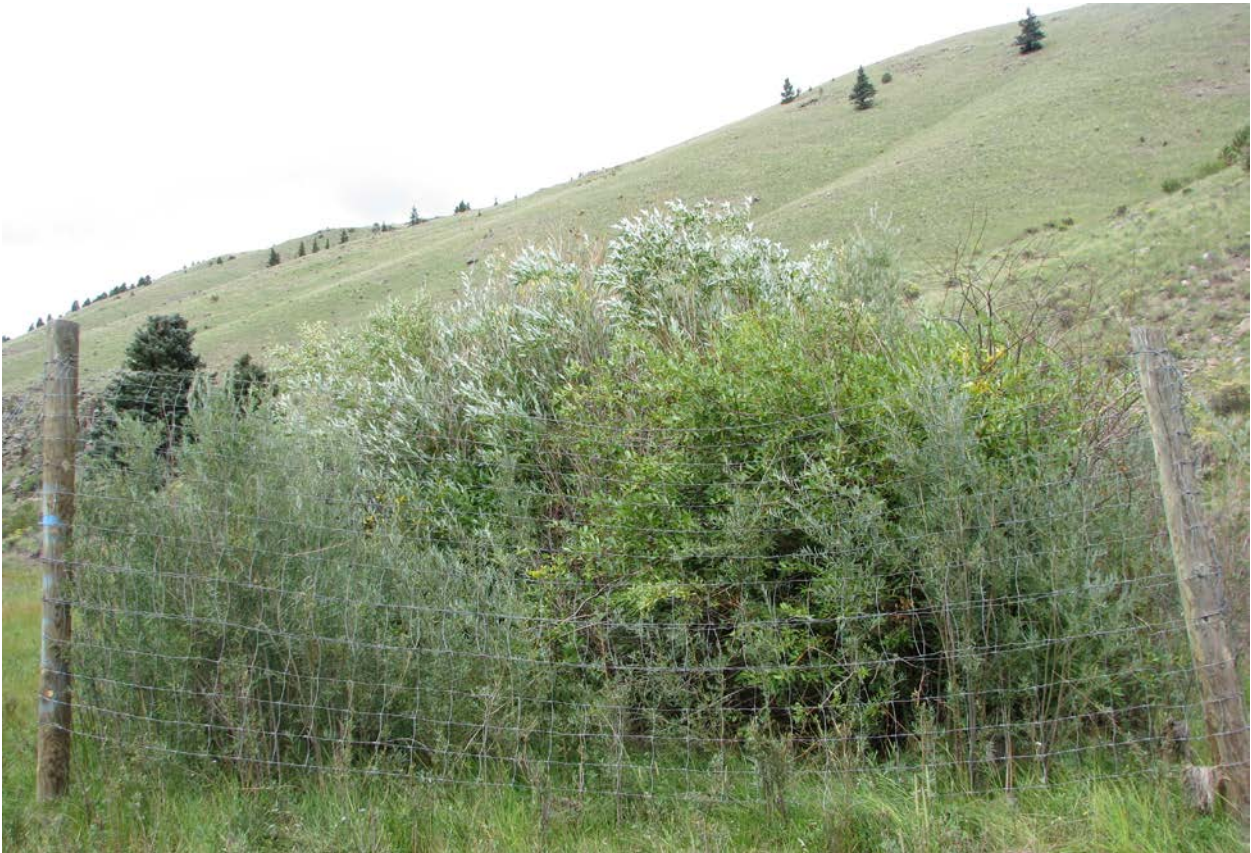
Figure 26. Degree of willow growth that occurs when willows in the lower reaches of Comanche Creek are protected from browsing by large ungulates

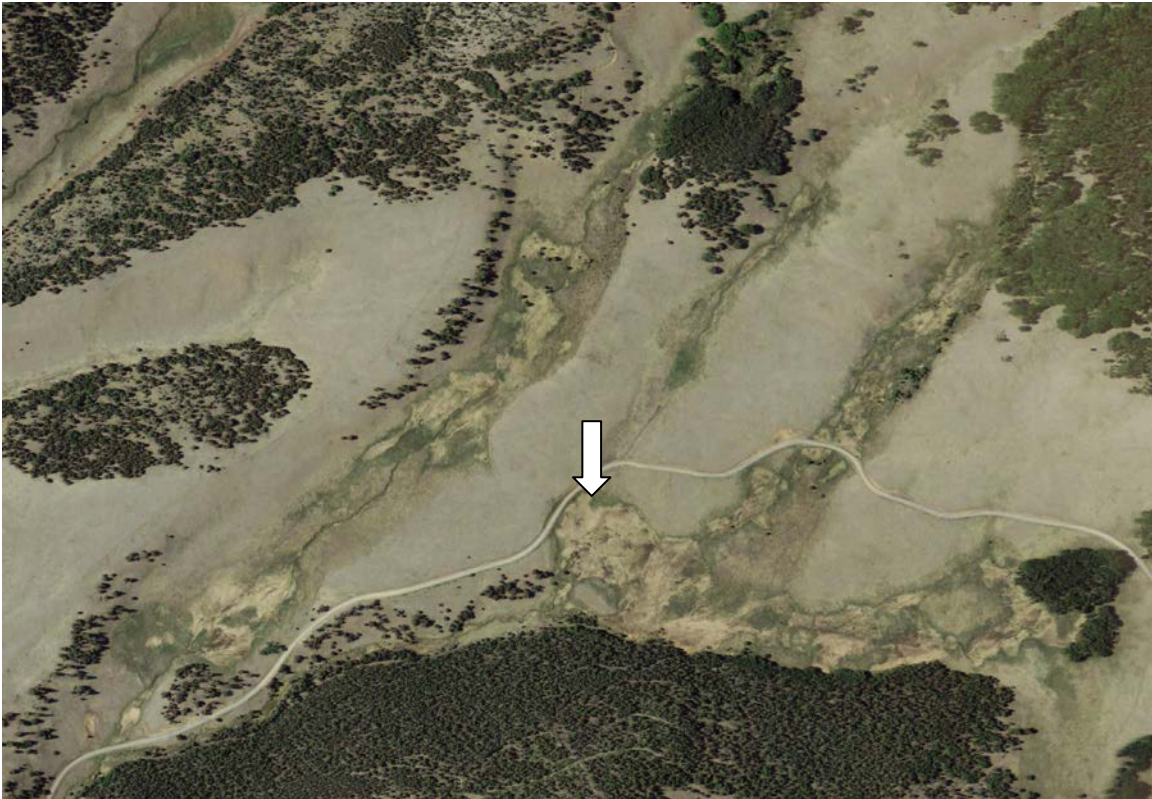
There are three tributaries to Holman Creek, each with associated expansive wetlands. There is a large fen (white arrow) just below the place where a road crosses the wetland complex with the highest priority for stabilization. The bright green in the photo below shows the fen and a large headcut (white arrow) which is draining the wetland complex. In 2015, restoration treatments were started in this area using the Coca Cola funding.

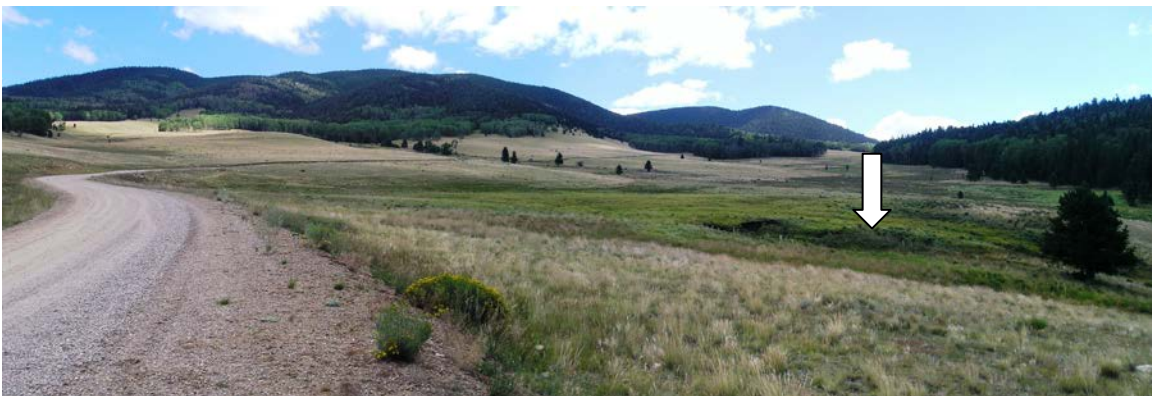
Above the road, there are expansive slope wetland areas that are currently drained by large headcuts and incised channels and converting to wet meadows. Some of these headcuts were treated in 2015 with Coca Cola funding.

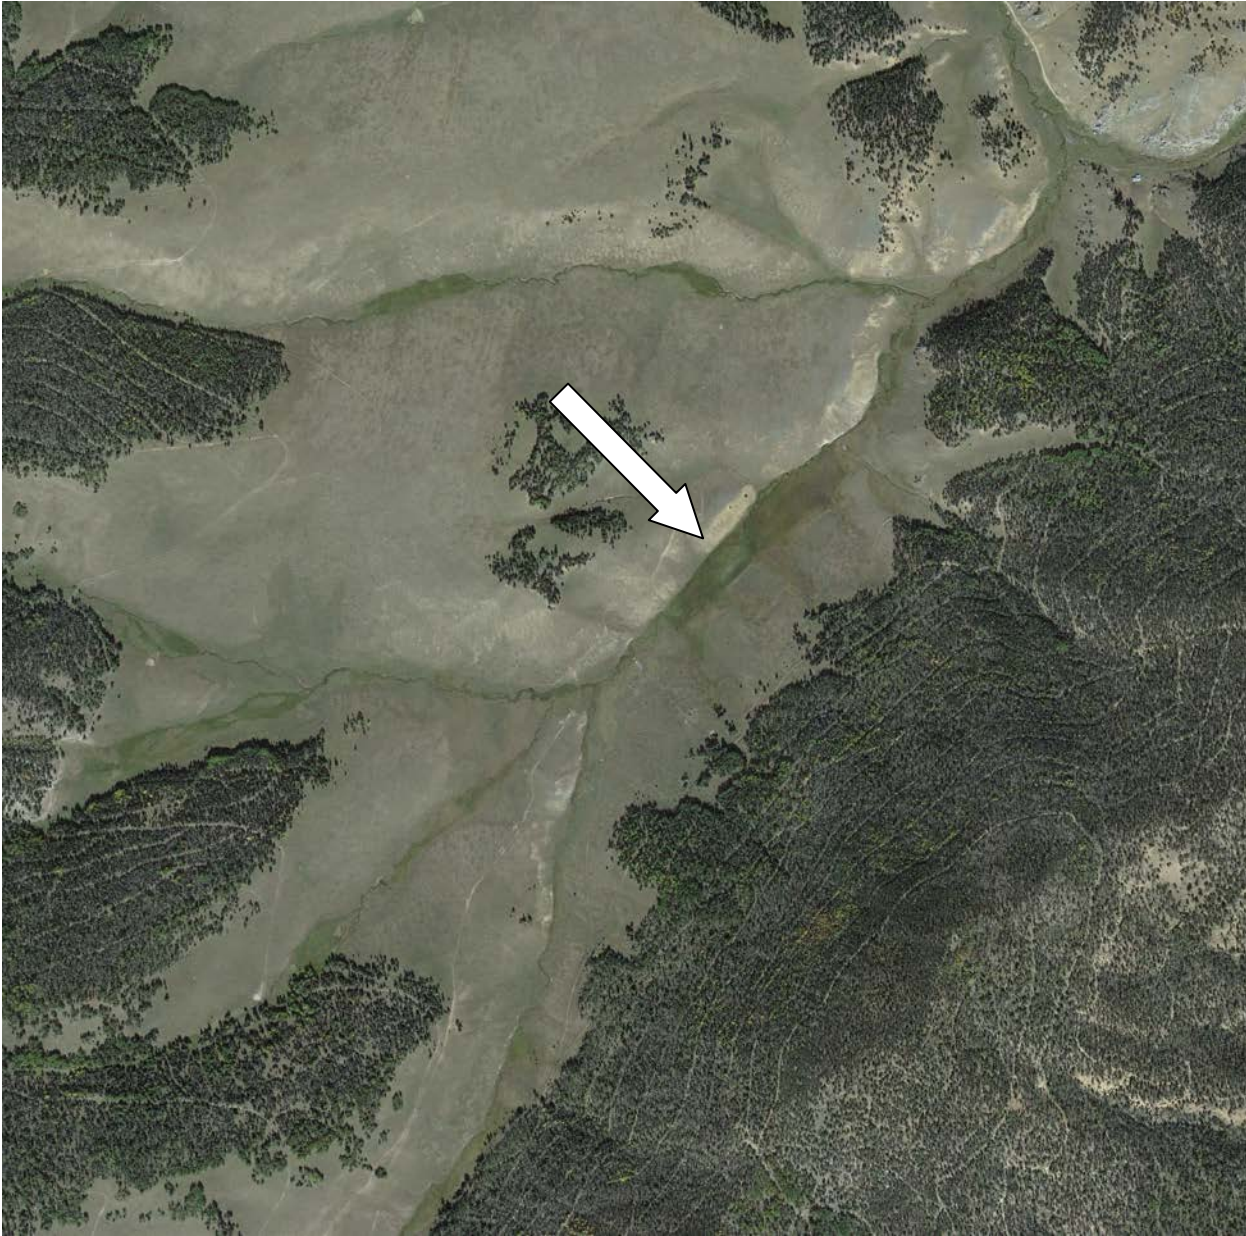
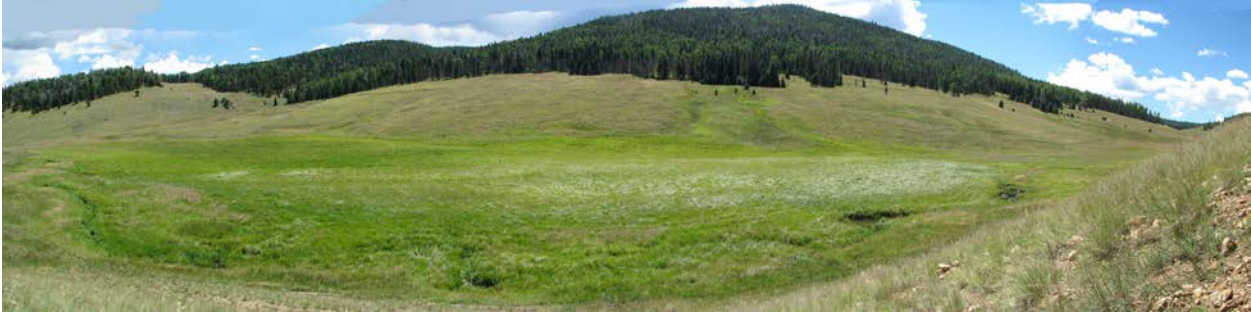
***Upper Comanche Creek Floodplain Wetlands (south of confluence with Vidal Creek)***

There are extensive wetlands, including large fen complexes, in the upper part of Comanche Creek that would benefit from restoration. Some of these headcuts were treated in 2015 with Coca Cola funding.

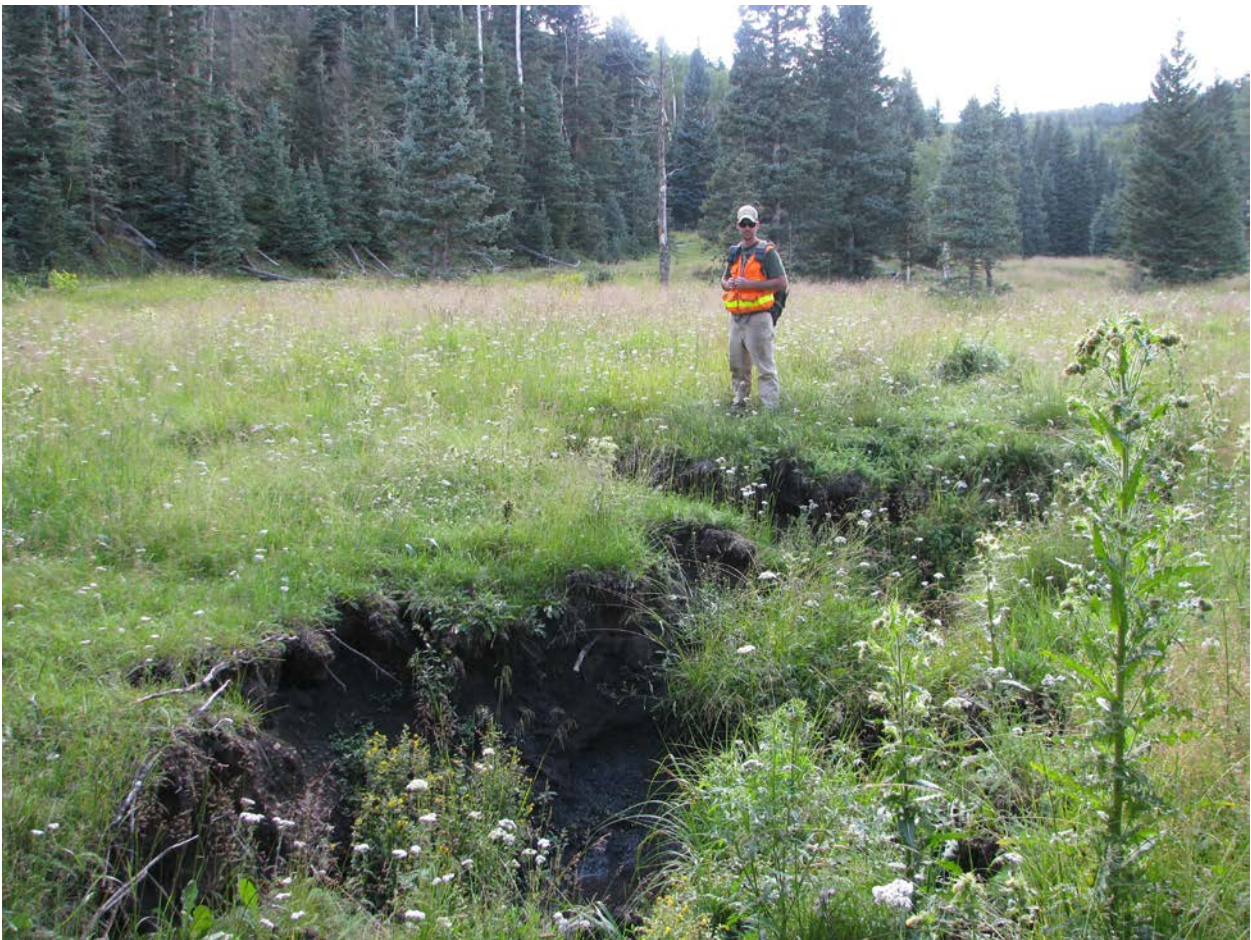
In the upper area of the watershed, there are large headcuts as the uppermost part of Comanche Creek moves up into the tree line and the gradient become steeper. Site access might be an issue for restoration contractors and volunteers.

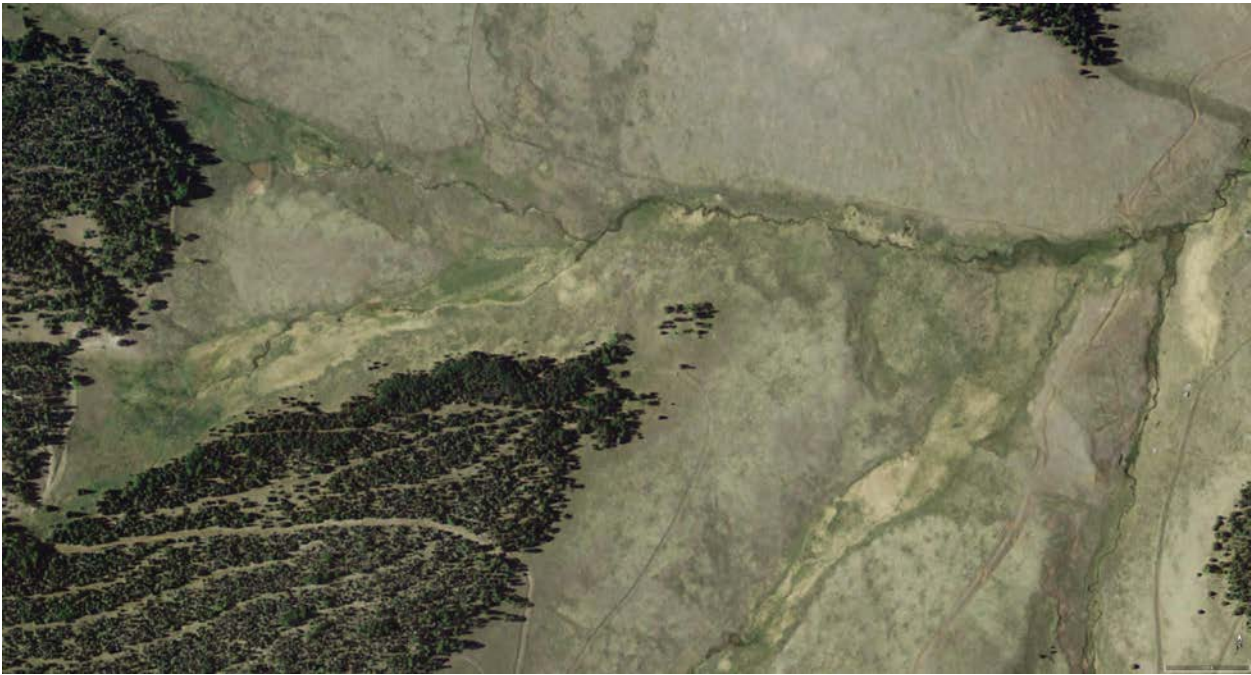
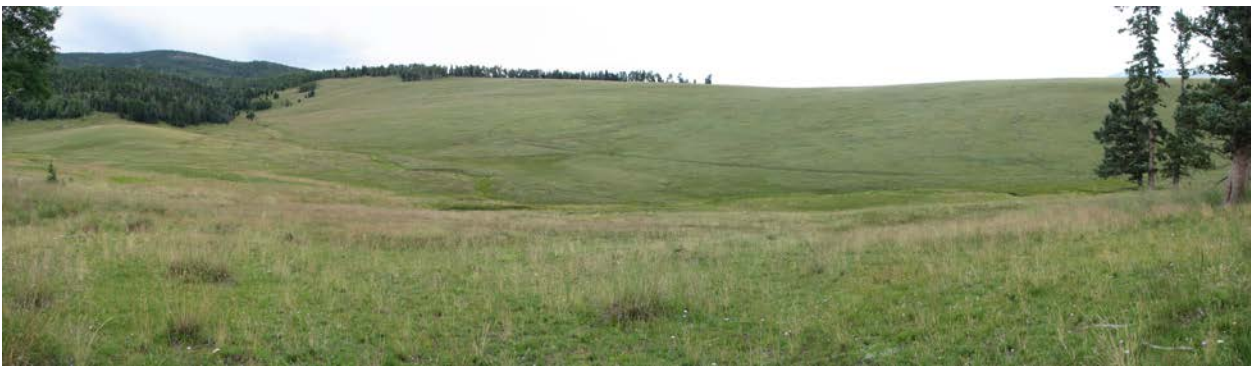
## ***Sawmill Creek***

There are two tributaries to Sawmill Creek with wetlands that have good potential for stabilization and restoration. Archaeological clearances might be an issue because of the location of the old Sawmill. Above the slope wetlands on the map as the gradient becomes steeper there are substantial headcuts which are degrading the system. There are significant groundwater inputs to the slope wetlands in this drainage, which increases the potential for successful restoration once the headcuts and incising channels are stabilized. Canada thistle is a concern at the confluence with Comanche Creek.

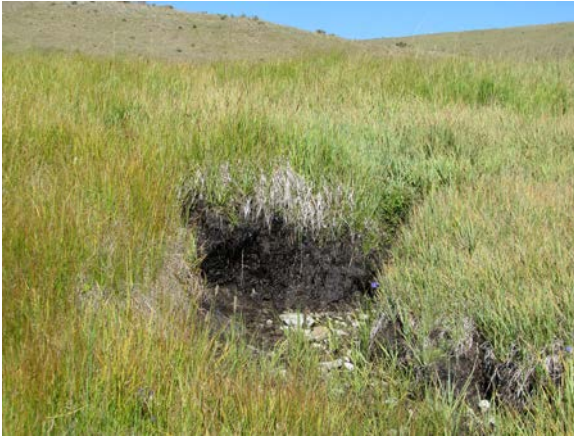
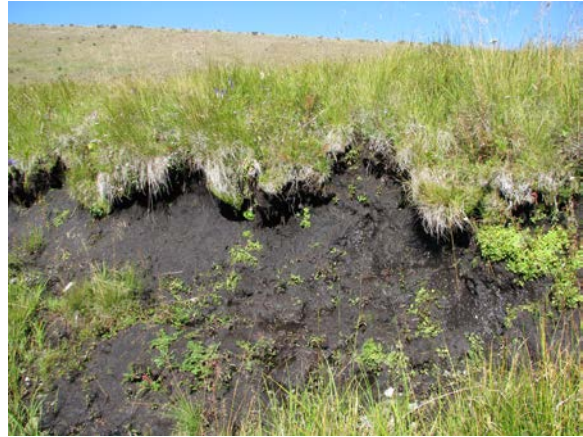
Headcuts are severe and are draining the fen. Stabilizing the large fen complex should be the highest priority in this drainage.

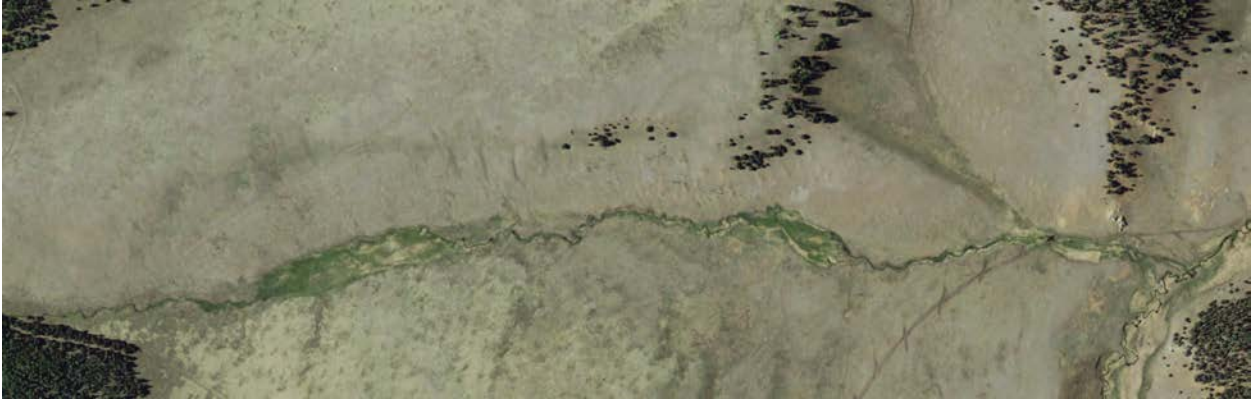
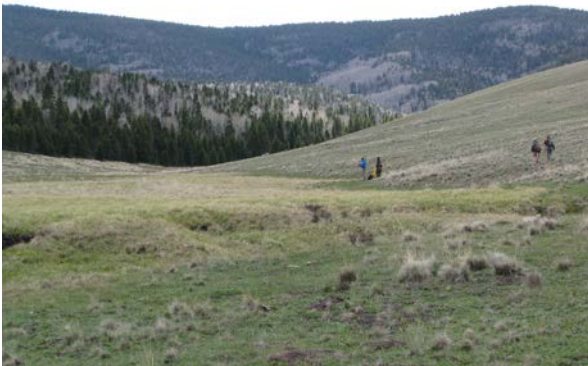
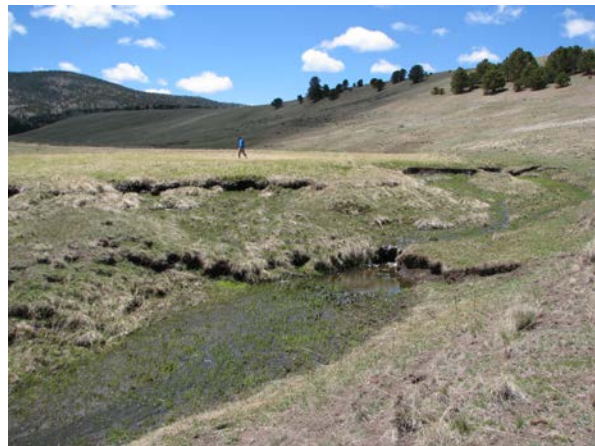
## ***Foreman Creek***

Foreman Creek has good access and a large slope wetland complex that is in need of stabilization. Restoration potential is high and access is good; however, the restoration material source might be an issue.

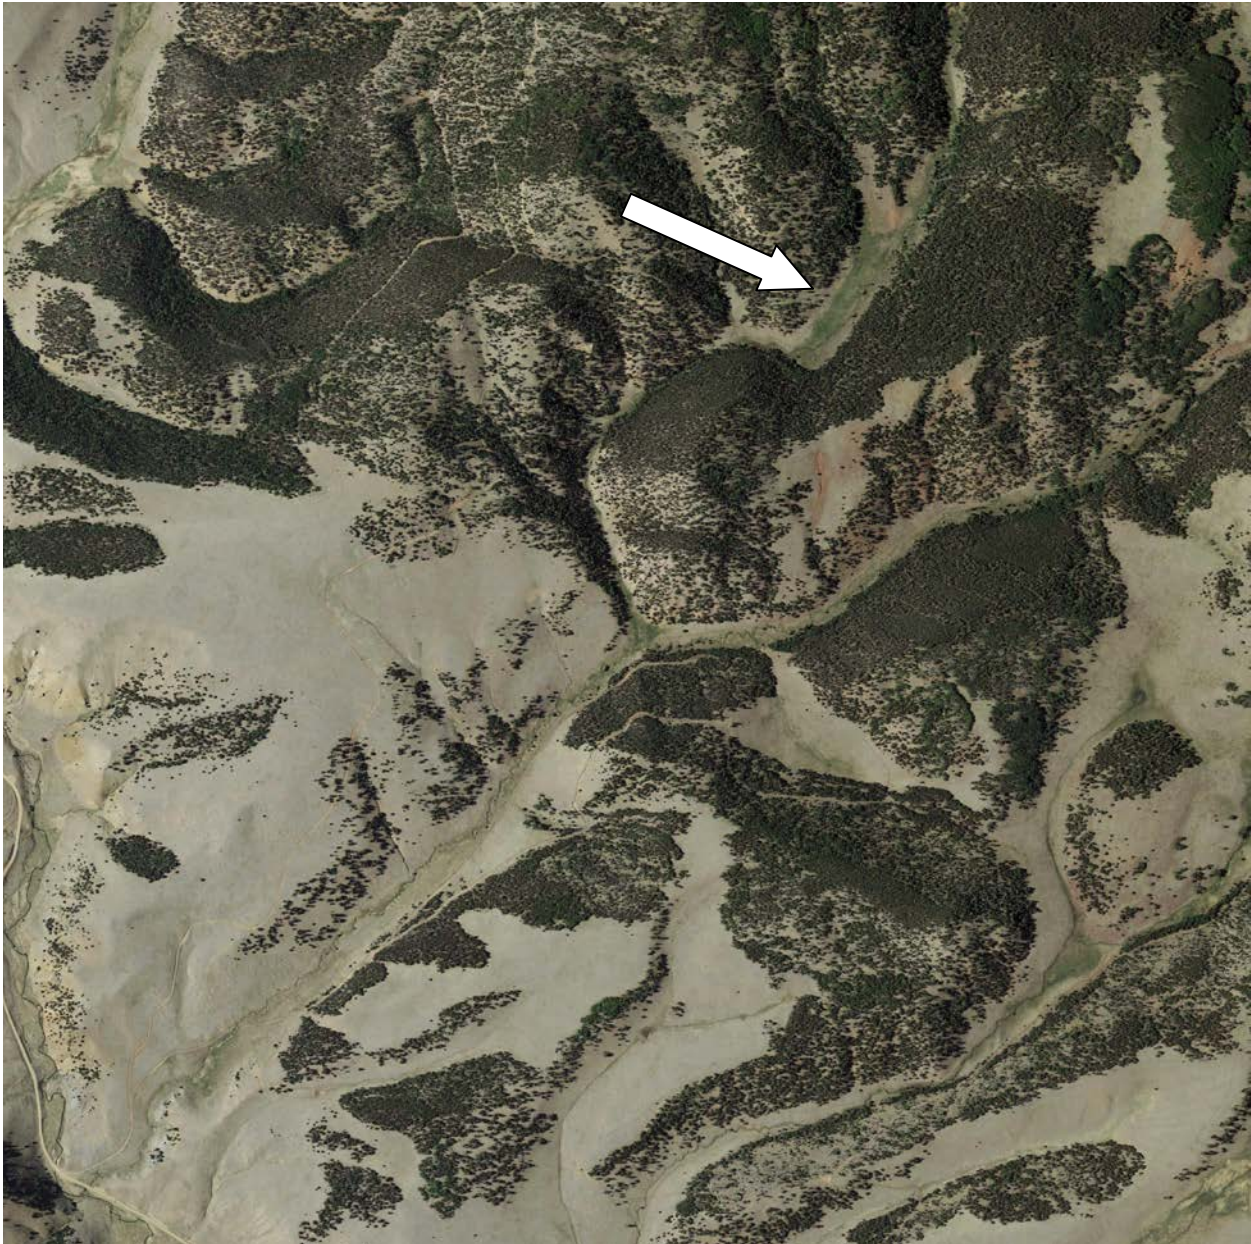
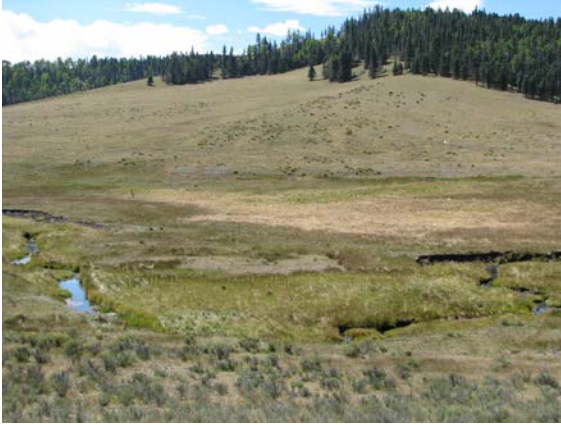
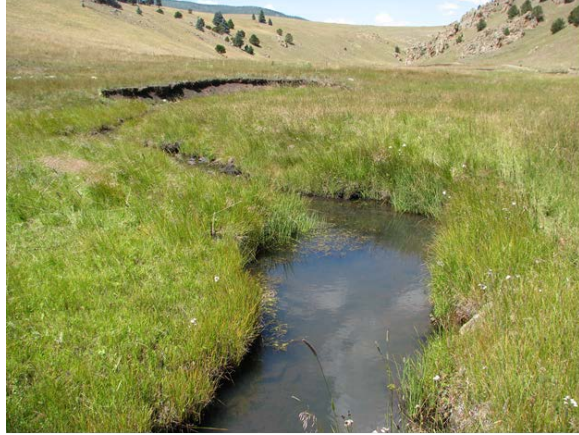
## *Little Costilla Creek*

There are large slope wetland complexes in the very highest portions of the Little Costilla Watershed. The lower portions of Little Costilla Creek have high potential as Rio Grande cutthroat trout habitat. Restoration of these wetlands needs more consideration weighing factors of access and logistics as well as the potential implications for Rio Grande cutthroat trout habitat with stabilization and restoration of these headwater wetlands.

Restoration work in the creek to prevent further down cutting or bank erosion will help stabilize the existing riparian wetlands and prevent further drying of wetland vegetation and conversion to wet meadow or upland vegetation types.

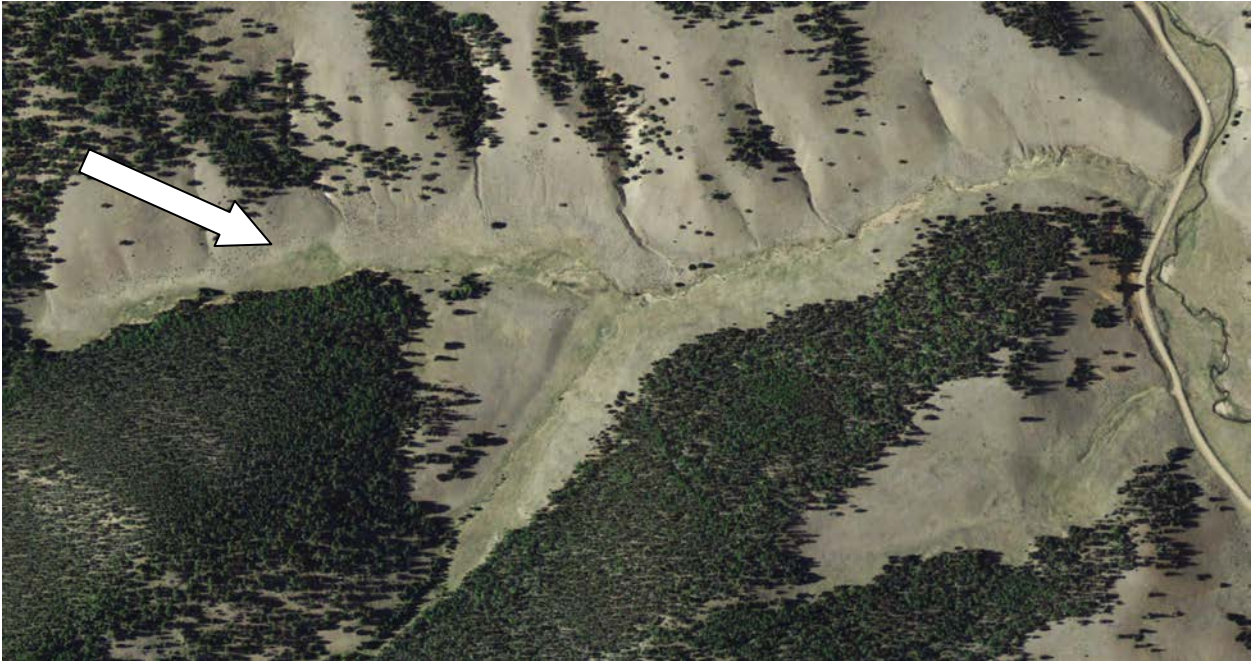
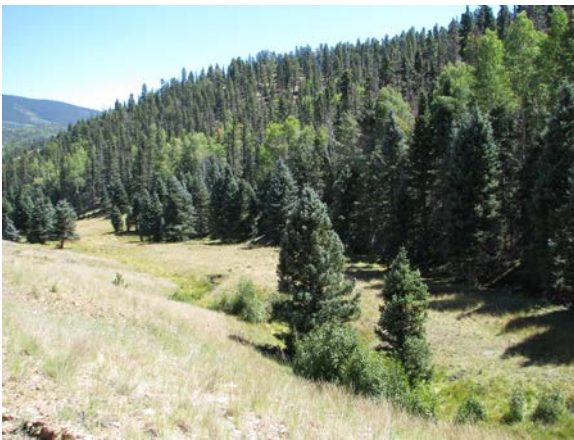
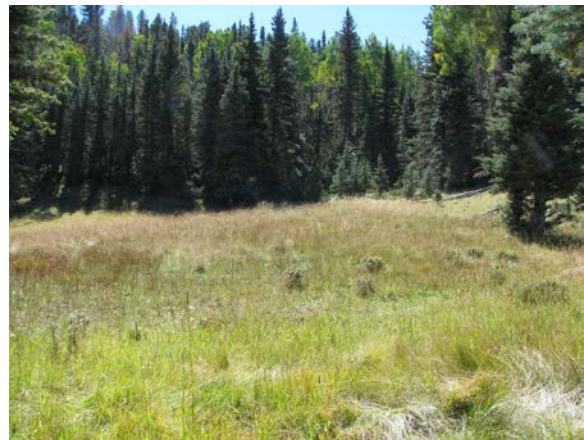
## ***Fernandez Canyon***

Fernandez Canyon has potential for wetland restoration and is currently Rio Grande cutthroat trout habitat.

High in the watershed, there are places (white arrow in aerial photograph) where former slope wetlands have become dry meadows. The restoration potential of these former slope wetlands should be balanced against the potential impacts on Rio Grande cutthroat trout habitat. Restoration of these upper slope wetlands might be beneficial to the Rio Grande cutthroat trout habitat in the lower sections of the tributaries leading down to Comanche Creek.
