# Wetland Action Plan

## Comanche Creek Watershed

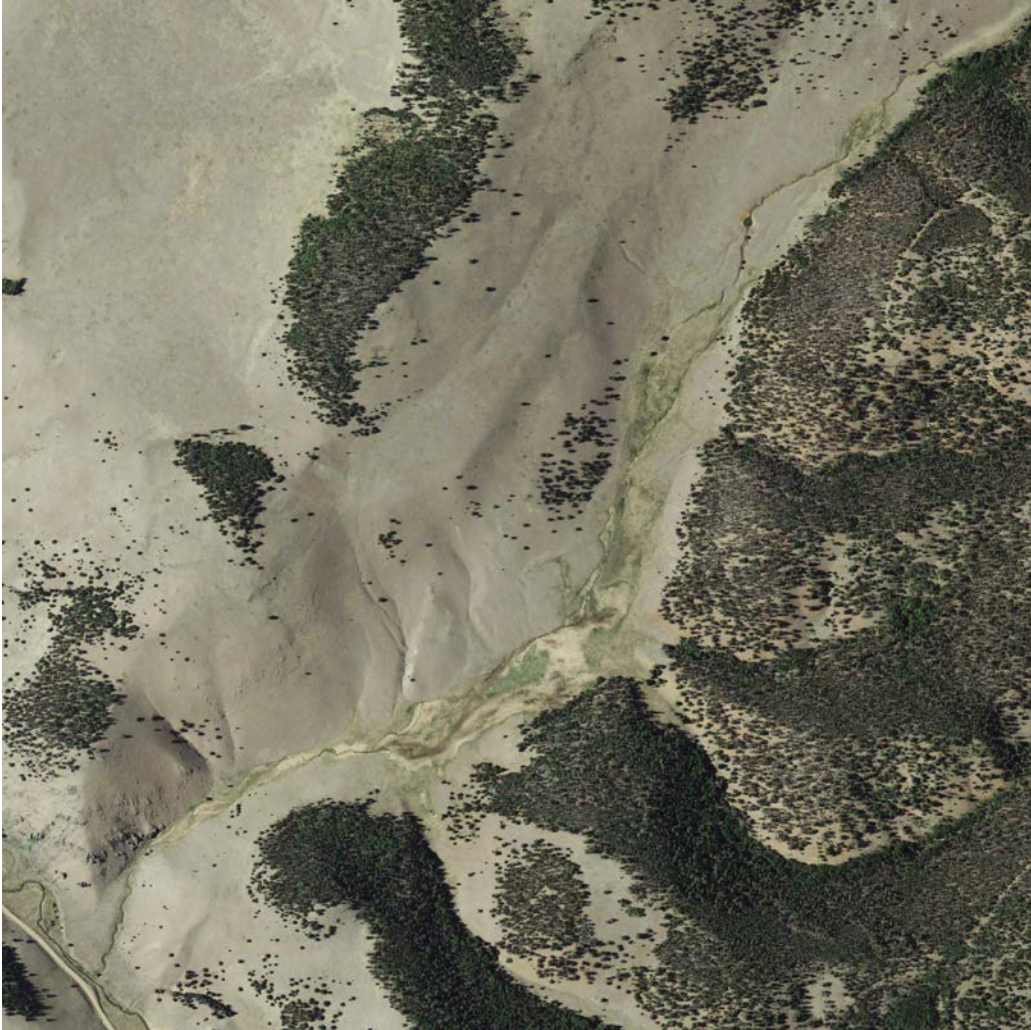
The extensive wetlands are draining through large headcuts and incised channels.

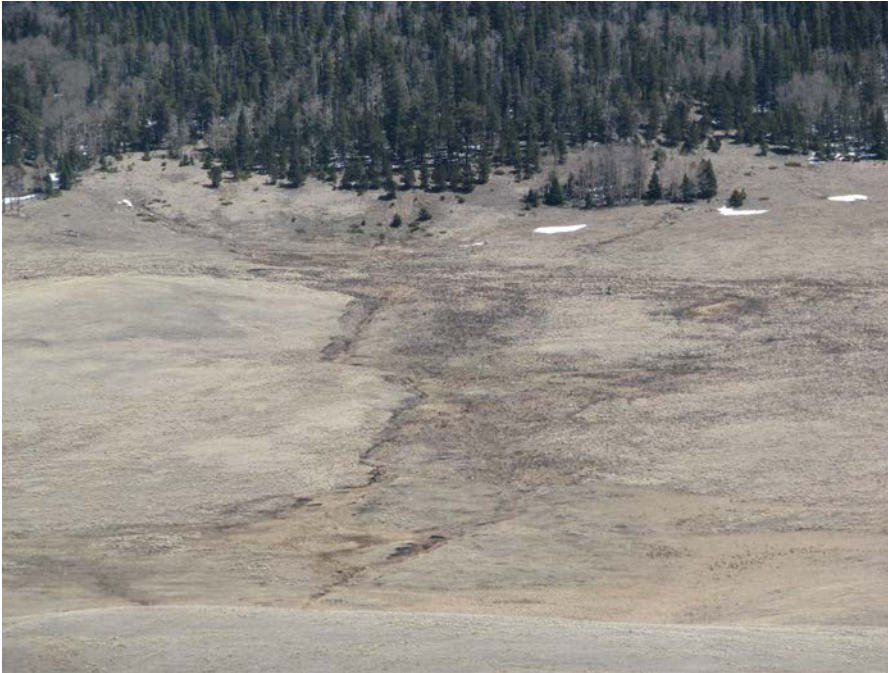
Springs feed many of the slope wetland complexes in the Vidal Creek Watershed. The picture above faces in the direction of the white arrow in the aerial image. The presence of groundwater augmentation increases the likelihood of restoration success once downcutting channels have been stabilized and the restoration treatments have returned the system to dispersed flow. Headcuts that are travelling up valley, illustrated by the photo below, are causing the wetlands to degrade in this watershed.

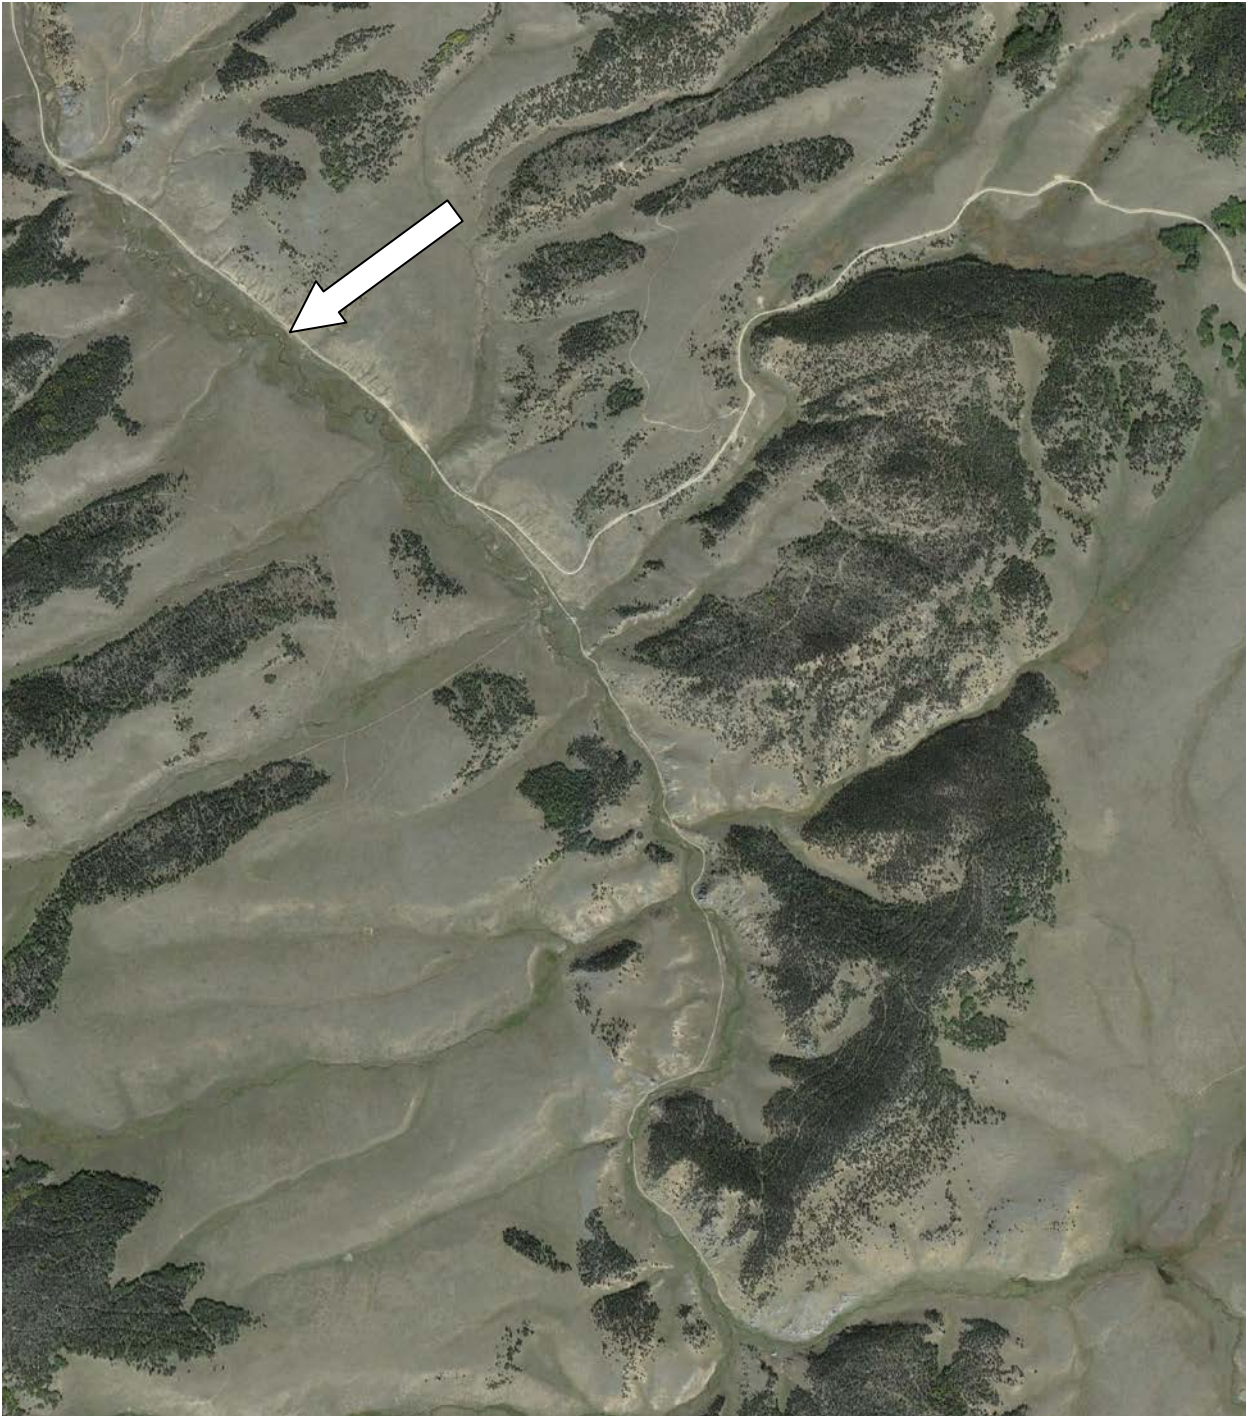
***Upper Comanche Creek (north of confluence with Vidal Creek)***

While the Comanche Creek channel has been the subject of many restoration treatments, less work has been focused on the riparian wetlands in the floodplain. Areas where slope wetlands intersect with the riparian wetlands should get priority for restoration attention, due to the higher quality of existing wetland and the high potential for restoration success because of the presence of groundwater that augments riparian hydrologic flow.

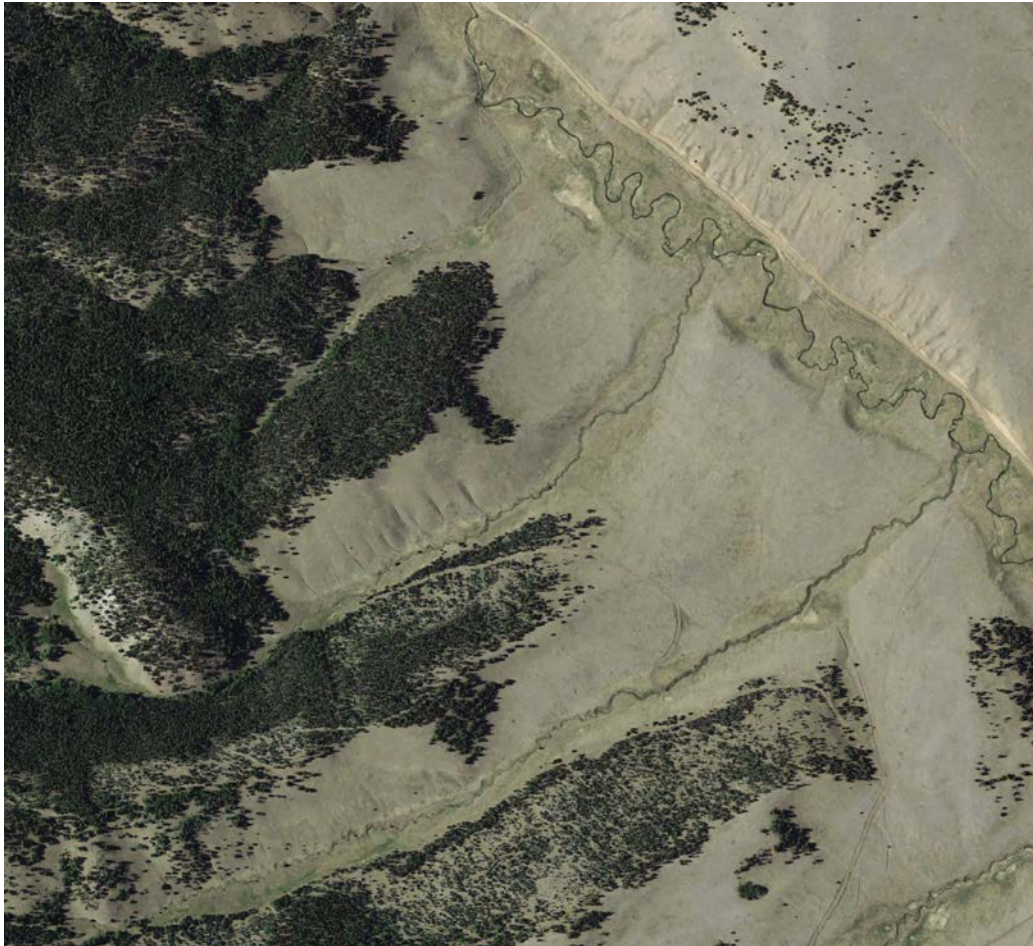
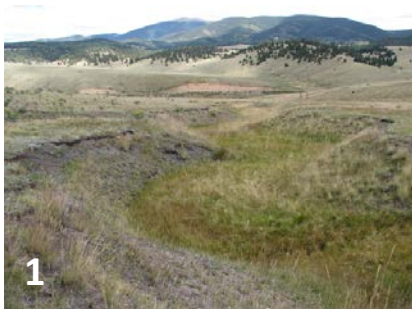
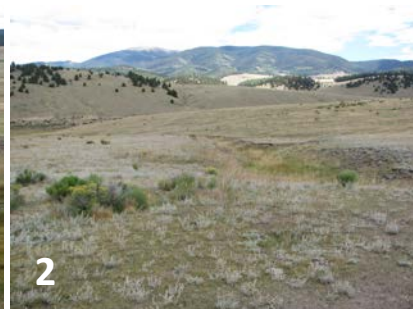
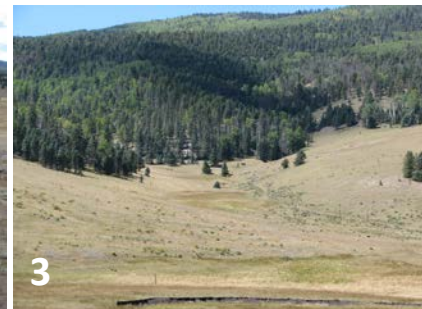
### ***Unnamed Tributaries 1, 2, and 3***

Unnamed Tributaries 1 and 2 (South to North) have a small watershed area and very little flow, and they are fairly incised. Restoration potential is low for 1 and 2. Unnamed Tributary 3 may have potential for restoration, but is likely an archaeological site due to the cabin and the existence of scattered debris. Where Unnamed Tributary 3 nears Comanche Creek, there is a large spring-fed slope wetland where the white arrow is pointing in the aerial photograph. This area should be considered for restoration treatment.

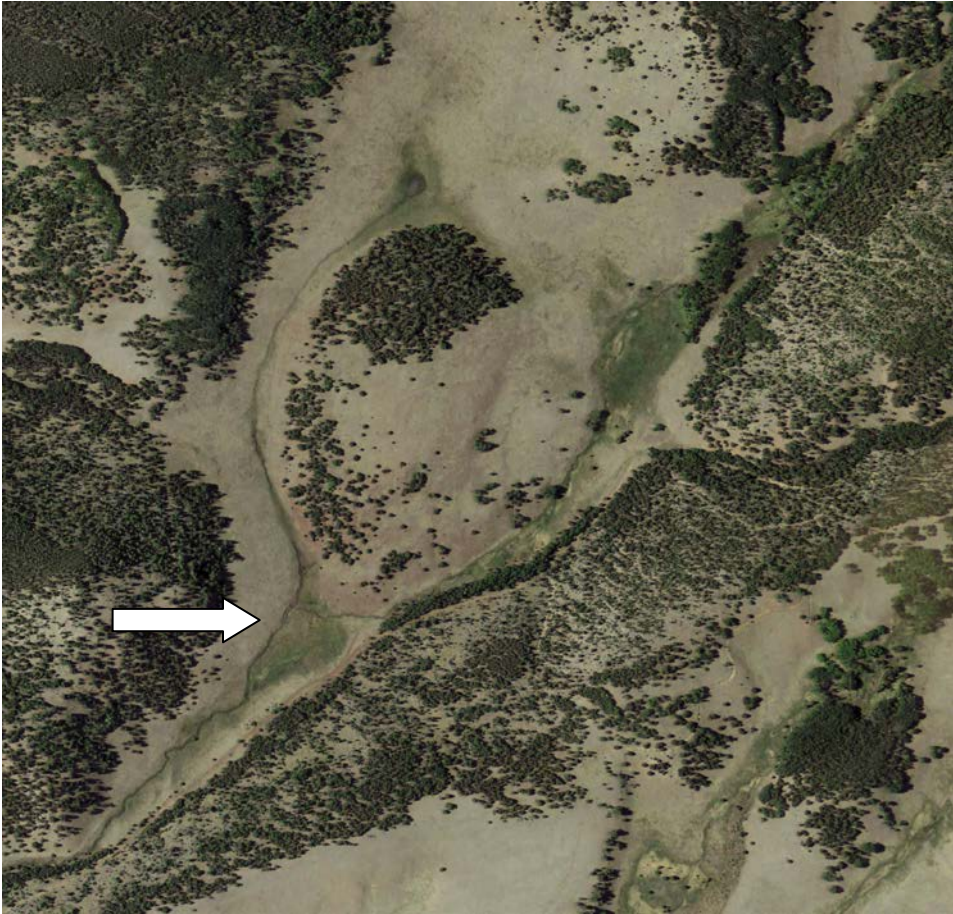
The slope wetlands visible in the aerial photograph were treated in 2013 and 2014. Over time, it is hoped that the lower wetland (white arrow) will once again expand across the entire valley.

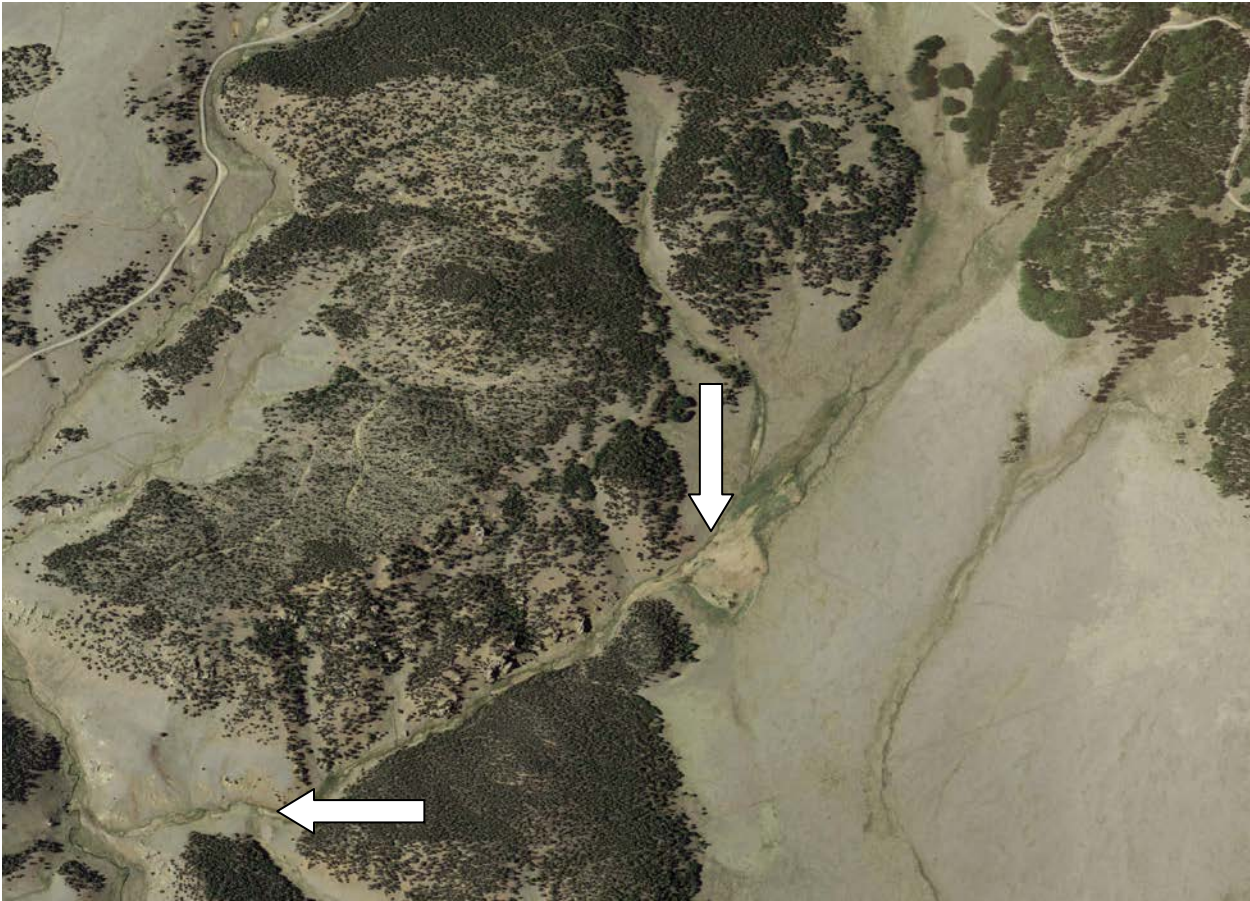
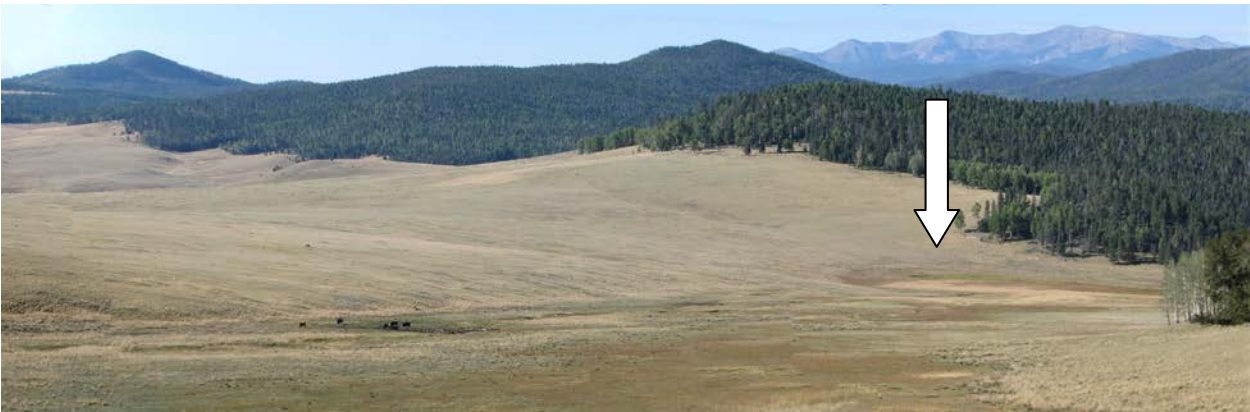
## *Grassy Creek*

Both the upper portion of Grassy Creek (vertical white arrow in aerial photograph) and the lower portion (horizontal white arrow) have been treated using RERI and NMED Slope wetland grant funds.
